**Final  
Interim Action Completion Report  
Rod Mill Area Closed Landfill  
Former Kaiser Aluminum Property  
3400 Taylor Way  
Tacoma, Washington**

April 14, 2014

**Port of Tacoma  
Tacoma, Washington**

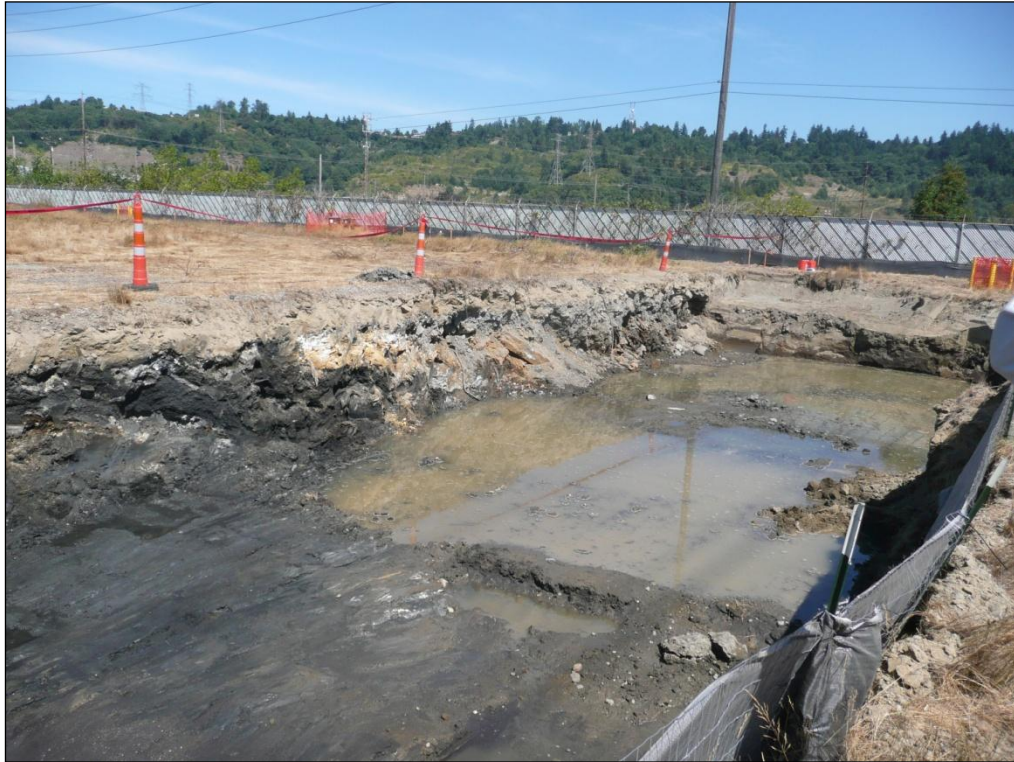
1. Looking northeast from the southern side of the Closed Landfill excavation (in progress).

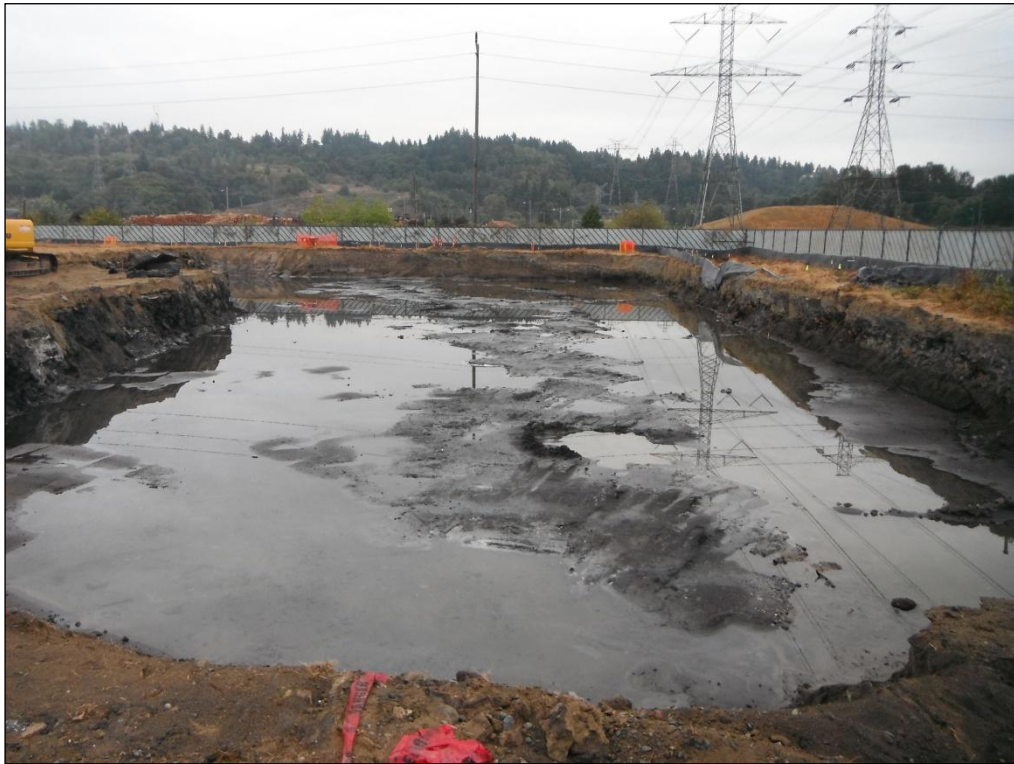
2. Looking east across the Closed Landfill area excavation (in progress).

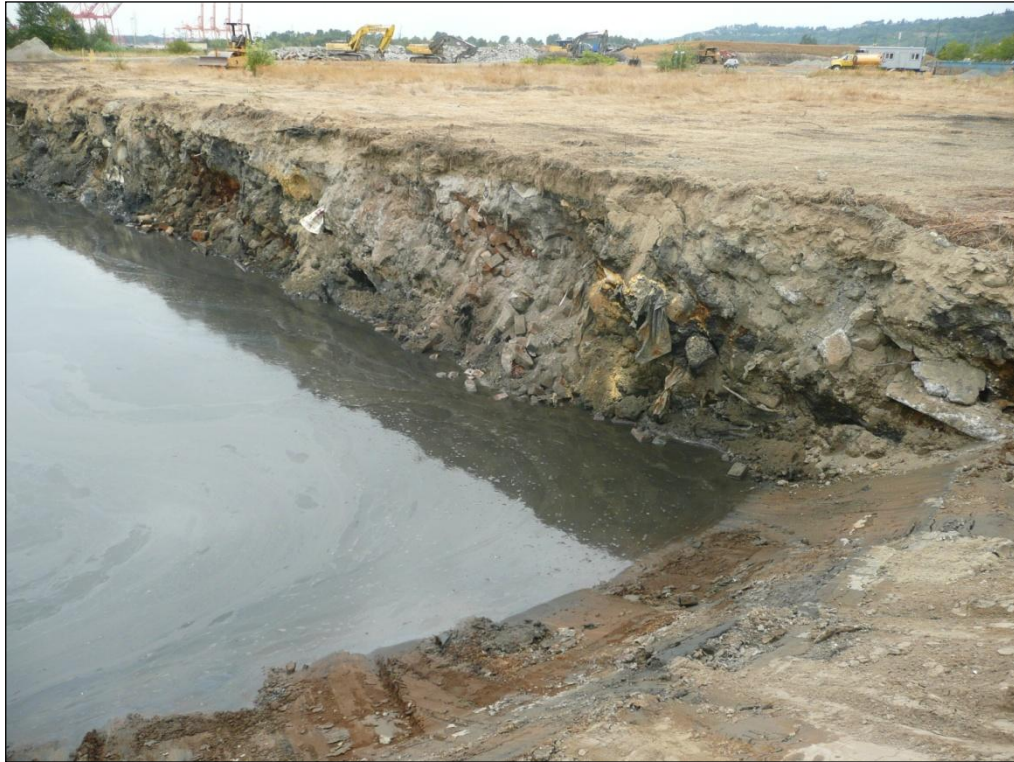
3. Representative waste material excavated from the Closed Landfill area, including bricks, concrete fragments, rebar, plastic sheeting, etc.

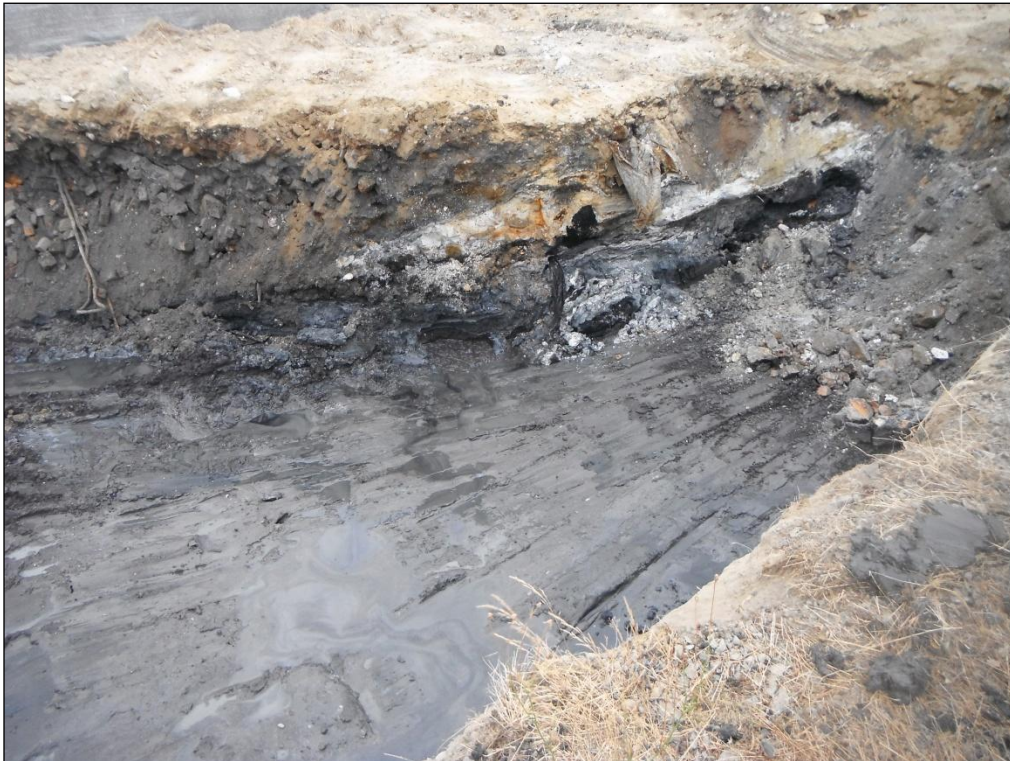
4. Closed Landfill waste and underlying native silty material.

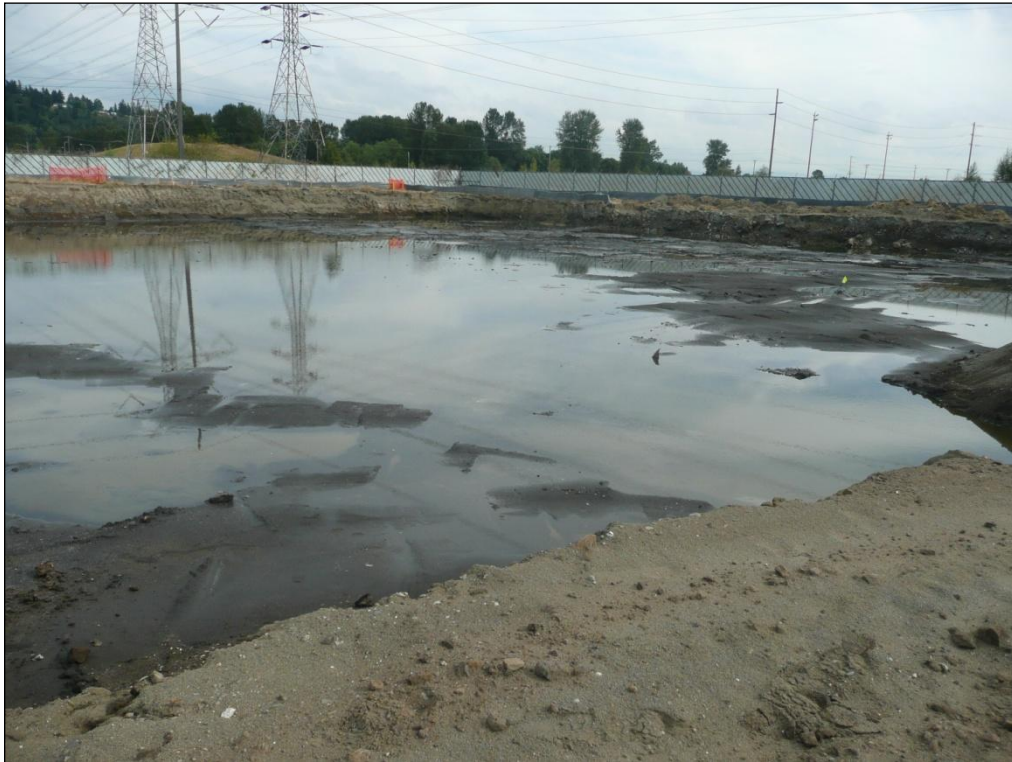
5. Looking southeast across the completed Closed Landfill excavation.

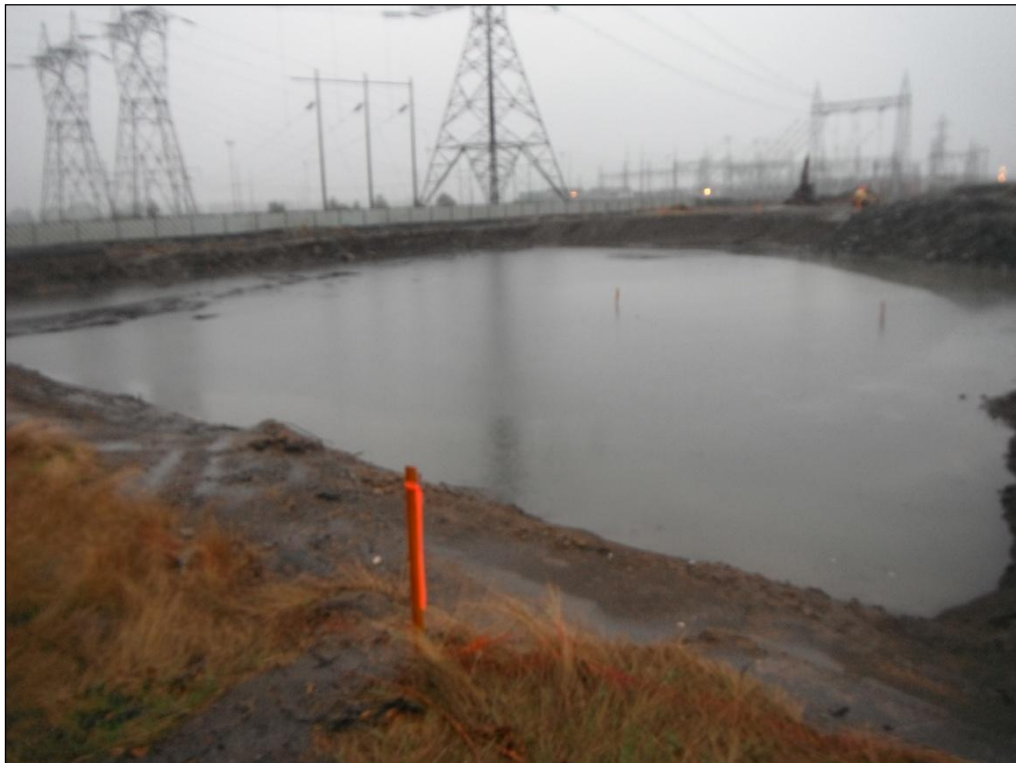
6. Looking southwest across the completed Closed Landfill excavation after a rise in groundwater level.

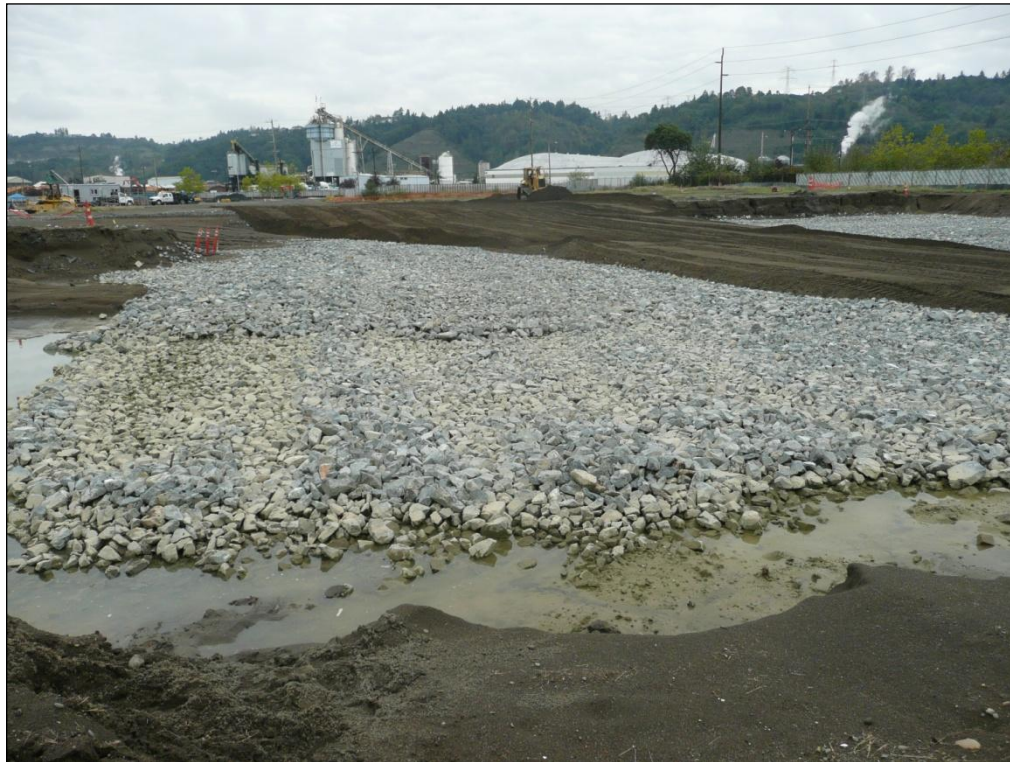
7. Looking north across the Closed Landfill area after placement of quarry spalls and during placement of surficial sand fill material.

Following receipt of Ecology's concurrence to proceed with backfilling excavation grids that met cleanup levels, the base of the excavation was backfilled with quarry spalls to bring the grade above the groundwater table and create a stable base prior to backfilling with soil. Approximately 3,000 tons of quarry spalls were placed within the excavation area.

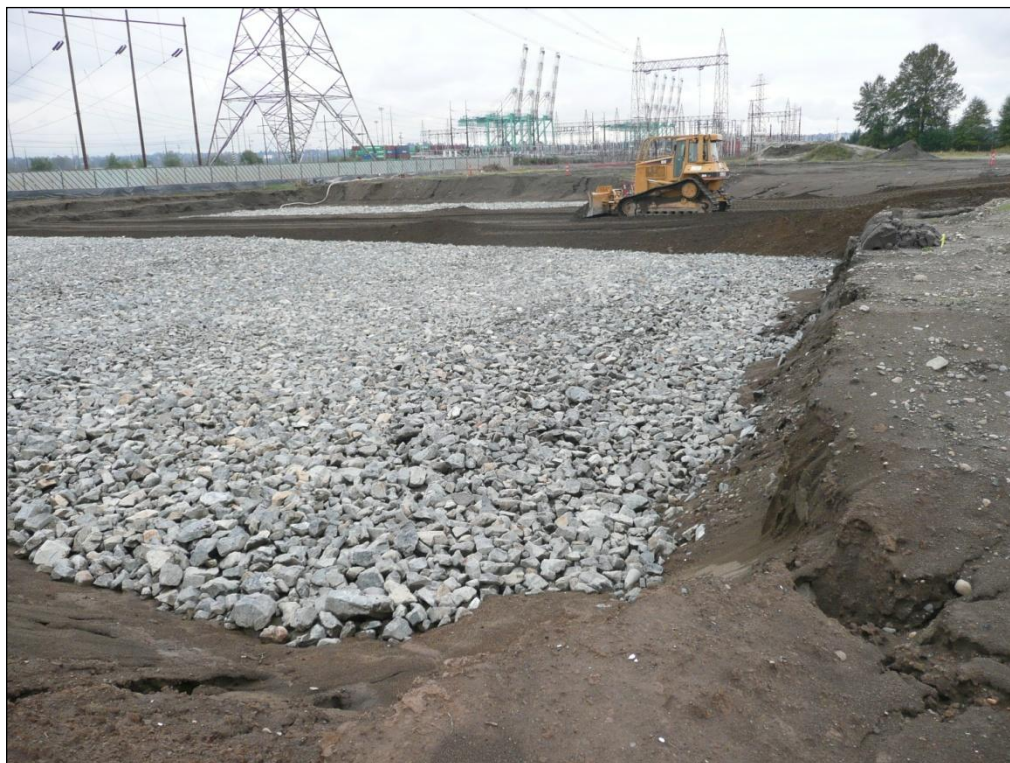
8. Looking southwest across the Closed Landfill area after placement of quarry spalls and during placement of surficial sand fill material.

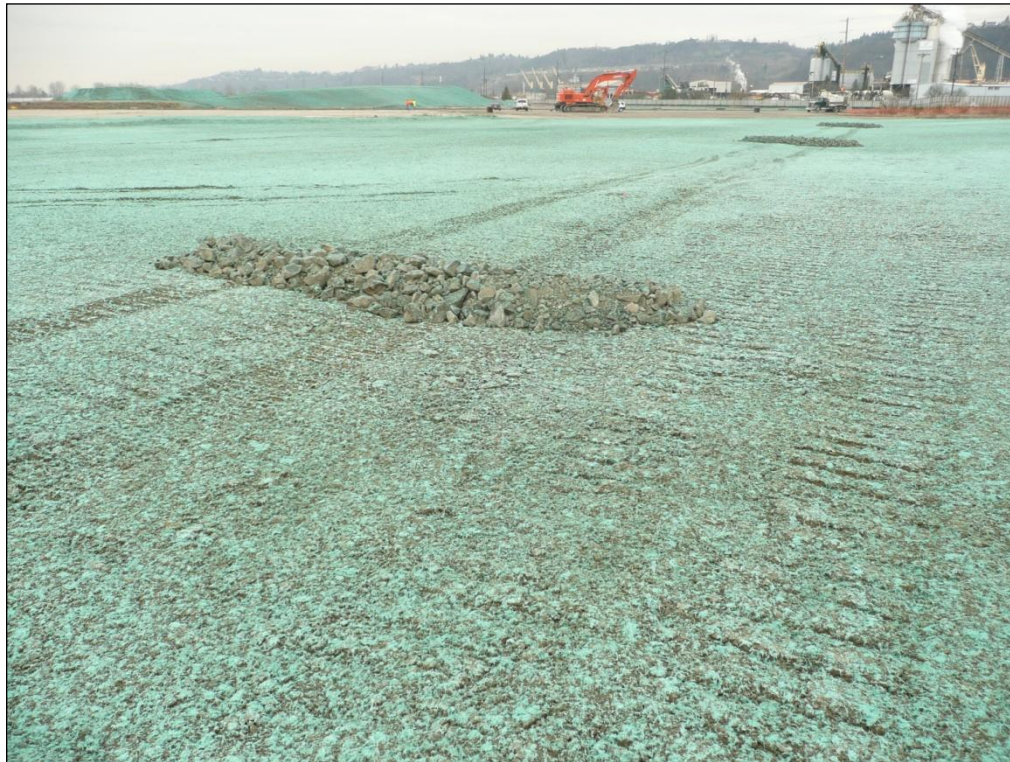
9. Looking northwest at the quarry spill check dams placed across the central drainage swale after completion of excavation backfilling.

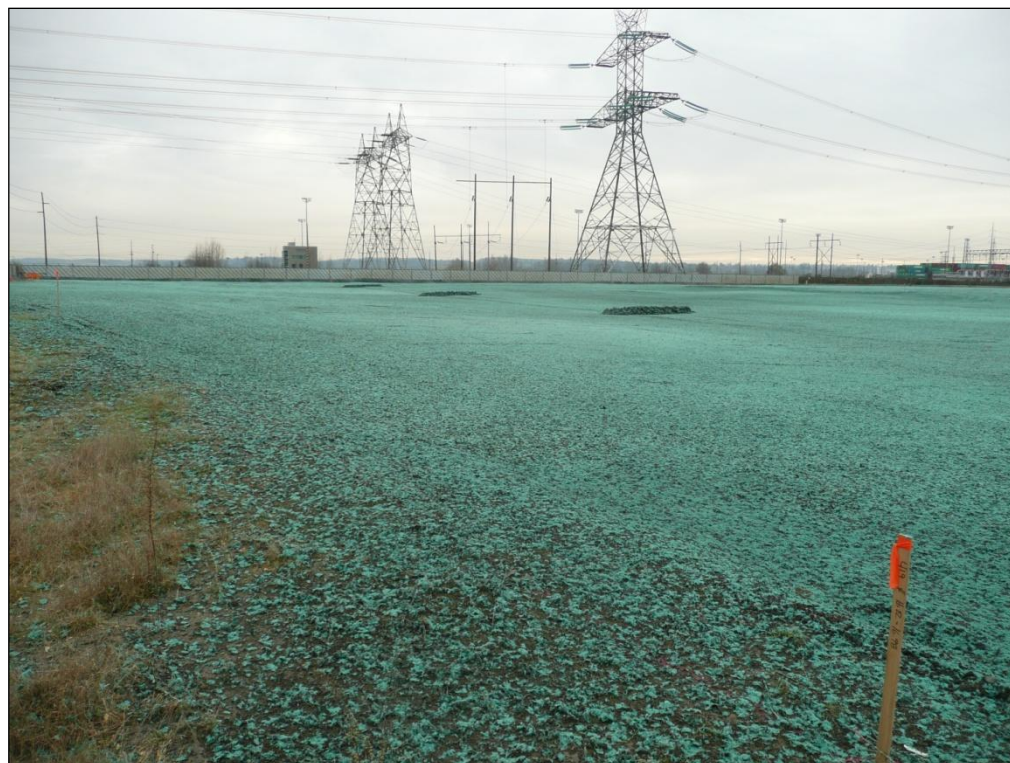
10. Looking southwest across the Closed Landfill area after completion of excavation backfilling and hydroseeding.
