NPDES Compliance Inspection Report

DEPARTMENT OF ECOLOGY
NORTHWEST REGIONAL OFFICE
INSPECTION REPORT

FACILITY: Treoil Industries, Ltd.

TYPE OF FACILITY: Distillation of tall oil

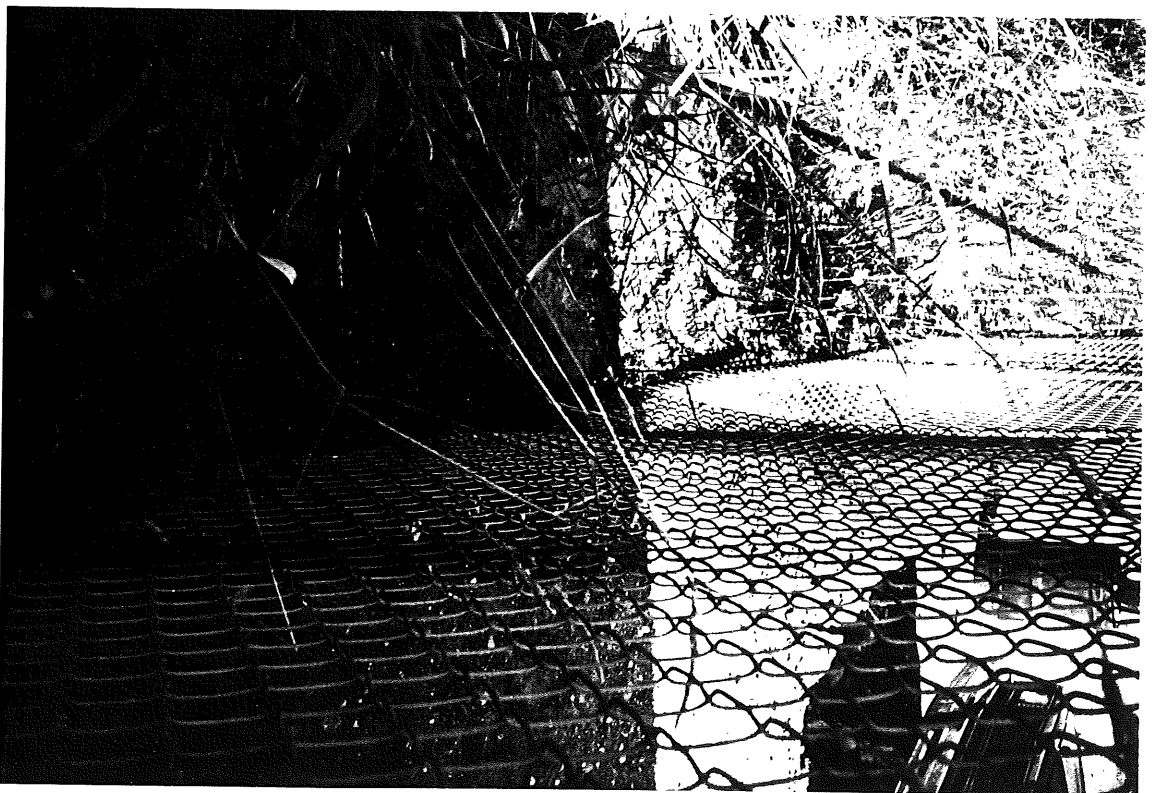
PHOTO NO: 2 DATE: 8/13/92 TIME: _____
TAKEN BY: PE WITNESS: DK
FILM/SPEED: _____ CAMERA: _____
DESCRIPTION: Trench leading to South Swamp
COMMENTS: oil contamination visible

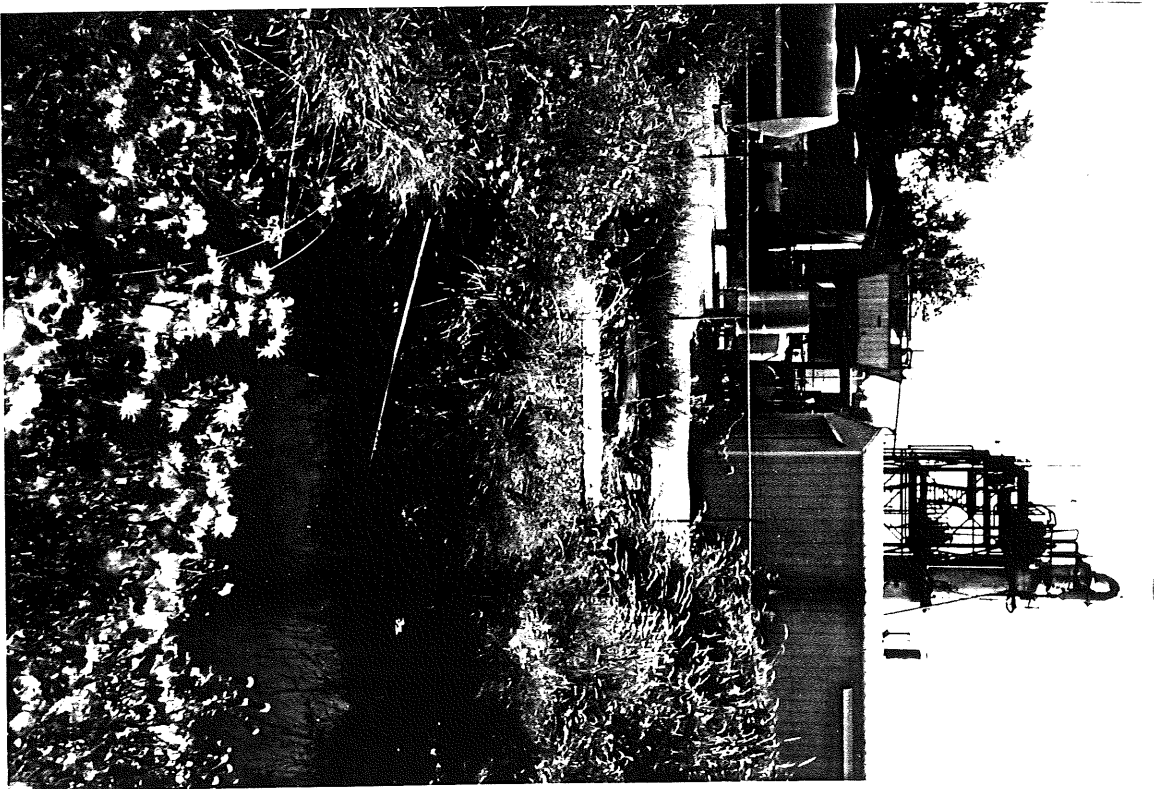
PHOTO NO: 4 DATE: 8/13/92 TIME: _____
 TAKEN BY: PE WITNESS: DK
 FILM/SPEED: _____ CAMERA: _____
 DESCRIPTION: Second ~~Swamp~~ ~~discharge~~ ~~ditch~~
channel of water swamp
 COMMENTS: Thick, fernoid, black

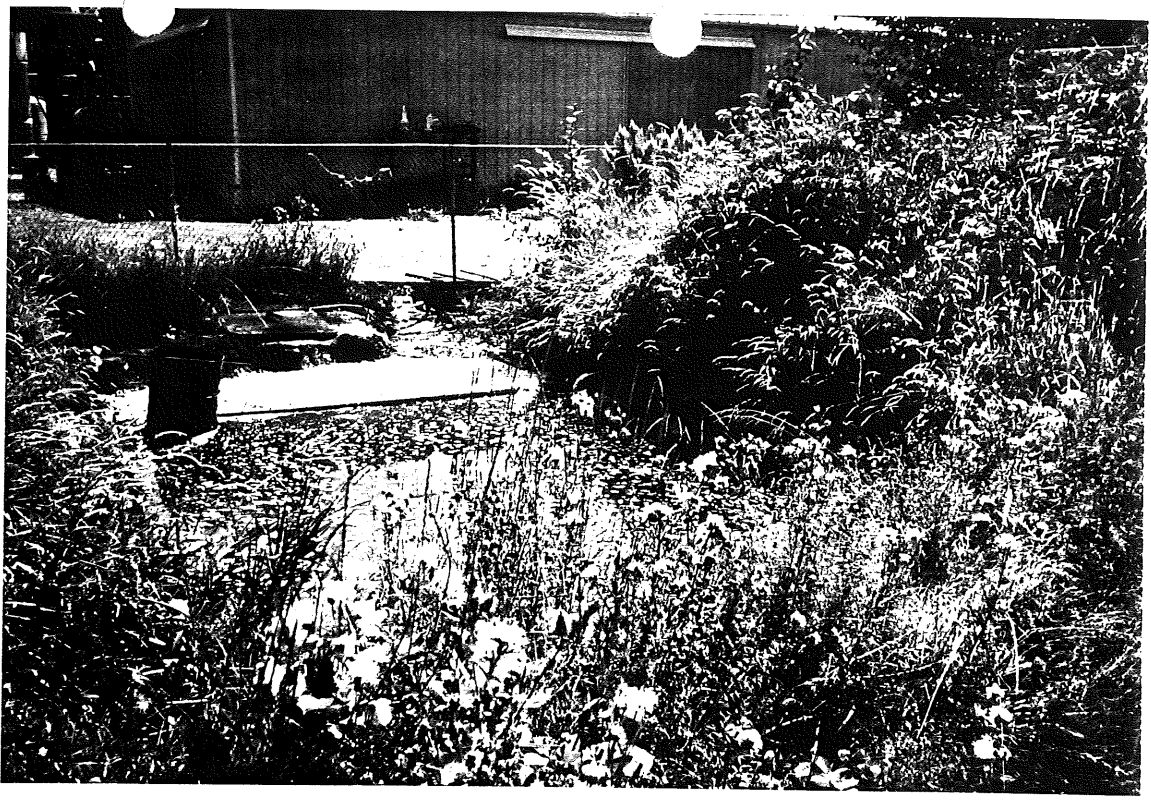
PHOTO No: 5
DATE: 8/13/92
TIME: 11:50
TAKEN BY: PC

First chamber
of North
Swamp

highly
contaminated

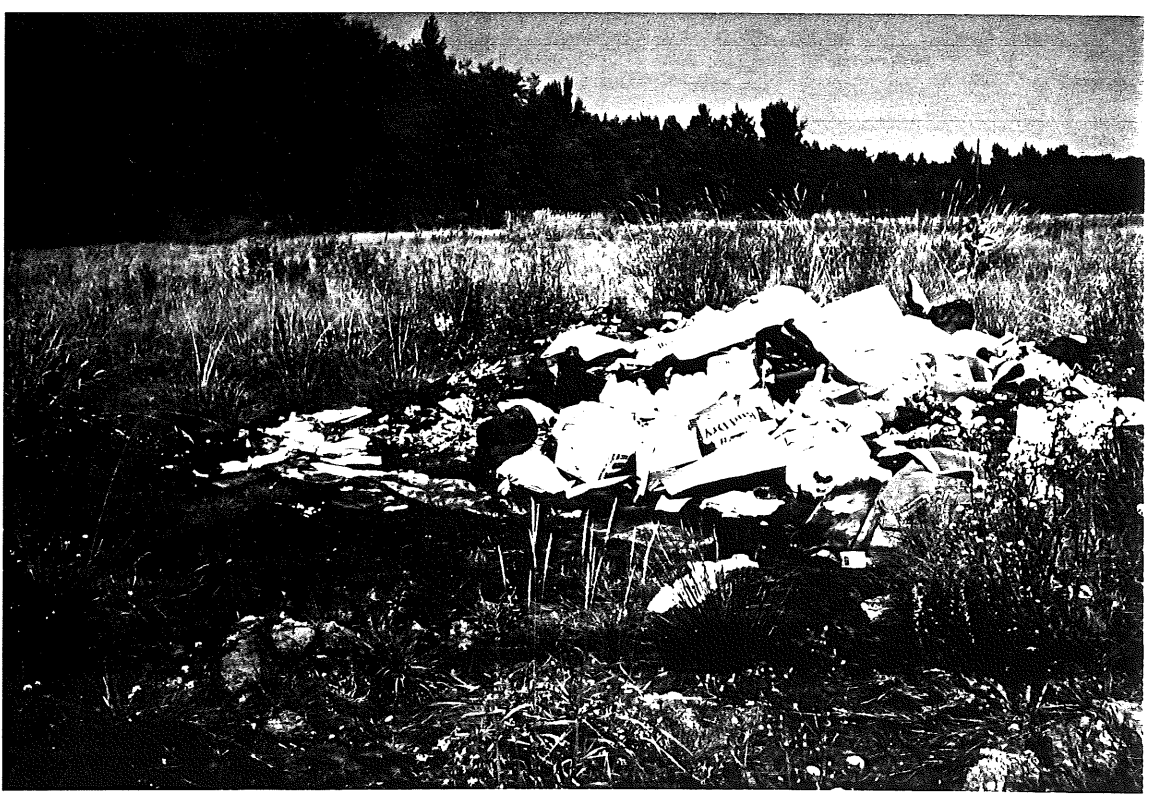
PHOTO No: 6
DATE: 8/13/92
TIME: _____
TAKEN BY: PC

5. Solid waste piles were haphazardly scattered about outside and inside the fenced property. An oily sludge was visible next to an empty drum.

solid waste
outside
fence

- I will try to contact Mr. Sidhu to determine what the plans are for the facility.
- I will contact solid waste inspector Stuart Kent and the Whatcom County Health Department to report the improper disposal of solid waste.
- I will also contact Norm Peck in the Clean Up program as this facility may be considered a contaminated site.

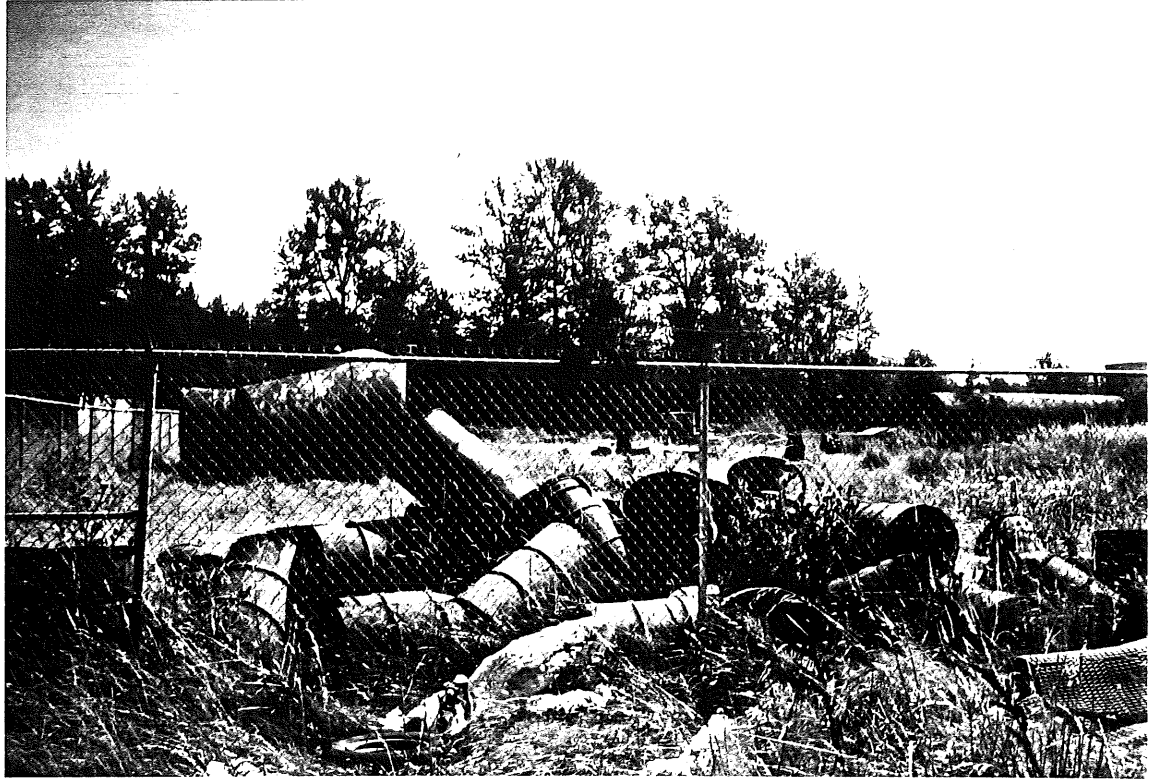
stray drums
inside fenced
property

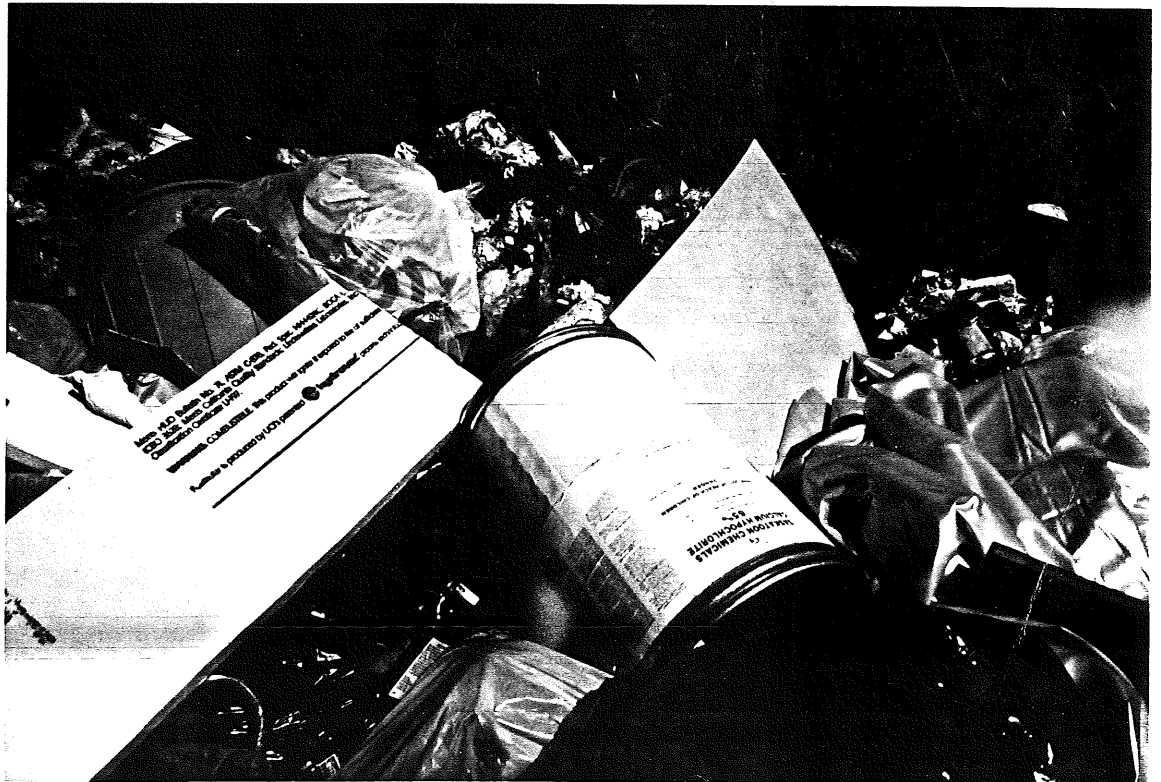
PHOTO No: 8

solid waste
outside fence

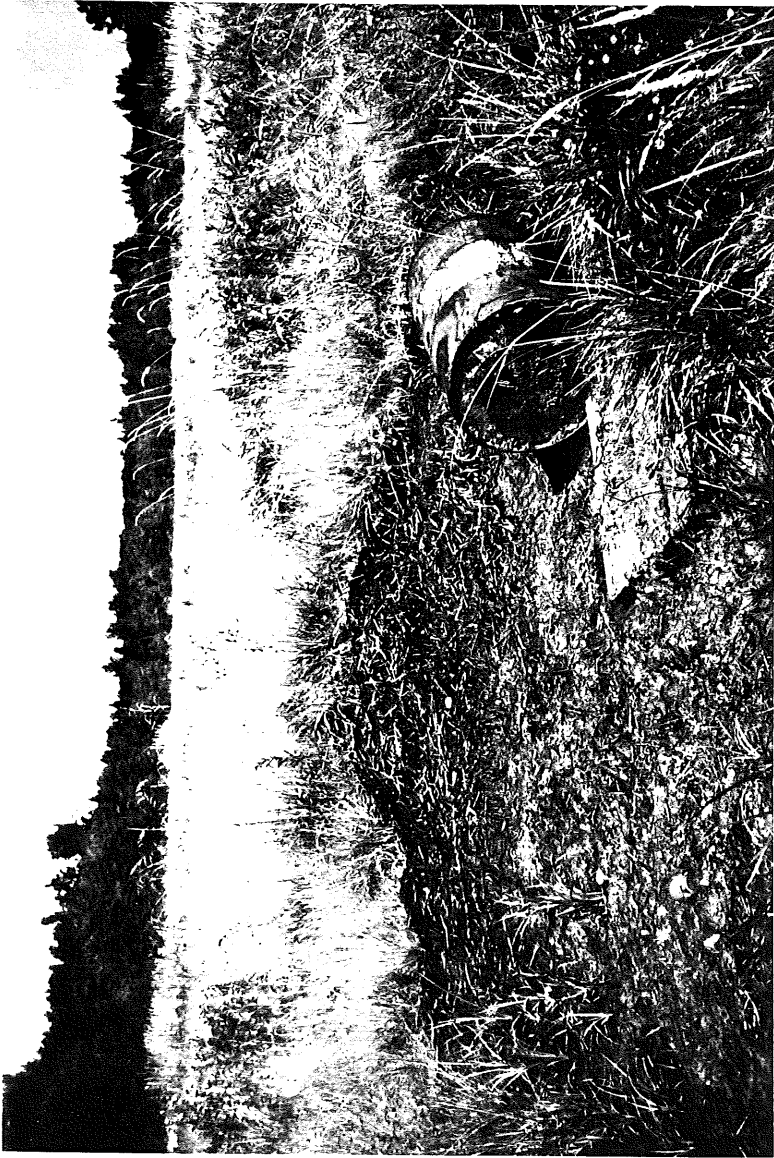
PHOTO NO: 9 DATE: 8/13/92 TIME: 12
TAKEN BY: PE WITNESS: DK
FILM/SPEED: _____ CAMERA: _____
DESCRIPTION: solid waste & soil contamination
COMMENTS: near North Swamp

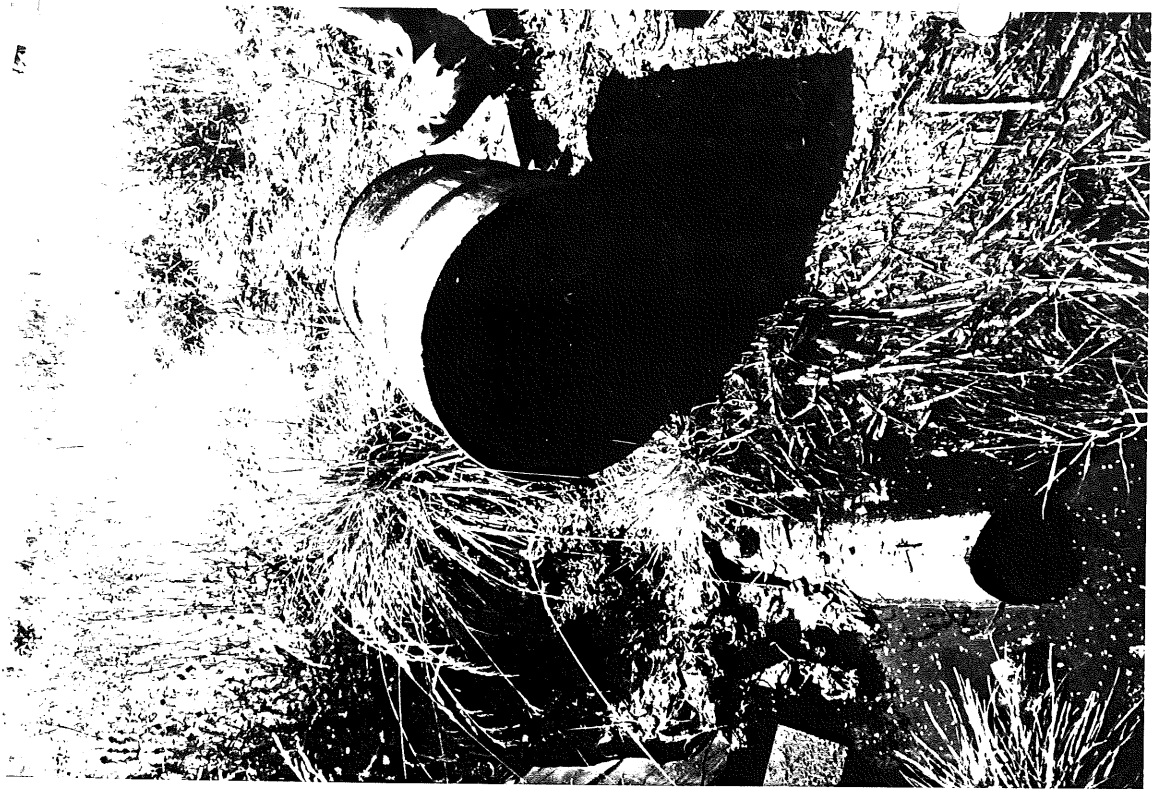
PHOTO NO: 10 DATE: 8/13/92 TIME: _____
TAKEN BY: PE WITNESS: DK
FILM/SPEED: _____ CAMERA: _____
DESCRIPTION: contaminated water & soil
COMMENTS: near North Swamp

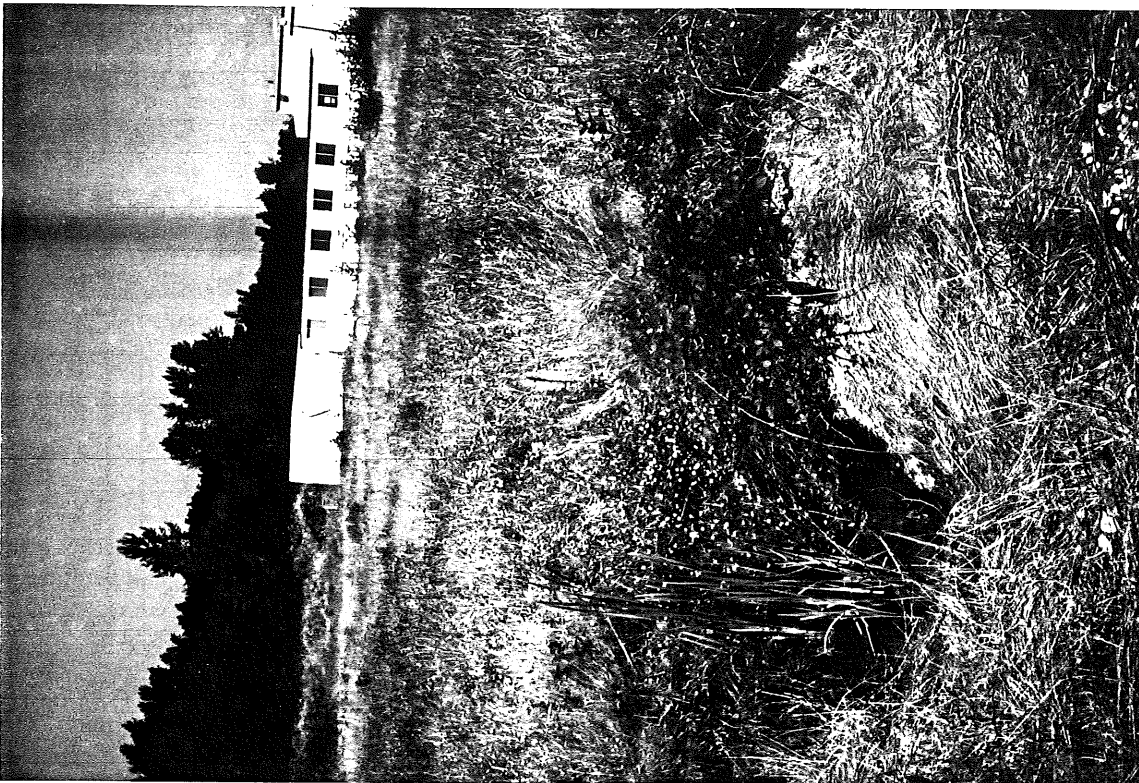
PHOTO NO: 12
 DATE: [Blank]
 TIME: [Blank]
 TAKEN BY: [Blank]
 WITNESS: [Blank]
 FILM/SPEED: [Blank]
 CAMERA: [Blank]
 DESCRIPTION: Discharge from property
 COMMENTS: enters drainage ditch along the road
