STATE OF WASHINGTON  
DEPARTMENT OF ECOLOGY

RE: Dangerous Waste Compliance Inspection at Treoil Industries, Ltd.  
RCRA ID#: (None) on July 11, 2006

**Washington Department of Ecology  
Hazardous Waste & Toxics Reduction Program  
Compliance Report**

**Site:** T.G. Energy/Treoil Industries, Ltd.  
**RCRA ID#:** None  
**Inspection Date:** July 11, 2006  
**Site Contacts:** John Caleb, TG Energy  
**Phone:** (360) 322-4031 **FAX:**  
**Mailing Address:** 1685 H. Street, # 562  
Blaine, Washington 98230  
**Site Location:** 4242 Alder Grove Road  
Ferndale, Washington 98248  
**At This Site Since:** **NAICS#:**  
**Generator/Site Status:** Unknown

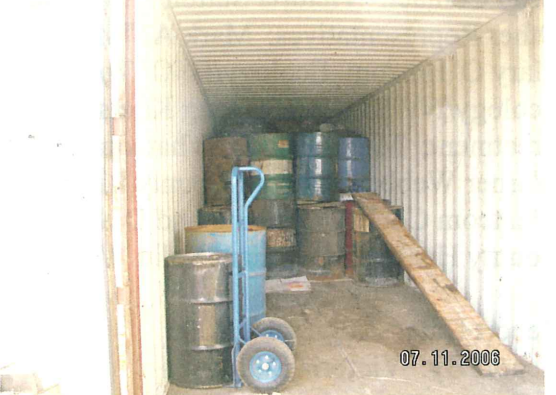
Area (Photo # /Time)	Notes	Photographs
(Photo # 6 / 11:18 am)	Drums stored in sea container.

On the west side of the site were two large sea containers. The reddish container was said to be empty, and the blue container was half filled with 55-gallon drums stacked two high (see Photo # 6). The drums did not have any labels or aisle space. John stated that the drums contained yellow oil, and some contained brown oil. John said the brown oil was grease from cooking food, and the yellow grease was from fryers that did not contain cooked food scraps. The drums were not labeled and only the front drums were visible.

Norm Peck stated that the drums that John had said contained brown grease from food scraps may actually be the drums that contain dangerous waste. Norm had sampled drums during his work on the site hazard assessment several years ago. These drums have been moved from their former location.

Test results from these samples showed that drums on site contained tall oil that failed the fish toxicity test under the Dangerous Waste Regulations and therefore was a state-only dangerous waste (waste code WT02). Some of the waste has been spilled onto the ground and is still visible in a few places. It has not been cleaned up.

- a) Waste in drums in the sea container (see Photo # 6);
- b) Waste in drums and tanks on site, excluding usable product drums and tanks;
- c) Lab chemicals in trailers (see Photo # 8);
- d) Sludge cleaned out of sumps, tanks or other containers or locations;
- e) Soil contaminated with spills (see Photos # 36, # 33, and # 34);
- f) Sludge and water inside secondary containment areas;
- g) Sandblast grit (see Photo # 11);
- h) Refractory dust (see Photo # 16).
- i) Any other wastes having the potential to be dangerous waste.

*Within 90 days of receipt of this letter, provide to the Department documentation that designation of the solid wastes listed above has occurred. This documentation shall include, but not be limited to, copies of the analytical results of designation testing and any contracts with testing laboratories.*

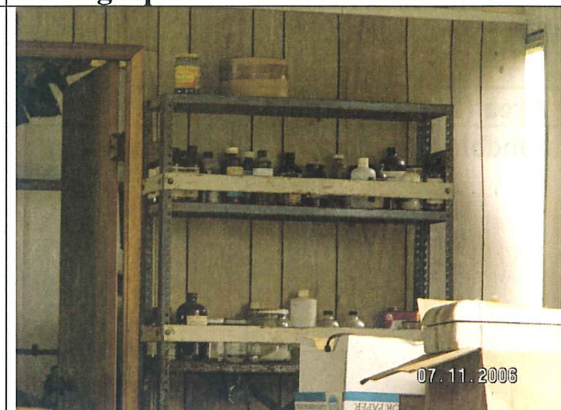
Area (Photo # /Time)	Notes	Photographs
North Side           (Photo # 8 / 11:35 am)	Lab chemicals inside trailer.

On the north side were two trailers that had been used as labs. Some lab chemicals are still stored there (see Photo # 8).

<p>A photograph showing the interior of a trailer. It features metal shelving units with various bottles and containers on them, likely lab chemicals. The date stamp '07.11.2006' is visible in the bottom right corner of the photo.</p>

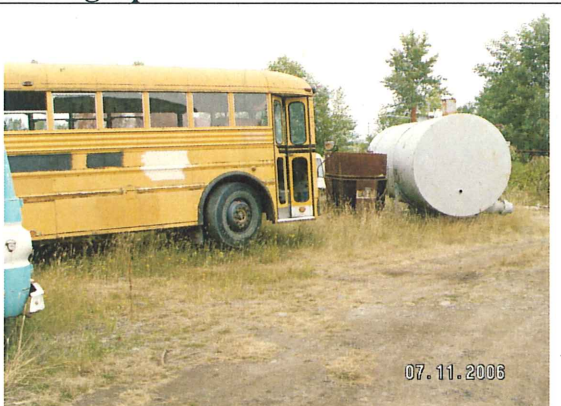
Area (Photo # /Time)	Notes	Photographs
Former Dangerous Waste Storage Area           (Photo # 38 / 1:00 pm)	Drums have been moved from this area to an unknown location.

At the location where Norm had previously found the drums of dangerous waste stored there were no drums (see Photo # 38). Therefore, Norm thought the brown grease drums in the sea container might actually be the dangerous waste.

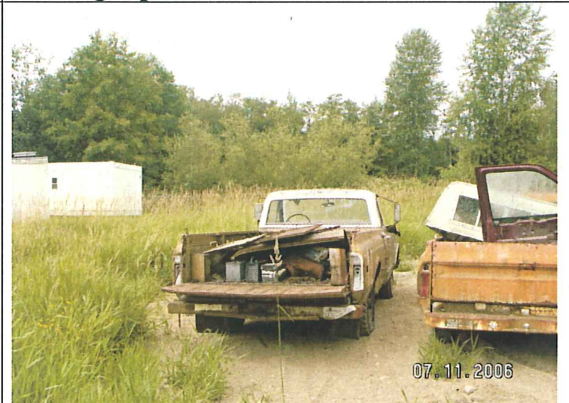
Area (Photo # /Time)	Notes	Photographs
North Yard           (Photo # 10 / 11:42 am)	Batteries stored outside in the back of junked vehicle.

We continued our walk around the site. The property had many types of solid waste strewn around. We went to the area where junk cars were stored. John said that the cars belonged to David Sullivan, a tenant on the property operating a business. One of the trucks had auto batteries stored in the bed (see Photo # 10). David Sullivan has been asked to remove his wastes from the site, but has not yet done so. Other wastes on the property belonging to Mr. Sullivan include spent sandblast grit and refractory dust.

<p>A photograph showing a junked vehicle, possibly a truck, with several large batteries stored in its bed. The vehicle is parked in a grassy area. The date stamp '07.11.2006' is visible in the bottom right corner of the photo.</p>

**2) Battery Storage** - Automotive and marine batteries are hazardous substances because of their acid and lead content. Used batteries are not considered hazardous wastes if they are returned to the vendor for recycling. For your protection against spills or leaks and a site contamination problem, it is best to store used batteries in a shed or have some type of cover rather than storing them in a pickup bed outside.

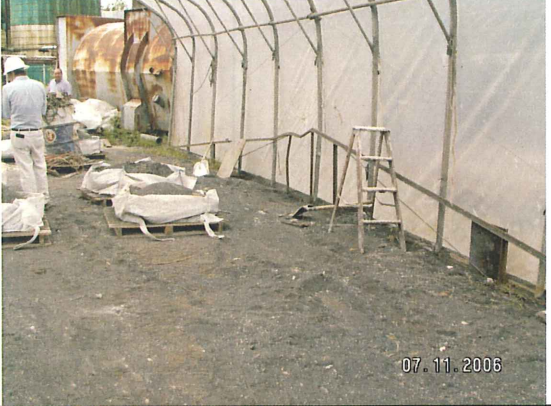
Area (Photo # /Time)	Notes	Photographs
Sandblasting Tent           (Photo # 11 / 11:54 am)	Sandblasting grit on ground.

On the east side of the site we observed sandblasting grit on the ground under an open tent (see Photo # 11). Further down toward the entrance there were bags of refractory dust broken open and strewn on the ground (see Photo # 16).

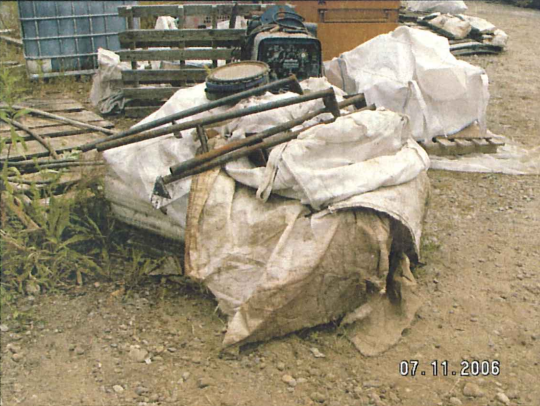
Area (Photo # /Time)	Notes	Photographs
Processing Area           (Photo # 32 / 12:51 pm)	Totes of caustic material used in the biodiesel processes stored on the ground.

We all went to the biodiesel production area where we observed bags of caustic soda used in test runs of the production process on the ground (see Photo # 32). One of the bags was open and some of the caustic may spill on the ground.

**1) Storage of Products for Biodiesel Process** – Drums of methanol and bags of caustic were stored without cover or containment. Best management practice for chemical products includes storing them in a manner that protects human health and the environment, as well as the value of the material. Caustic stored in open bags on the ground could easily allow spillage and soil contamination. Please consider storing the products in a safe manner.

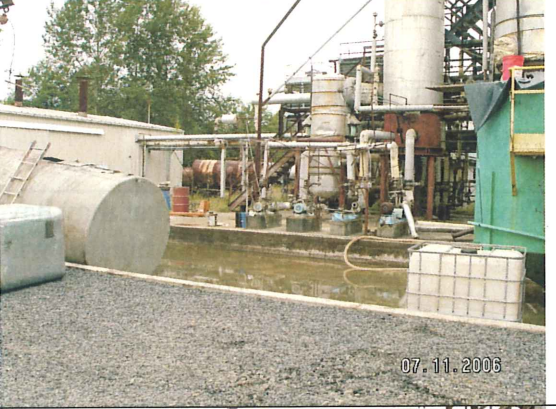
Area (Photo # /Time)	Notes	Photographs
Processing Area            (Photo # 21 / 12:43 pm)	Containers in containment pond.

The biodiesel tanks were located on a covered concrete pad. The pad had a coat of grease. Another tank was located just outside the covered area in a secondary containment pond (see Photo # 21). The pond had water in it. On one end of the pond was a pump and hose that appeared to be used to drain the pond water to the ground (see Photo # 24).

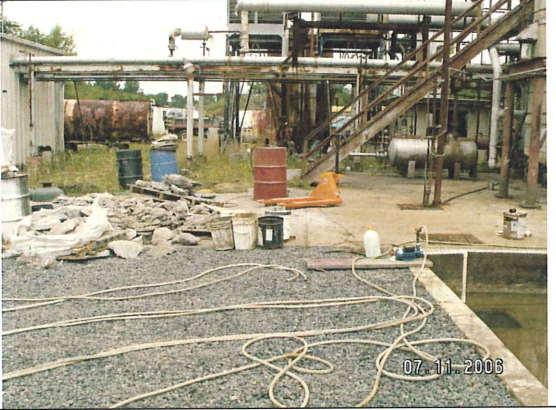
A photograph showing a large, rectangular containment pond filled with water. In the background, there are several large cylindrical tanks and industrial structures. A date stamp '07.11.2006' is visible in the bottom right corner of the photo.
Processing Area            (Photo # 24 / 12:46 pm)	Hose appeared to be for emptying containment pond.

A photograph of an industrial processing area. In the foreground, there is a gravel-covered ground with several yellow hoses coiled on it. In the background, there are various pipes, tanks, and a staircase. A date stamp '07.11.2006' is visible in the bottom right corner of the photo.

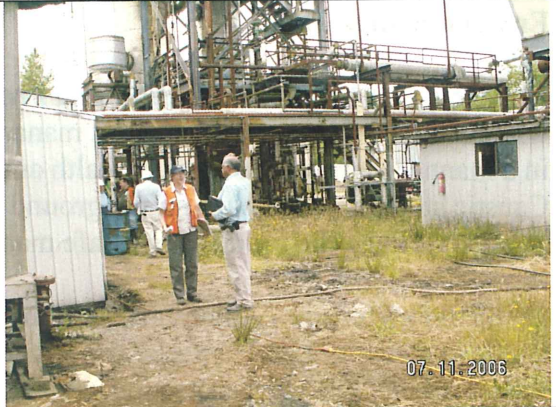
Area (Photo # /Time)	Notes	Photographs
Near Processing Area            (Photo # 36 / 12:58 pm)	Overview of area that may have been contaminated with spilled dangerous waste.

Just north of the processing area we observed what appeared to be oil staining and contaminated soil. Norm Peck pointed out these areas and said that this is from the waste that designated as state-only toxic dangerous waste (see Photos # 36, 33, 34).

A photograph showing an overview of an industrial area. In the foreground, three workers in safety gear are standing on a dirt path. In the background, there are various industrial structures, pipes, and tanks. A date stamp '07.11.2006' is visible in the bottom right corner of the photo.

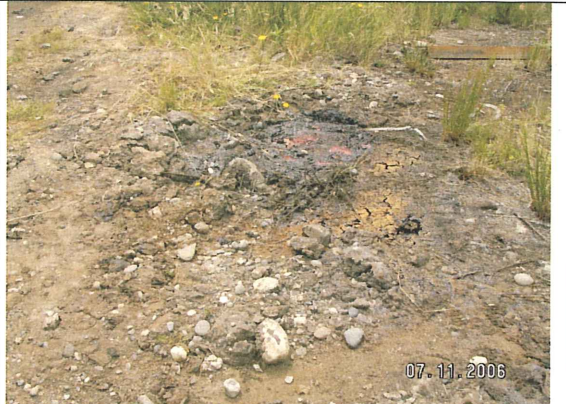
<p>Near Processing Area</p> <p>(Photo # 33 / 12:56 pm)</p>	<p>Soil that may have been contaminated with spilled dangerous waste.</p>

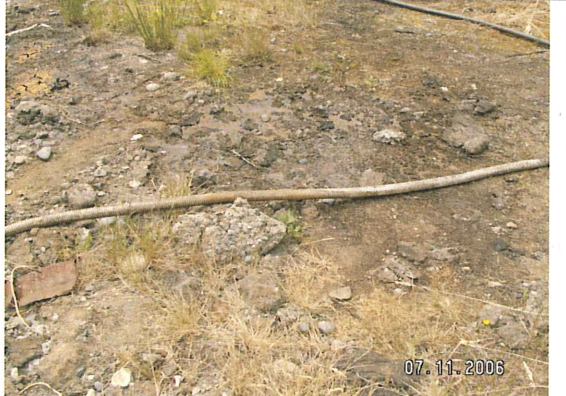
<p>Processing Area</p> <p>(Photo # 34 / 12:56 pm)</p>	<p>Soil that may have been contaminated with spilled dangerous waste.</p>
