Wetland and Stream Delineation Report

Cashmere Mill Site
Cashmere, Washington

for
Port of Chelan County

January 30, 2014 (revised April 14, 2014)

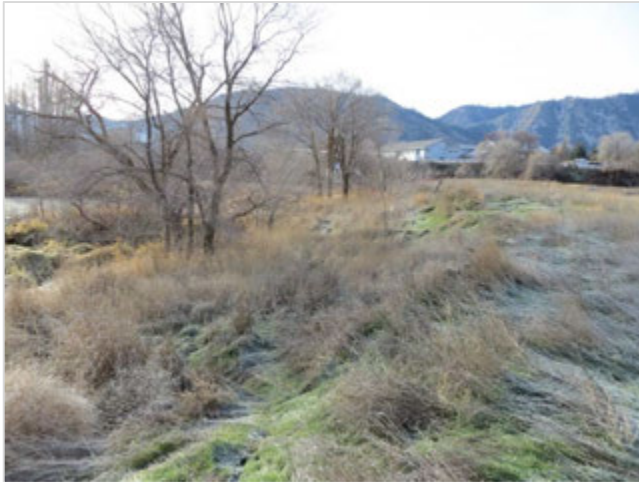
Photograph 1
Northeast corner of delineation looking south. Note apparent elevation difference between wetland and upland areas.

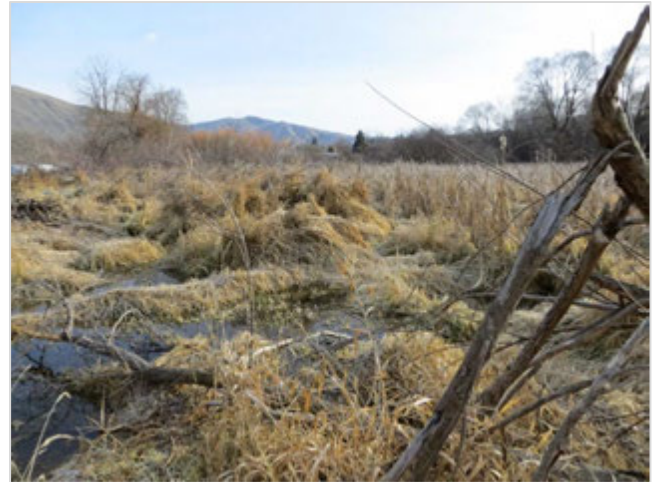
Photograph 2
Southeast corner of delineation looking east. Note large emergent cattail area extending off-site.

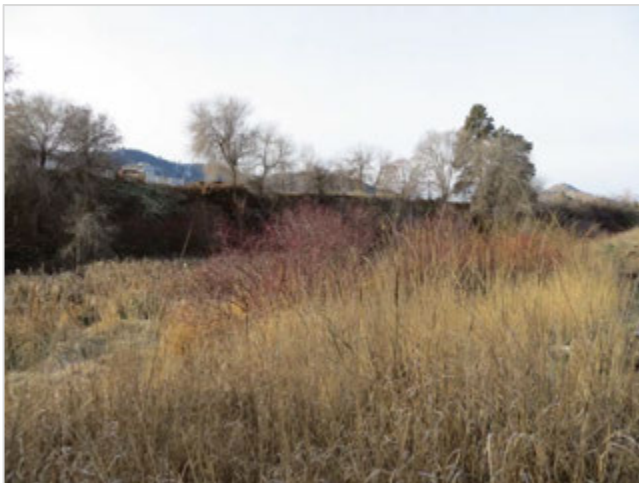
Photograph 3
Southern, more constricted riparian corridor looking west from upland berm. Note 20+ foot rise to development south of the channel.

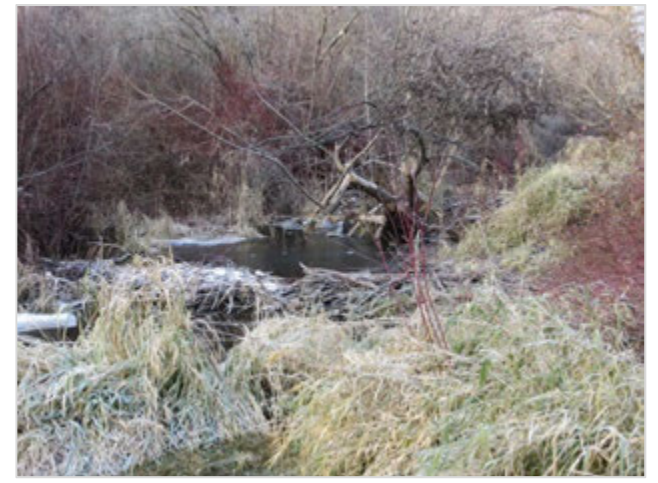
Photograph 4
Large beaver dam complex in site's central area. A second, similar-size dam exists approximately 30 feet upstream just visible in frame.

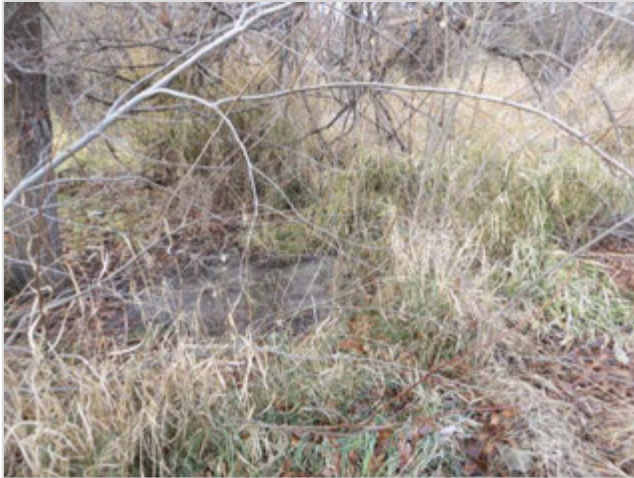
Photograph 5
Extensive backwatering in low areas lacking berms
behind beaver dams.

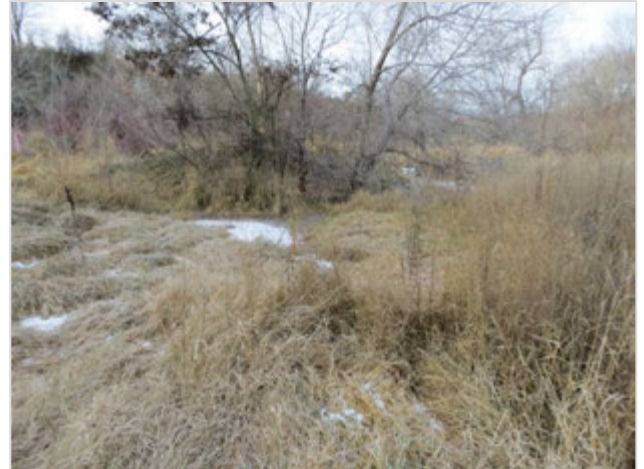
Photograph 6
Additional view of backwater areas outside wetland
vegetated or riparian areas.

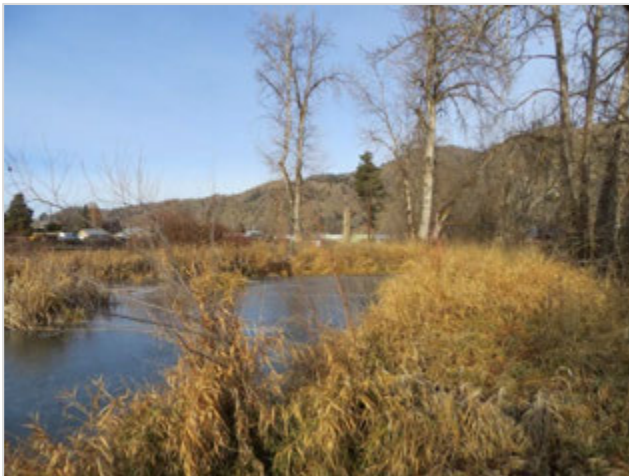
Photograph 7
Ponded area and raised berms looking north in the
site's northwest area.

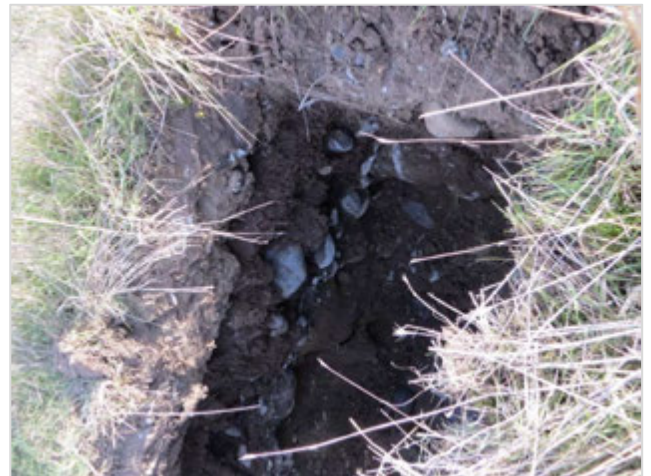
Photograph 8
Typical upland soil conditions viewed in
excavator-dug test pit.

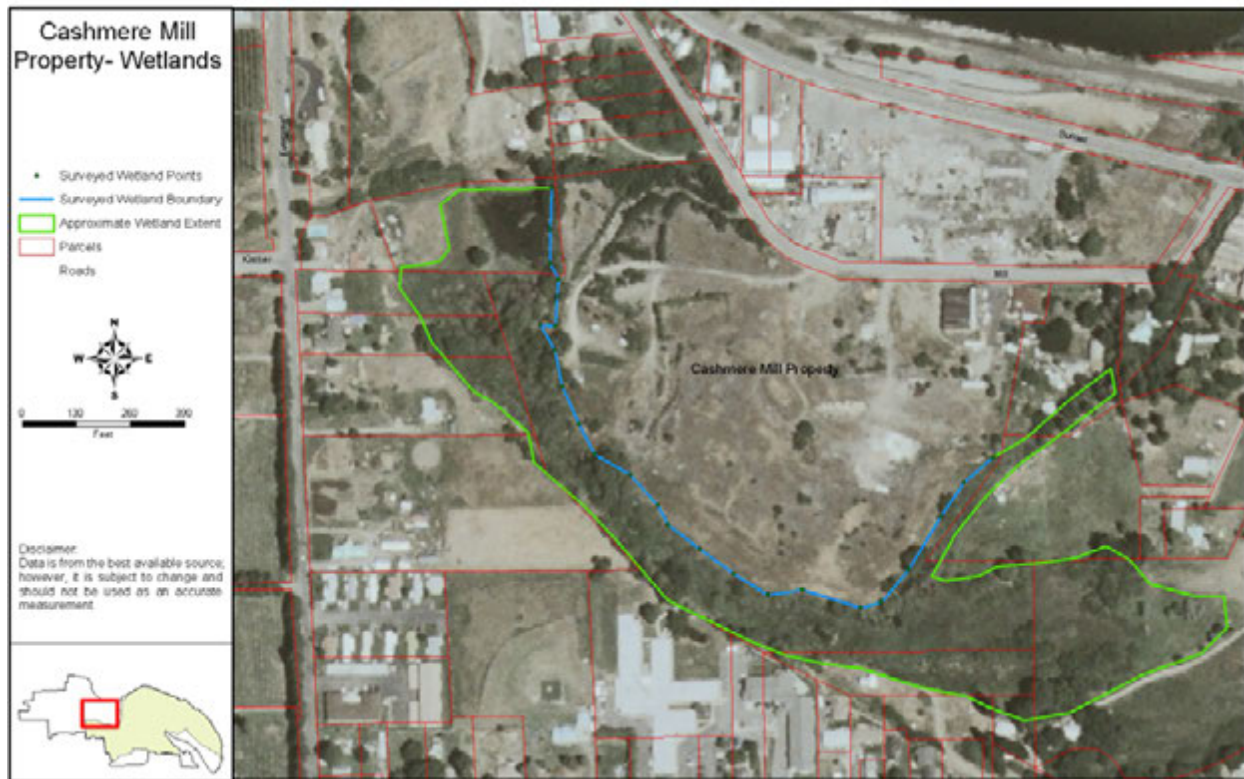
Figure 2. Aerial photo (2006) with wetland delineation.

The wetlands are part of a complex series of beaver dams and lowlands that make up this portion of Brender Creek. While there are some plan community and minor geo-morphological differences within the wetland area, the entire area was considered one large wetland for purposes of the ratings forms. The wetland delineation was done within the property boundary and the surveyed length is 1984.6 feet. The acreage of the wetland directly on or adjacent to the property is approximately 13 acres in size.
