Re: Additional Groundwater Sampling Results
1006 Lake Street, Kirkland, Washington
Project No. 080009-001-02

Site Location and Exploration Locations
1006 Lake St. Kirkland, WA

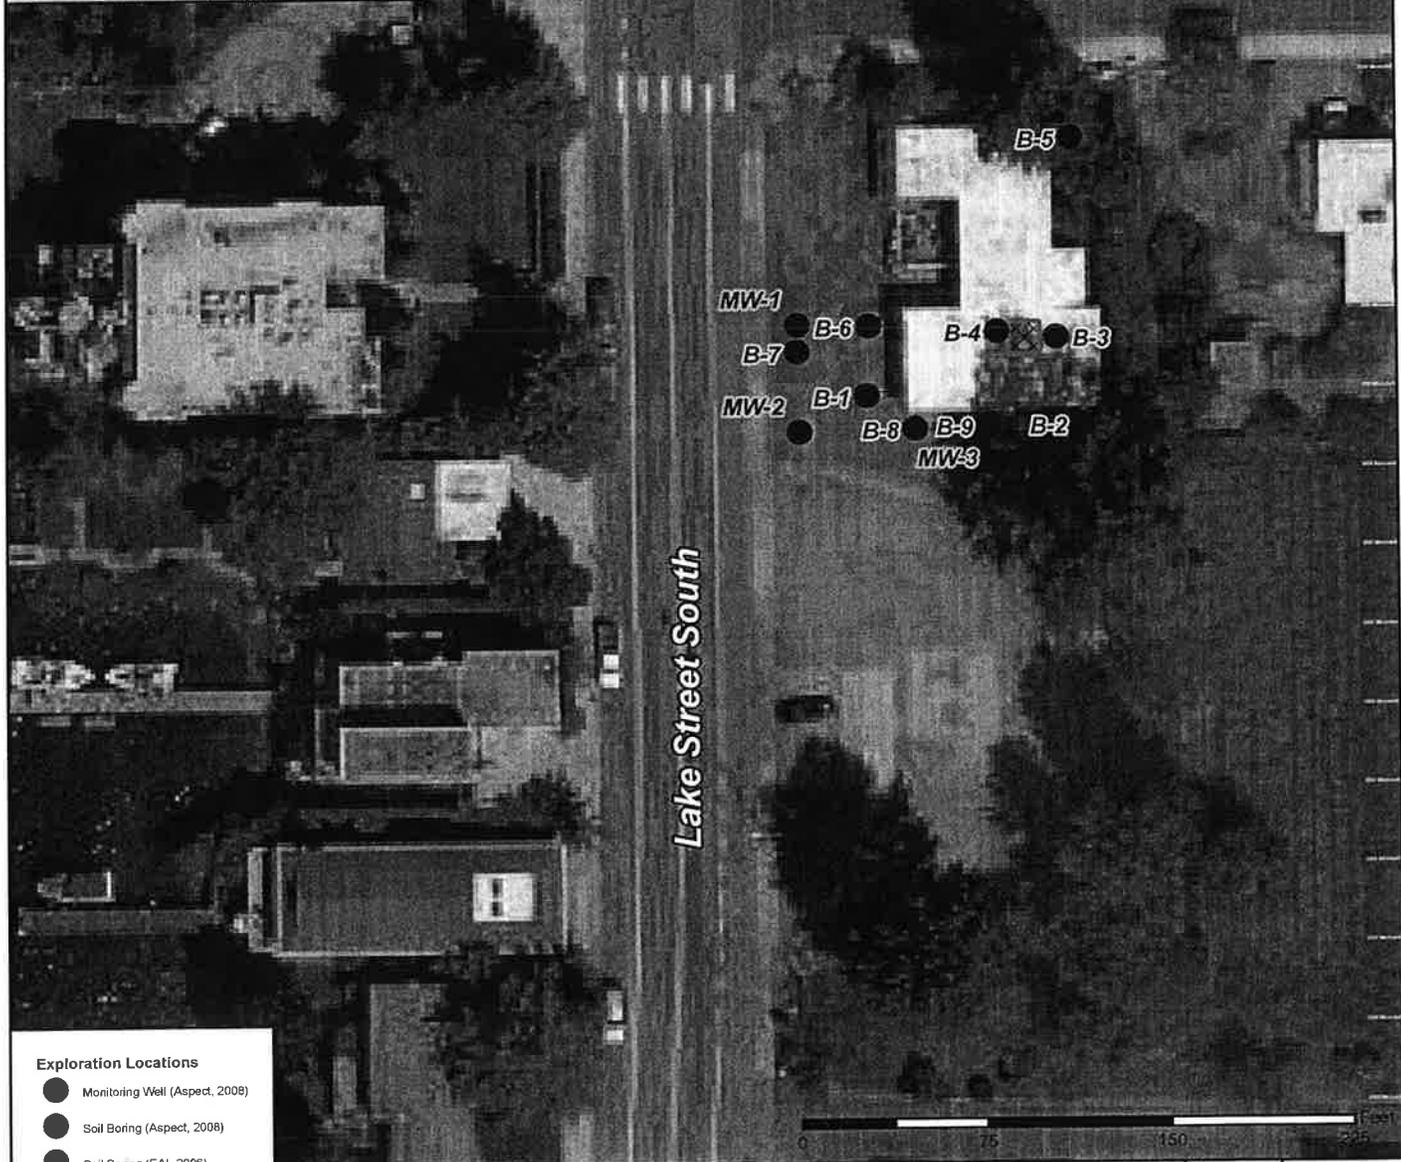
Exploration Locations

A previous investigation to evaluate site soil and groundwater conditions was performed by Environmental Associates, Inc. (EAI, 2006). Four soil borings (B-1 through B-4) were drilled at the property in July 2006 using a direct-push (e.g., Geoprobe) drill rig. Approximate boring locations are shown on Figure 1.

Aspect Consulting, LLC (Aspect) completed a subsequent soil and groundwater investigation in January 2008 (Aspect, 2008). Five soil borings (B-5 through B-9) were completed at the site at the locations shown on Figure 1. Borings B-6 through B-9 were completed using a Geoprobe drill rig. Boring B-5, located behind the building, was drilled using a hand auger due to access limitations for a drill rig. Soils encountered during drilling generally consisted of dense silty sand and hard sandy silt, which is interpreted as a native glacial till unit. Due to the dense nature of the till, the Geoprobe borings could not advance through this unit, hitting refusal at between 4.5 and 8 feet below ground surface (bgs). Water was encountered in only one boring (B-5) next to the sanitary sewer line.

- Drill three groundwater monitoring wells (MW-1 through MW-3) at the locations shown on Figure 1;
- Develop the wells and collect groundwater samples for analysis of VOCs; and
- Measure groundwater elevations to confirm that the general groundwater flow direction is westward toward Lake Washington.

The top of casing elevations of the monitoring wells were surveyed and depth to groundwater measurements were converted into groundwater elevations (Table 3). Based on the groundwater elevation data, groundwater flow across the site is generally to the west, with a slight northward component. Based on this, wells MW-1 and MW-2 are located downgradient from the dry cleaning operation and dry cleaning machine where PCE in shallow groundwater was previously detected.

Based on results of the three investigations completed to date, impacts associated with the dry cleaning operation appear to be limited to shallow groundwater in the area near the dry cleaning machine. The chlorinated VOC PCE was detected in a groundwater sample collected at boring B-5 at a concentration that exceeds MTCA cleanup levels by a factor of two. Chlorinated VOCs were not detected in soil samples collected adjacent to the dry cleaning machine or outside the building footprint, in groundwater samples collected adjacent to the sanitary sewer line, or in groundwater downgradient (west) of the dry cleaning operation.
