UST SITE CLOSURE REPORT

VISTA FIELD AIRPORT
6915 W. Grandridge Blvd.
Kennewick, WA 99336

April 30, 2014

Blue Mountain Environmental and Consulting Company, Inc.
PO Box 545/125 Main St.
Waitsburg, WA 99361
509-520-6519

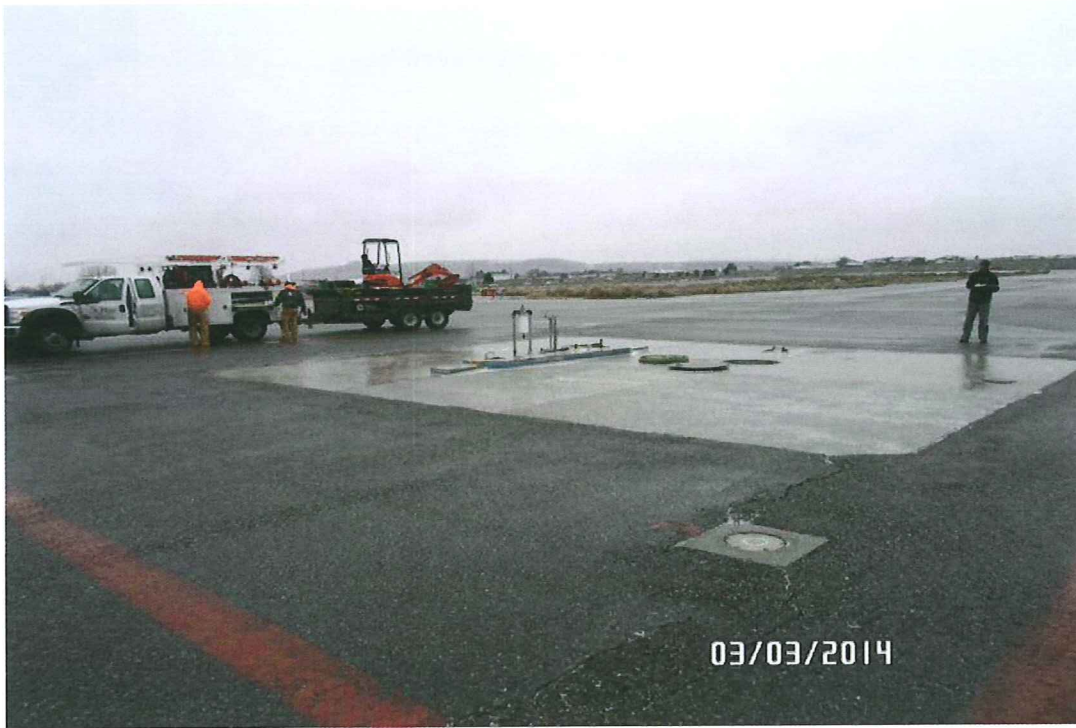
SITE PRIOR TO EXCAVATION

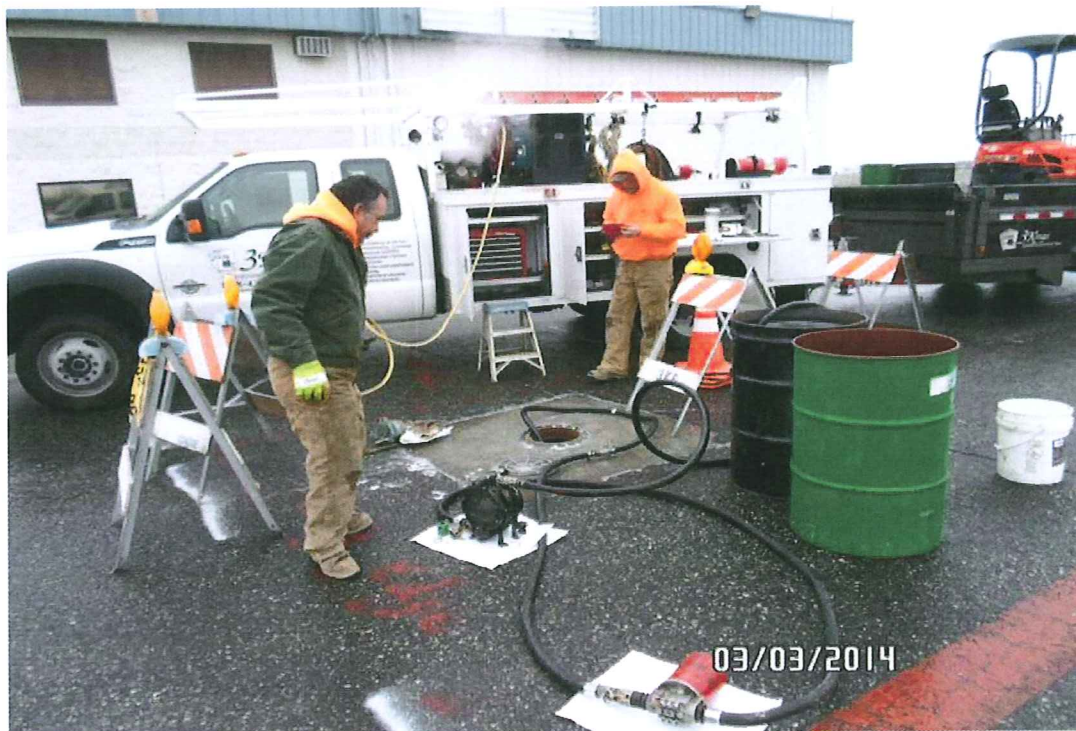
REMOVING RESIDUAL FUEL

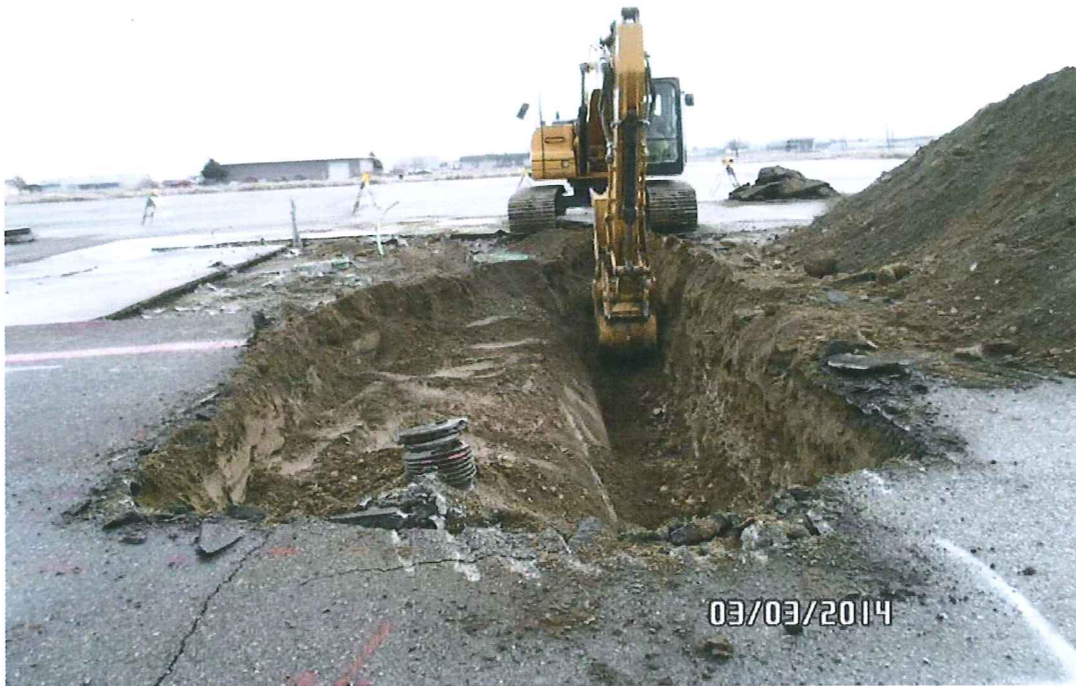
EXCAVATION OF USTs.

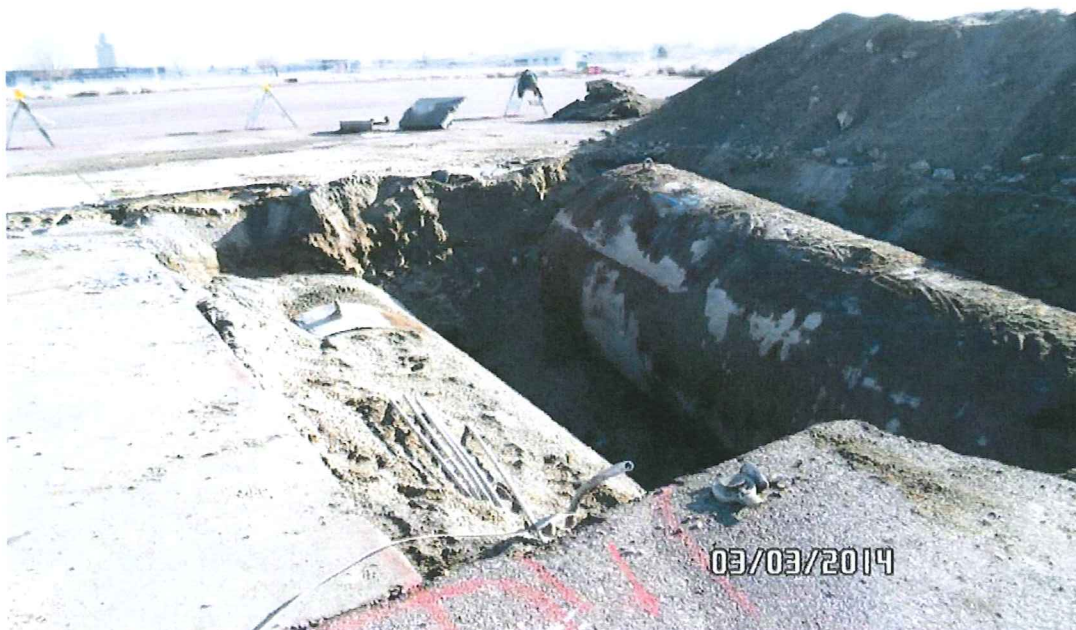
EXCAVATION OF USTs

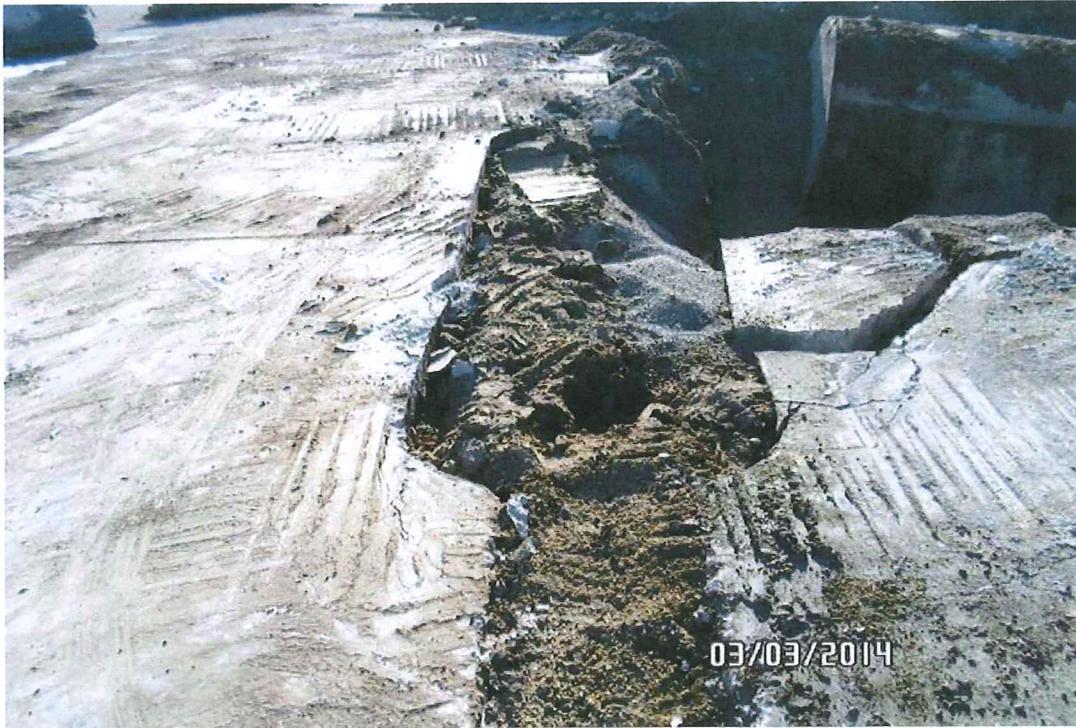
REMOVED PUMP ISLAND

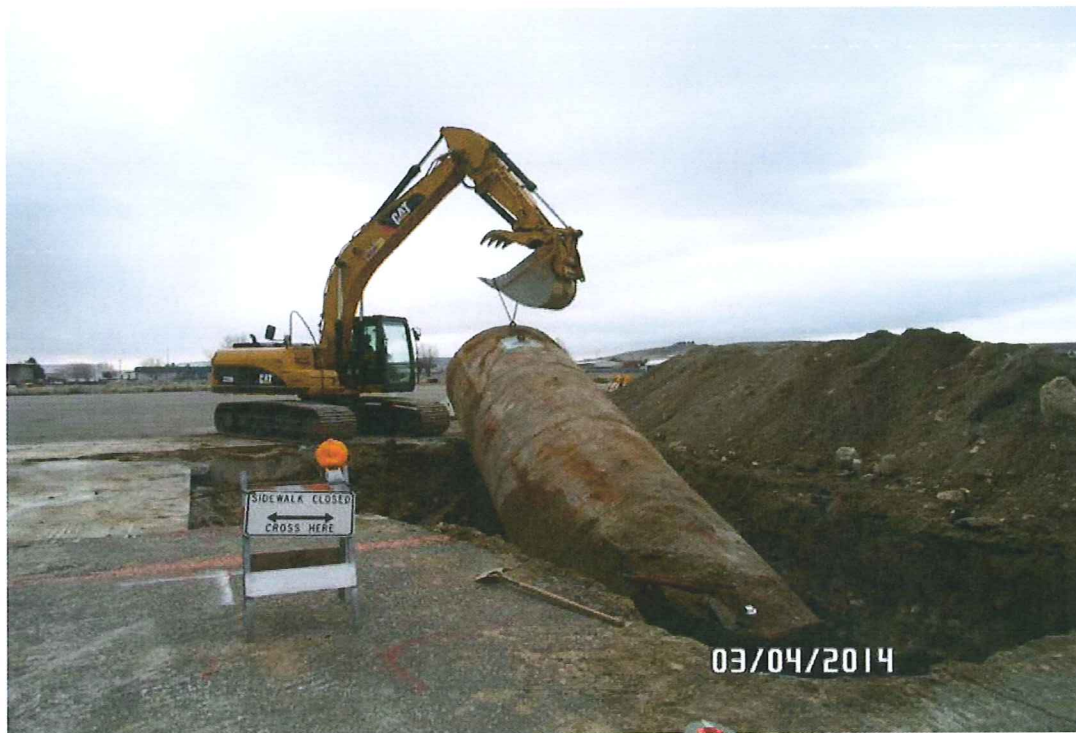
REMOVAL OF 12000 GALLON UST

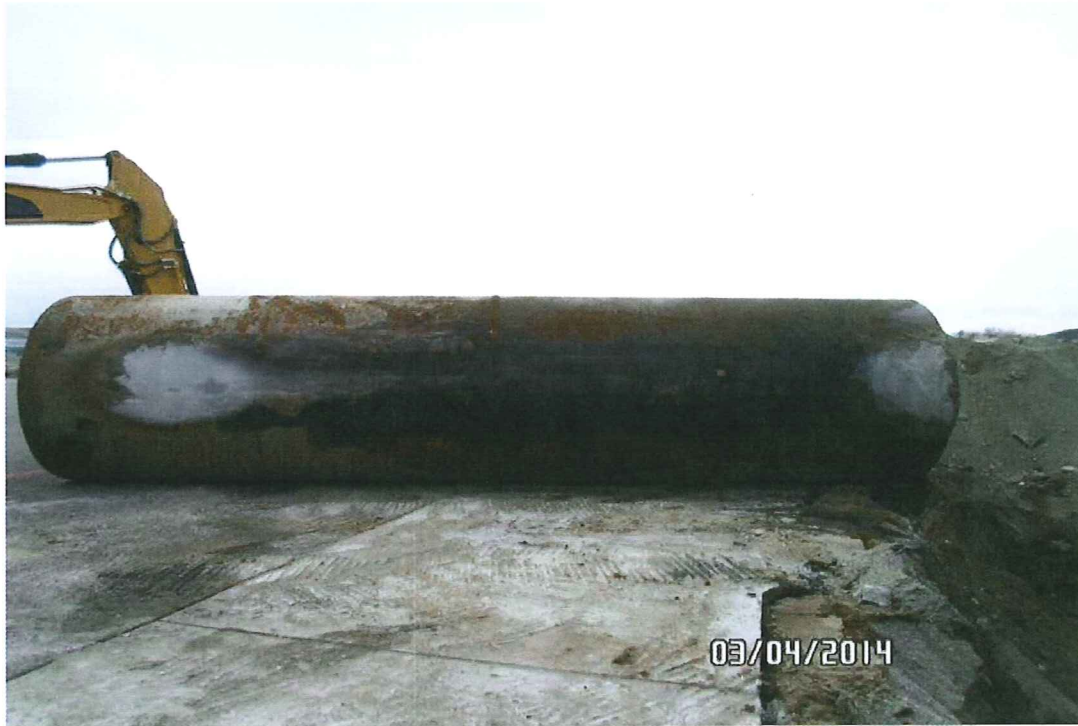
12000 GALLON UST AFTER REMOVAL

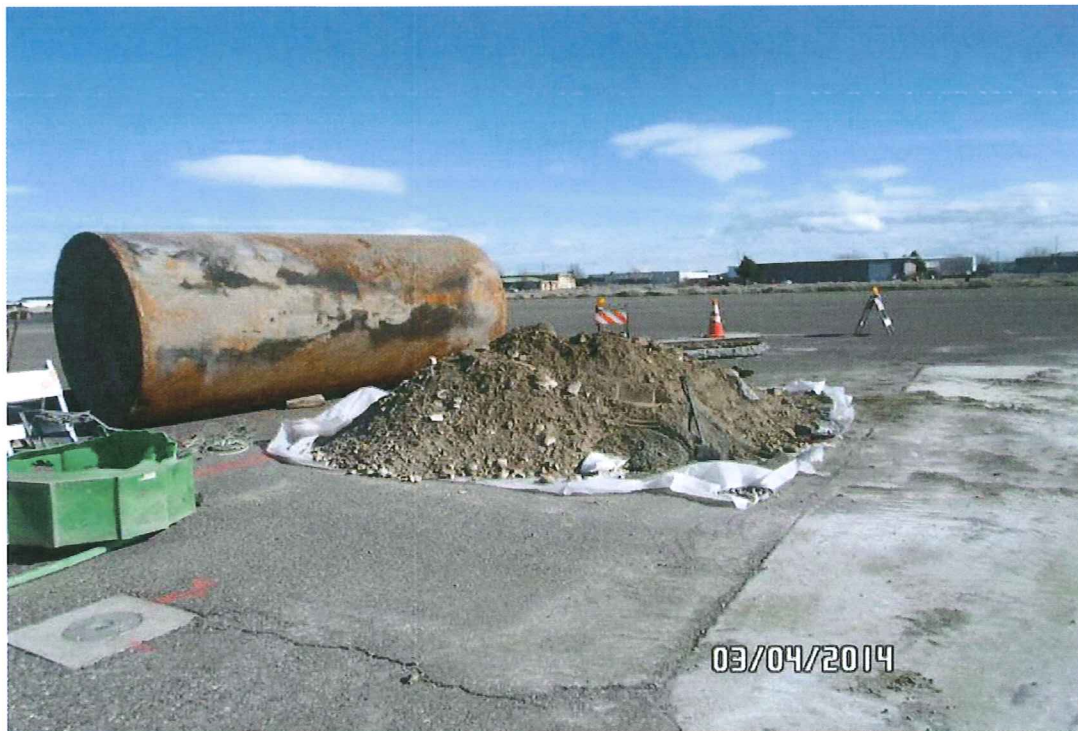
6000 GALLON UST AFTER REMOVAL AND STOCKPILED SOIL

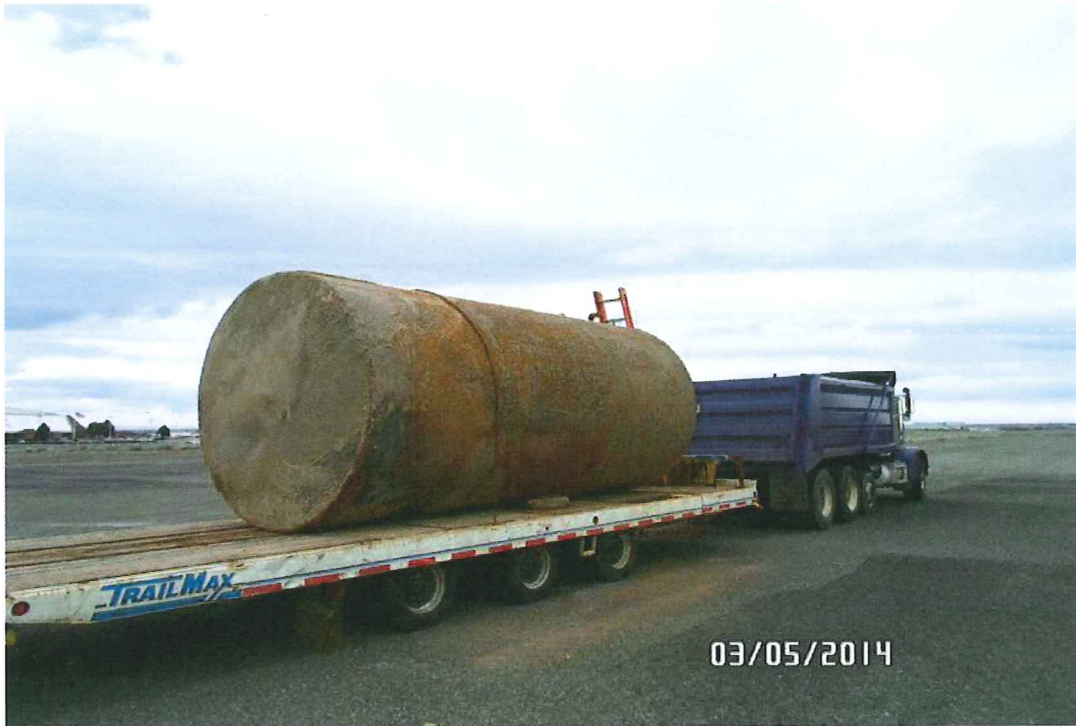
6000 GALLON UST SECURED FOR TRANSPORT

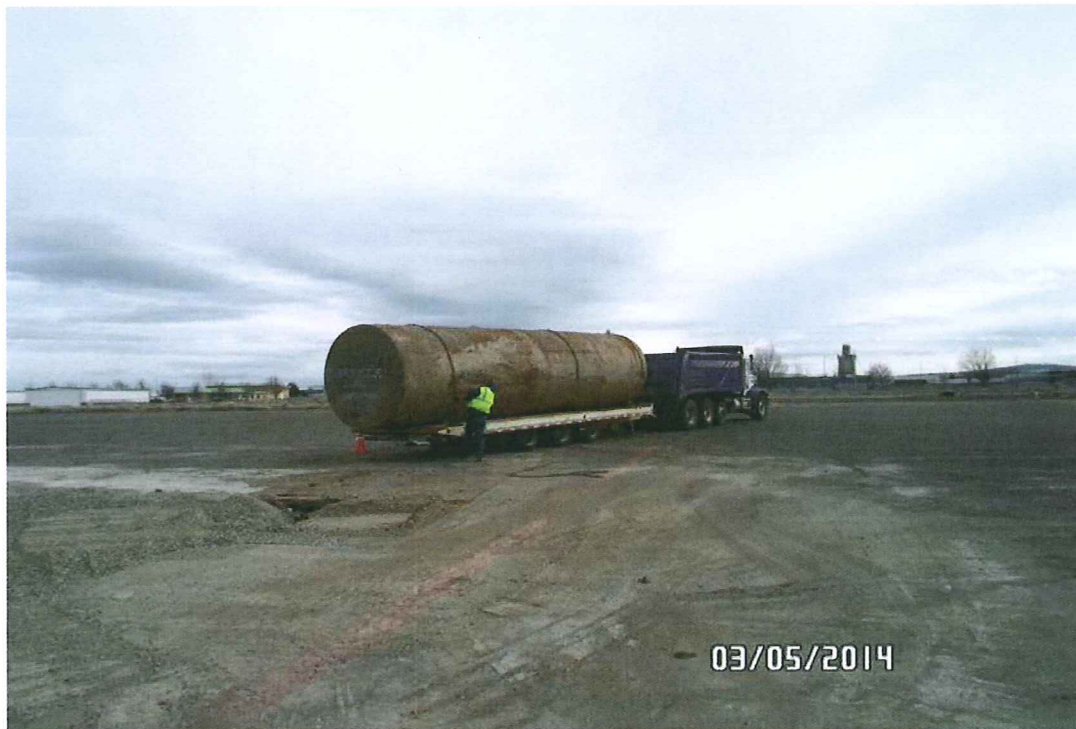
12000 GALLON UST SECURED FOR TRANSPORT

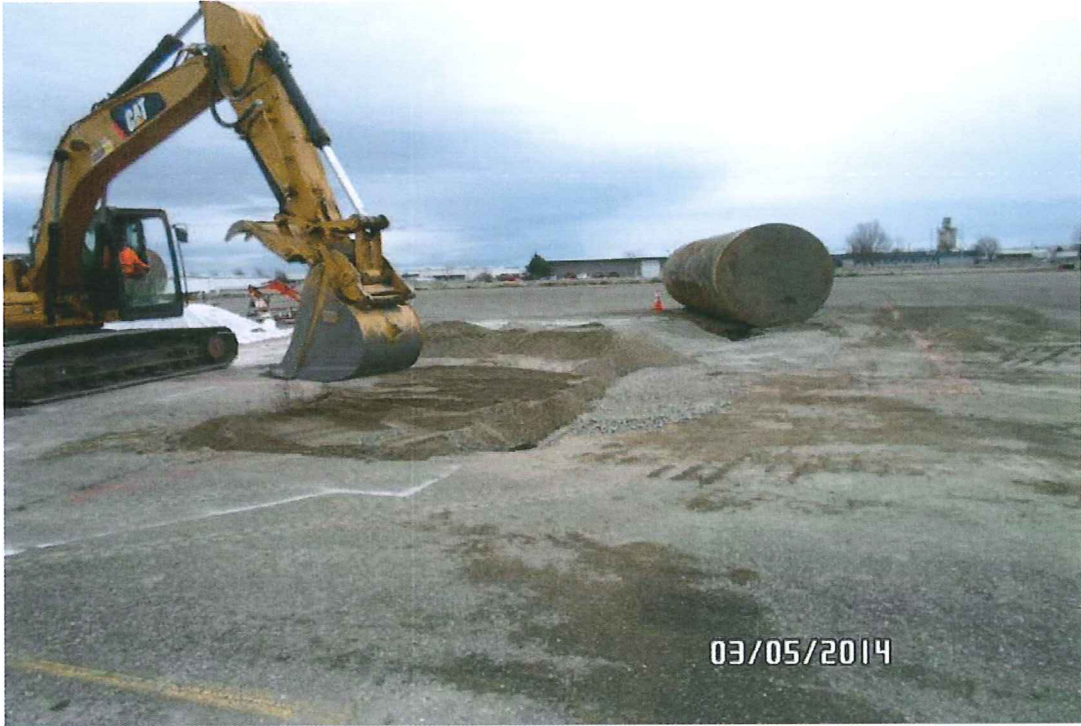
BACKFILLING EXCAVATION

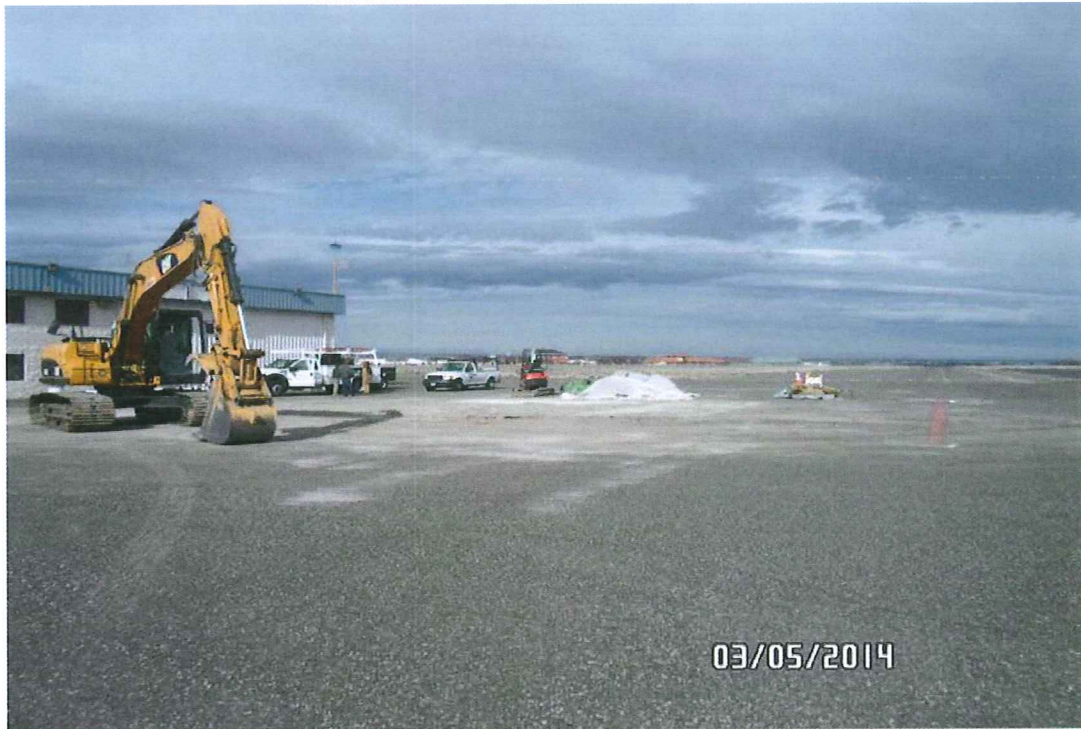
SITE AFTER BACKFILLING AND UST REMOVAL

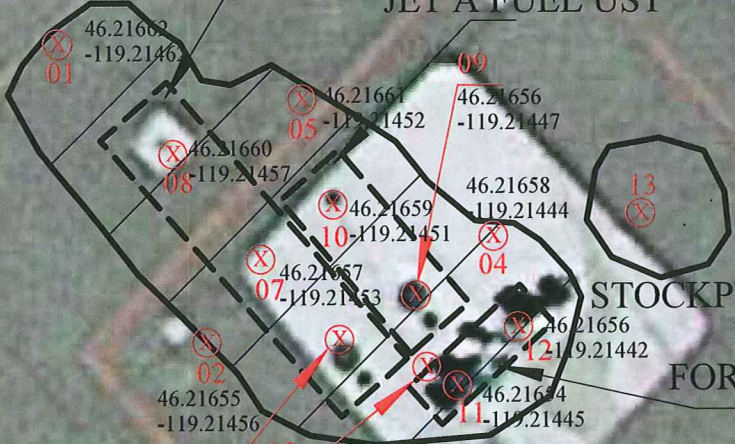
FORMER 12000 GALLON
100 II AVIATION FUEL UST

FORMER 6000 GALLON
JET A FUEL UST

STOCKPILE

FORMER PUMP ISLAND

EXCAVATION
