**BIOLOGICAL EVALUATION**  
**WEST BAY PARK PROJECT**

National Marine Fisheries Service  
U.S. Fish and Wildlife Service

Anchor Environmental, L.L.C.  
1423 Third Avenue, Suite 300  
Seattle, Washington 98101

**Figure 1**  
Vicinity Map  
West Bay Park Biological Evaluation  
Olympia, Washington

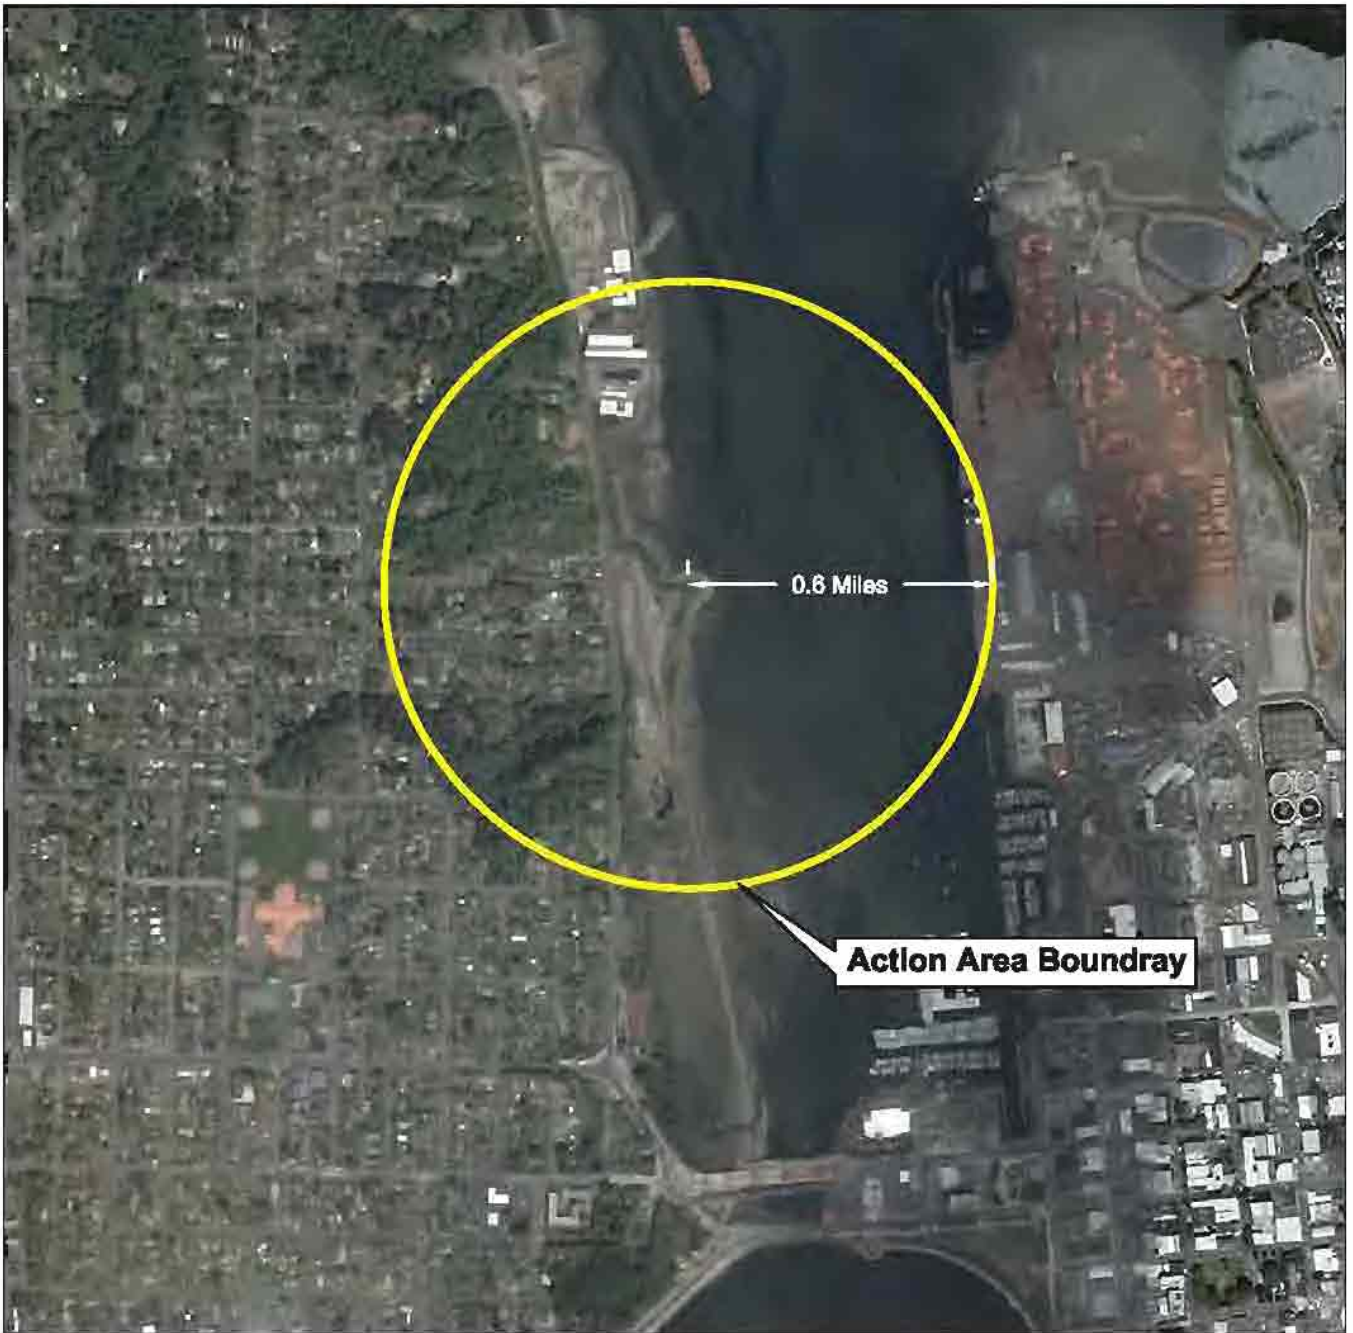
Photo Source: Google Earth 2007.

The *Action Area* is defined as the area to be affected directly or indirectly by the federal action (50 CFR §402.02). In-water noise impacts are typically the basis for setting the extent of the Action Area in aquatic areas. In this project, work in the Action Area will be performed outside the water to the greatest extent possible, but some activities, such as piling removal, must occur in water. However, vibratory methods will be used for piling removal and sheet pile installation, and significant in-water noise impacts (such as impact pile driving) are not expected. Therefore, the extent of the aquatic portion of the Action Area for this project is defined on the basis of expected water quality impacts in aquatic areas. To be conservative about the extent of expected water quality impacts to listed fish species, the Action Area will include a water quality (i.e., turbidity) boundary at a radius of 150 feet from the point where shoreline work is occurring. This distance defines a typical mixing zone determined by Ecology to comply with state water quality standards (WAC 173-201A-110). The aquatic portion of the Action Area will therefore extend laterally 150 feet into the aquatic area from the shoreline (shoreline defined by the MHHW line) (Figure 2).

Based on these assumptions, peak airborne noise levels will decrease to ambient airborne noise levels within 3,200 feet (0.6 mile). Therefore, the aquatic portion of the Action Area will therefore extend laterally 0.6 mile into the air from the park (Figure 2).

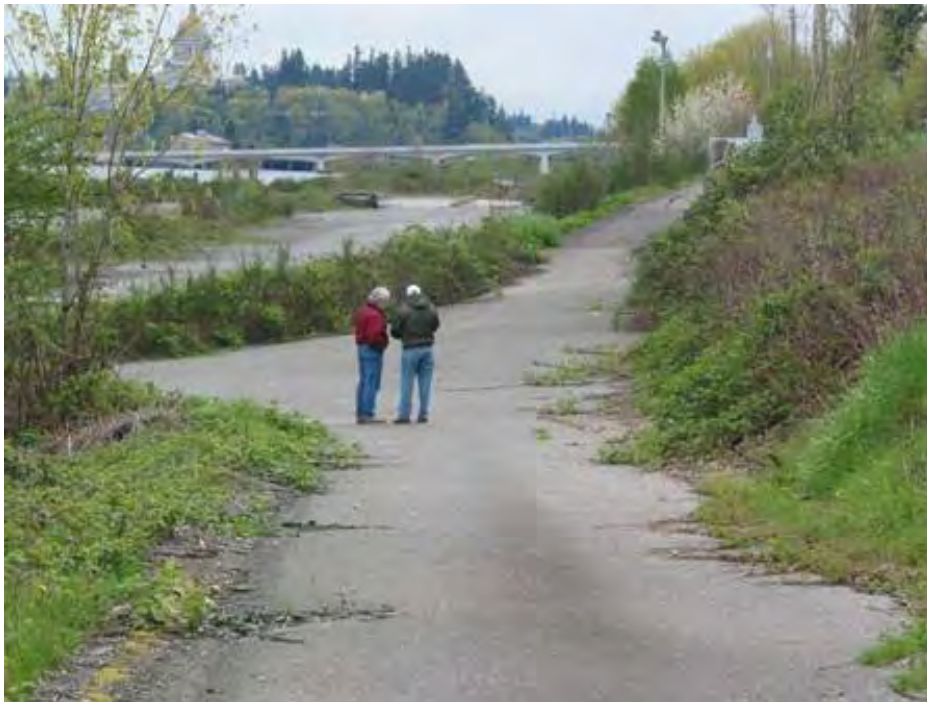
**Photo 1**  
**Overview of upland area, looking south; invasive vegetation and concrete roads/pads are visible in the foreground and upper left**

ornamental cherry trees and miscellaneous grasses (Photos 1 and 3). The area near Rotary Point includes a relatively intact strip of salt-tolerant vegetation such as pickleweed (*Salicornia virginica*) and sea plantain (*Plantago maritima*), as well as miscellaneous grasses and weeds (Photo 4). Eelgrass (*Zostera L*) does not occur at the site, as it does not occur in the extreme reaches of the South Puget Sound, including Budd Inlet (WDNR 2001).

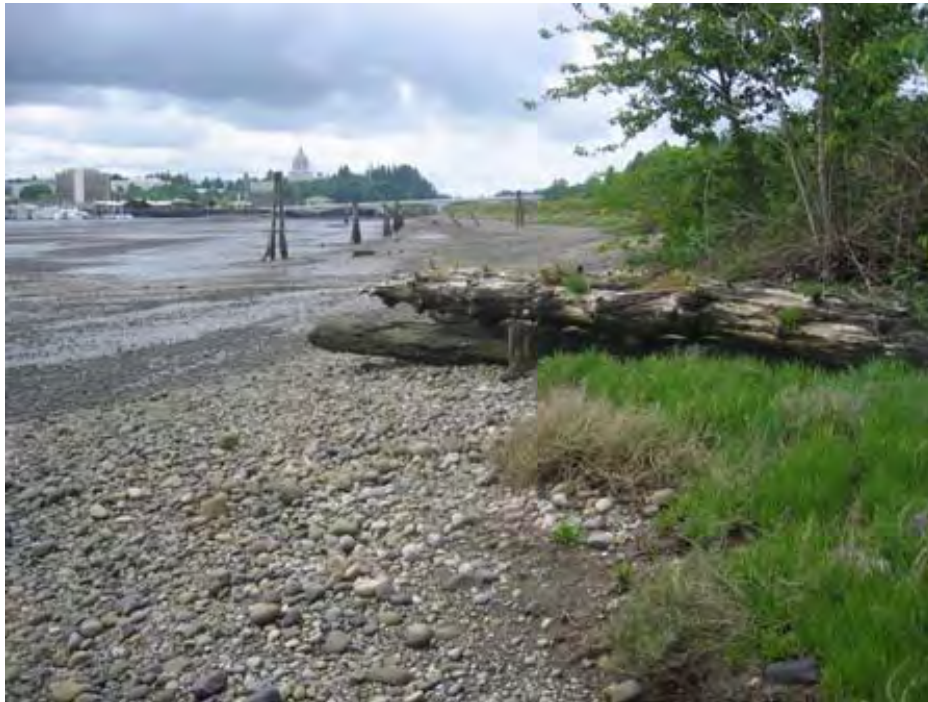
**Photo 2**  
**Overview of park shoreline, looking south toward Capitol building**

The current shoreline consists of a cobble beach but contains areas of concrete, asphalt, metal, and brick debris, as well as derelict piling from past industrial uses. The shoreline vegetation is a mix of native and non-native species. The shoreline is not generally armored except for a low concrete wall in one section of the shoreline. Downtown Olympia and the State Capitol building can be viewed from many locations within the property (Photo 2)

West Bay Drive, which is located parallel to the project shoreline, separates the park vegetation from the hillside landward of the park, which contains mature conifers and large deciduous trees. Within the park, upland vegetation includes mostly immature trees and shrubs, including abundant amounts of invasive Himalayan blackberry (*Rubus discolor*) and Scotch broom (*Cytisus scoparius*); this vegetation is interspersed with roads and areas of concrete paving throughout the park (Photo 2). Dominant shoreline vegetation includes, again, Scotch broom and Himalayan blackberry, with occasional

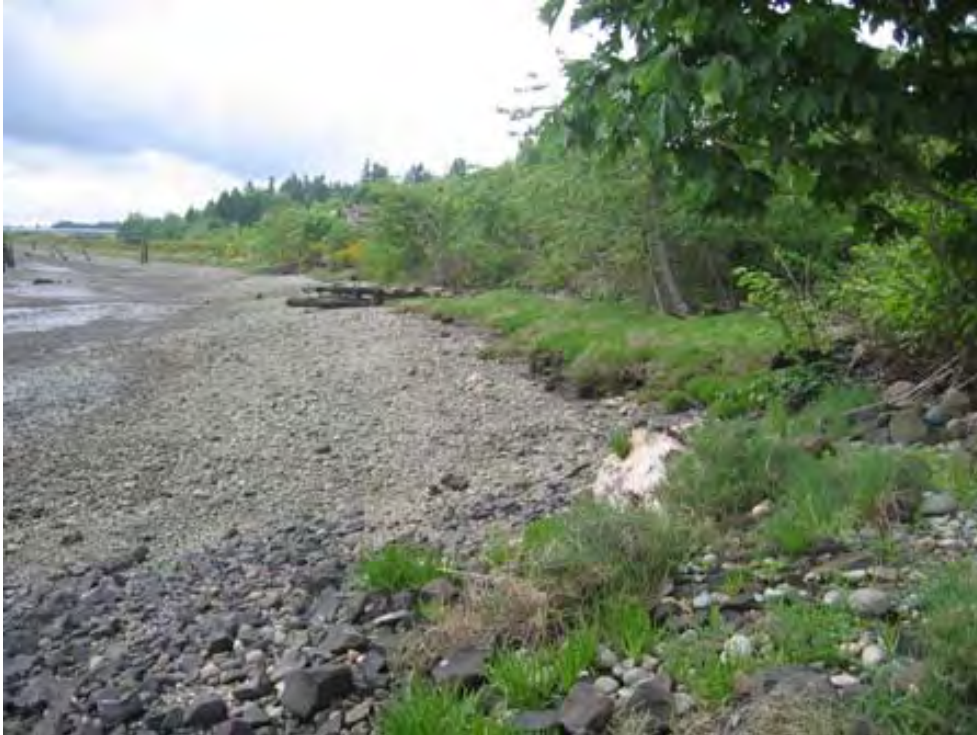
**Photo 3**  
Typical shoreline vegetation conditions, looking south along park property

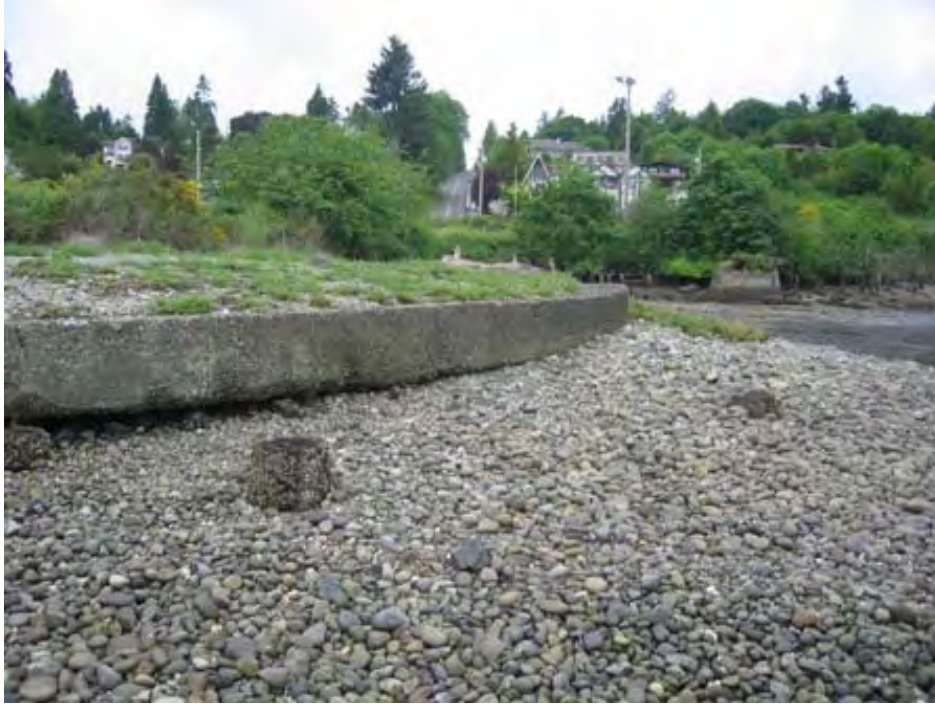
**Photo 5**  
Beach and intertidal substrate sizes and concrete wall, looking north

Very little shoreline armoring is present along the Action Area shoreline; however, in several areas, the low concrete wall is exposed to the shore (Photo 5). The dominant naturally-occurring substrate size is large gravel and cobble (Photo 5 and 3), but there is also a substantial amount of concrete, asphalt, metal, and brick debris in places (Photo 7), along with many derelict piles (Photo 8 and 9).

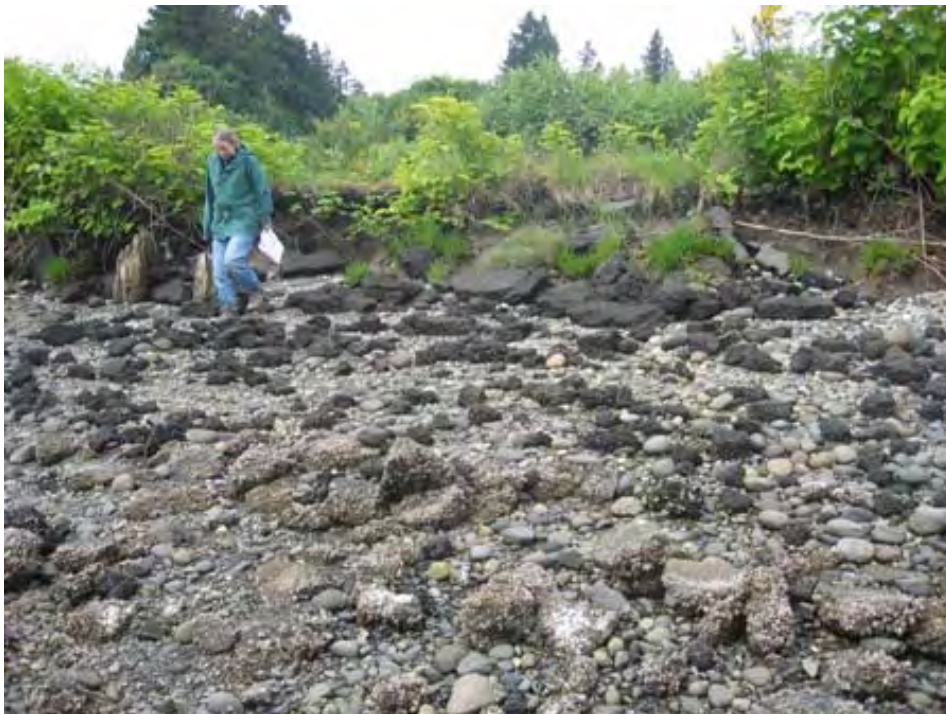
**Photo 6**  
Beach and intertidal substrate sizes and scattered debris, looking west

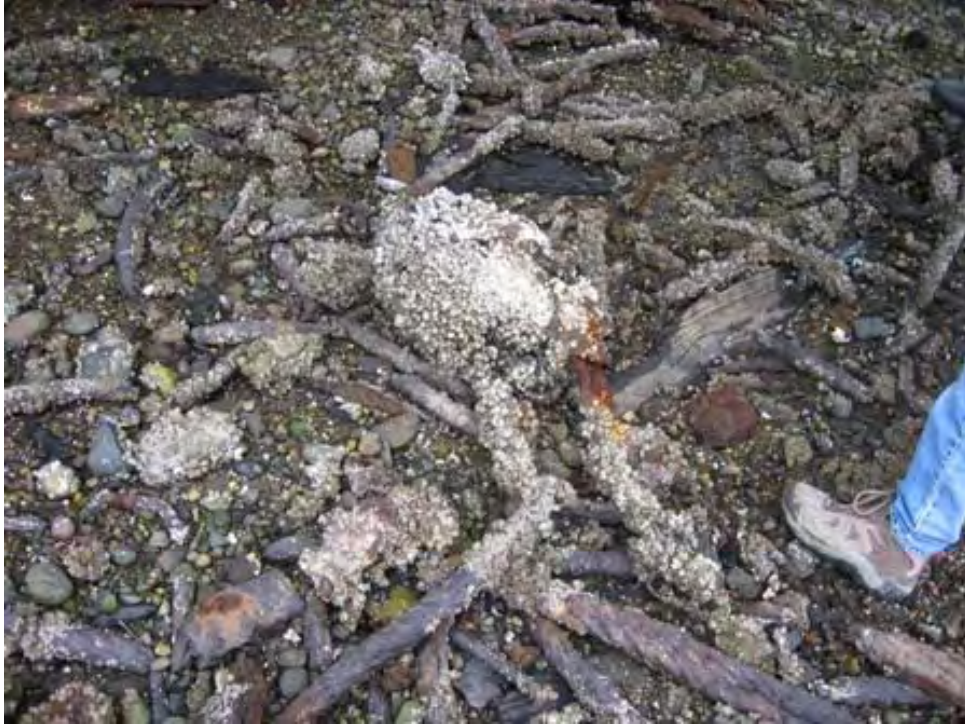
**Photo 7**  
**Beach substrate and debris**

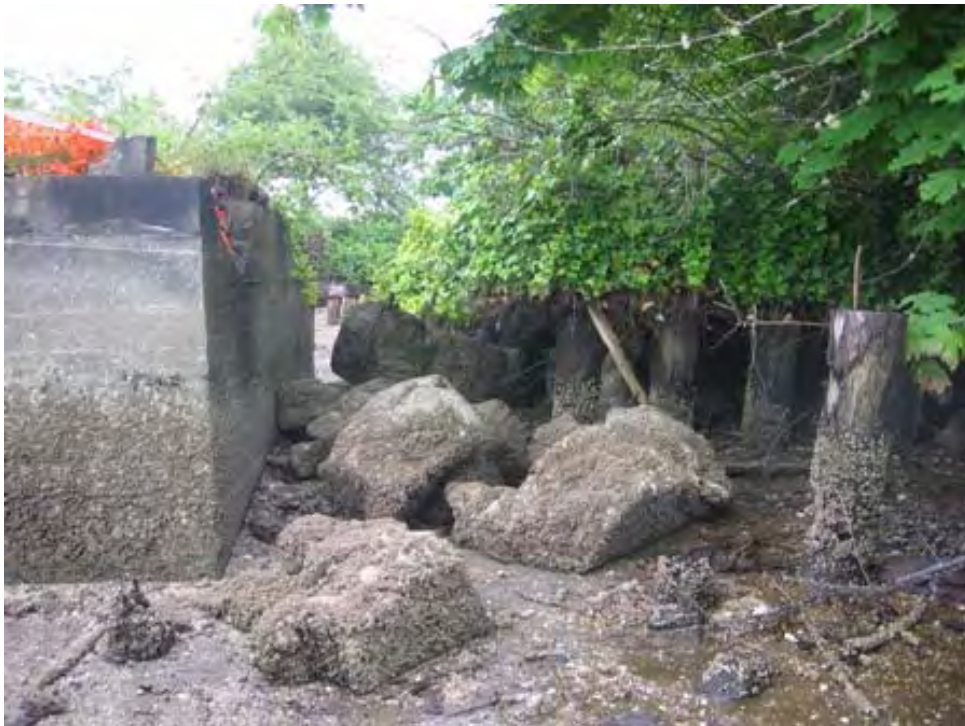
**Photo 8**  
**Beach substrate, concrete debris, and derelict piling, looking south**

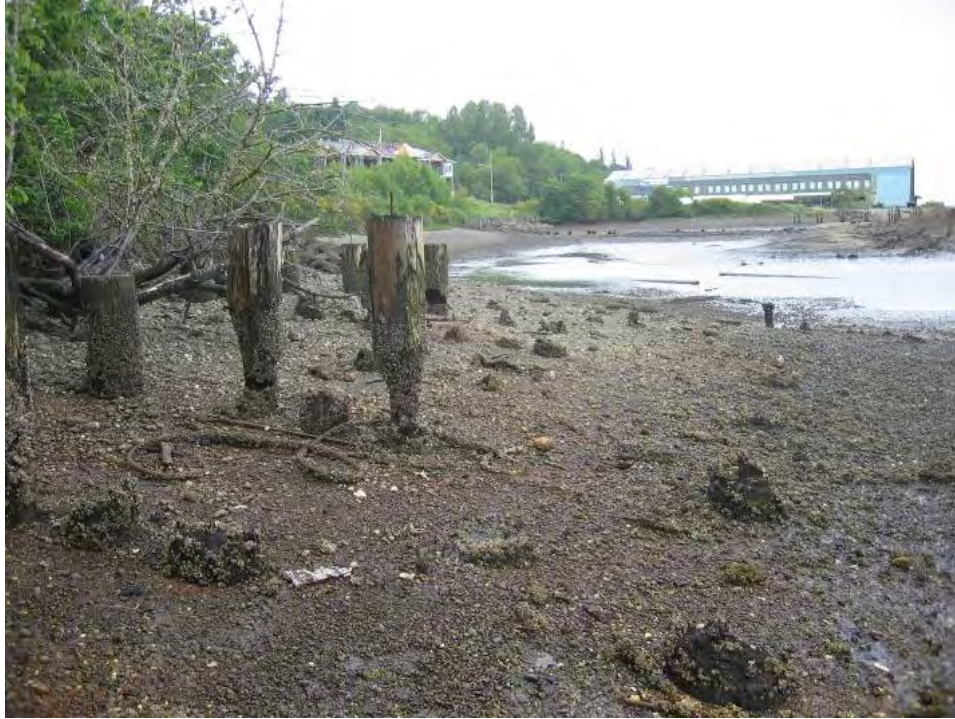
**Photo 9**  
**Derelict pilings in shoreline area, looking north**

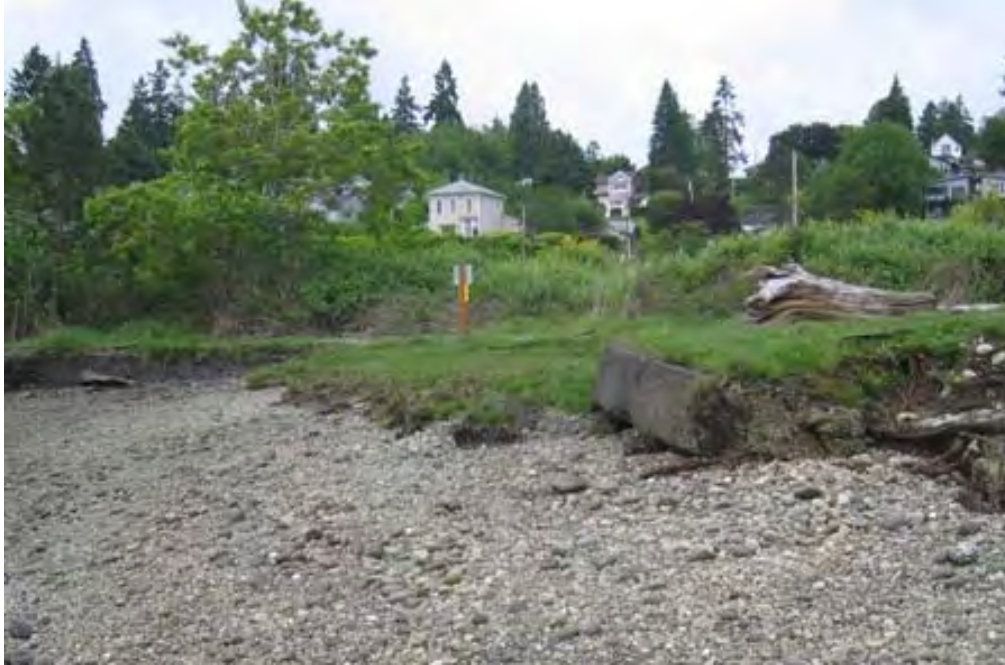
**Photo 10**  
**Erosion at the park shoreline, looking southwest**

Shoreline slopes in the Action Area are approximately 5:1 in the upper intertidal and then grade down to a large flat (approximately 2:1) in the shallow water area exposed at low tide (Photo 1). Elevations in the Action Area range from +14.6 feet at MHHW to approximately +3 feet MLLW. Moderate to severe shoreline erosion is occurring in several areas (Photo 10).

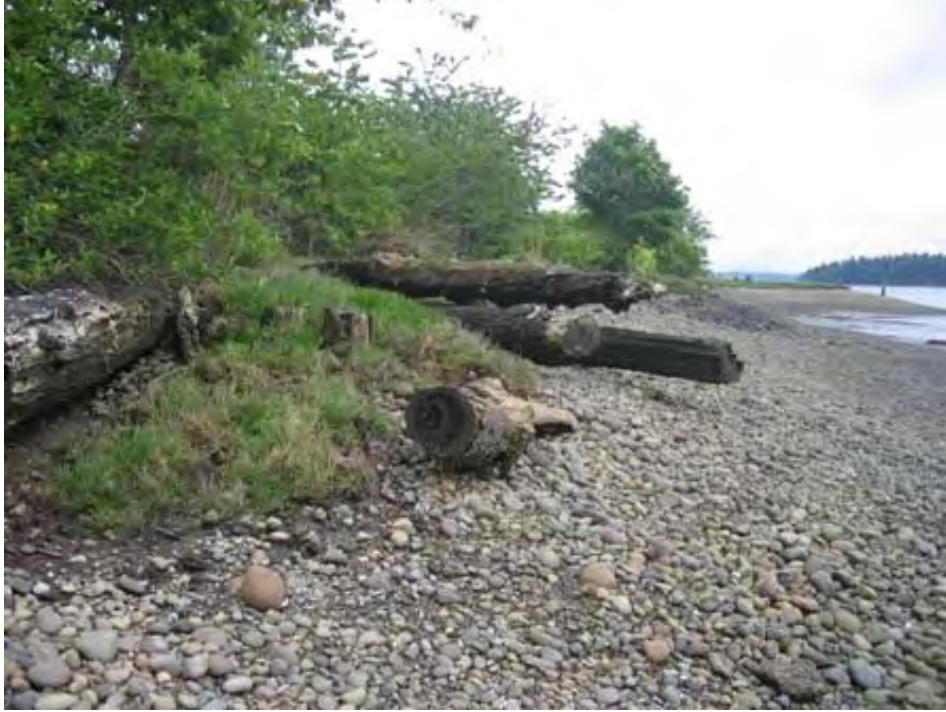
**Photo 11**  
**Large woody debris accumulations at the park shoreline**

LWD along marine shorelines helps prevent erosion, promotes sediment accumulation, and provides diverse habitat (Herrera 2005). In the Action Area, LWD is present but sparse (Photos 1 and 11), which has been attributed to a lack of source LWD from the adjacent riparian area and elsewhere in the vicinity (Herrera 2005).
