**REMEDIAL INVESTIGATION AND
CLEANUP ACTION SUMMARY**
Former UCO Facility
9225 – 151st Avenue NE
Redmond, Washington
King County Tax Parcel 720170-0051

Project No. T-6776

Subject: Remedial Investigation and Cleanup Action Summary
Former UCO Facility
9225 – 151st Avenue NE
Redmond, Washington
King County Tax Parcel 720170-0051

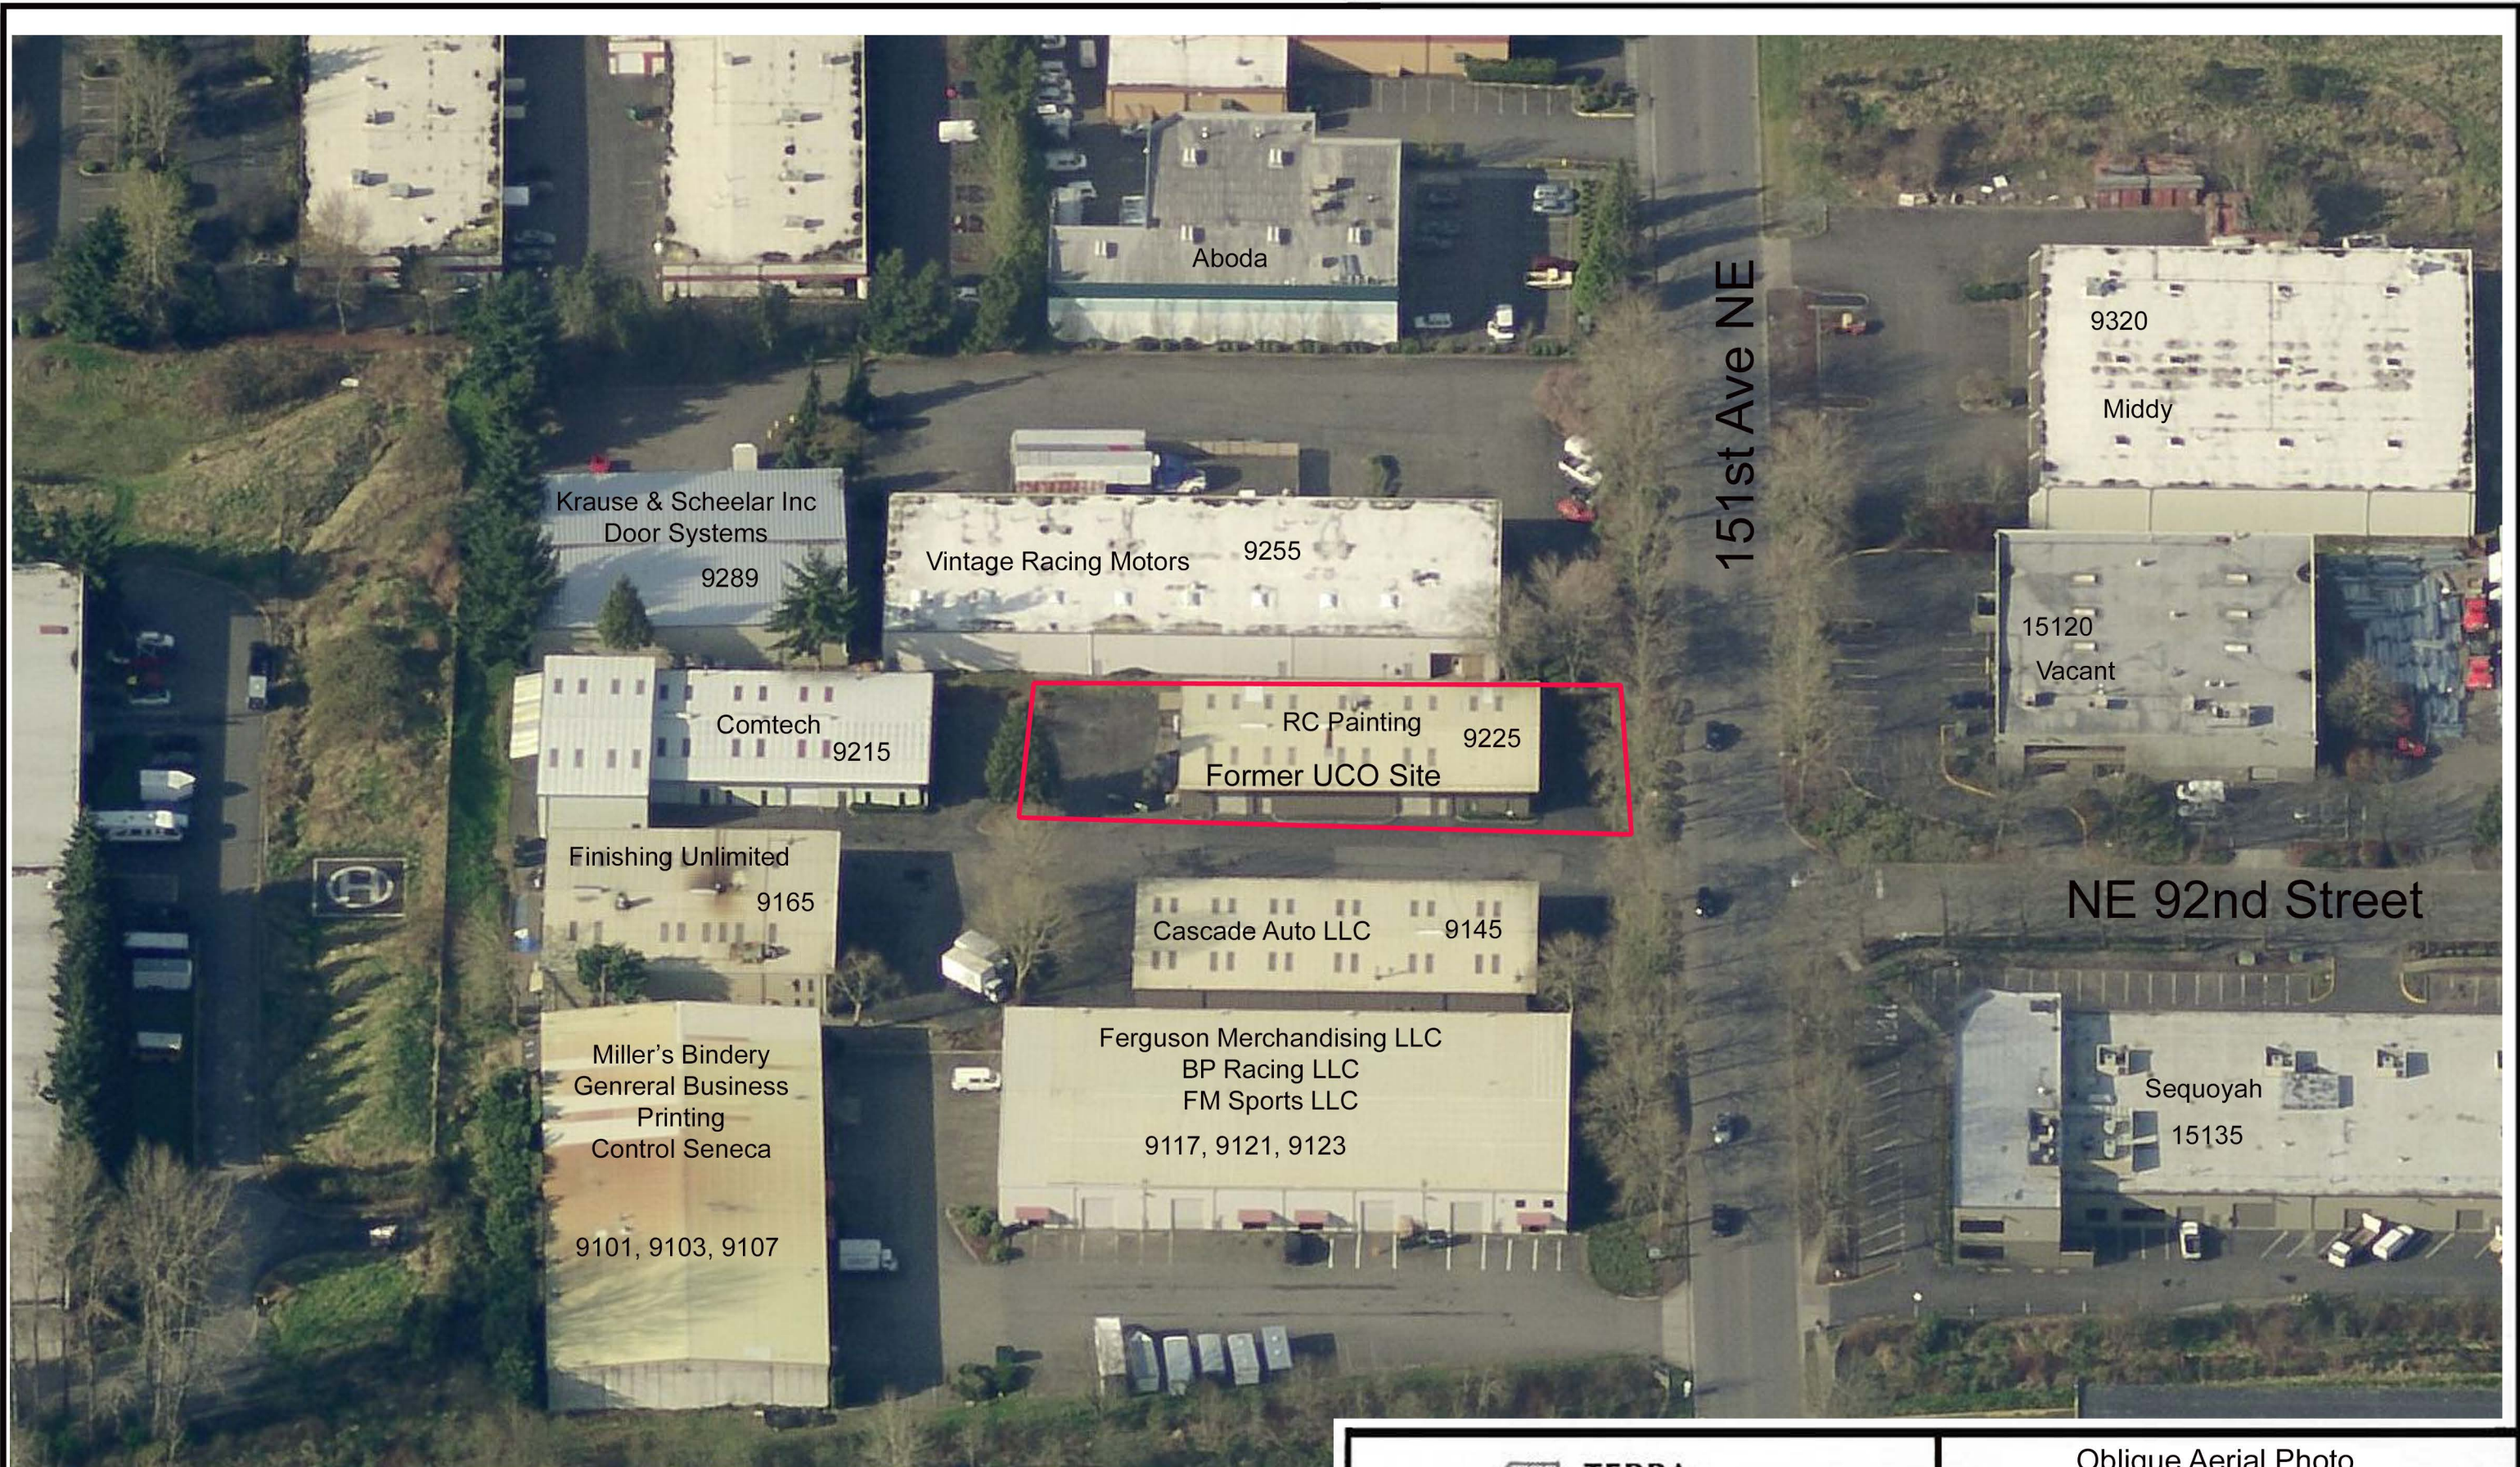
Figure 3

Oblique view looking north. Date of Photo April 8, 2011.
Photo copyright Pictometry

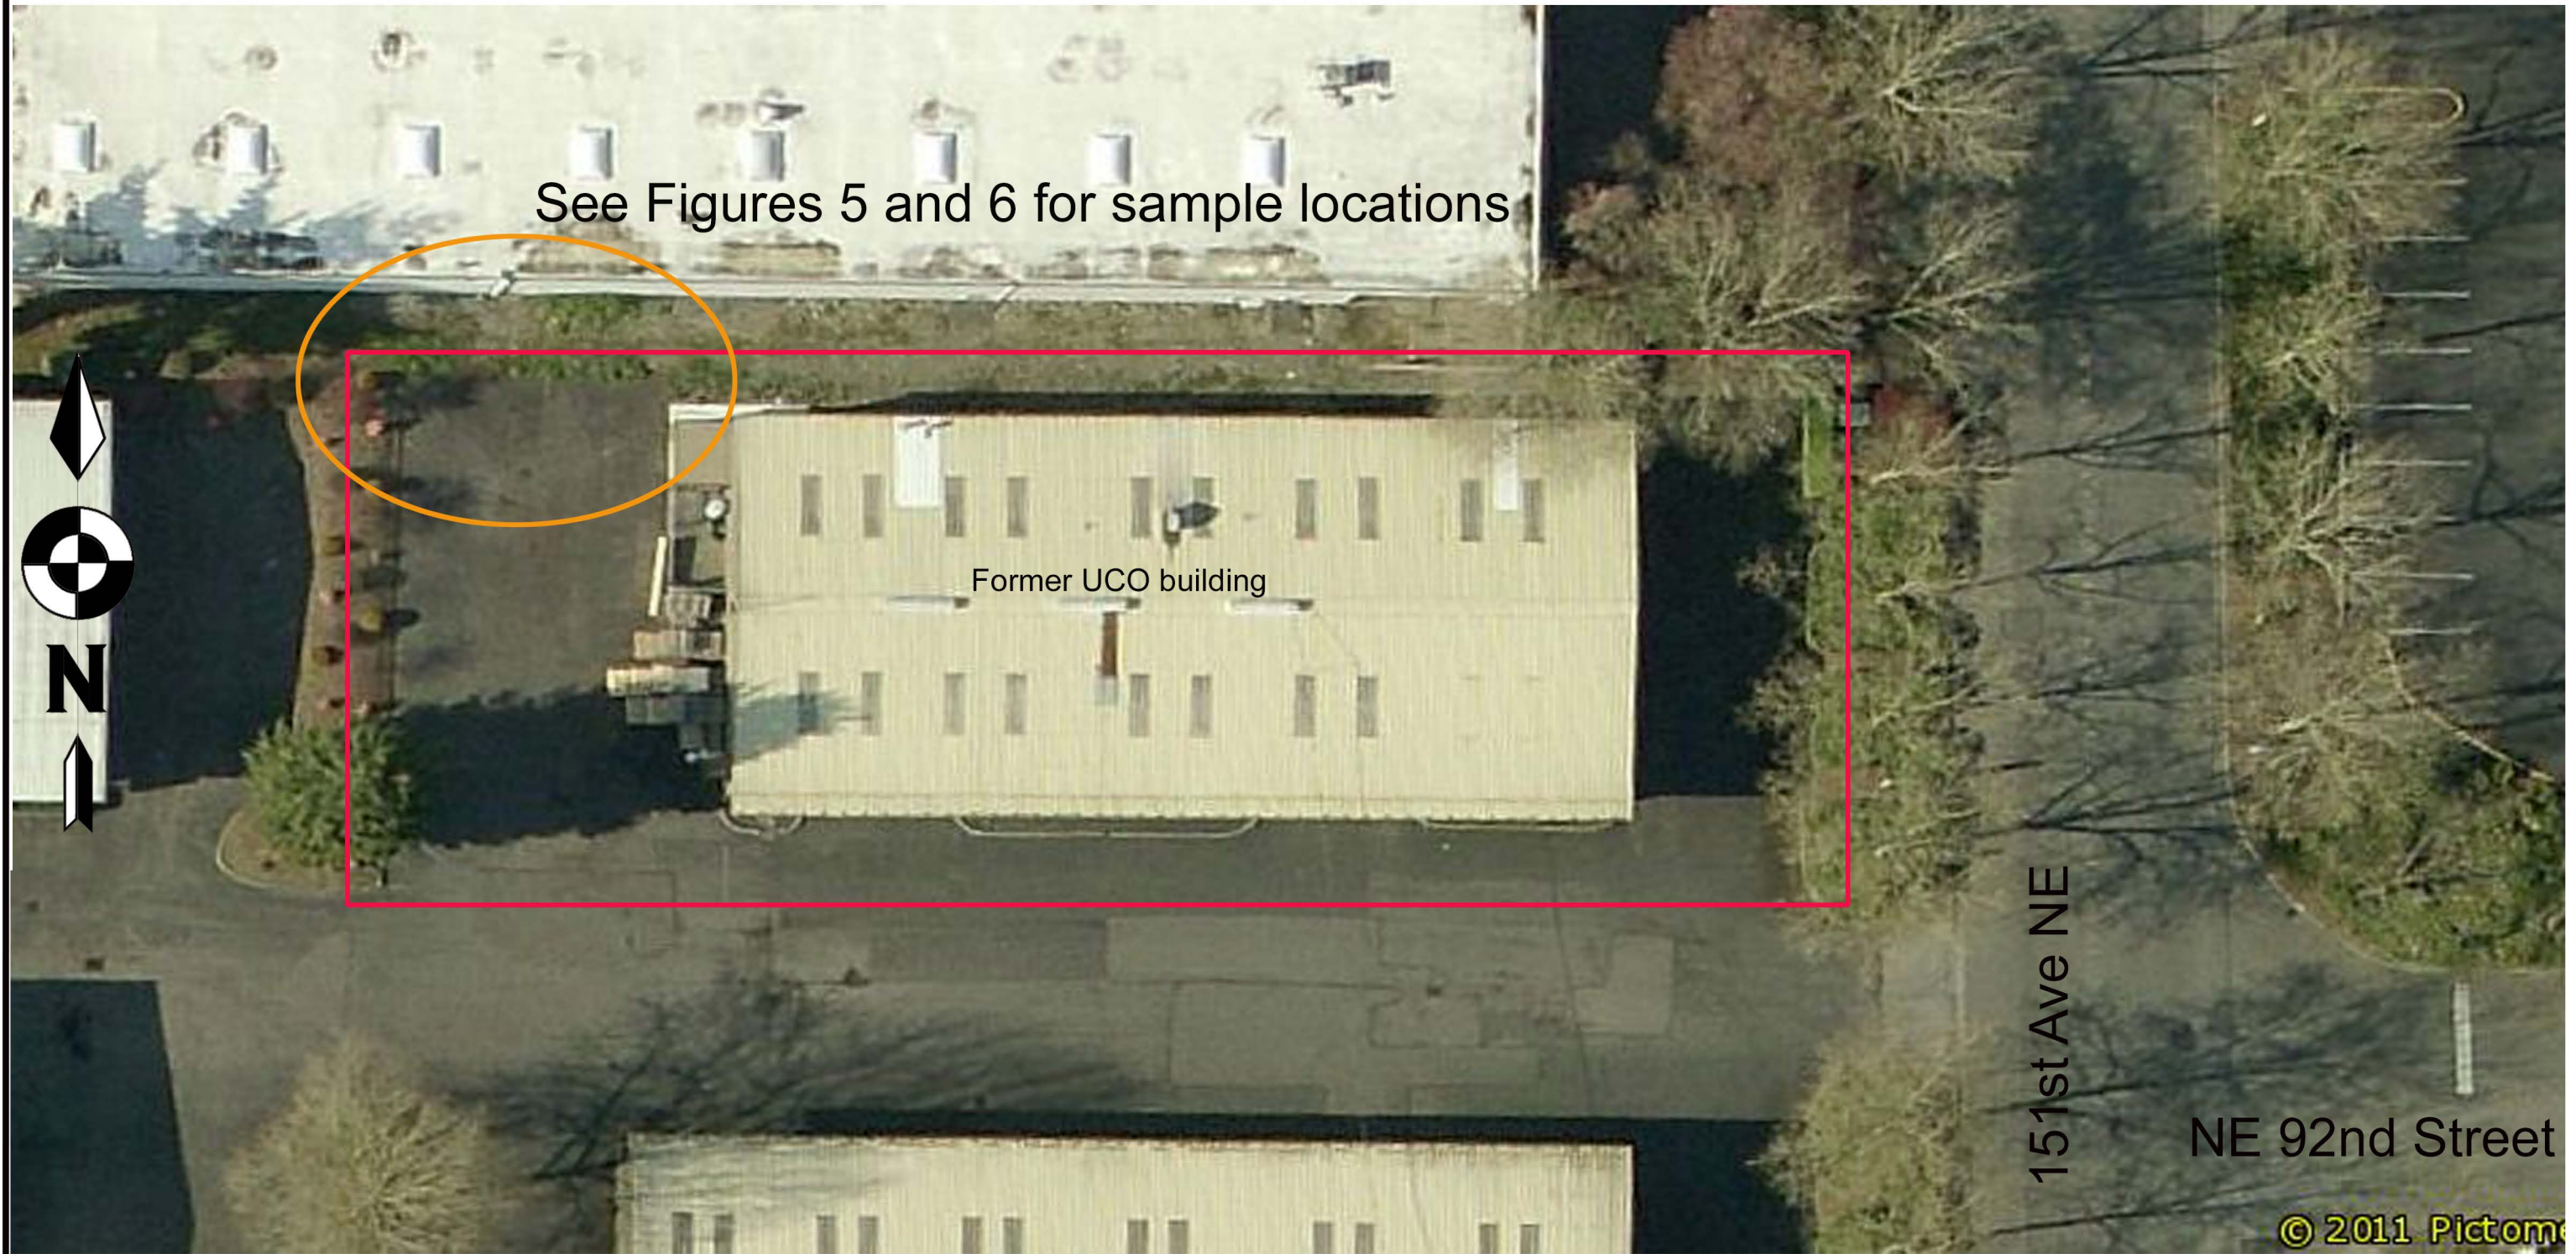
Proj. No. T-6776 Date May 2014 Figure 4

See Figures 5 and 6 for sample locations

Former UCO building

Index Location Plan
UCO
Redmond, Washington

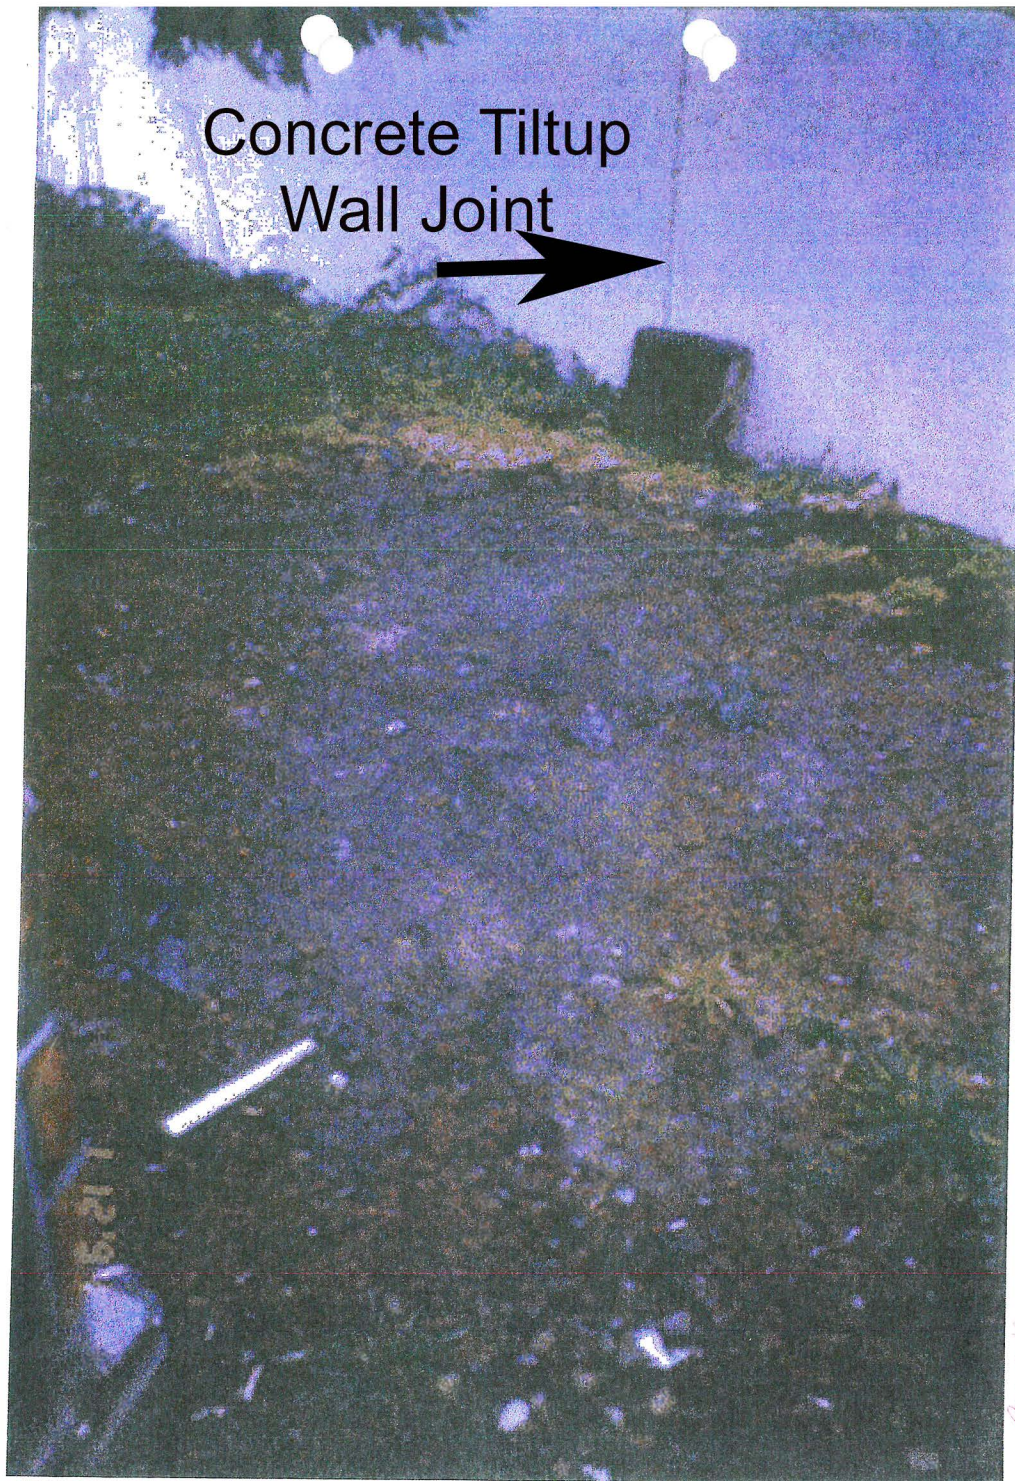
Photo taken by Metro
1994

Note tailgate of truck in Metro photo,
Photo taken by Terra Associates was
taken from a position slightly west of
SKCPH photographer's location

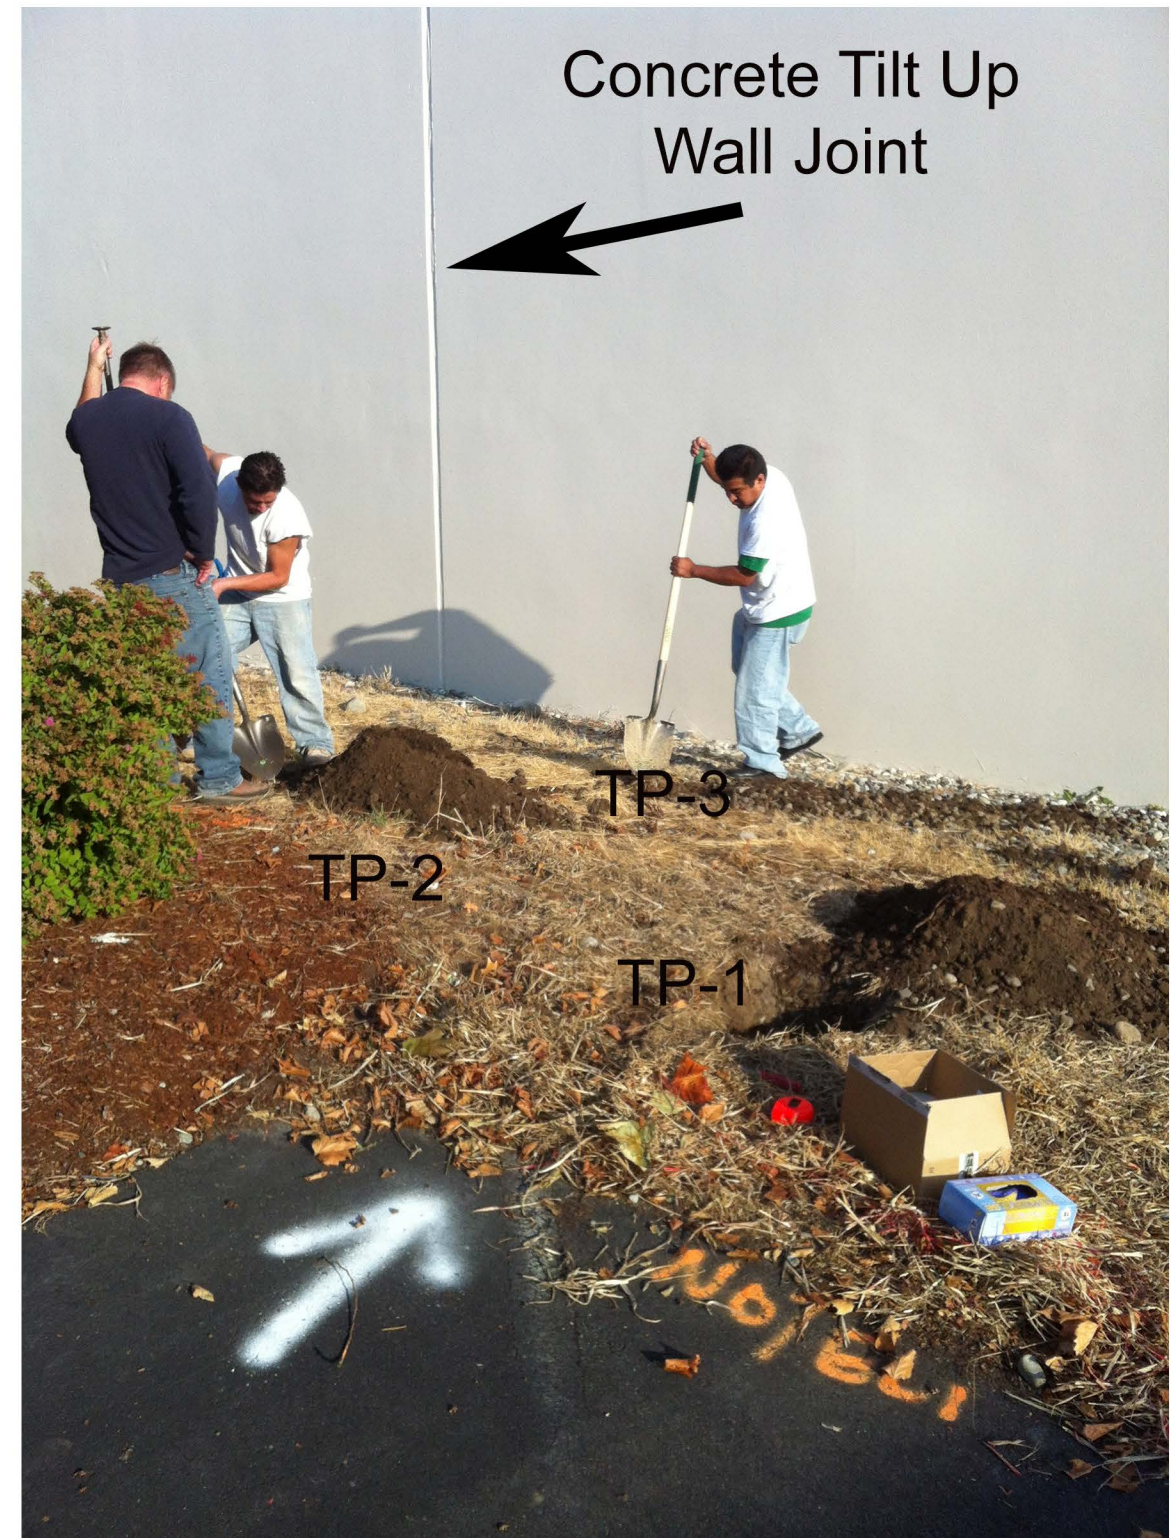
Photo taken by Terra Associates, Inc
2012

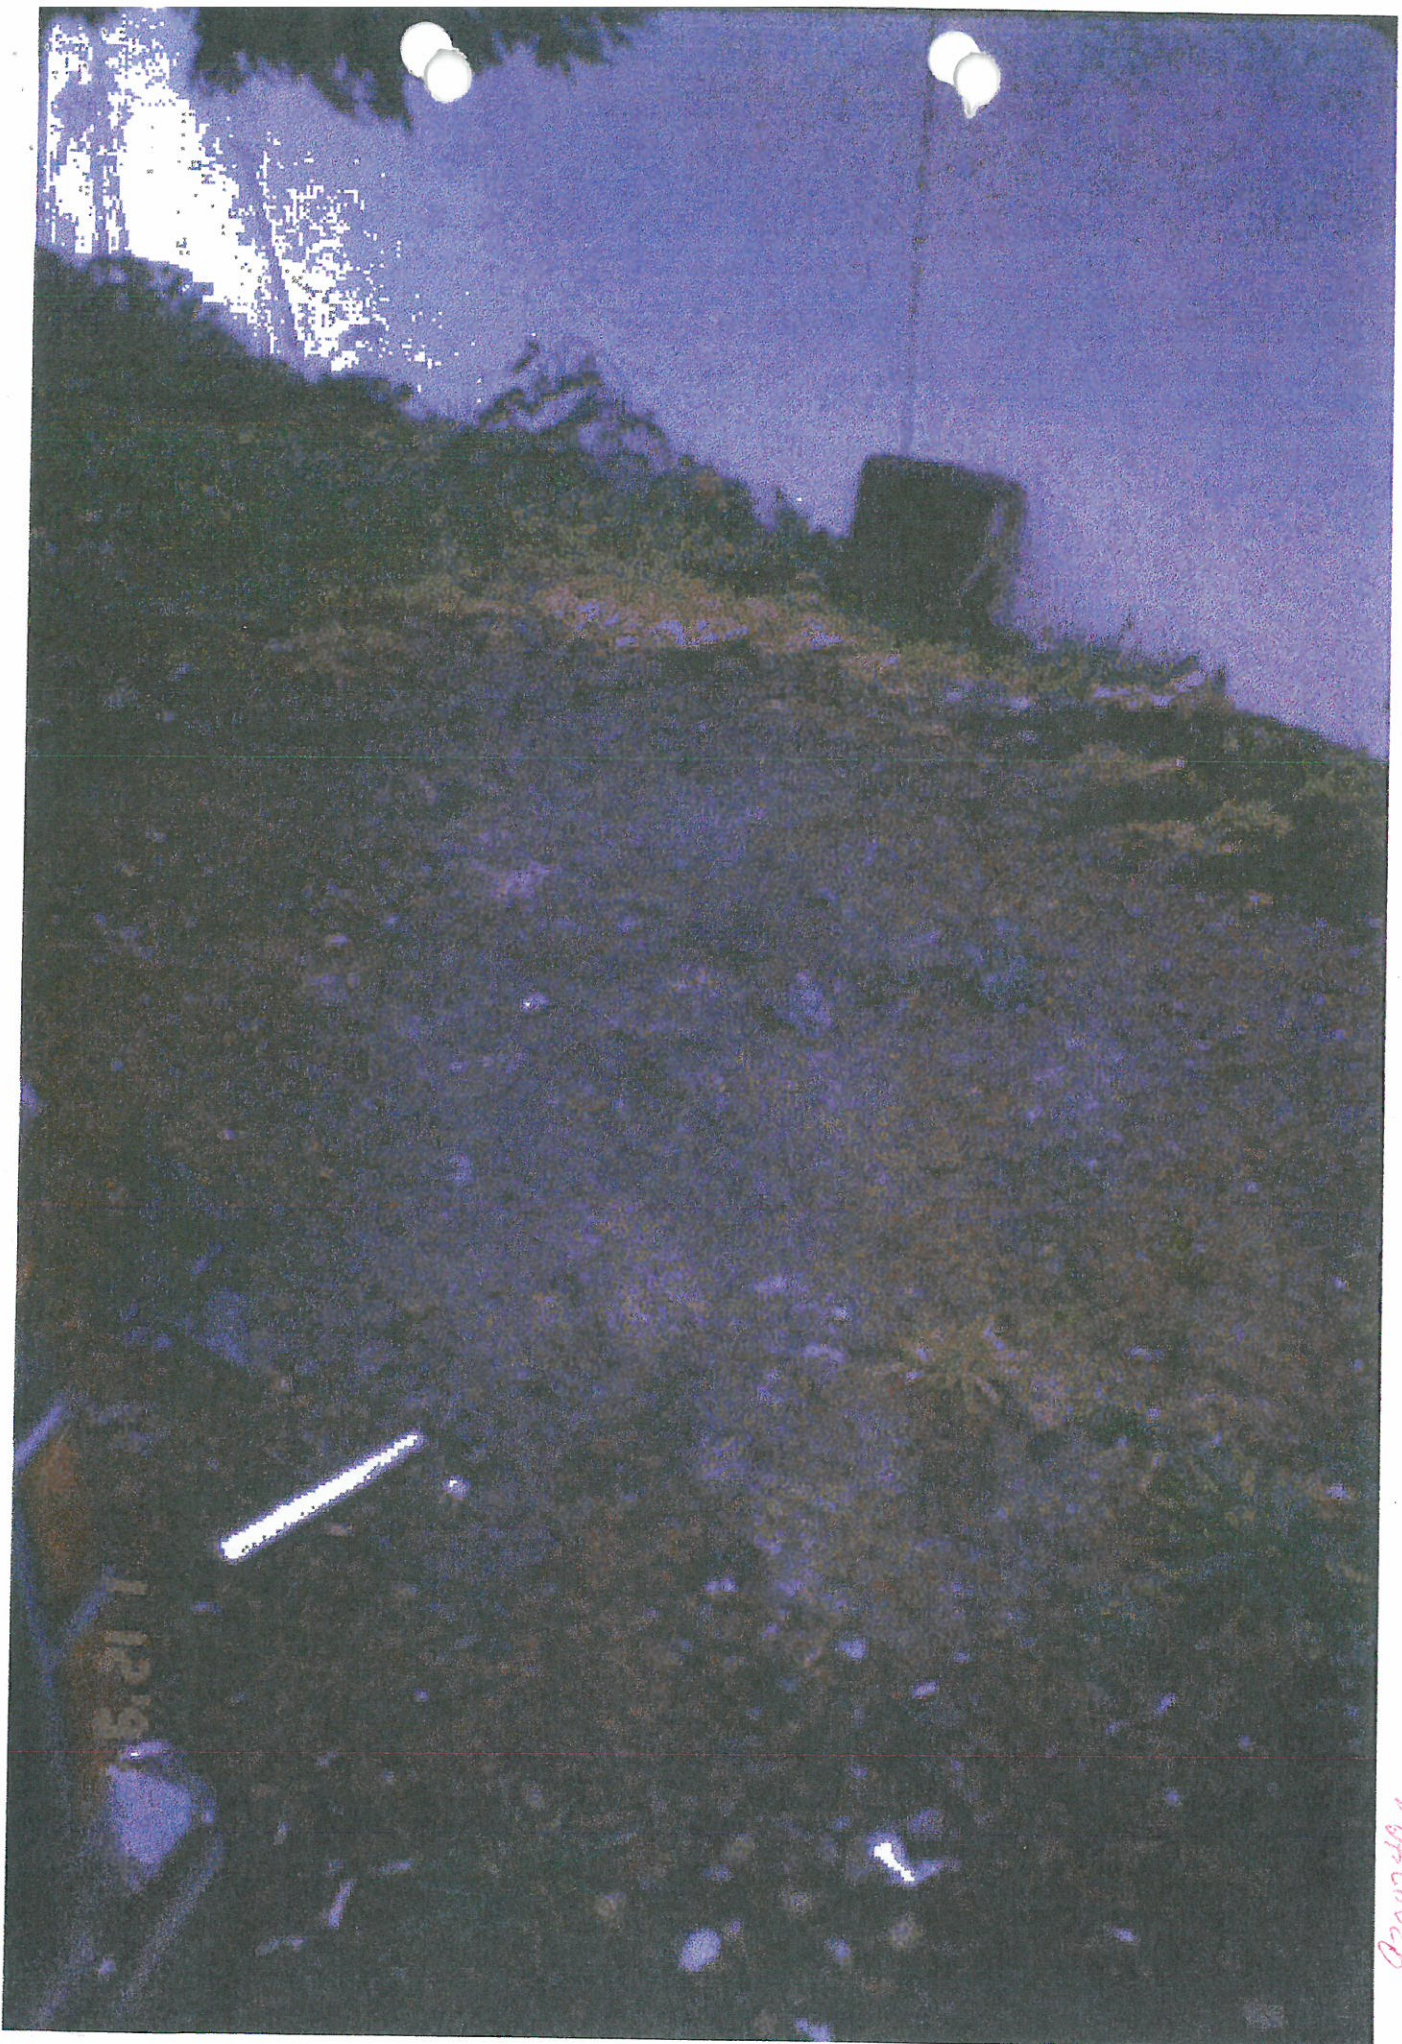
9300240 C
STAINED AREA

Site/Business is in an industrial park setting. UCO Corp does machine work on aluminum to make precision products. Behind the building is a small lot, and at the back corner of the parking lot you can see an eight by twelve (8 X 12) foot area stained black with distressed vegetation. Small metal flakes can be seen mixed in with the stain and water appears to bead on contact. Walking around this area, one can find more metal flakes and also metal shavings. Against the back wall of the building there is an uncovered air compressor pad with indications of oily-like runoff from the cement pad to the parking lot.

The staining appears to be a recent event (within the last few months). This conclusion is based on observations of the stained area (no dirt, dust or leaves on top or covering the stain), and the dead and distressed vegetation (a couple of thistle plants in the process of dying). The stained area is currently three (3) times larger than reported in the original complaint call (96 sq ft versus 30 sq ft). The caller is a member of the Redmond Fire Dept., and it is unlikely the caller reported stain size was incorrect by this much.

Talked with the owner of UCO, Greg Draper, explaining the complaint call and our findings. Mr. Draper admitted that in the past there was some cutting oils and compressor oil dumped and /or swept out to the back area. But he said they've stopped this practice a couple of years ago. If it is still going on, then it must be a new employee. Mr. Draper explained they sell/recycle their aluminum, so "why would we want to throw away aluminum shavings." Mr. Draper then started to talk about how competitive the market is getting and how it is difficult to compete with so many regulations. Mr. Draper assured me that he would take care of this problem and clean up anything he finds around his property.

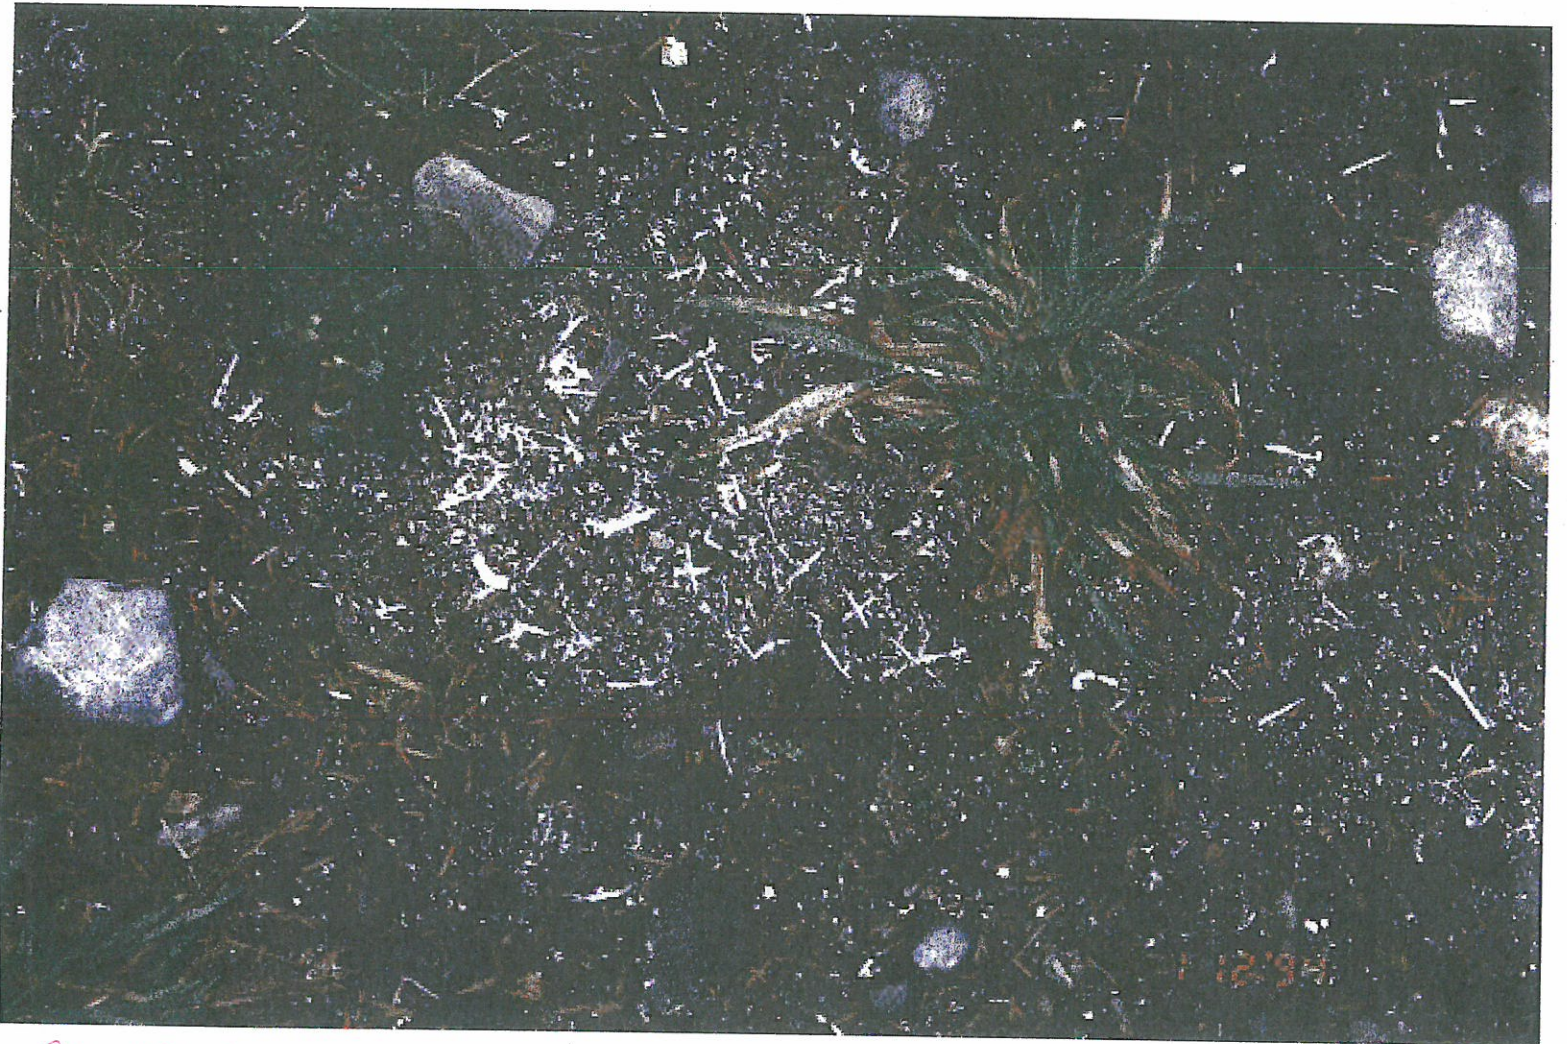
9300420d

METAL FILINGS ON GROUND.
