Phase II Environmental Site Assessment
Harrington-Beall Greenhouse Property
18531 Beall Road S.W.
Vashon Island, Washington

May 9, 2006

**PHASE II ENVIRONMENTAL SITE ASSESSMENT
HARRINGTON-BEALL GREENHOUSE PROPERTY
18531 BEALL ROAD S.W.
VASHON ISLAND, WASHINGTON**

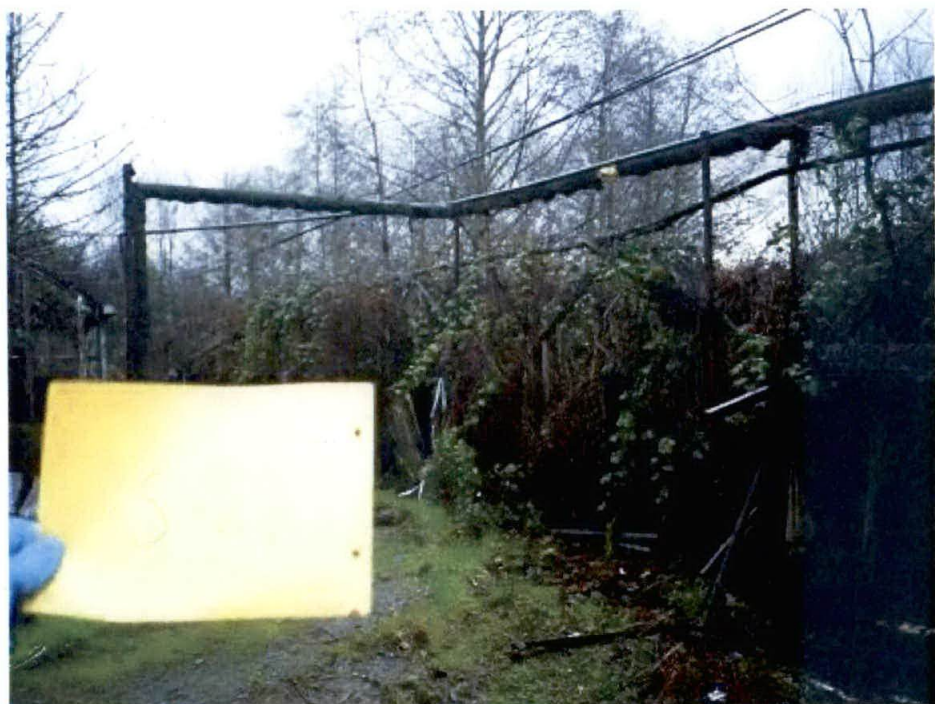
Photograph No. A-4

The insulation wrapping around former steam pipes is assumed to contain asbestos. The condition of pipe wrapping is very poor. The wrapping is missing at many locations and has been incorporated into underlying soil. CDM collected five discrete soils samples (S21 through S25) below steam pipe areas that appeared to have degraded insulation wrapping. Sample locations are shown on Figure 4. The samples were analyzed for percent asbestos by polarized light microscopy/dispersion

Asbestos fibers were detected in discrete samples S21, S23, and S24 collected below steam pipe areas that have degraded insulation wrapping (see Figure 4 and Table 10). Asbestos fibers included chrysolite in S21 and S23 and amosite in S24.

Description: Asbestos
testing in soil - Sample S21
location - Note
deteriorated insulation
wrapping on steam pipe.

Asbestos was identified in two of five soil samples analyzed. It should be assumed that the insulation around the former steam pipes and the former product piping between the easternmost ASTs and Building #83 is asbestos containing material (ACM) until a formal hazardous materials survey is performed. The insulation on all the piping is severely deteriorated and has become incorporated into the soil below the pipes in many areas. Care should be taken to minimize disturbance in areas containing the pipe wrapping until proper ACM abatement takes place.

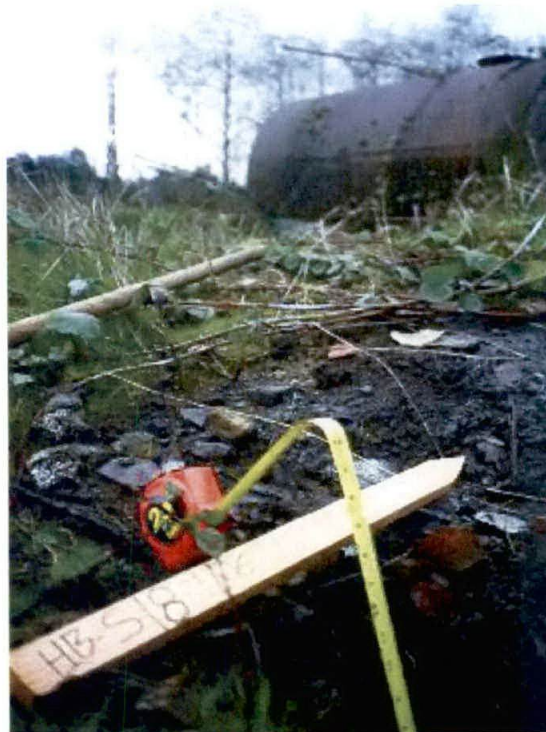
Photograph No. A-8

Description: Former Fuel Storage
Tank Assessment - Sample S18
location - Note hydrocarbon-
stained soil at surface.

Based on the types of contaminants of concern and surficial nature of impacted soils, the most viable approach for cleanup of this site is source removal. Source removal can be accomplished through soil excavation. Soil excavation would involve the physical removal and off site disposal or treatment of contaminated soil, and if necessary, replacement with clean fill. Other cleanup technologies such as bioremediation and phytoremediation may be applicable to the site; however, feasibility studies would be needed to verify this. Prior to undertaking any cleanup a site-specific TEE may be required to define risk to the environment from the site. The goal of the TEE process is to develop cleanup levels that are protective of terrestrial ecological receptors (plants and animals) from exposure to contaminants of concern.

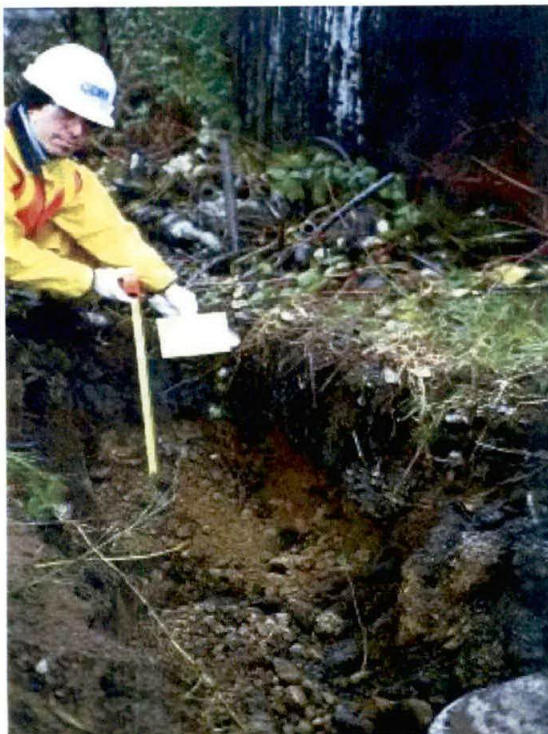
Photograph No. A-14

Description: Former Fuel Storage
Tank Assessment Test pit
TP3/surface sample S20 locations.
Note near surface hydrocarbon-
stained soil. Former Fuel Storage
Tank in background.

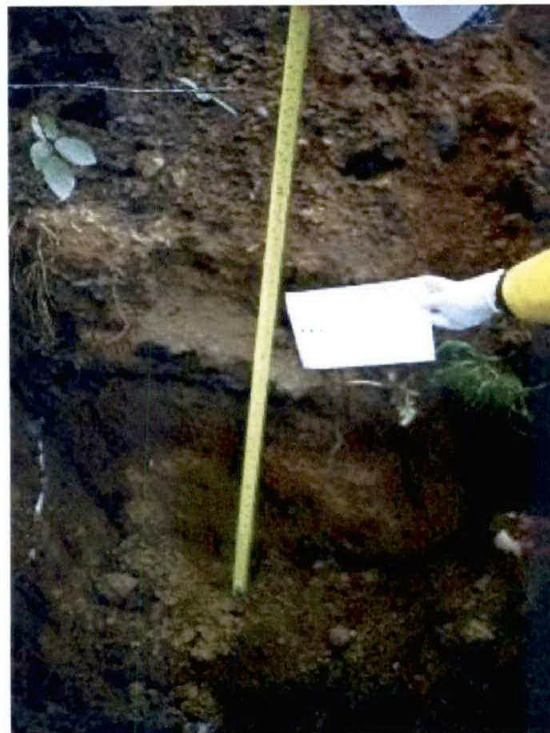
Photograph No. A-16

Description: Former Fuel Storage
Tank Assessment - Test pit TP8
soil horizon - Note hydrocarbon
staining in upper 1 foot of soil.

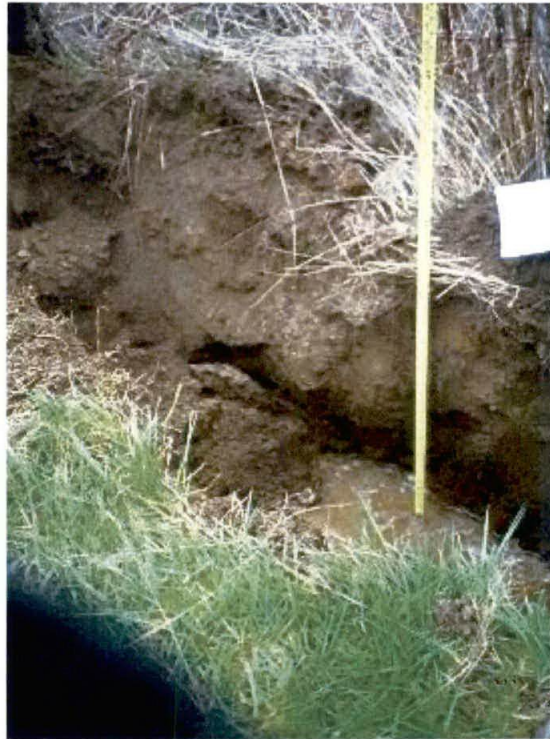
Subsurface exploration during this Phase II ESA encountered primarily brown to gray silty sand with some fine gravel and organics within the 6-ft maximum depth of exploration. Several of the test pits excavated during CDM's subsurface exploration encountered till-like soils with iron oxidation mottling. Groundwater seepage was noted in 10 test pits at depths between 1½ and 4½ ft bgs. Groundwater was not encountered in the other seven test pits. The water seepage is believed to be perched groundwater that resulted from recent heavy precipitation. The 8-week period prior to CDM's investigation saw 18.5 inches of rain as measured at SeaTac International Airport; normal precipitation for this period is 10.75 inches (National Weather Service web site). Some standing water was noted in the Experimental Garden area on the east side of the site.

Description: Experimental Garden
Site Assessment - Test pit TP10
location, note perched
groundwater at base of test pit.

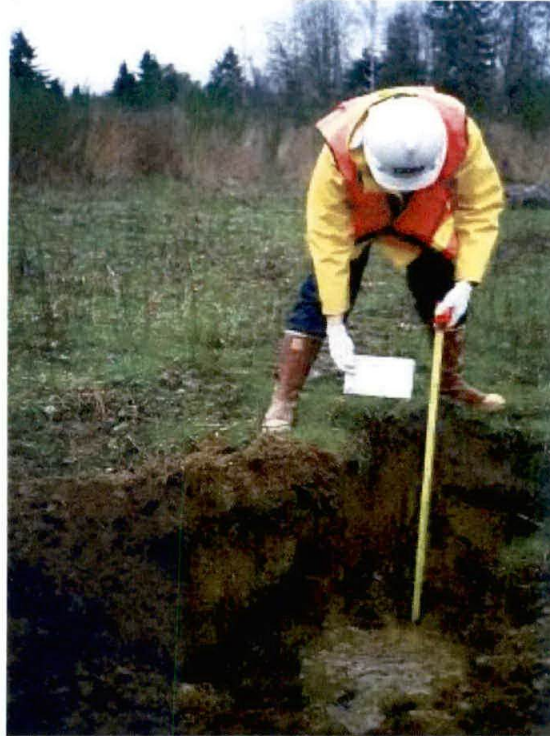
Description: Experimental Garden
Assessment – Test pit TP13
location, note perched
groundwater at base of test pit.
