**LIMITED REMEDIAL ACTION REPORT
FORMER GODFATHERS BUILDING**

**At the Westpark Shopping Center
4001 West Summitview Avenue
Yakima, Washington**

Project Number 05-942

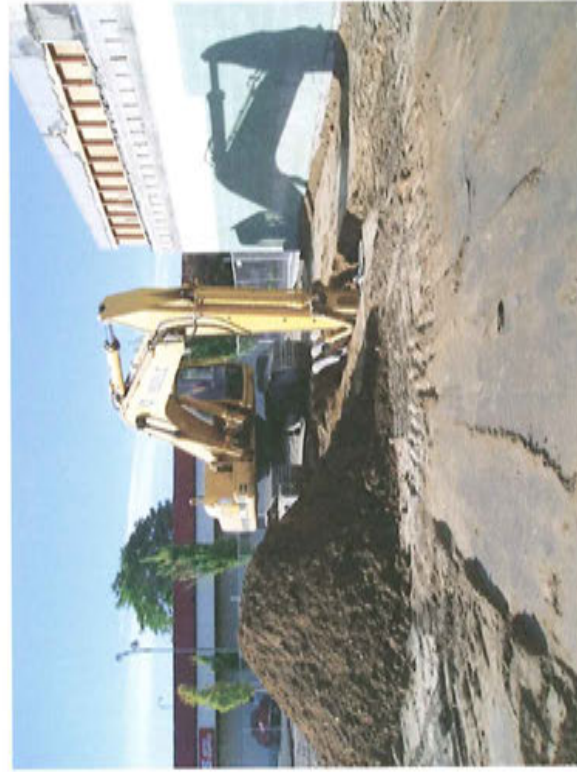
Test pit location #7 along the west side of the former Godfathers building area.

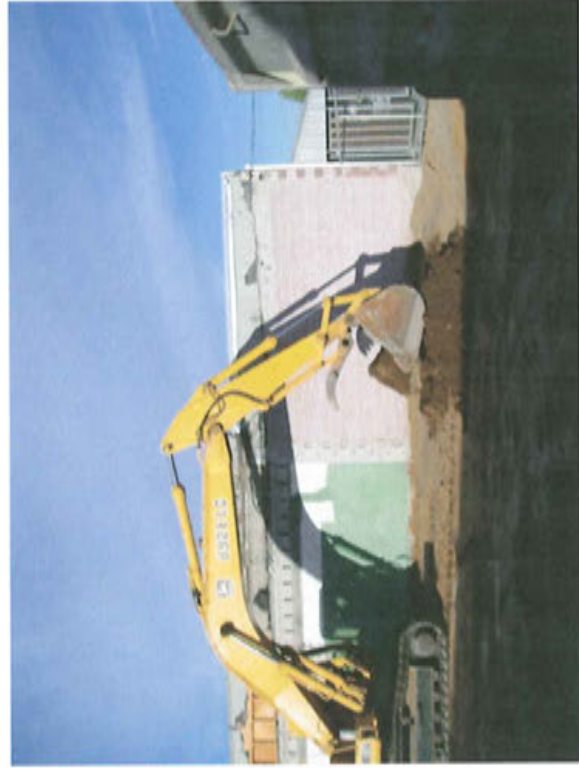
Test pit excavation activities during the September 22, 2009 site investigation. Dry cleaner's building in background.

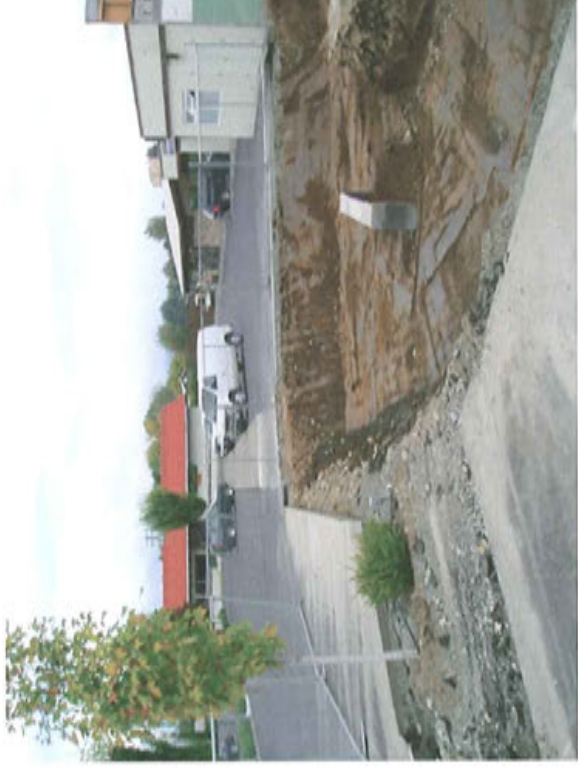
Near surface soils were removed to facilitate excavation of PCE contaminated soils.

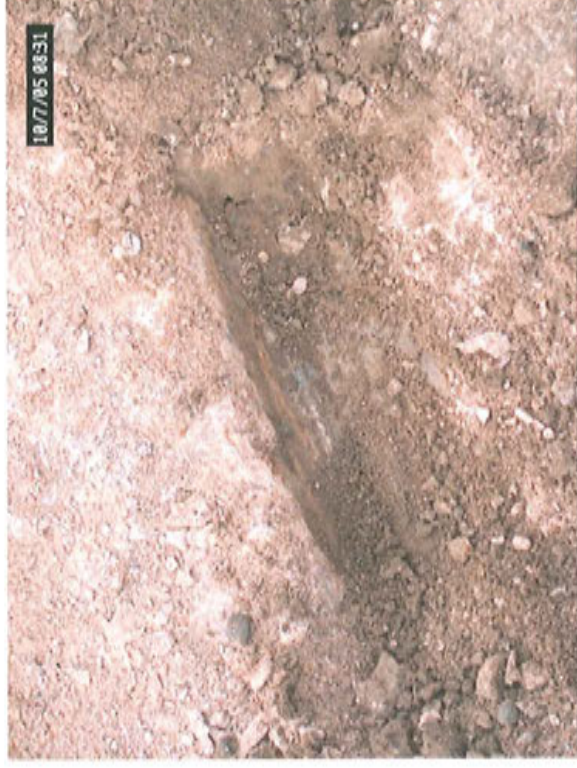
Excavator bucket teeth resulted in scraping through the caliche-like soil rather than direct excavation.

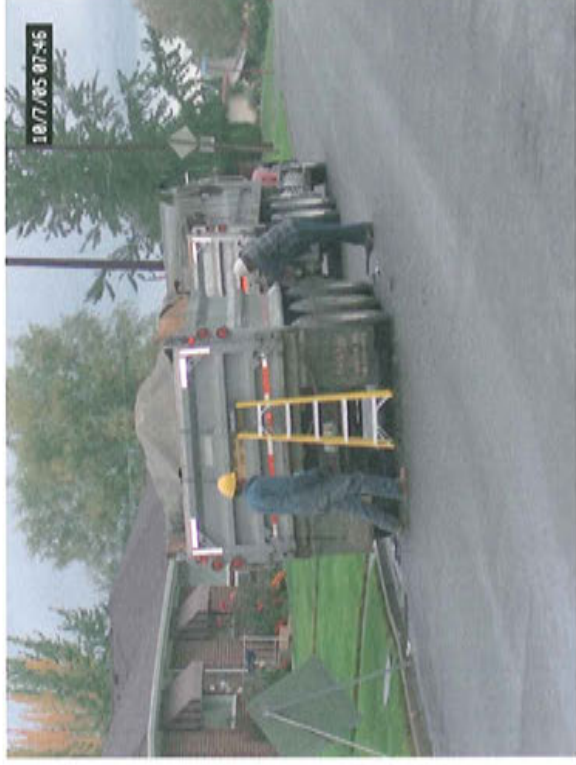
Truck and pup trailer in the process of securing for transport of PCE contaminated soils to Roosevelt Regional Landfill.

Following receipt of initial laboratory analysis, Fulcrum contacted Rabanco to request disposal of PCE contaminated soil at the Roosevelt Regional Landfill. Following consultation with Brian Dick, Ecology's Hazardous Waste Program, he confirmed that disposal at the Roosevelt Regional Landfill was appropriate as a part of a contained-in disposal process.

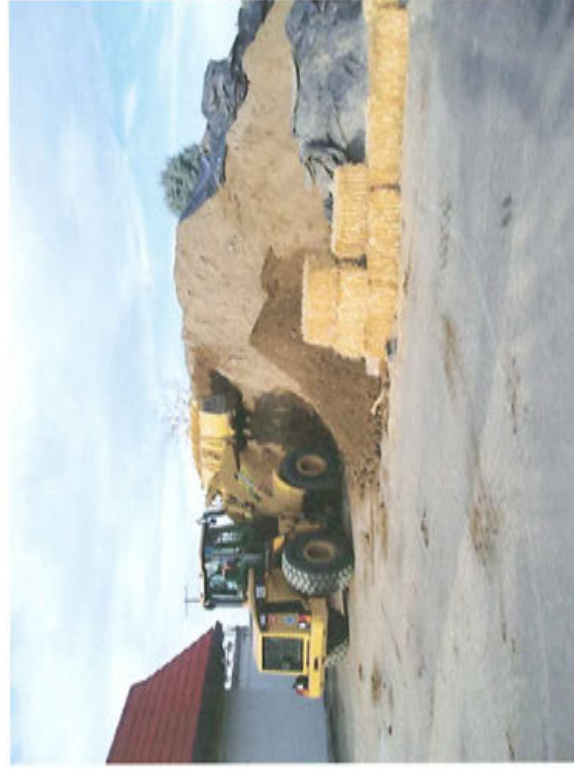
Stockpiled soils located west of the dry cleaner's building.

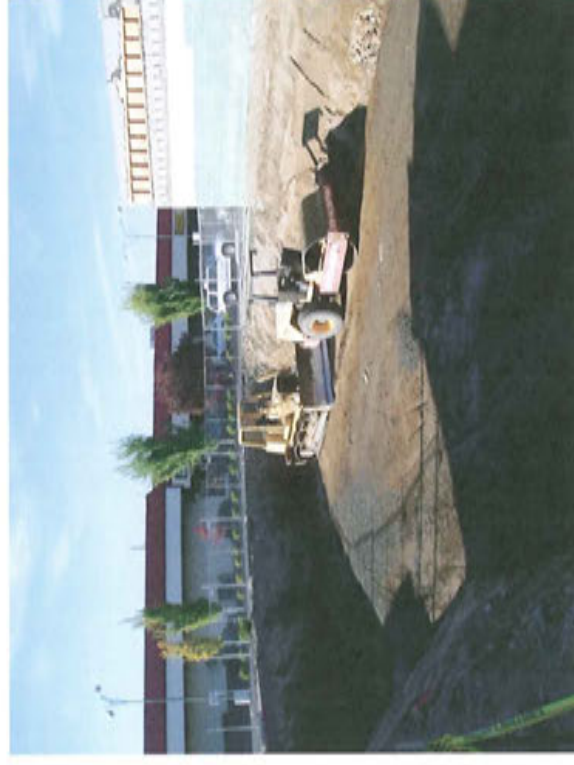
Approximate final extents of the excavation following sidewall stabilization.

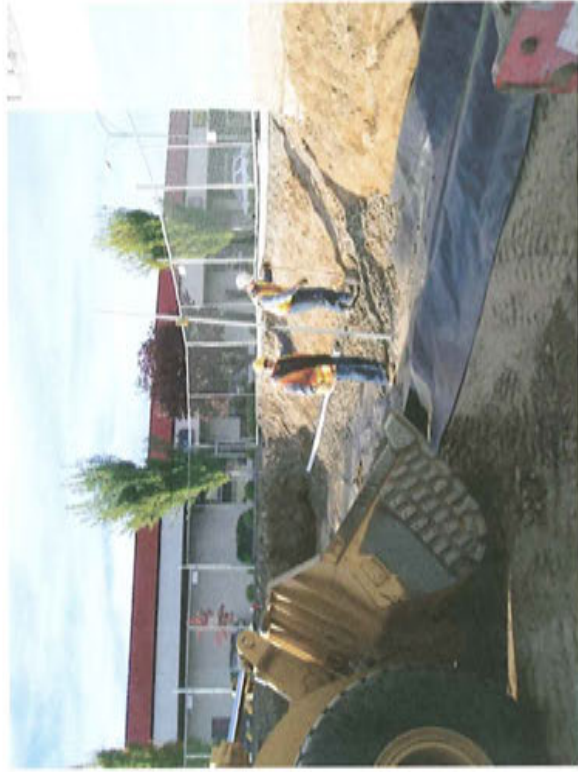
Installation of the HDPE barrier along the west extent of the former Godfathers building excavation.

The passive soil venting consisted of perforated drain piping wrapped in a geotextile fabric and enclosed within washed round sorted gravels. The HDPE liner was secured below the sorted gravels and to the foundation of the dry cleaner's building foundation.

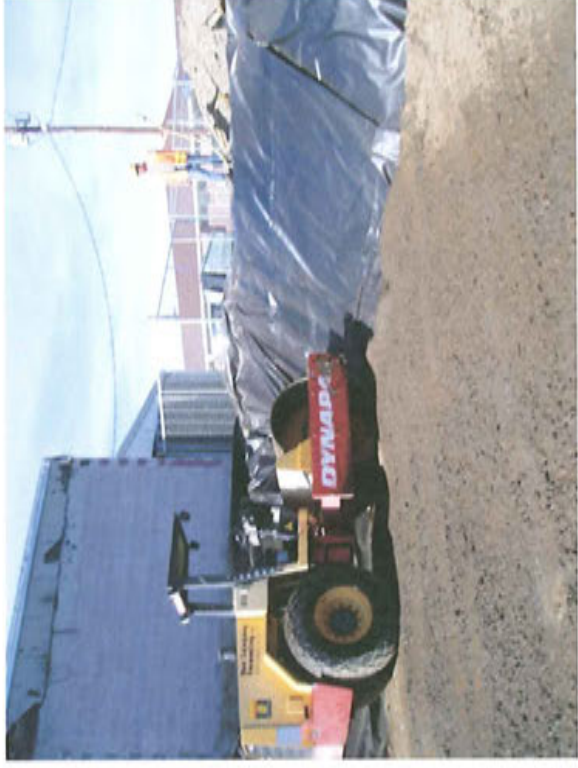
Compaction of soil along the lower extent of the HDPE barrier along the north boundary of the excavation.

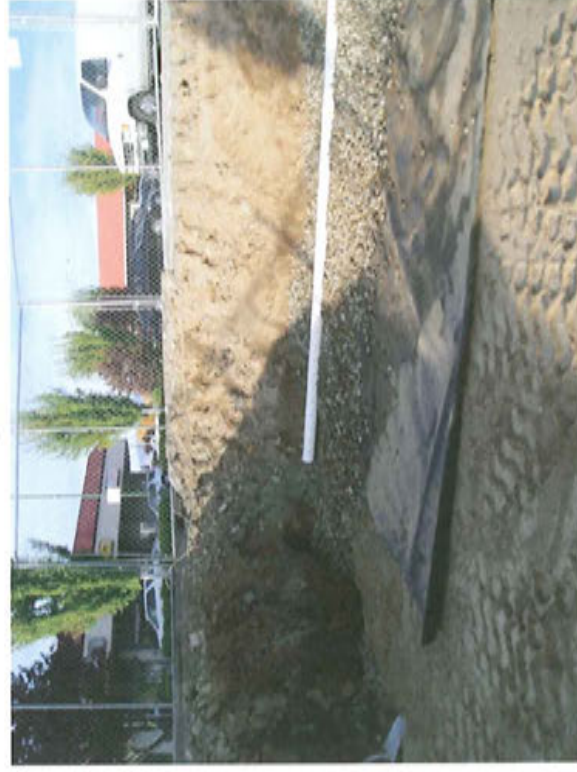
Perforated piping, gravel, and HDPE barrier installation along the south portion of the west excavation sidewall.

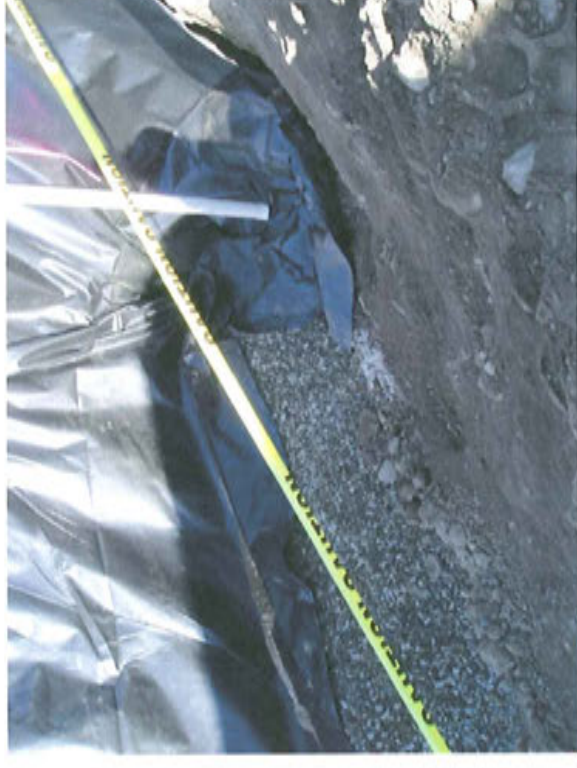
Passive venting system, gravel, and HDPE barrier during installation.

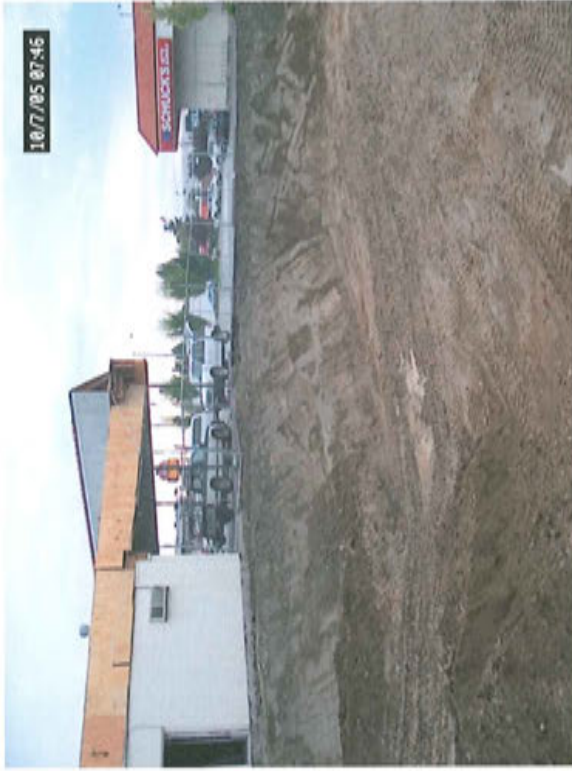
The southeast portion of the excavation following completion of excavation activities and import of clean soils.

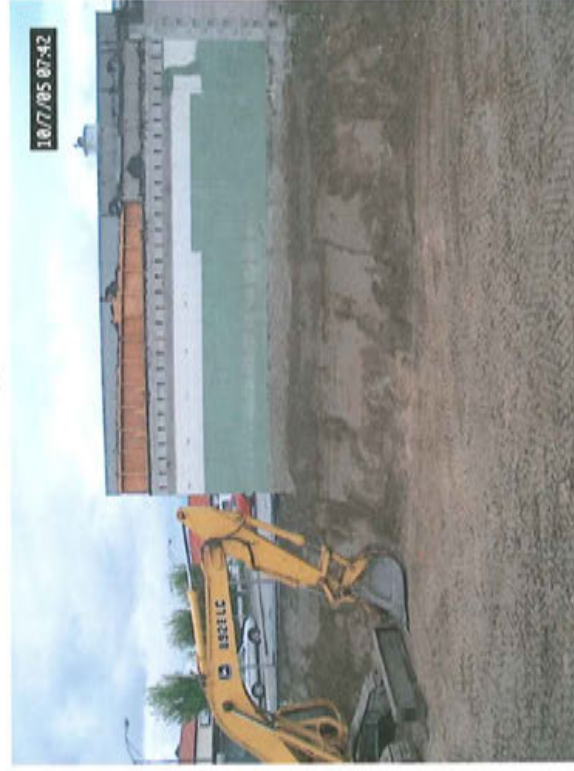
Clean soil used following completion of the vapor barrier to reestablish a slope and support the building structure.

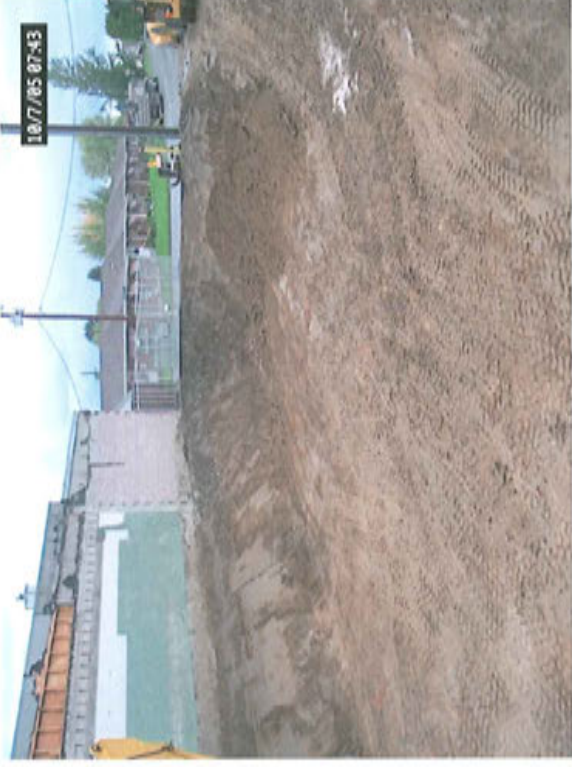
Delivery of clean imported soils along the north portion of the excavation.

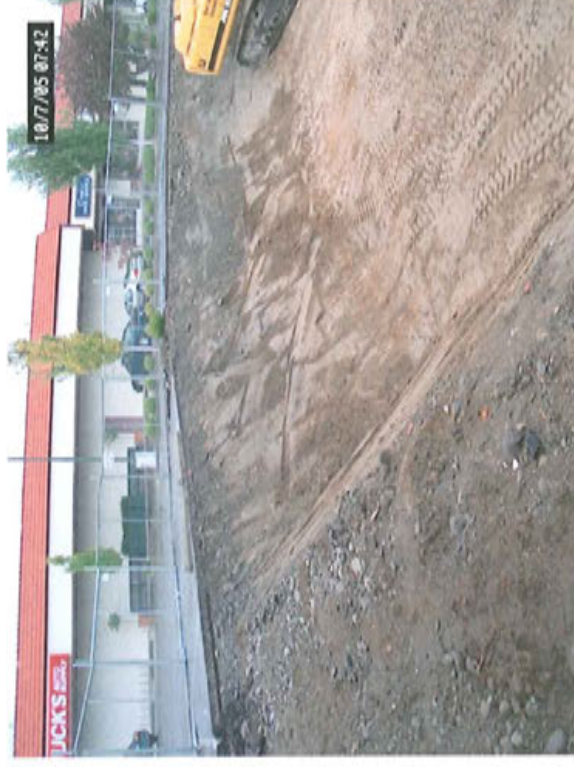
The south sidewall of the excavation following sidewall stabilization.
