May 20, 2013

RE: Remedial Action - Soil Excavation, Groundwater Monitoring Well Installation, and Sampling Letter Report

Villa Grove Texaco
9200 Littlerock Rd
Tumwater, WA 98512

Project Name: Villa Grove Texaco Soil Excavation

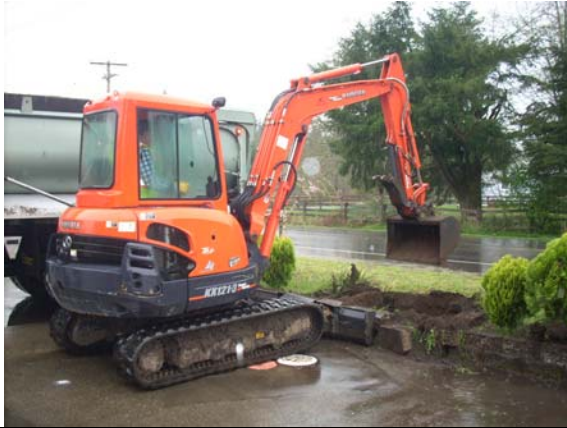
Photo
#1:

*Excavating Soil at Location of Former
Monitoring Well MW-6 (Looking West)*

On April 9, 2013, approximately 15.32 tons of petroleum contaminated soil were excavated at the location of monitoring well MW-6 to a depth immediately above the saturated zone (6 feet bgs), using a track-hoe operated by Advance Environmental, Inc. When it was estimated that the contaminated soil was removed, soil samples were collected from the base of the excavation and from the sidewalls. These samples were field screened for petroleum hydrocarbon volatiles using a photo ionization detector (PID) instrument. Because groundwater was found at approximately 4 to 6 feet bgs, further excavation to a deeper depth was not possible. Subsurface conditions at the excavation location generally consisted of a brown gravelly sand with silt to the base of the excavation at 6 feet bgs.

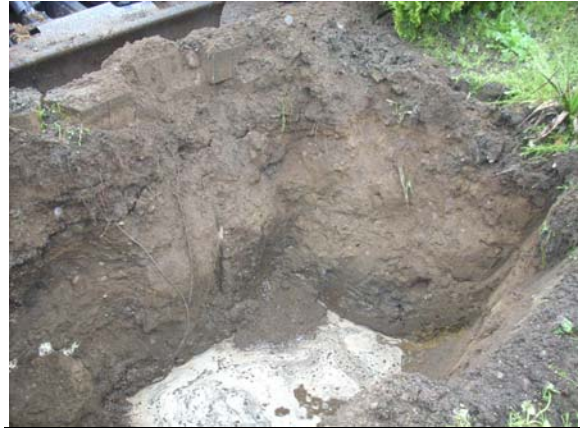
Photo
#2:

Groundwater Accumulating in Excavation

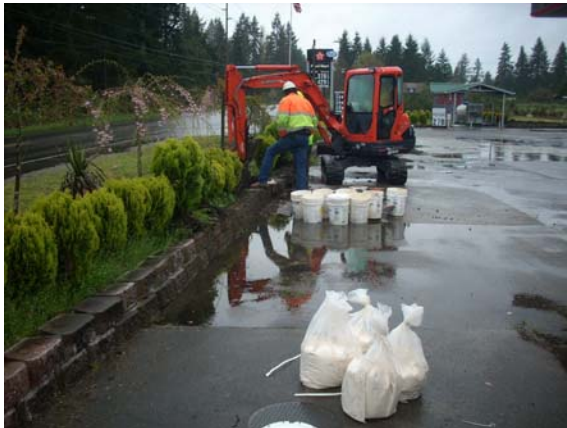
Photo
#3:

*ORC®-A Staged for Mixing in Excavation
(Looking Northeast)*

After collection of the samples for field screening, the excavation was backfilled with recycled concrete backfill material and top soil. To accelerate the microbial degradation of any remaining petroleum hydrocarbons in soil, 300 pounds of Regenesi's Oxygen Releasing Compounds-Advanced® (ORC-A®) powder was added to the groundwater accumulated in the excavation at a depth of approximately 6 feet bgs. ORC-A® is an updated formula of the ORC used previously at the site. According to Regenesi, ORC-A® is a:

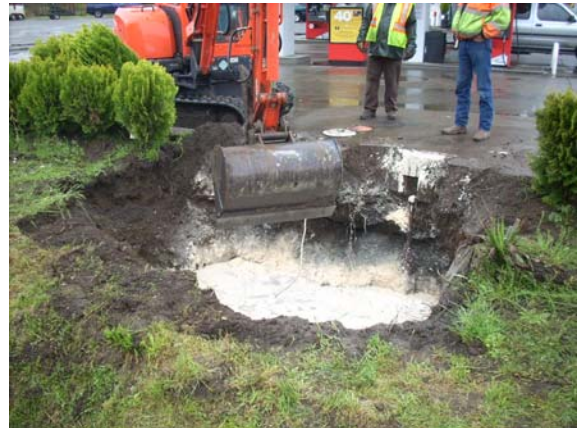
Photo
#4:

Mixing ORC®-A in Excavation Before Backfilling

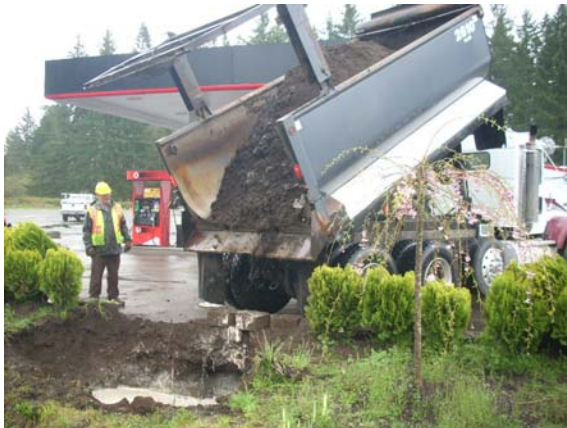
Photo
#5:

Backfilling Excavation (Looking East)

The excavation backfill was then compacted. Because it was in a landscaped area, the area was re-landscaped and a brick retaining wall replaced. The final dimension of the excavation was approximately 8 feet wide by 12 feet long by 6 feet in depth.

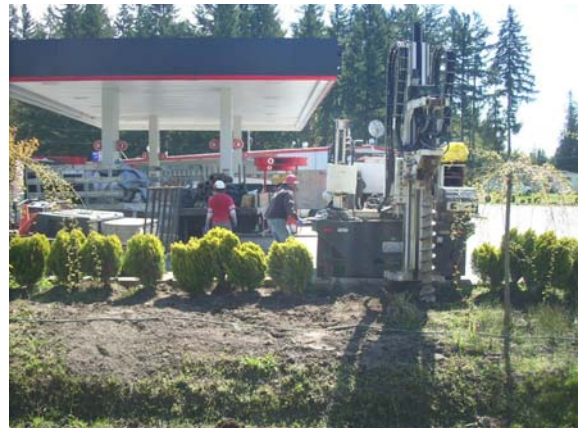
Photo
#6:

*Drilling Replacement Monitoring Well MW-6R
South of Excavation (Looking East)*

During excavation, groundwater monitoring well MW-6 was entirely removed and transported offsite for disposal. To replace the well that was removed, on April 17, 2013, AEG and its subcontractor ESN Northwest drilled and installed a new monitoring well approximately 5 feet south of the excavation.

This well, designated MW-6R, was drilled and constructed using a 9-inch outside diameter/ 4¼-inch inside diameter hollow-stemmed auger. The well was constructed using 2-inch PVC well screen and casing to a depth of 11½ feet bgs. The screened interval is 8½ feet long from 3 feet to 11½ feet bgs. The well was completed a “flush-mount well” per the Ecology regulations, WAC 173-160 - Minimum Standards for Construction and Maintenance of Wells. A copy of the boring log and well construction diagram is attached in Appendix A - *Supporting Documents*. At the time of drilling, water was encountered at a depth of approximately 4 feet bgs.
