## **Soil Remediation Closeout Report**

**Ruth Dykeman Children's Center  
1033 SW 152nd Street  
Burien, Washington**

**March 21, 2014**

**Project No. T12050f**

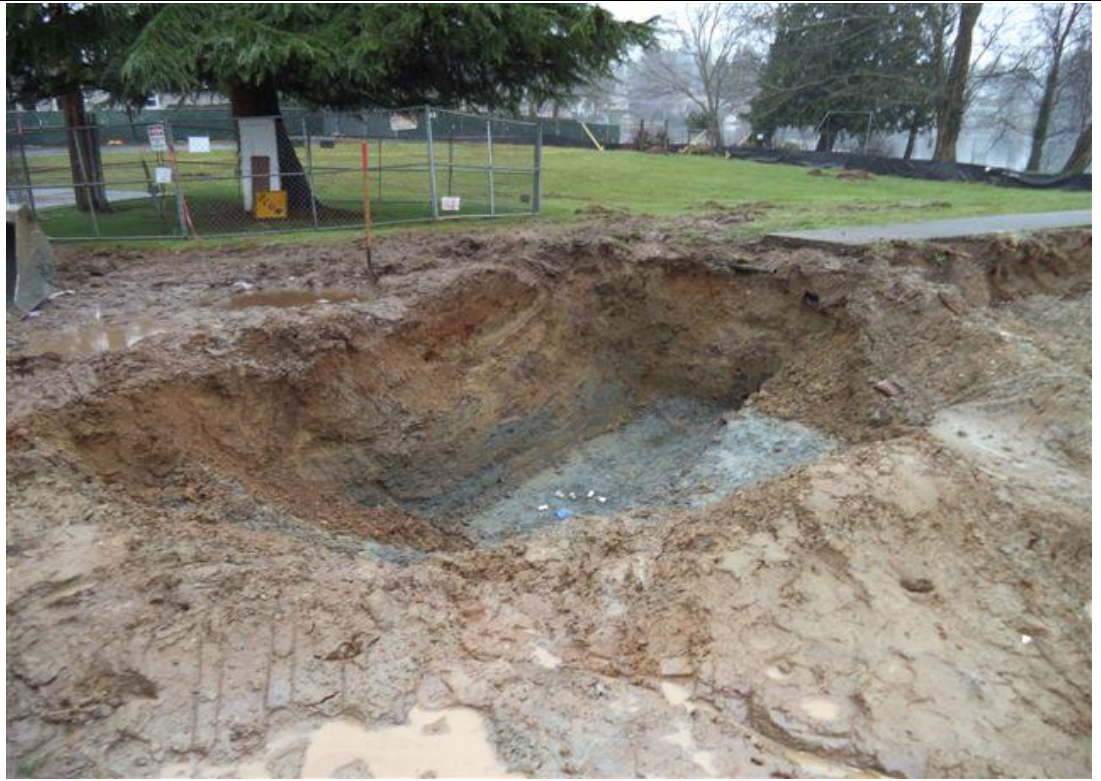
<b>Photo No.</b> 1
<b>Direction Photo Taken:</b> South
<b>Description:</b> View of excavation upon E3RA arrival.

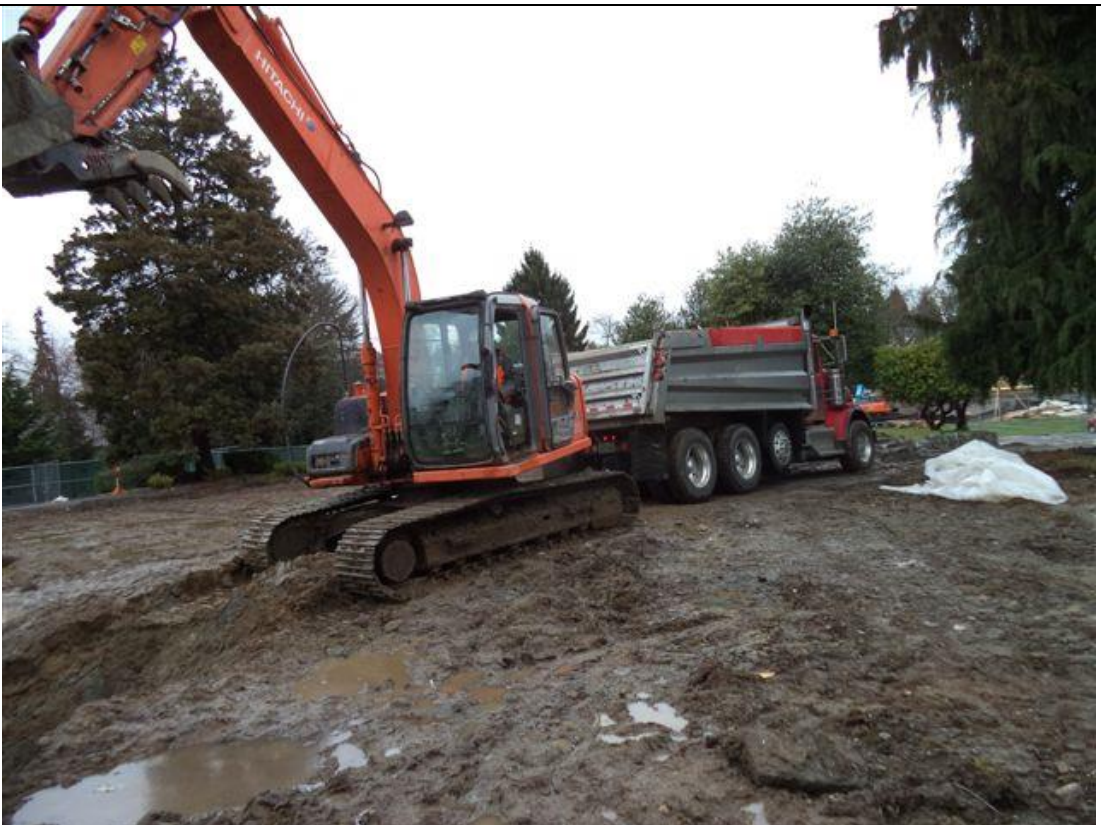
<b>Photo No.</b> 2
<b>Direction Photo Taken:</b> East
<b>Description:</b> View of PCS being loaded into dump truck.

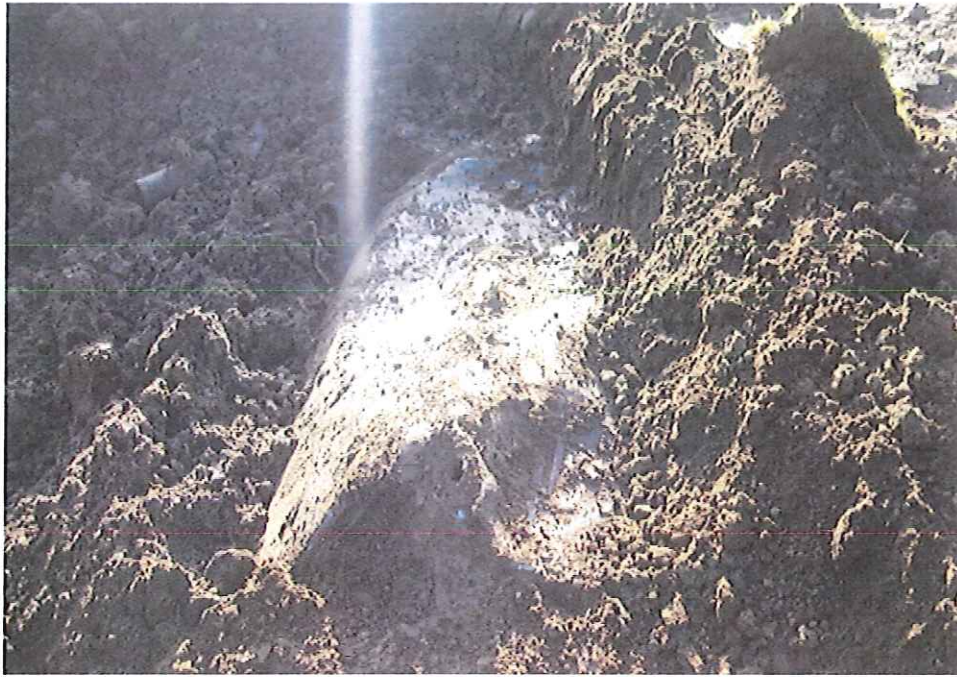
Gym tank top exposed under 30" of earth cover.

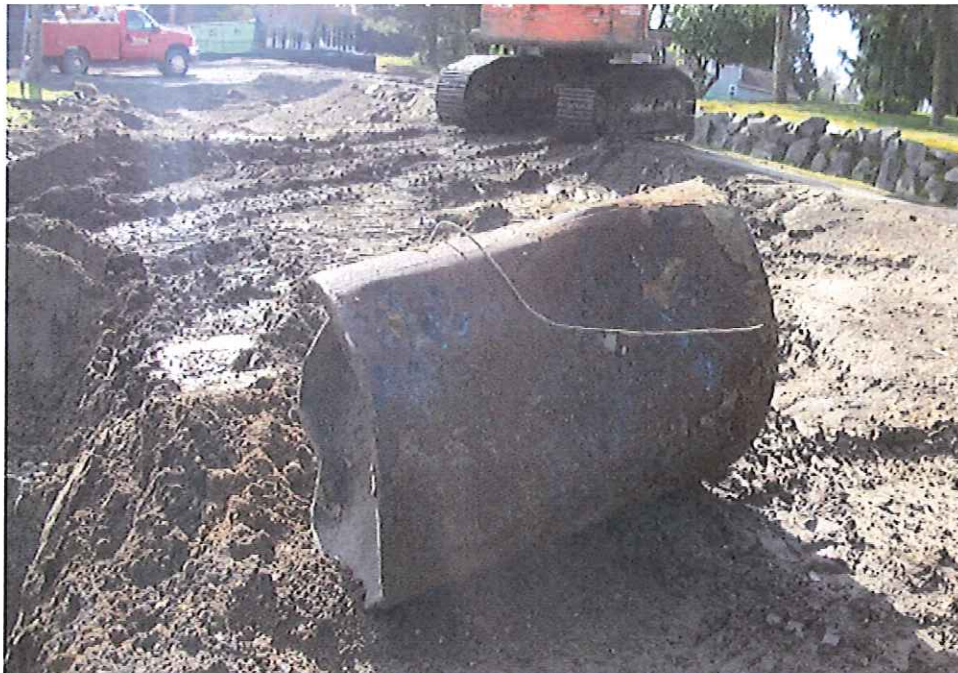
Removed 500 gallon gym site tank. No visual or olfactory indications of PCS noted.

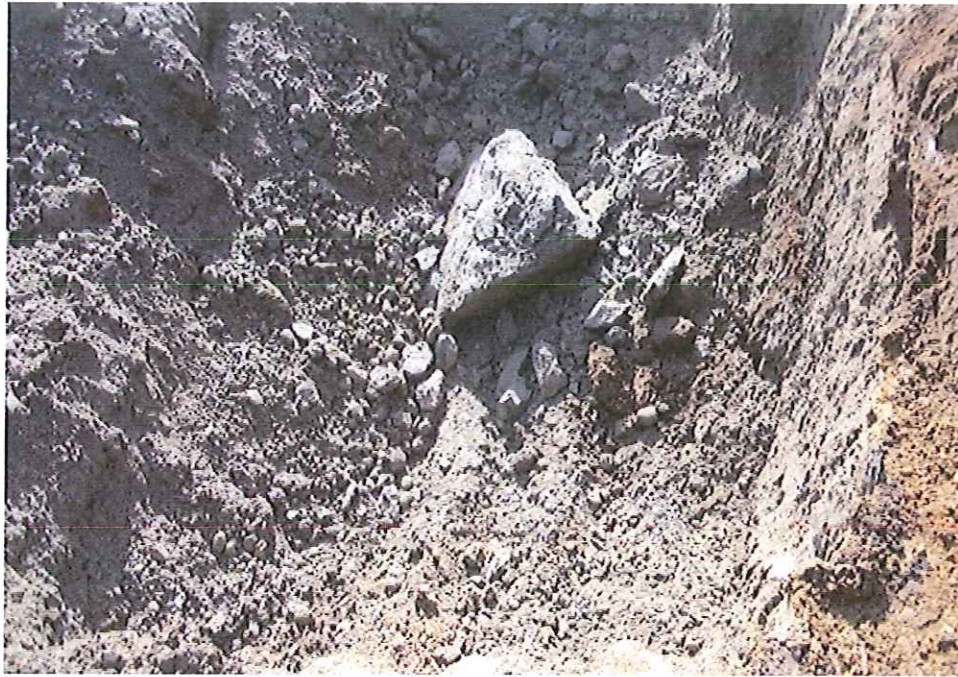
Gym UST tank pit bottom. Soil sample analytical results were at the non-detect level.

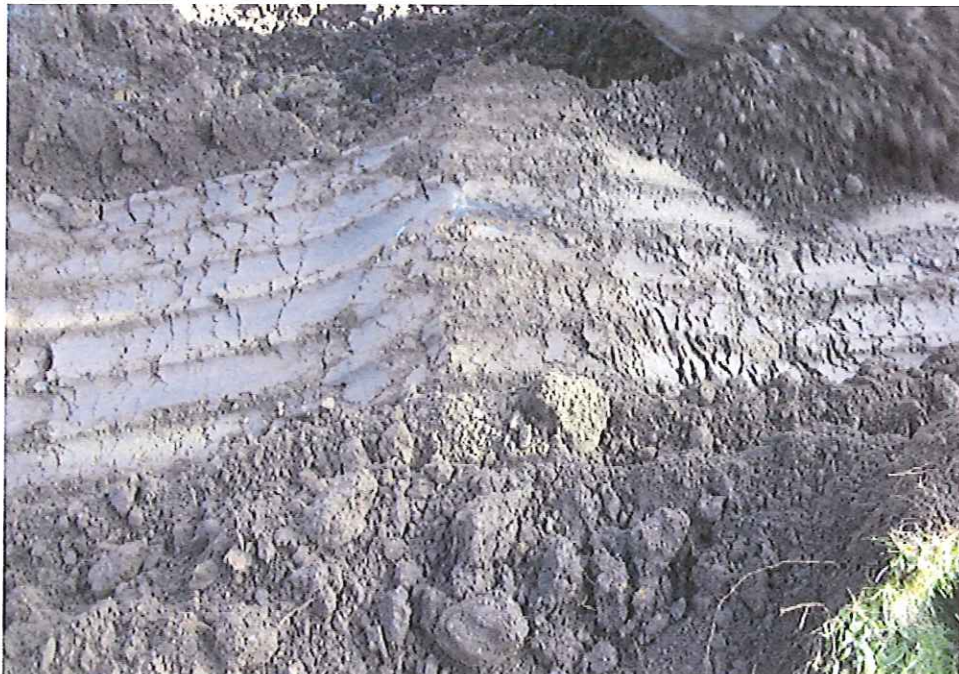
Heather building UST exposed under 12" of earth cover.

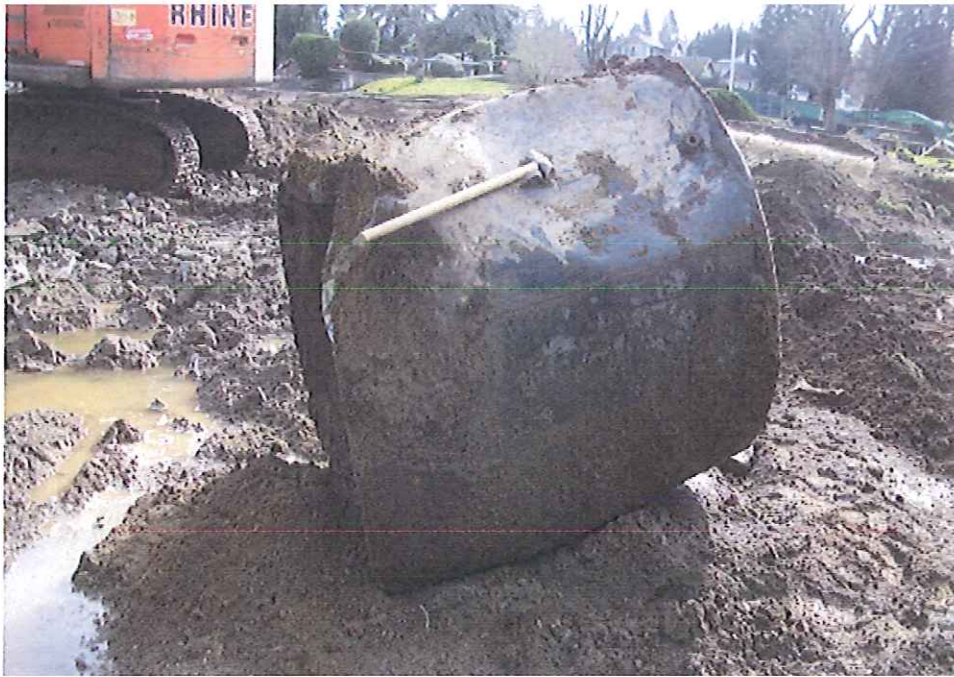
Removed Heather building tank was sized at 64" x 72" with a nominal capacity of 1,000 gallons.

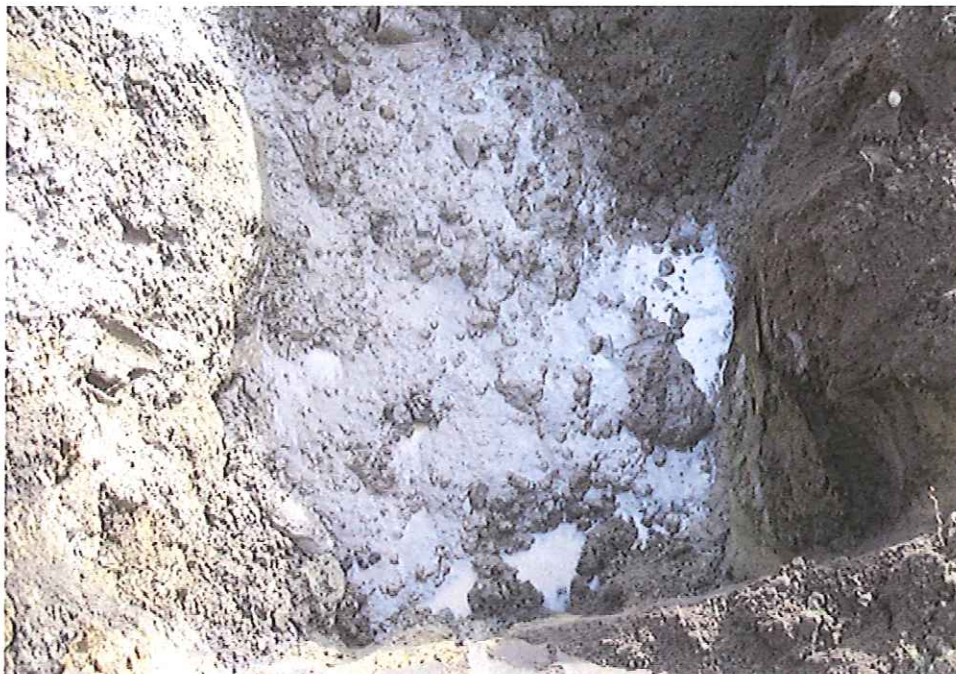
Heather building tank pit following removal. No visual or olfactory indications of PCS noted.

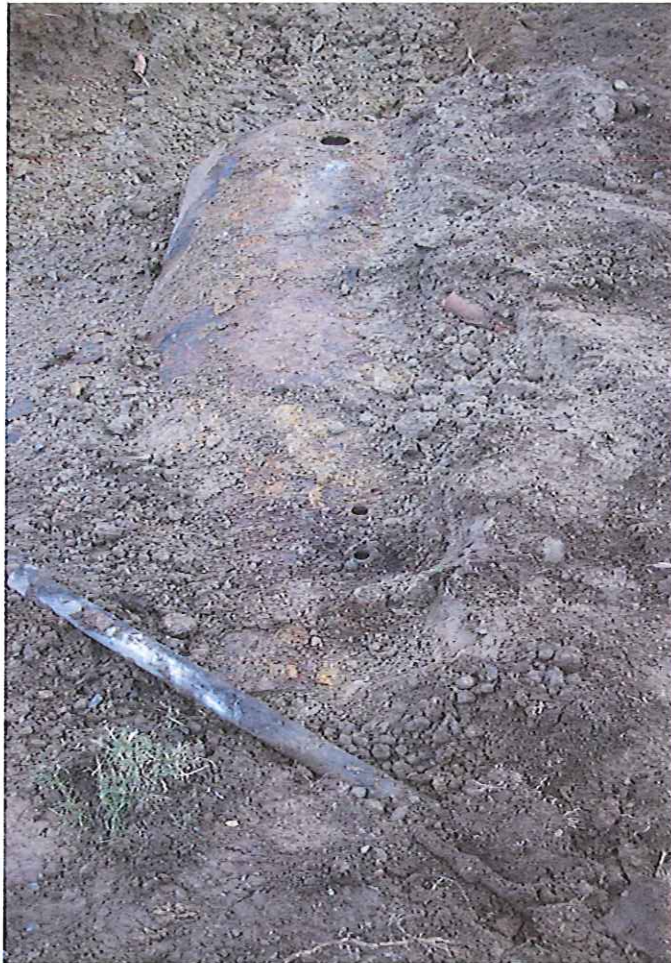
Holly building tank top exposed under 20" of asphalt and earth cover.

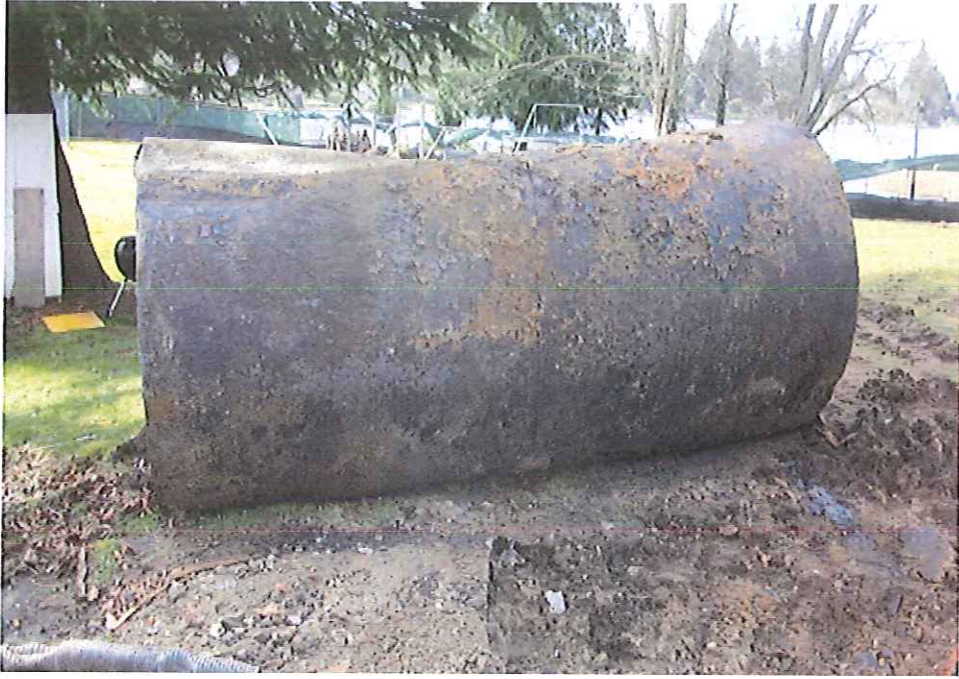
The removed Holly building tank was sized at 60" x 144", with a nominal capacity of 1,780 gallons (40 bbl).

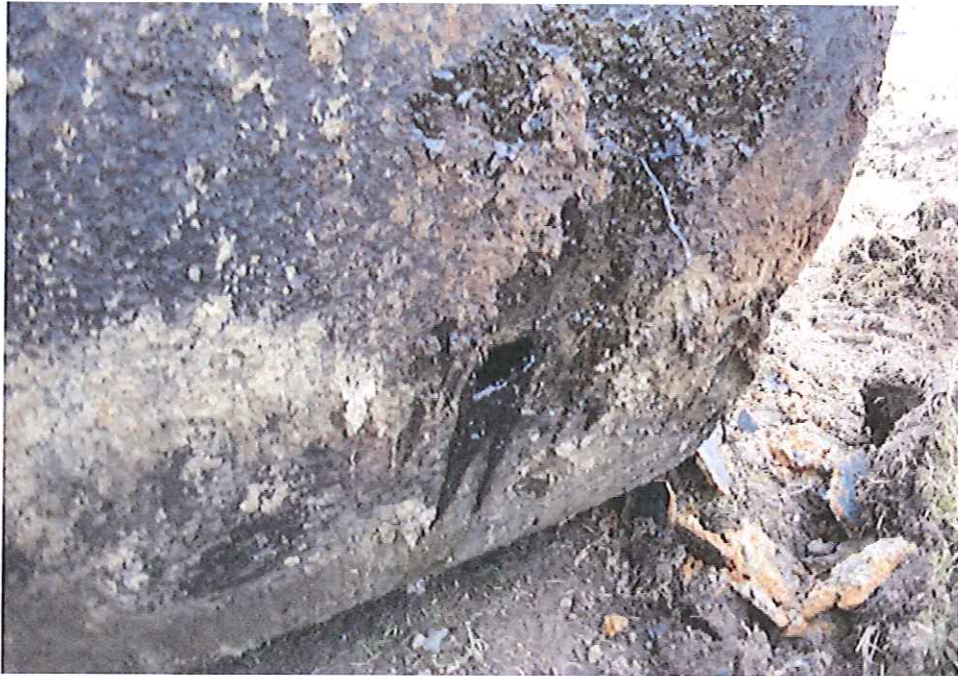
The Holly building was located on the south side of the campus, between the gym and Heather building. The building had been demolished prior to the UST removal. The heating oil UST was located at the rear of the former building in the driveway/parking area. The tank was exposed under approximately 20" of asphalt and earth cover. The tank was sized at 60" X 12', with a nominal capacity of 1,780 gallons. The tank had originally contained PS 300 (black oil) for the building's heating system. At some unknown time in the past, the heating system was converted to diesel fuel. A large hole was noted on the removed tank bottom. The soil in the tank pit area of the Holly building was consistent with the soil encountered in both the gym and Heather building tank pit areas. Visual and olfactory indications of possible PCS were noted in the tank pit bottom soil. Because of the possible PCS encountered, only one confirmation soil sample was obtained from the tank pit. The laboratory analytical result of the obtained sample confirmed that petroleum-contaminated soil above the MTCA Method A cleanup level was present in the Holly building tank pit area.

A large hole was discovered in the UST bottom. The tank had originally contained PS 300 (black oil) prior to being converted to a diesel heating fuel storage tank.

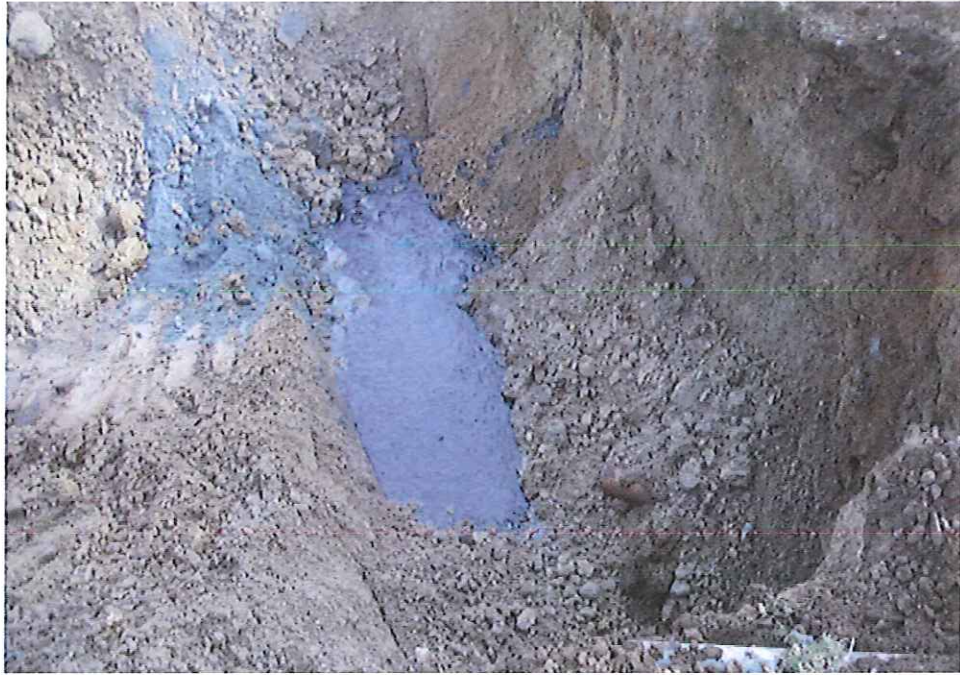
Looking west at the Holly building tank pit following removal. Obvious PCS noted.

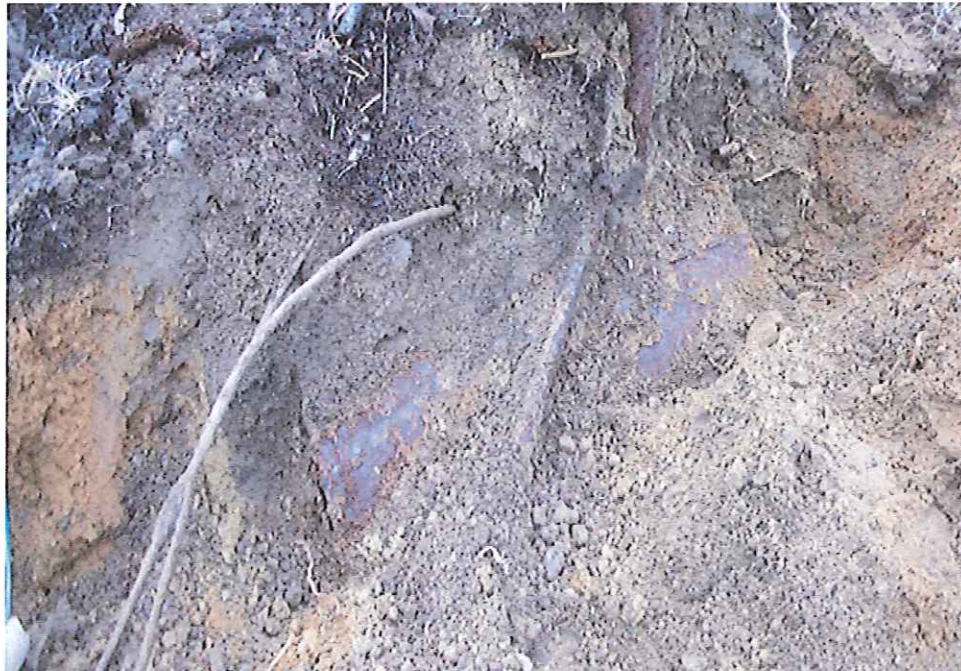
During the course of the UST removal, another heating oil tank fill pipe was observed approximately 20' west of the large UST, in a garden area adjacent to the sidewalk. This tank was measured and was determined to be sized at 20" X 30", with a nominal capacity of 41 gallons.

The additional diesel fuel starter tank discovered at the Holly building was exposed under 20" of earth cover.

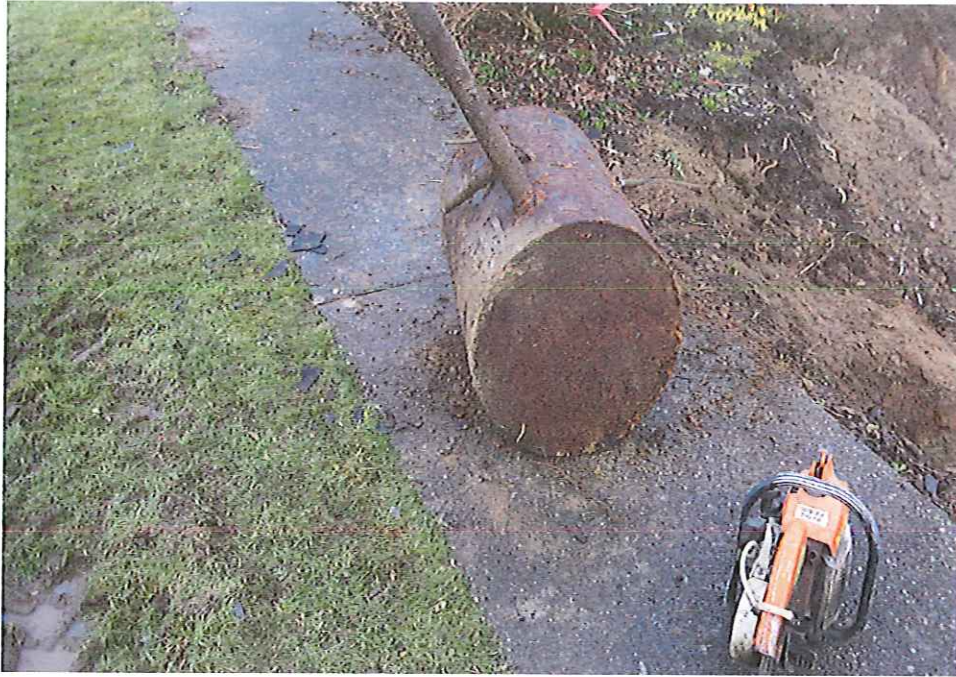
It is assumed that this tank had been used as a diesel fuel starter tank when the larger UST contained the PS 300 fuel. The tank was exposed under 20" of earth cover. No pin holes and/or steel or weld failures were noted on the removed tank. The soil in this tank pit area was consistent with the soil encountered in the other tank pit areas of the site. No visual or olfactory indications of PCS were noted in the tank pit area. One soil sample was obtained from the tank pit bottom at approximately 4.5' - 5'. The laboratory analytical result of the obtained sample was at the non-detect level.

The removed starter tank was sized at 20" x 30", with a nominal capacity of 41 gallons.

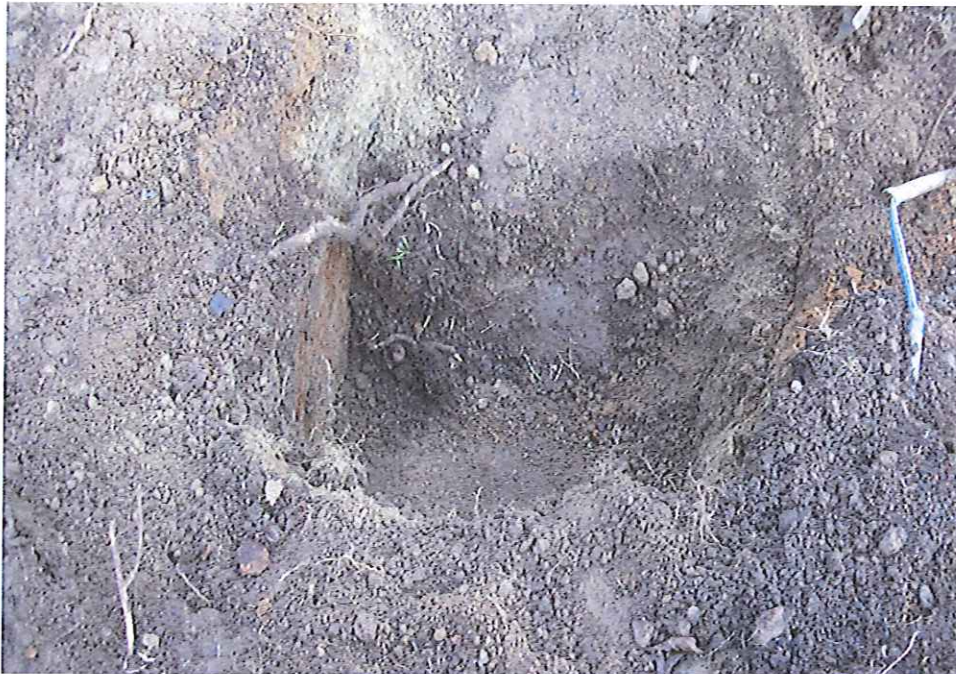
Looking south at the starter tank pit bottom subsequent to removal. No visual or olfactory indications of PCS noted.
