Title of Report: Archaeological Monitoring Report for the Cornet Bay Marina Remediation Project, Whidbey Island, Island County, Washington

Archaeological Monitoring Report for the Cornet Bay Marina  
Remediation Project, Whidbey Island, Island County, Washington

Submitted by:  
Historical Research Associates, Inc.  
Carol Schultze, PhD, RPA  
Angus Raff-Tierney, MA

Seattle, Washington  
August 2014

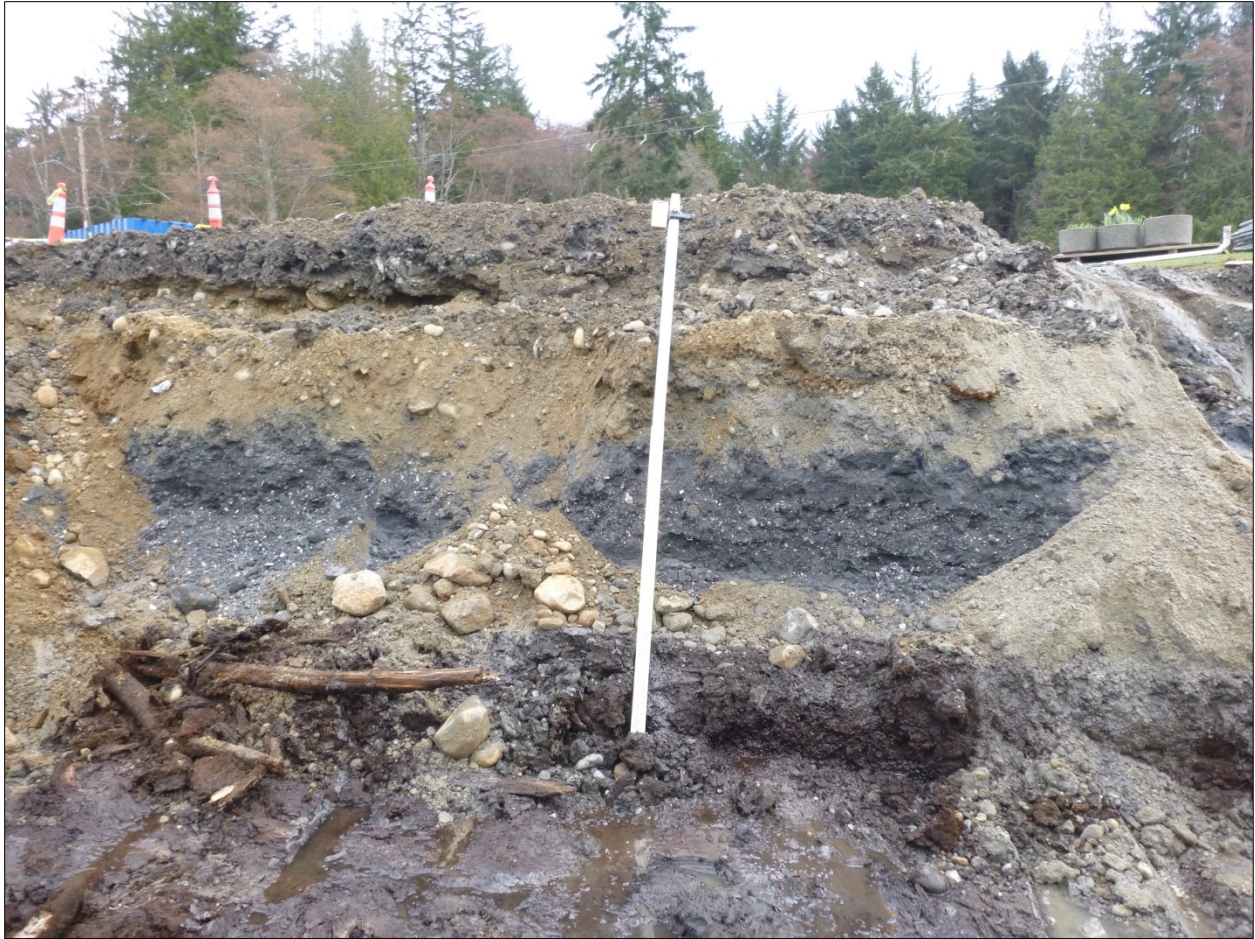
Four types of sediment were observed in the AI: terrestrial fill, dredged marine fill, native sediments, and glacial deposits (Figure 4-1). Terrestrial fill covered the AI to depths ranging from 2 to 4 ft below surface, or 10 to 12 ft above mean sea level (amsl). It consisted of brown compact sandy silt with 40 percent subround gravel and pebbles. Beneath this upper stratum was a deposit of dredged marine fill. This deposit varied in depth from 4 to 6 ft along the road/historic shoreline to 12 ft nearer to the bay. The marine dredge fill consisted of blue loose sandy clay with sparse shell fragments. The thickness of the dredge fill deposit varied throughout the AI but was generally thicker towards the bay and thinner along the road.

On the southern side of the AI, the native surface was 4 to 6 ft beneath the present surface level (Figure 4-1). In this area, the native surface was between 2 and 10 inches in thickness and consisted of black sandy silt with rootlets and decaying wood. Wood fragment density in this layer increased to the east becoming peat. This layer graded into glacial till with increasing depth below surface. The glacial till was dense blue clay with 20 to 40 percent unsorted subround pebbles and gravels.

Figure 4-1 Southeastern AI showing layered terrestrial fill on top, marine fill dredge, and native peat on bottom, view south.

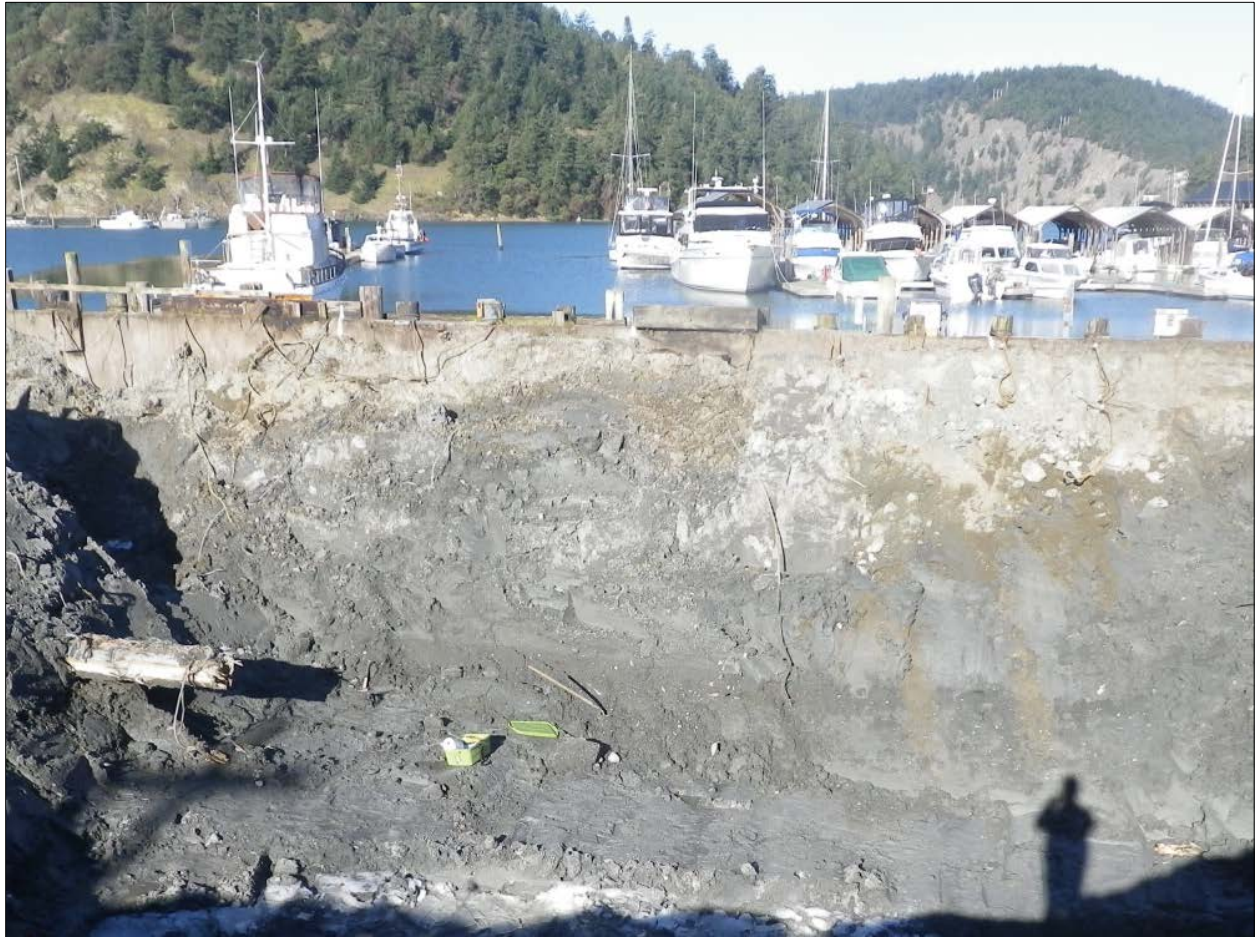
On the bay-side, north of the AI, native soil was present 11.5 ft deep (2.5 ft amsl) and included two strata (Figure 4-2). The upper stratum was gray blue sandy clay with sparse bands of rounded gravel and bands of browner grey. This contained a few small whole and crushed shells. Some of the shells were in their natural position (vertical), indicating an intact ground surface; however, others were lying flat, indicating some disturbance. This top stratum is about 13 inches thick, the same color as the fill above, and could be distinguished from the fill by merit of being free of clam fragments and gravels. Shells in this area were predominantly mud clam (*Macoma nasuta*), a native bivalve adapted to silty marine sediments. The lower native stratum consisted of greenish grey-brown silty sand with many whole mud clams in natural position, and fewer gravels. There were also a few rounded pebbles. The boundary between these two native strata is abrupt and can be clearly seen as a distinct change in hue. The lower boundary of these native strata is indistinct; however, they graded into a

deposit of glacial till as depth increased. The glacial till consists of dense blue clay with some pebbles and gravels.

Figure 4-2 Northwestern AI, view north. The native surface can be seen as a straight horizontal color change from lighter to darker grey to the right of the log.

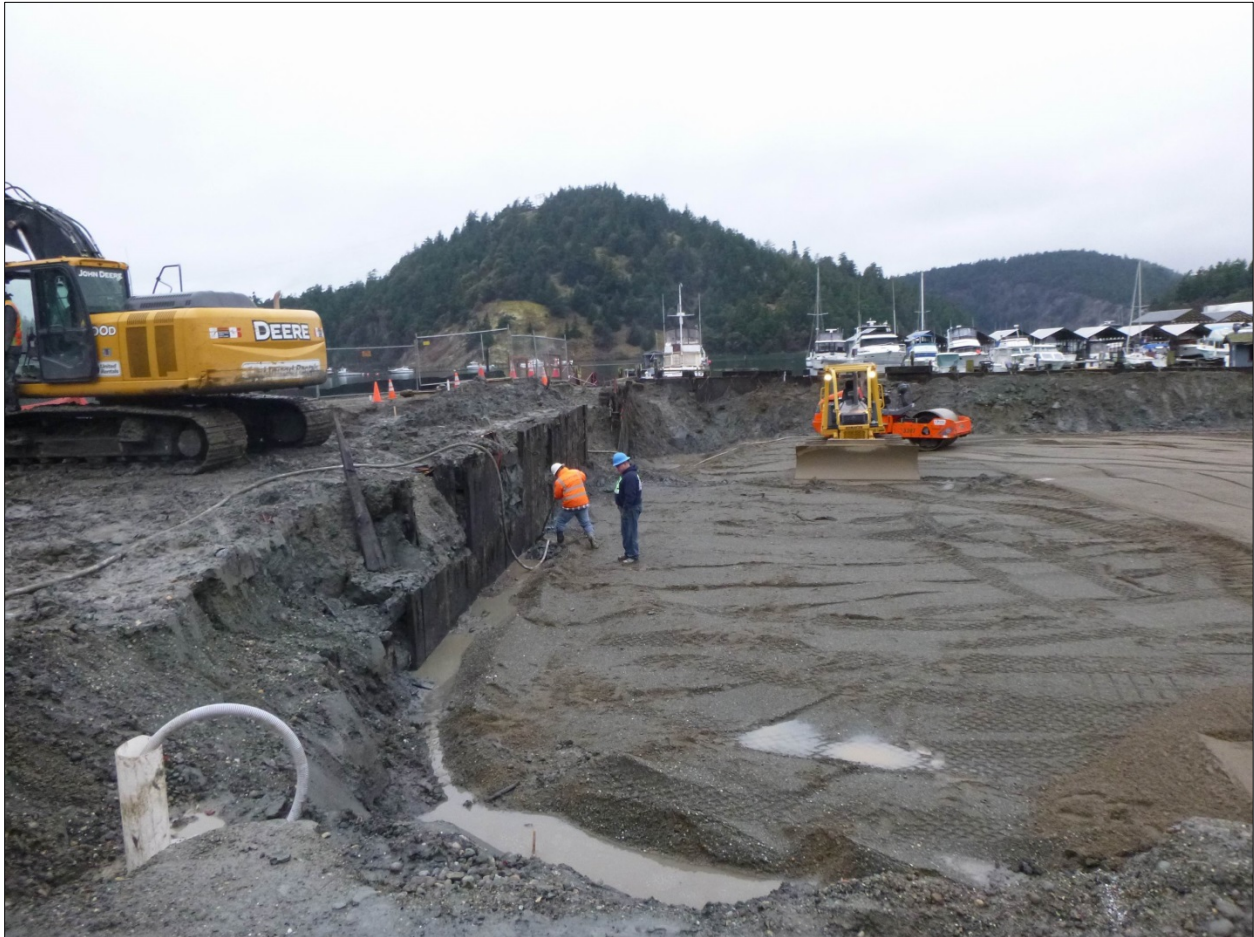
Removal of the terrestrial and marine fill sediments uncovered a creosote-treated wood bulkhead that extends along the northern bay edge of the project AI. This was recorded as a historic-era site (45IS333) prior to its removal (Schultze 2014). The bulkhead is approximately 400 ft long and 10 ft deep with two right angles extending the bulkhead south (Figure 4-3). It was built in the early 1960s, prior to the opening of the marina in 1963. Upon submission of the site record and through phone

Figure 4-3 Overview of the southwestern extent of the bulkhead, view north. Goose rock can be seen in the background.

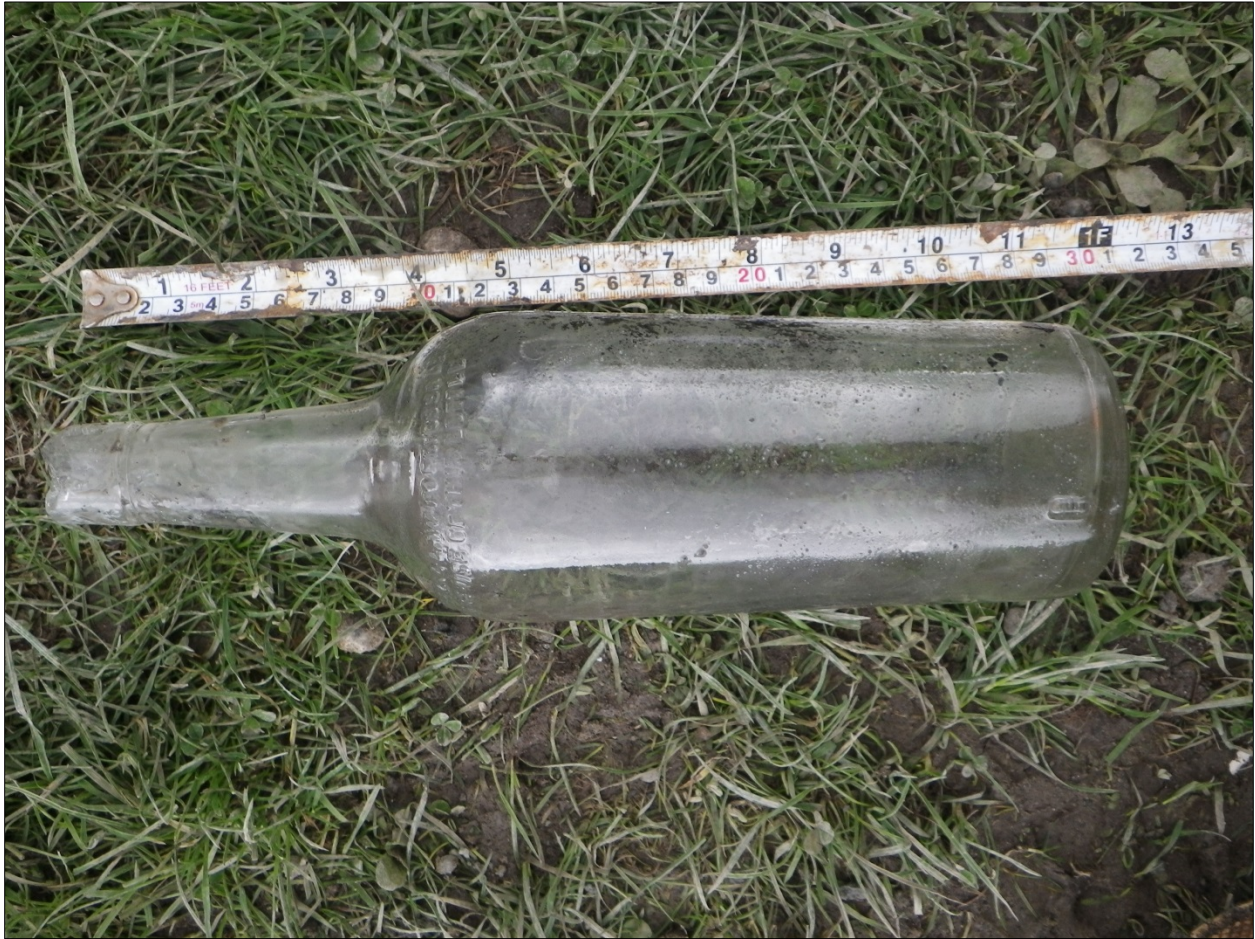
following script embossed on the bottom and sides, “D90, 57-52”, “4/5 Quart”, and, “FEDERAL LAW PROHIBITS SALE OR RE-USE OF THIS BOTTLE.” The bottle is 11 inches long with a 3 inch diameter base, and a 1 1/16 inch diameter stopper top (Figure 4-4). All liquor bottles were required to have the federal law statement imprinted from 1935 and 1964 (Lindsey 2014). While having this date range makes the bottle historic, it was found in a secondary context in the fill and as such was not recorded.

Figure 4-4 Liquor bottle embossed with, “FEDERAL LAW PROHIBITS SALE OR RE-USE OF THIS BOTTLE” from fill levels.

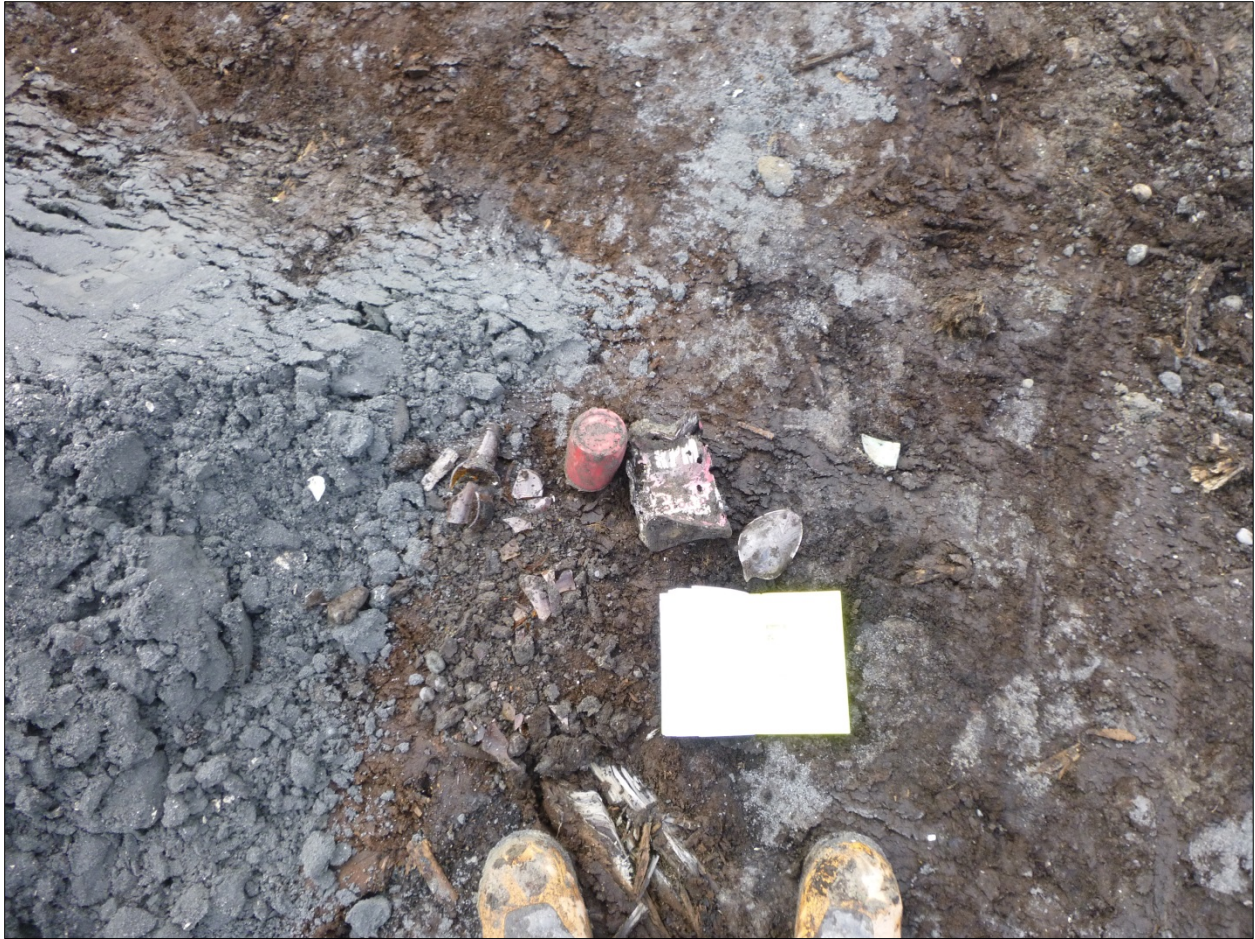
A few modern artifacts, including cans and glass, were observed scattered throughout the AI. In the southeastern area, there was a localized refuse dump associated with the native surface (Figure 4-5). Although this refuse was associated with the native surface, it did not contain any diagnostic characteristics and was therefore was not recorded.

Figure 4-5. Modern artifacts associated with native peat deposits in the southeastern excavation limits.

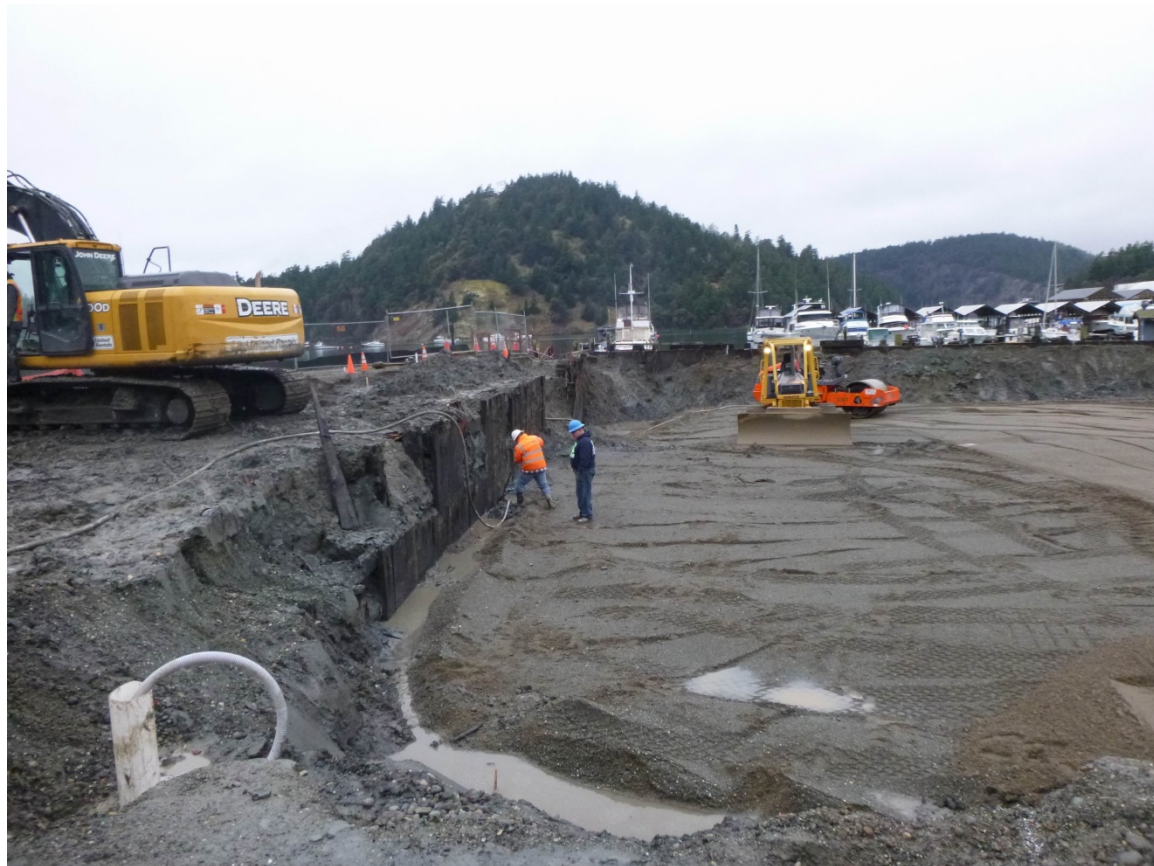
The creosote-treated wood bulkhead was observed during archaeological monitoring at the Cornet Bay Marina Remediation Project (project). The northwestern length and portions of the southwest and northeast lengths of the bulkhead were exposed prior to the remediation, and are shown on project plans (Figure 2). An unanticipated section of the bulkhead, located in the southwestern portion of the project area, was recorded during monitoring (Figure 3).

Figure 3: Overview of east side exposed southwest section of the bulkhead (view to northwest).

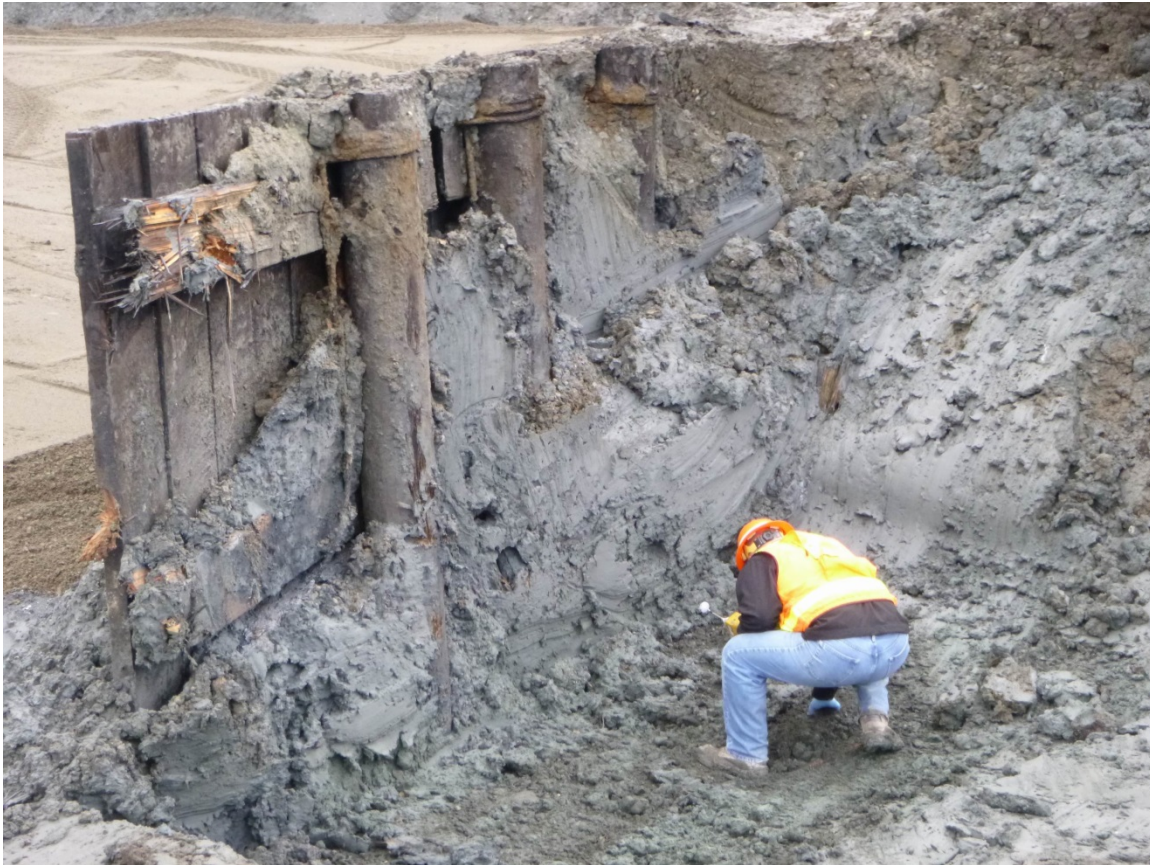
The bulkhead appears to have a fairly standard method of construction, consisting of tightly-spaced vertical boards braced with three horizontal boards and supported by vertical pilings lashed with 1-inch metal cable (Figures 4, 5). The wood has been creosote-treated. Vertical boards measure approximately 3.5 inches thick by 1 foot wide. Vertical boards removed during project activities measured 8 to 10 feet in length (Figure 6), although the total length of all vertical boards is uncertain. At the far southern end of this section, approaching the historic shoreline, shorter vertical boards were required (measuring 3 feet, 1 inch), and they were braced by a single length of horizontally oriented boards.

Figure 4: Overview of exposed portion of southwest section of bulkhead, southwest face, along the middle portion of the bulkhead. Note vertical boards, horizontal braces, and cable-wound piles (view to east).

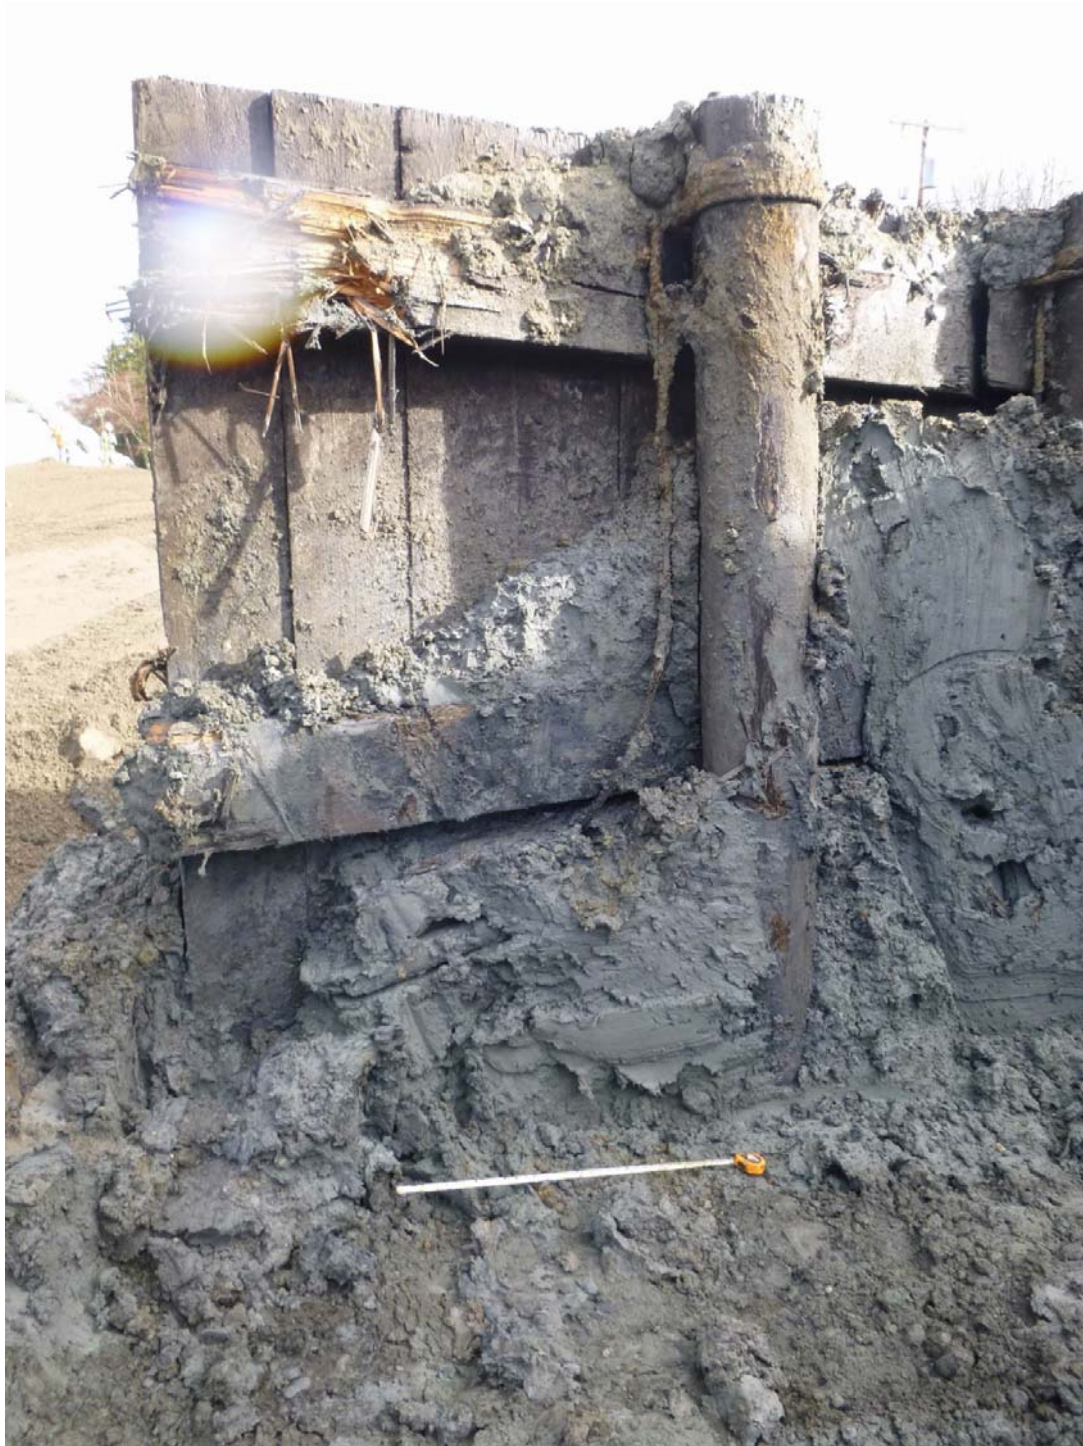
Figure 5: Same section of bulkhead as Figure 4, closer view (tape at 2 feet and view to east).

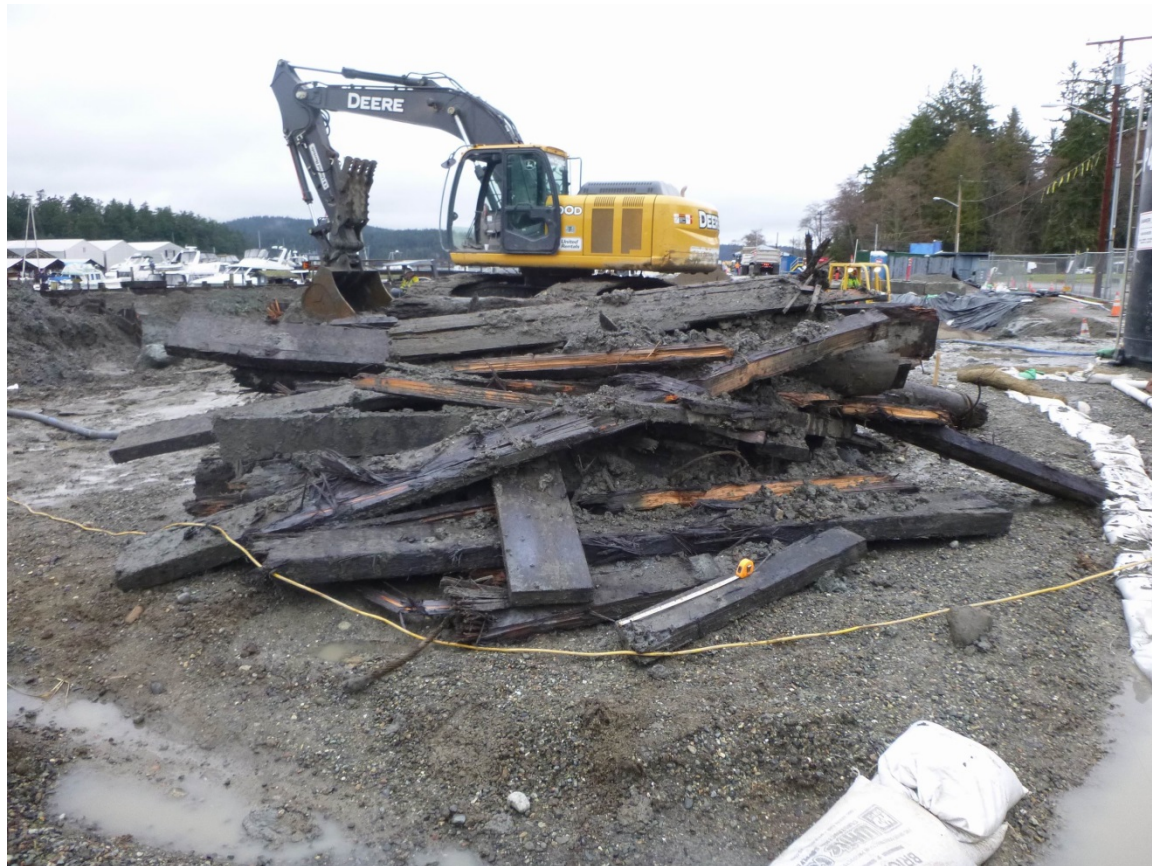
Figure 6: Overview of removed portions of the bulkhead, showing variable lengths and widths of creosote-treated components to the bulkhead (view to north).

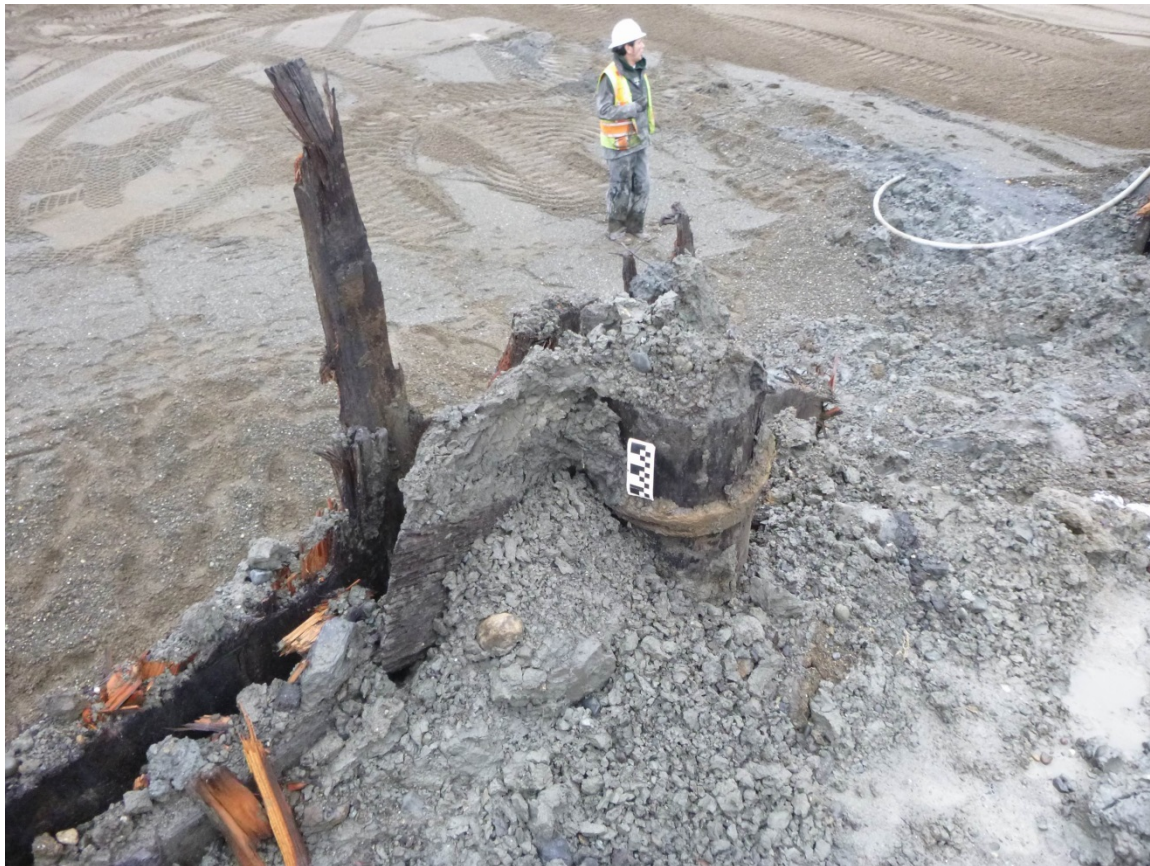
Horizontal braces tended to be thicker, measuring approximately 4 inches, and ranging between 8 inches and 1 foot wide. Horizontal braces were nailed to vertical boards approximately 3 feet apart along the outer face of the bulkhead. Observed pilings range in diameter between 1 foot and 18 inches, and the upper cable is lashed approximately 8 inches below the upper surface of the pilings (Figure 7).

Figure 7: Overview of upper portion of a cable-wound support pile, showing diameter and size of cable (view to southeast).
