Able Clean-up Technologies, Inc.

RE: Report for a gasoline spill for Coleman Oil, located at the Coleman Oil Bulk Plant, 3 Chehalis Street, Wenatchee, Washington.

Appendix A

Photographs of Site

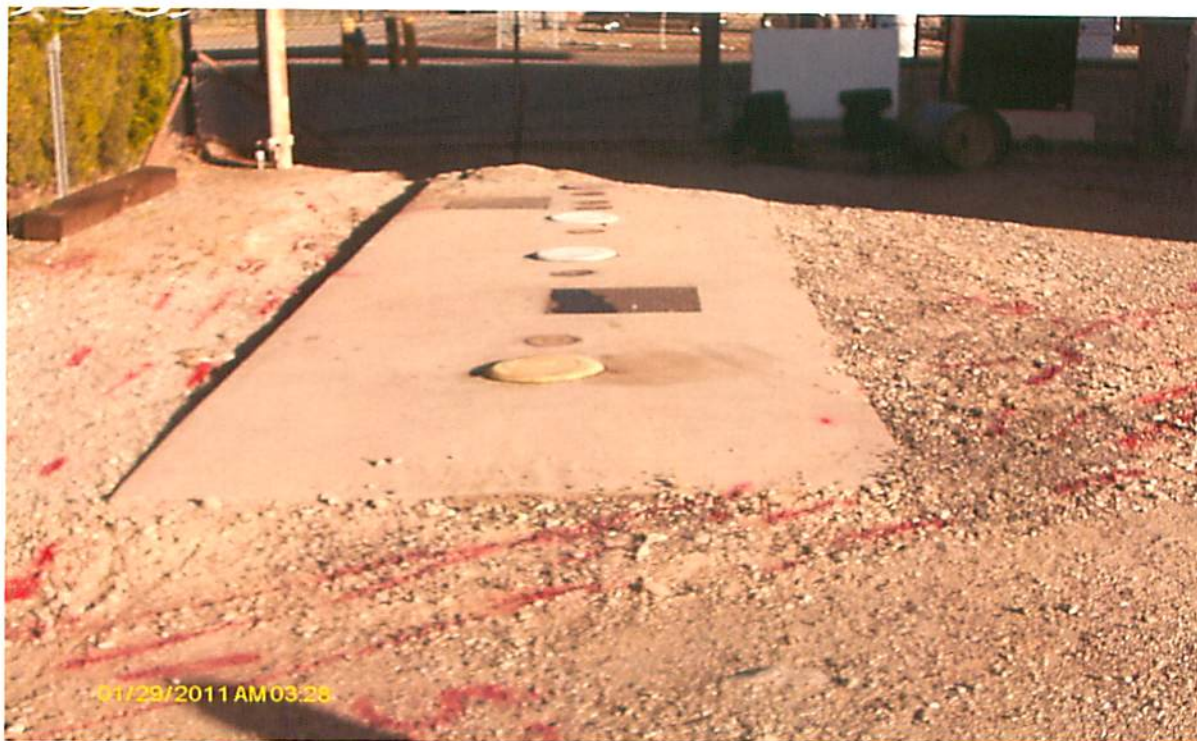
On May 30, 2013 at 4:00pm a refueling tanker from Coleman Oil was refilling a four (4) compartment underground storage tank (UST) at the Coleman Oil Bulk facility when the one compartment being filled was over-filled and the fuel was released from the fill port of the UST. The UST is used to supply fuel for the retail sales dispensers located just to the south of the bulk plant. The bulk plant is located at 3 Chehalis Street, Wenatchee, Washington. According to Coleman Oil personnel, the excess fuel had run across the concrete pad in three directions; south, west & east into the surrounding soils and that no liquid was recovered. The initial estimate for gasoline released into the environment was 300 gallons. Able Cleanup Technologies Inc. (ACT) was called on May 31, 2013 at 2:30 pm by Jim Cach with Coleman Oil to respond and start cleanup actions on the spill. As required: both general and private emergency locating was called.

This is the site when ACT first arrived. The release occurred from the far white fill cap. This picture was taken looking in a southeasterly direction.

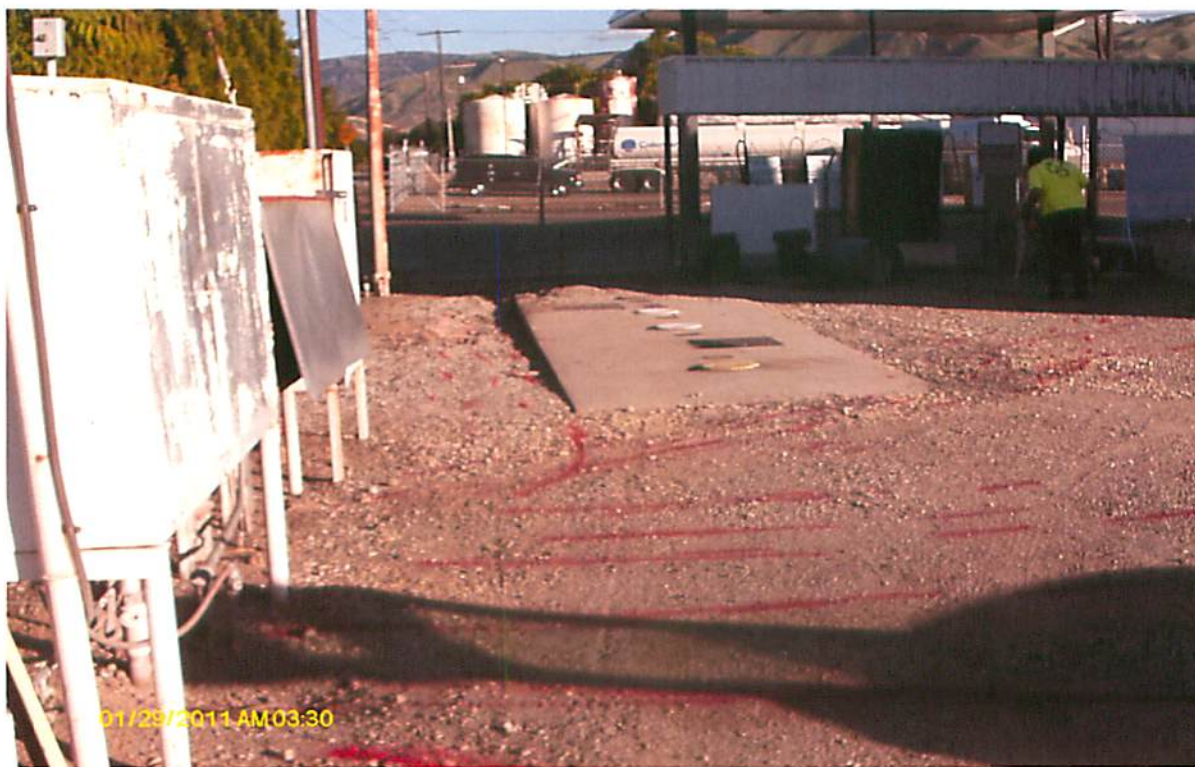
This is the site when ACT first arrived. Note the red lines denoting underground utilities. This picture was taken looking in a southeasterly direction.

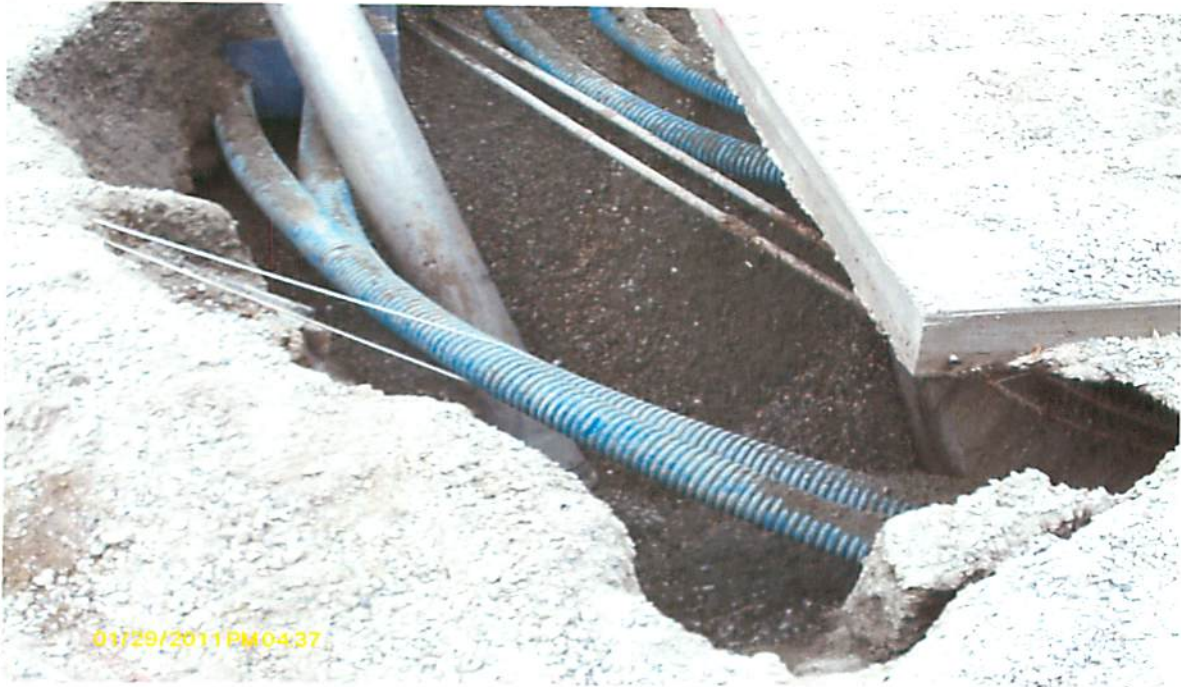
This picture shows the vacuuming process and the product lines. This picture was taken looking in a southwesterly direction.

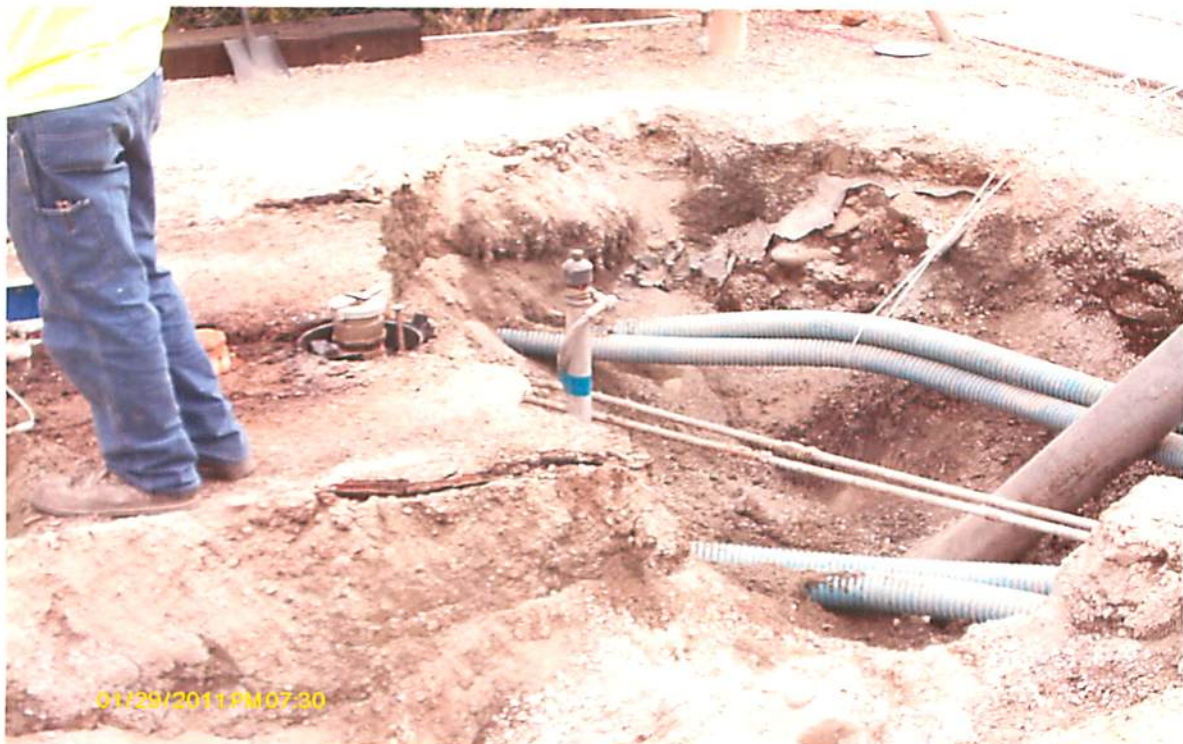
This picture shows the continued vacuuming process and the product lines. This picture was taken looking in an easterly direction.

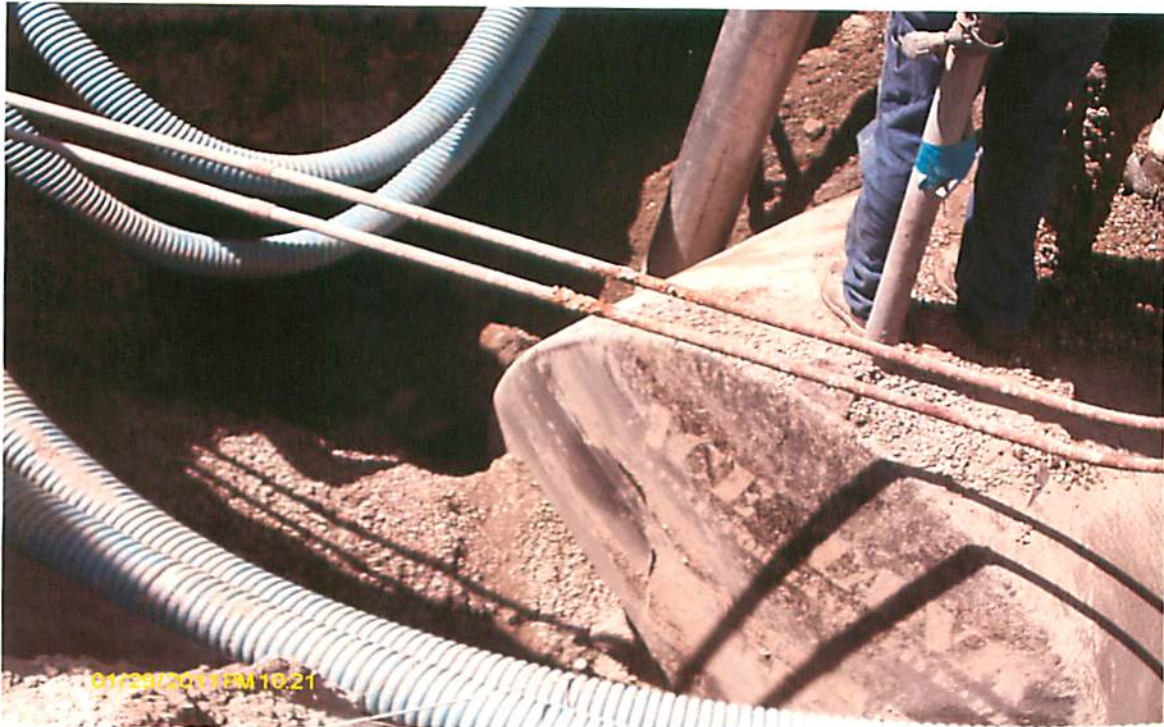
This picture shows the continued vacuuming process and the UST. This picture was taken looking in a westerly direction.

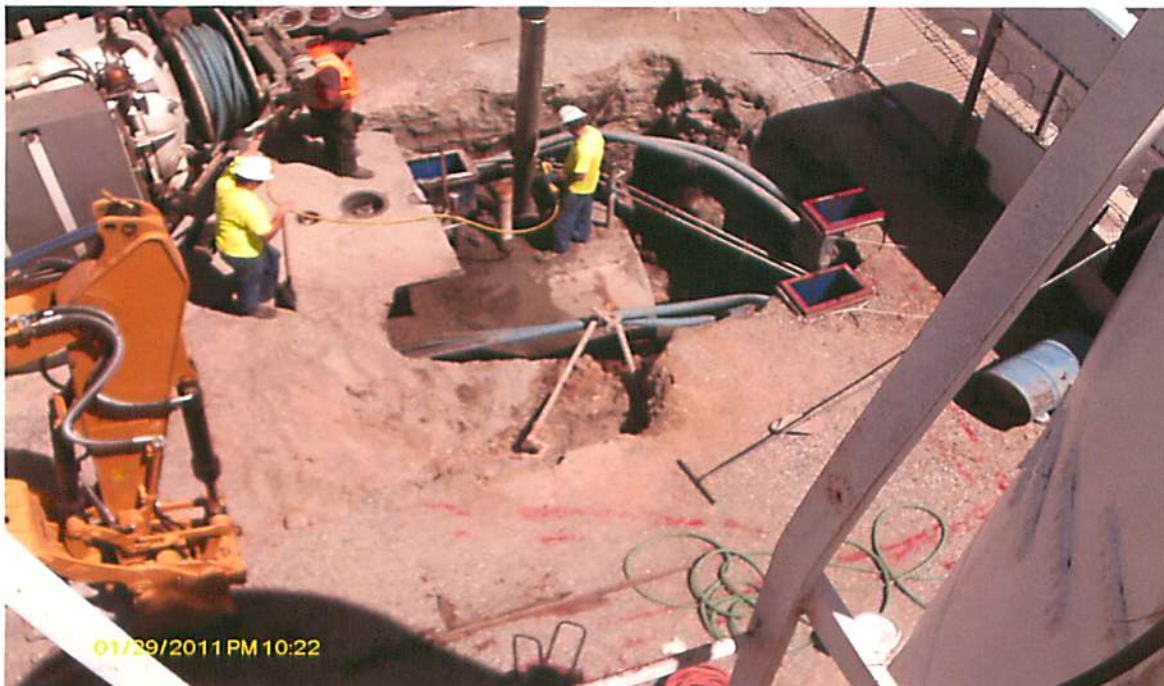
This picture shows the continued vacuuming process and the UST. This picture was taken looking in an easterly direction.

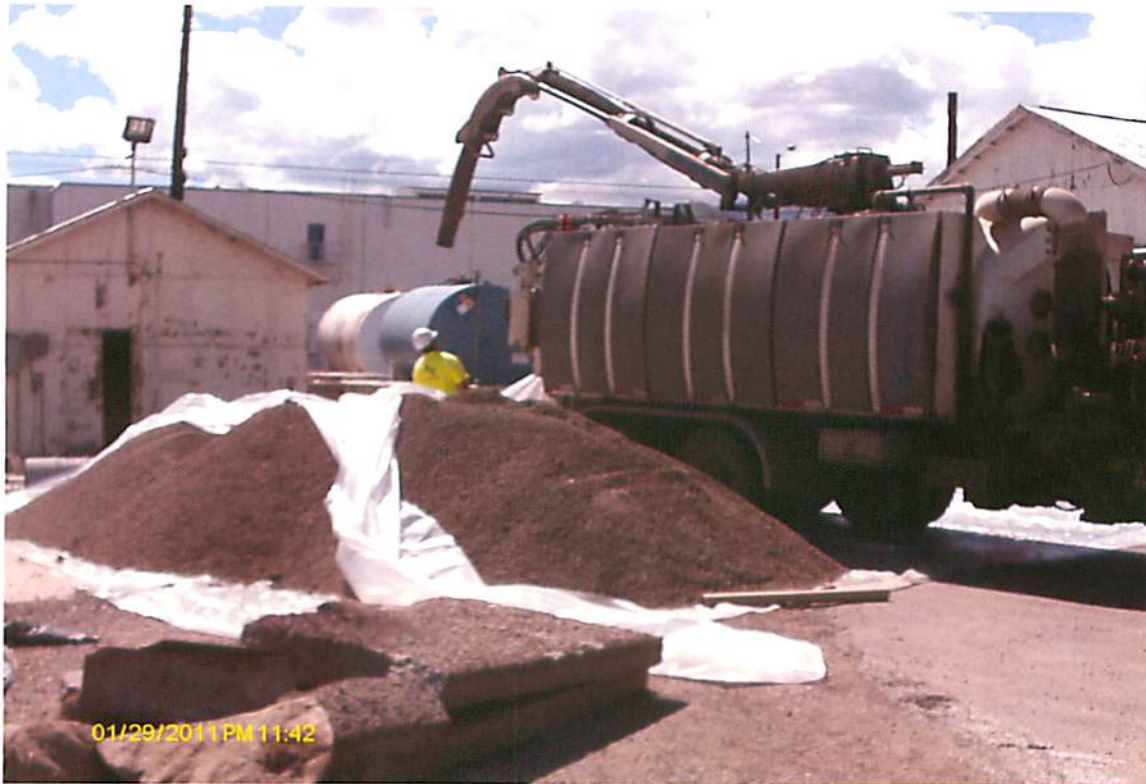
This picture shows the contaminated stockpile. This picture was taken looking in a westerly direction.

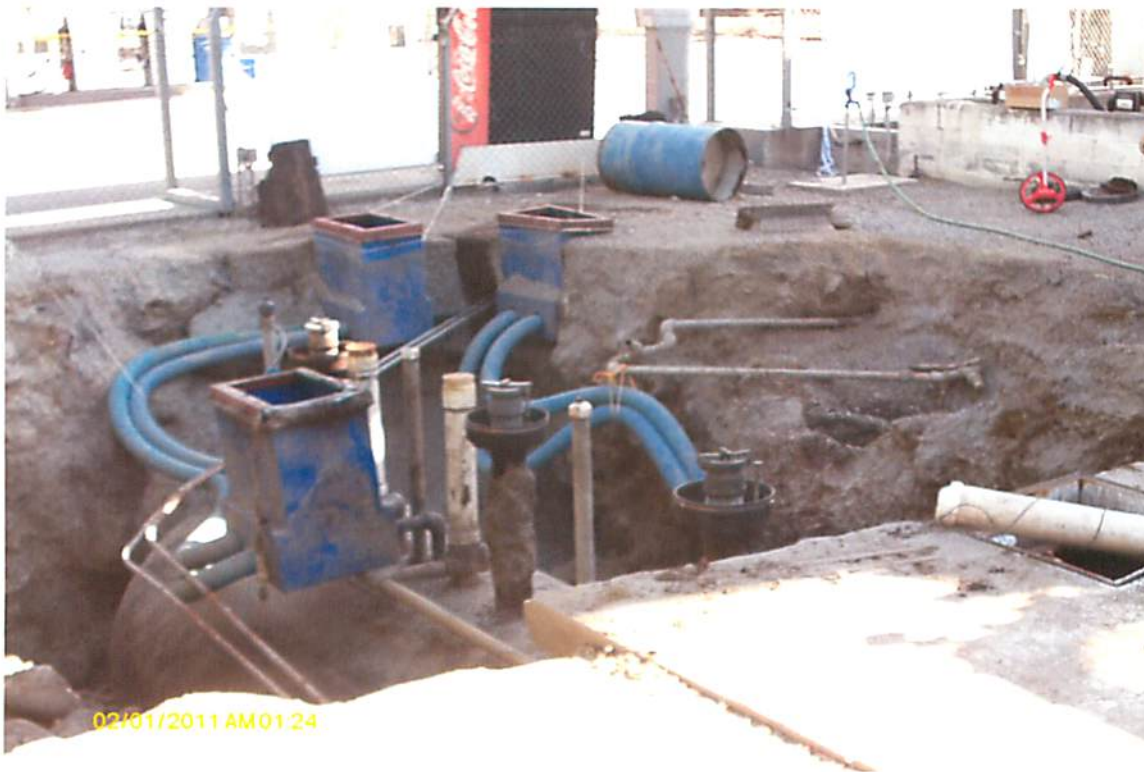
The UST that was exposed is a Stip 3 dielectric coated steel double walled tank with four (4) compartments: three (3) for gasoline and one (1) for on-road diesel. The tank had sacrificial anodes, interstitial monitoring and spill buckets & boxes. The piping is double walled flexible and corrosion resistant. The site was in compliance with the WDOE and has a site facility number of 83844381.

This picture shows the excavation process and the exposed UST. This picture was taken looking in a southerly direction.

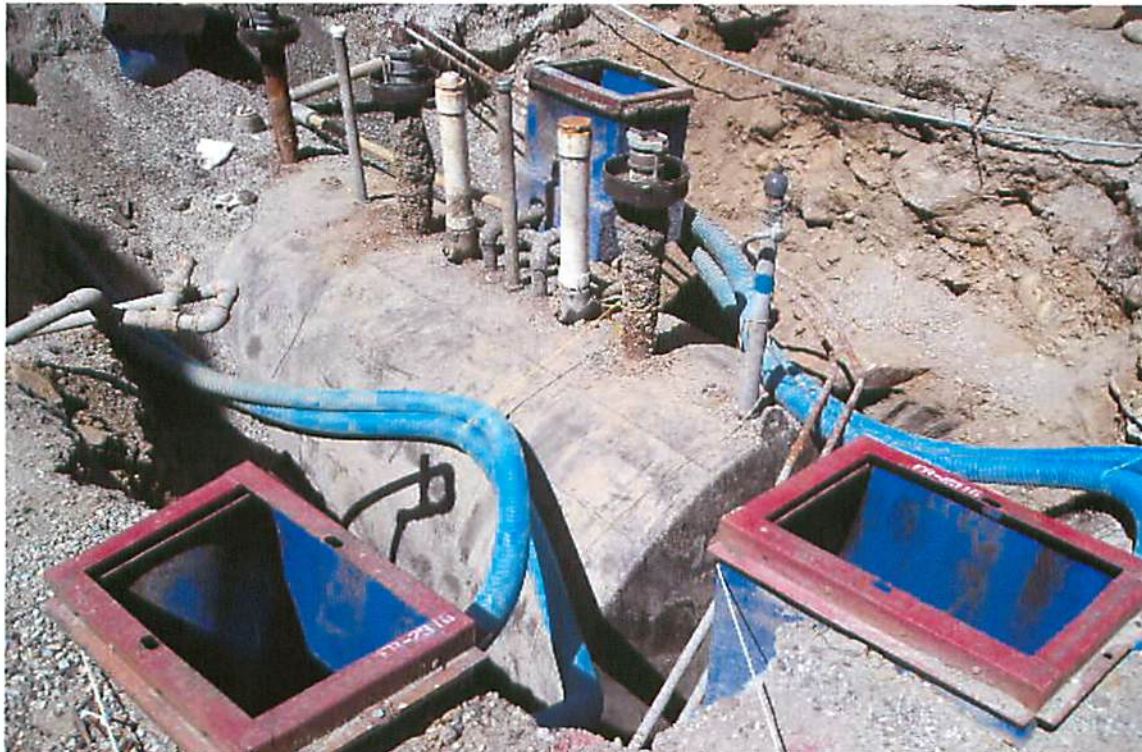
This picture shows the continued vacuuming process and the UST. This picture was taken looking in a northerly direction.

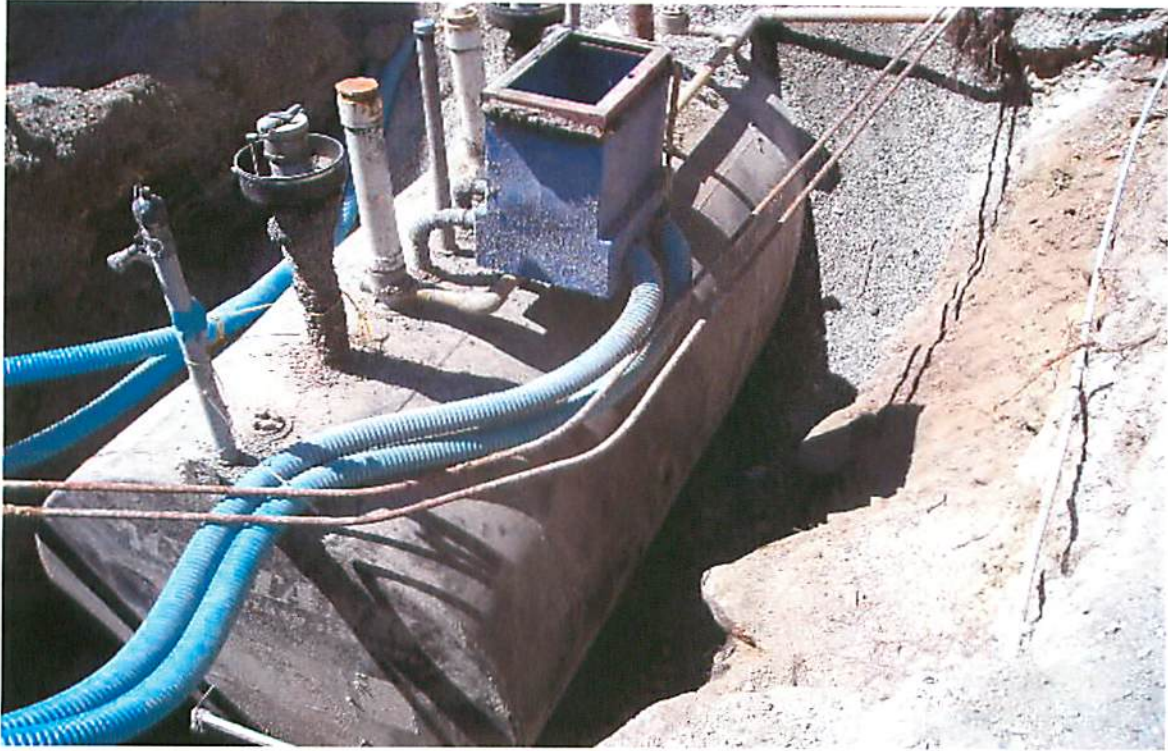
This picture shows the excavation and the UST. This picture was taken looking in a northwesterly direction.

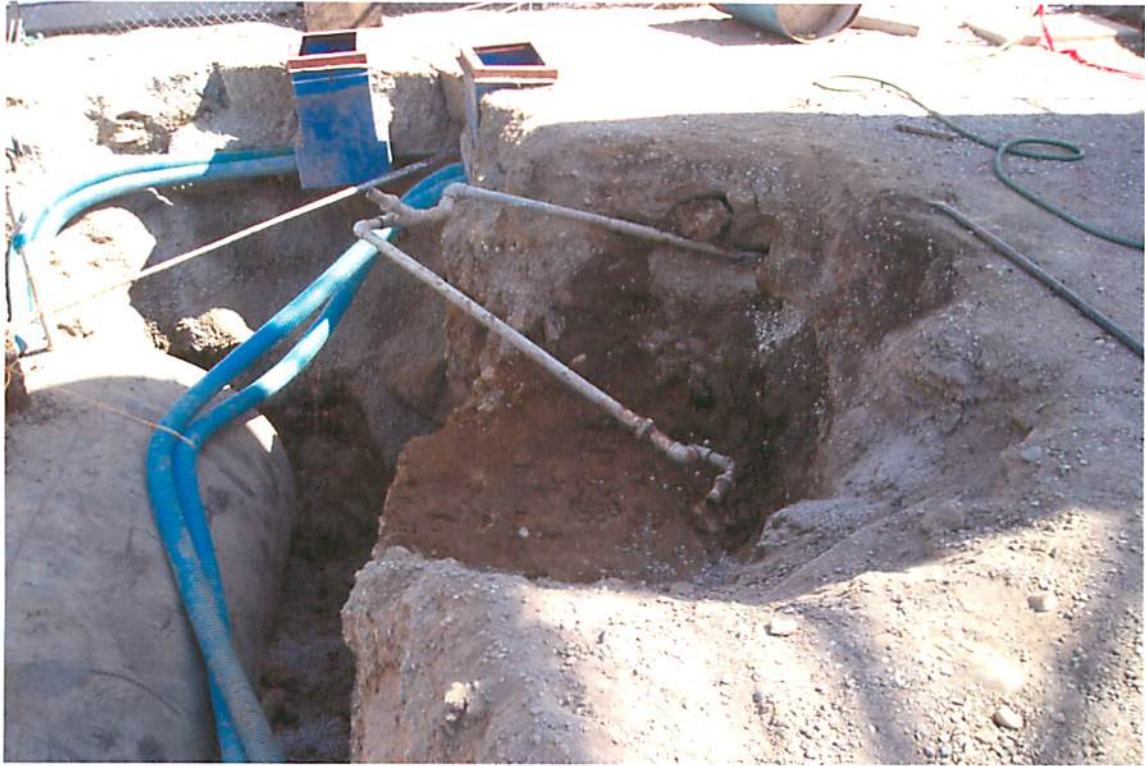
This picture shows the additional excavating process and the UST. This picture was taken looking in a southeasterly direction.

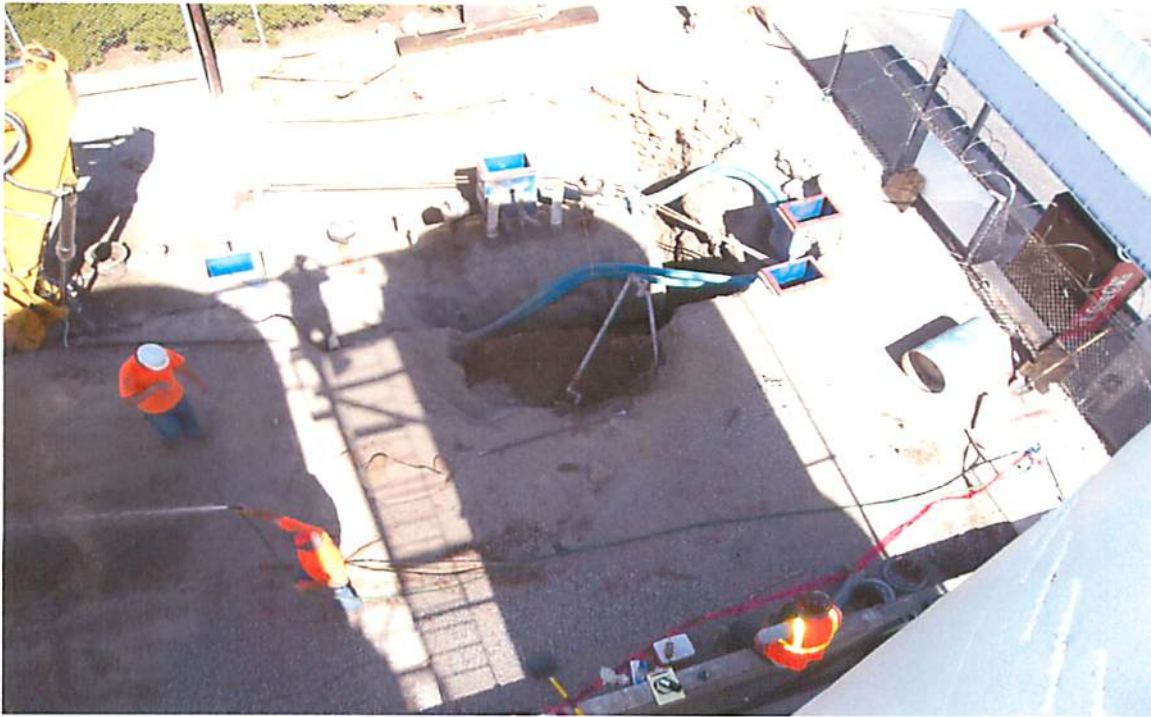
The approximate area of gasoline PCS was 21 feet long and an 18 feet wide excavation that extended to a depth of 12 feet. 96.08 tons of PCS were disposed of under permit 106645WA at the Wenatchee Disposal Facility. The excavation will be backfilled by a licensed UST tank installer provided by Coleman Oil.

This picture shows the finished excavation and the UST. This picture was taken looking in an easterly direction.

All contaminated soils and containment plastic was removed, transported and disposed of at the Wenatchee Landfill. The excavation will be backfilled with proper inert material by a licensed contractor (CDA Service Station). Bringing the UST back into service is not part of the cleanup report and will not be addressed in this report.

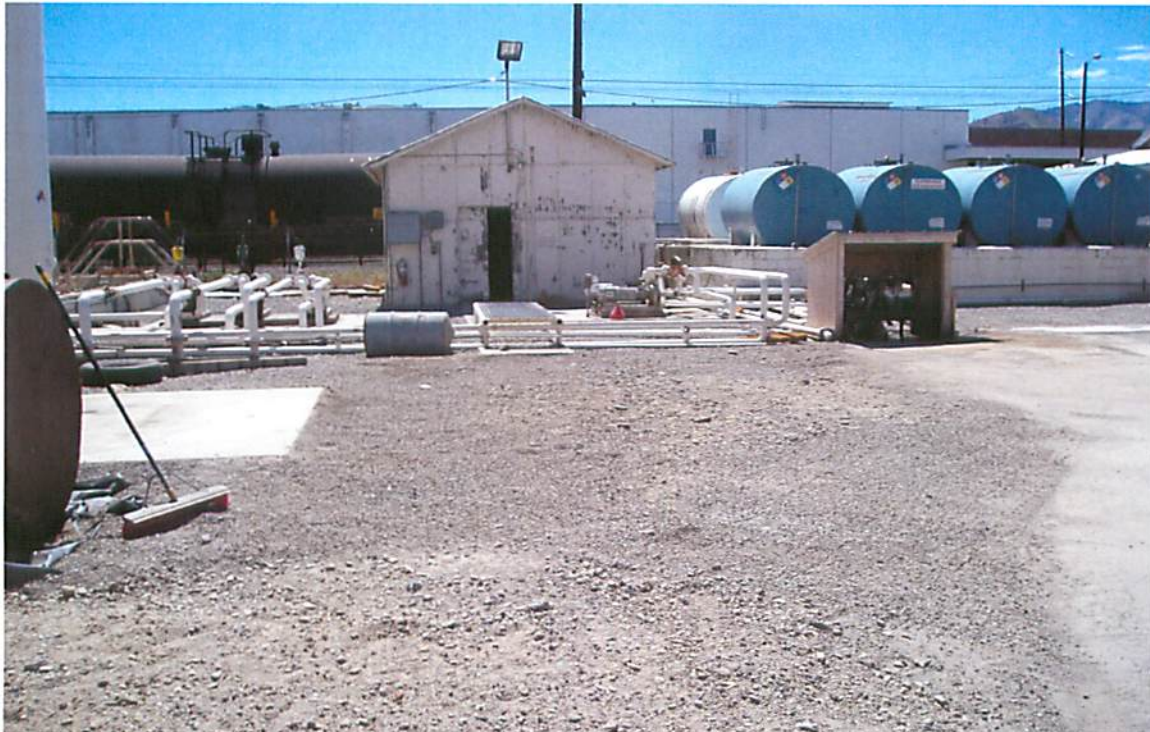
This picture shows the stockpile area after removal of the contaminated soils and plastic. This picture was taken looking in a southwesterly direction.

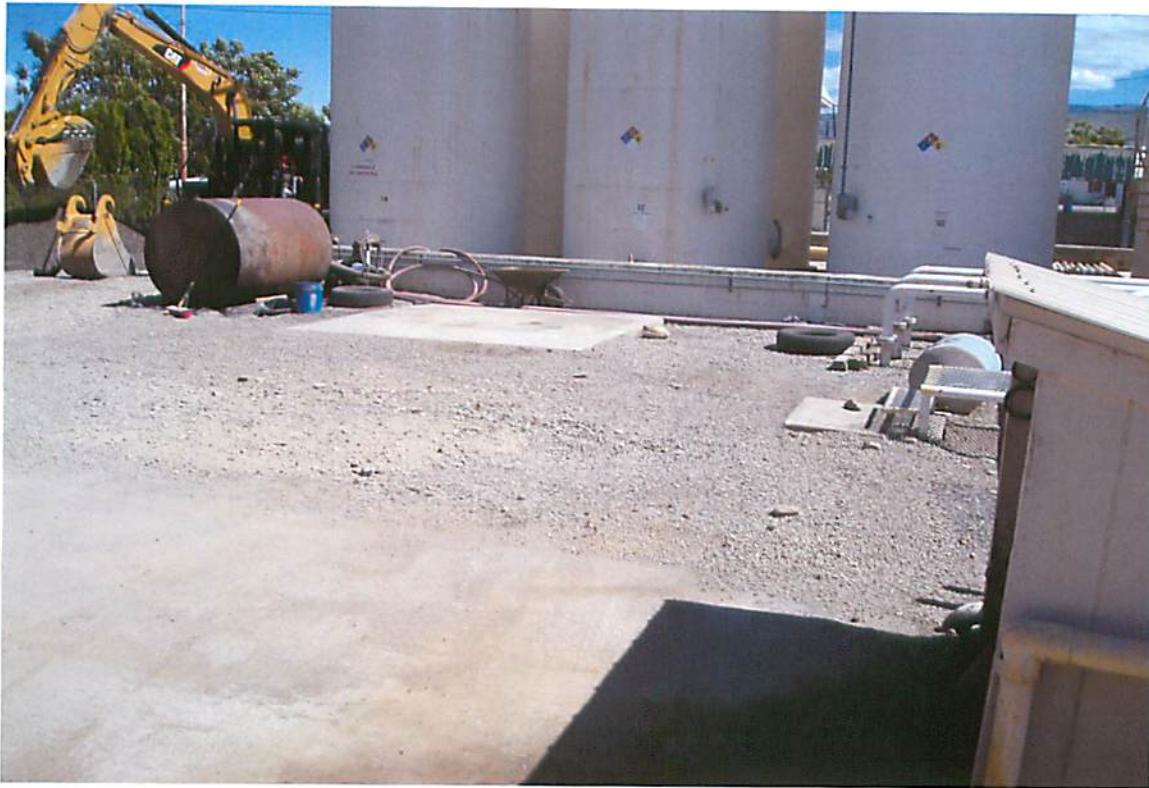
This picture shows the stockpile area after removal of the contaminated soils and plastic. This picture was taken looking in a southeasterly direction.
