### **Multibeam Bathymetry and Sidescan Sonar Survey Results**

**HYDROGRAPHIC AND GEOPHYSICAL SURVEYS**  
**AT NORTHLAKE SHIPYARD**

**SEATTLE, WASHINGTON**

**SUBMITTED TO**  
**ECOLOGY AND ENVIRONMENT, INC**  
**DECEMBER, 2008**

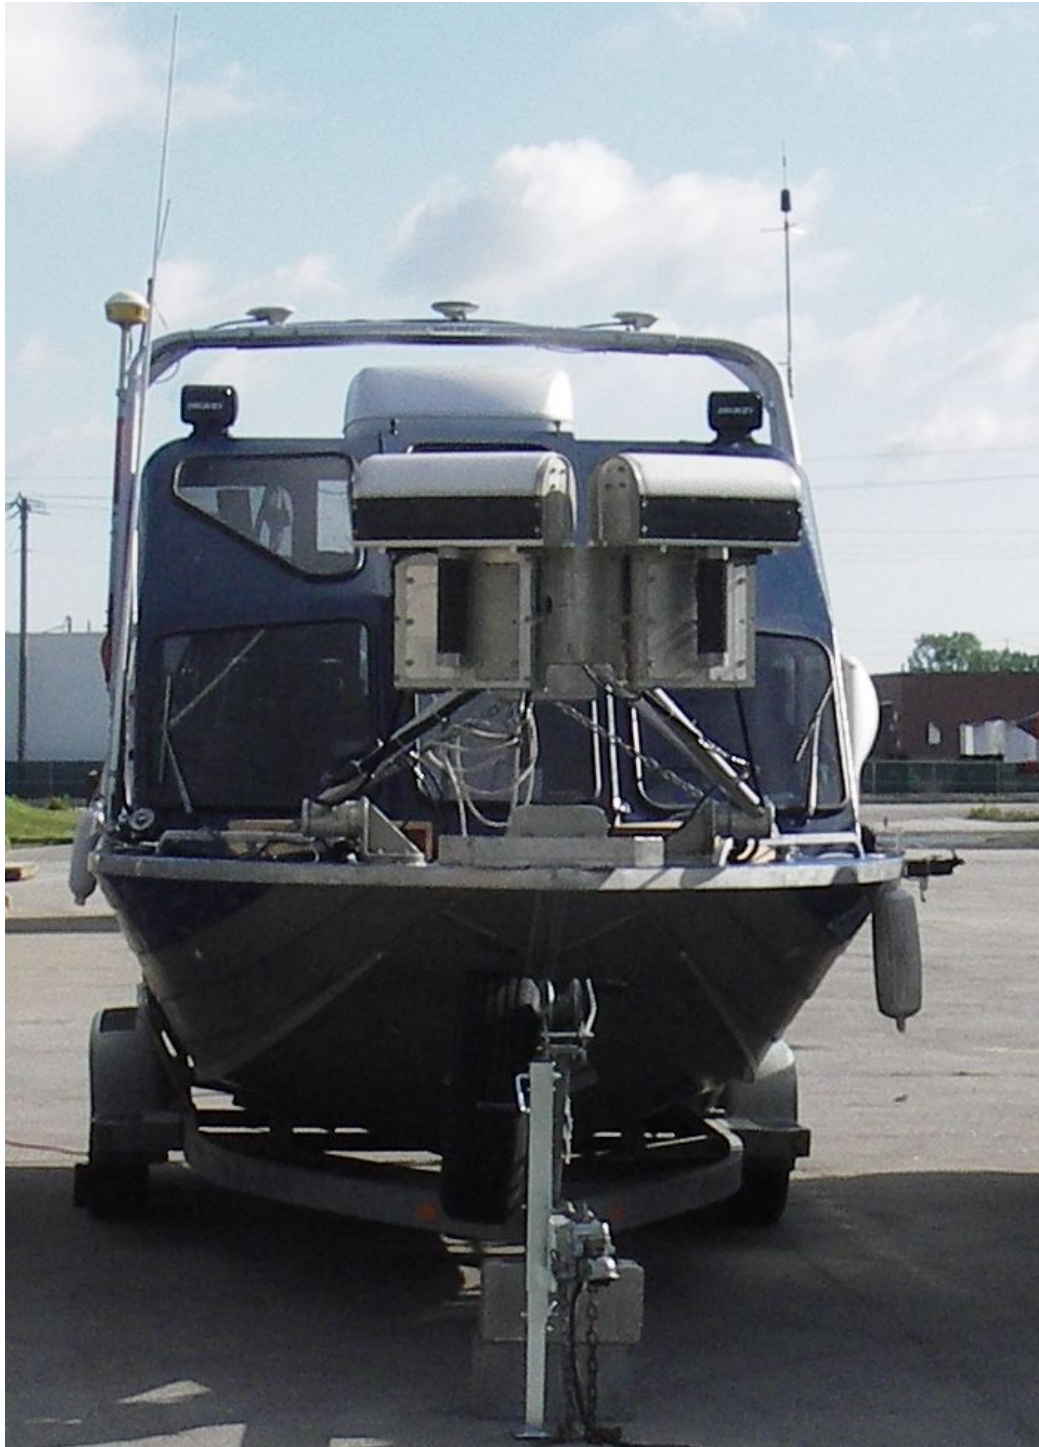
**Figure 2-3 – TtEC Multibeam Sonar Mount**

The multibeam sonar heads were mounted to the vessel using a retractable bow mount pole, shown in Figure 2-3 (mount up for transport). The mount is rigidly attached to the bow of the vessel, with the Leica GPS antenna mounted on an extension pole, directly above the sonar. When the vessel is launched, the pole is rotated to vertical, and secured with a bracket mounted at the waterline. For this survey, to facilitate viewing under other vessels and structures, each of the two sonar heads were rotated approximately 30 degrees outboard.

The sidescan sonar was suspended on lines from the starboard bow ~2 feet below the water surface. The GPS antenna was mounted 2 feet to port of the sidescan at the same along track position.

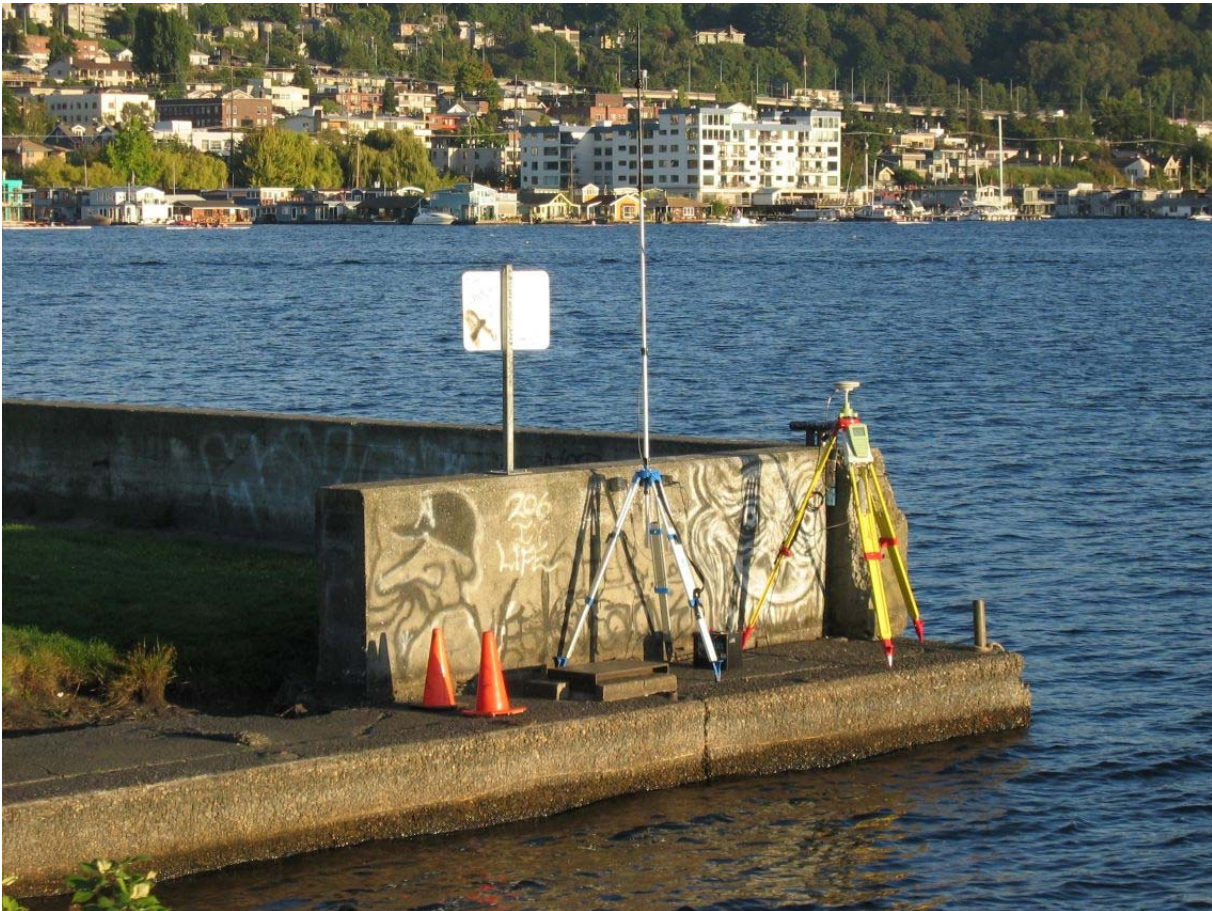
Figure 3-1 - RTK GPS Base Station – Gas Works Park (SAG SY4165)

The base station was set up each morning of the survey and the rover was used to re-check the position at the Brian Cary control point. The same results were obtained in each case.

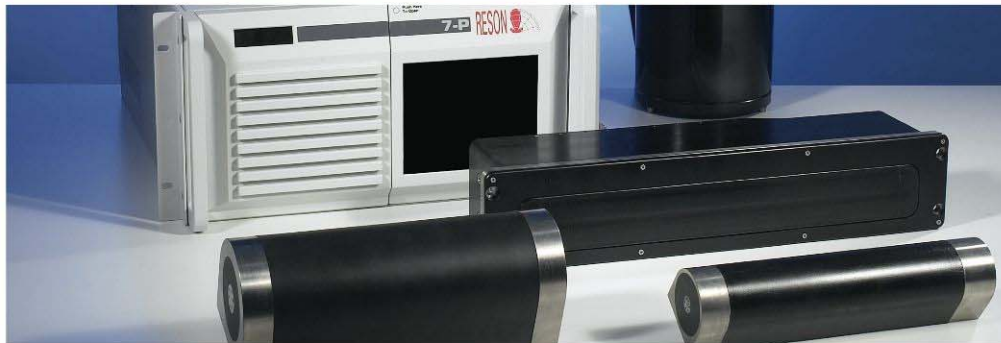
### SeaBat 7125

- Unparalleled Resolution and Installation Flexibility
- Single or Dual-Frequency Operation (200 and/or 400kHz)
- 256 or 512 Focused 0.5° Beams at 400kHz (1° at 200kHz)
- 128° Swath Coverage (4x Water Depth)
- 400 meter Depth Rated (6000 meter option)
- Built-in test environment (BITE)
- Complies to IHO SP44 Special Order + USACE Class 1

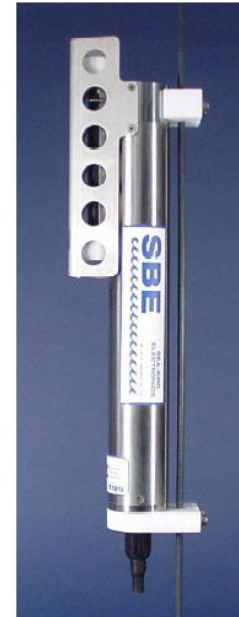
### SENSOR INTERFACE ELECTRONICS

Temperature is acquired by applying an AC excitation to a hermetically-sealed VISHAY reference resistor and an ultra-stable aged thermistor (drift rate typically less than 0.002 °C per year). The ratio of thermistor resistance to reference resistance is determined by a 24-bit A/D converter; this A/D also processes the pressure sensor signal. Conductivity is acquired using an ultra-precision Wien-Bridge oscillator. A high-stability reference crystal with a drift rate of less than 2 ppm/year is used to count the frequency from the oscillator.
