Re: Progress Report – Dirks Fine Dry Cleaning – Inglewood Plaza
701 228th Avenue NE, Redmond, Washington
Cleanup Site ID: 1044
Facility/Site No.: 62794175
VCP Project No.: NW2746

This letter report has been prepared by Apex Companies, LLC (Apex) on behalf of Regency Centers, LP (the current Site owner) to provide the Washington State Department of Ecology (Ecology) with updated information for the former Dirks Fine Dry Cleaning (Site; now occupied by Inglewood Dry Cleaners) located at 701 228th Avenue NE, Redmond, Washington (Figure 1). The Site was first enrolled in the Voluntary Cleanup Program (VCP) in April 1999 due to release(s) from historical dry cleaning operations by Dirks Fine Dry Cleaning. Soil, soil gas, and groundwater investigations, and groundwater monitoring activities were completed at the Site from 1998 through at least early 2009. A soil vapor extraction (SVE) system operated at the Site from May 2004 through at least June 2009. The Site was re-enrolled in the VCP in 2007 after the property was acquired by Regency Centers, LP (Regency). Reports describing these site investigation and remediation activities were submitted to Ecology in the 2007 VCP application pa

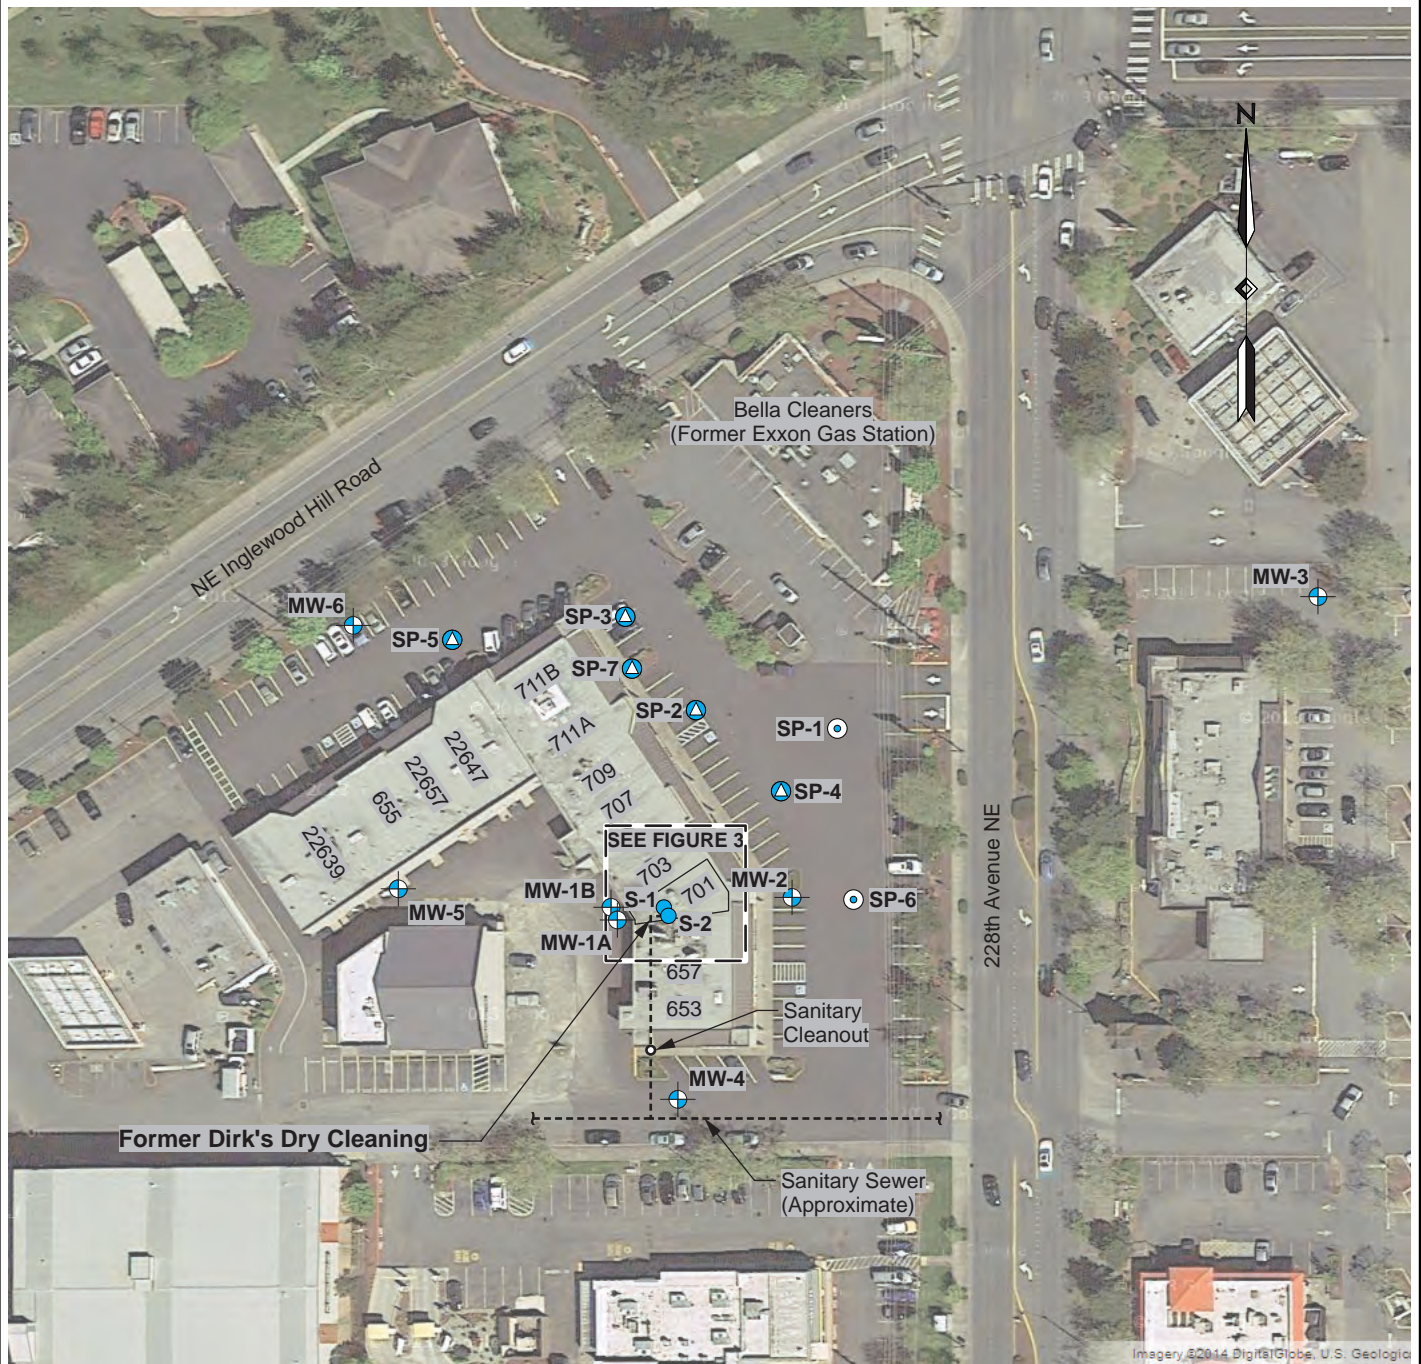
Figure
2

Bella Cleaners, a facility that performs dry cleaning services, has operated at the former Exxon gas station property since approximately 2004. It is unknown whether Bella Cleaners uses HVOCs. The current layout of the Inglewood Plaza shopping mall and the location of the former Exxon gas station and current Bella Cleaners facility are shown on Figure 2.
