**SECOND QUARTER GROUNDWATER
MONITORING REPORT
FORMER DRY CLEANING BUILDING
1006 LAKE STREET SOUTH
KIRKLAND, WASHINGTON**

ES-2880.05

September 15, 2014

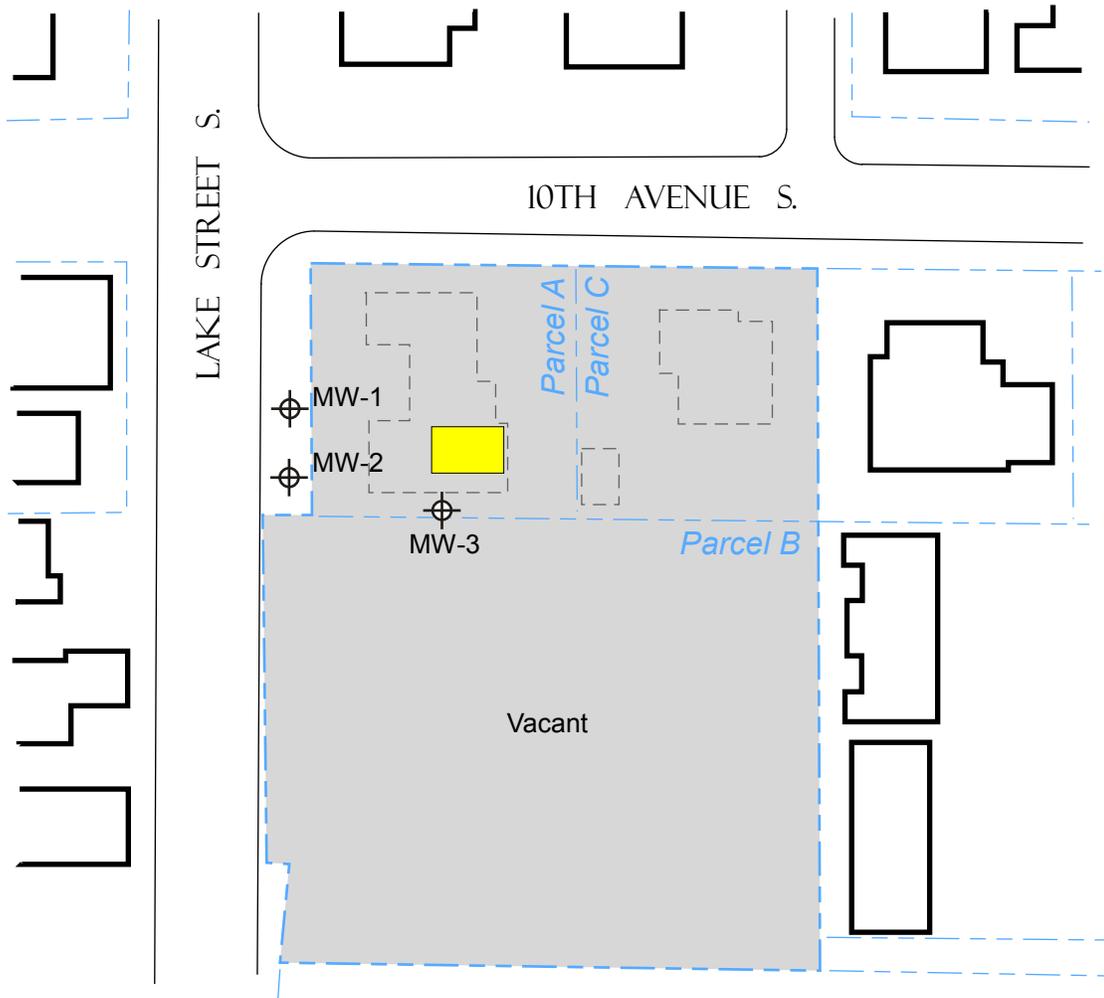
Earth Solutions NW LLC Geotechnical Engineering, Construction Monitoring and Environmental Sciences	
Site Plan Potala Village Kirkland, Washington			
Drwn. GLS	Date 09/12/2014	Proj. No. 2880.05	
Checked TWS	Date Sept. 2014	Plate	2

During the June 23, 2014 sampling event, groundwater samples were collected from monitoring wells MW-1 and MW-2 that were previously installed at the site by Aspect Consulting, LLC in 2008. A water sample could not be obtained from well MW-3 since it was severely damaged during building demolition and site grading activities. Locations of the groundwater monitoring wells are presented on Plate 2 in Appendix A.

Sampling activities were conducted on June 23, 2014 by ESNW. Groundwater samples were obtained from wells MW-1 and MW-2 that were previously installed at the site by Aspect Consulting, LLC in 2008. A water sample could not be obtained from well MW-3 since it was severely damaged during building demolition and site grading activities. Locations of the groundwater monitoring wells are presented on Plate 2 in Appendix A.
