STATE OF WASHINGTON
DEPARTMENT OF ECOLOGY

Re: No Further Action at the following Site:

- **Site Name:** Washtucna Fertilizer Plant
- **Site Address:** Hwy 261 and North Street Junction
- **Facility/Site No.:** 567
- **VCP Project No.:** EA0215

Site Description

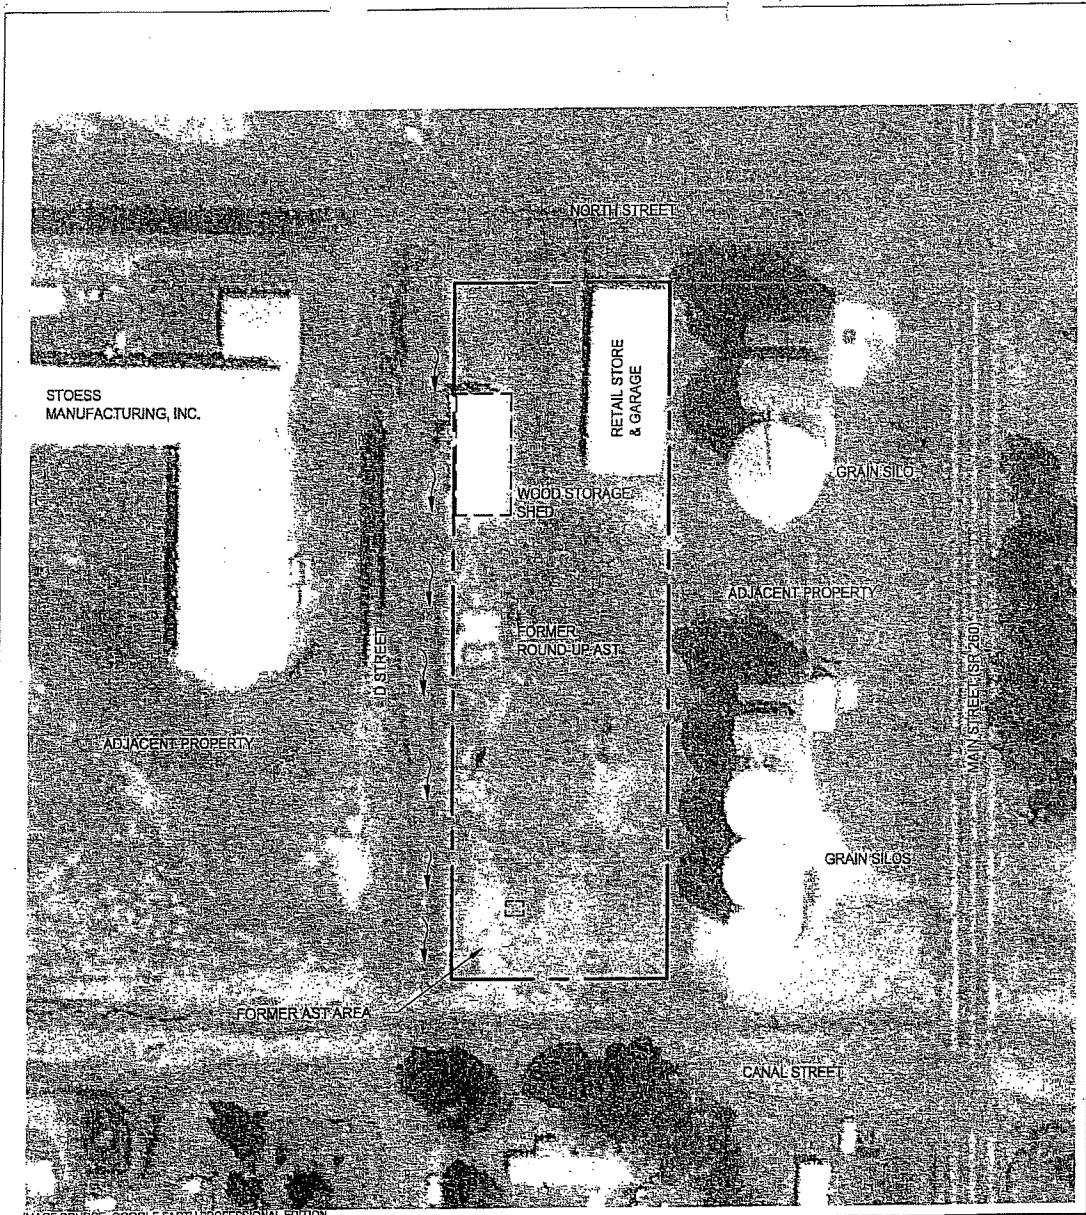
Figure 5.
AREAL EXTENT - TPH AFFECTED SOIL
 FORMER WASHTUCNA FERTILIZER PLANT
 WASHTUCNA, WA
 PROJECT No. 36310134
 AUGUST 20, 2012

- PROPERTY LINE
- DRAINAGE DITCH
- ESTIMATED AREAL EXTENT OF TOTAL PETROLEUM HYDROCARBON (TPH) AFFECTED SOIL

Several areas of concern were identified at the Site during site investigations in 1994. A Remedial Investigation was completed in 2012 that identified two areas with petroleum hydrocarbons concentrations exceeding cleanup levels. Several pesticides and herbicides were identified in Site soils, but at concentrations below cleanup levels. Remedial cleanup actions were conducted in 2014. Approximately 117 cubic yards of petroleum impacted soils were excavated and transported off-site for disposal. Confirmation soil samples indicated all impacted soil had been removed.
