**Interim Cleanup Action Work Plan  
1401, 1407 & 1409 Pacific Avenue  
Sauro's Property  
Tacoma, Washington**

May 18, 2009

**City of Tacoma**

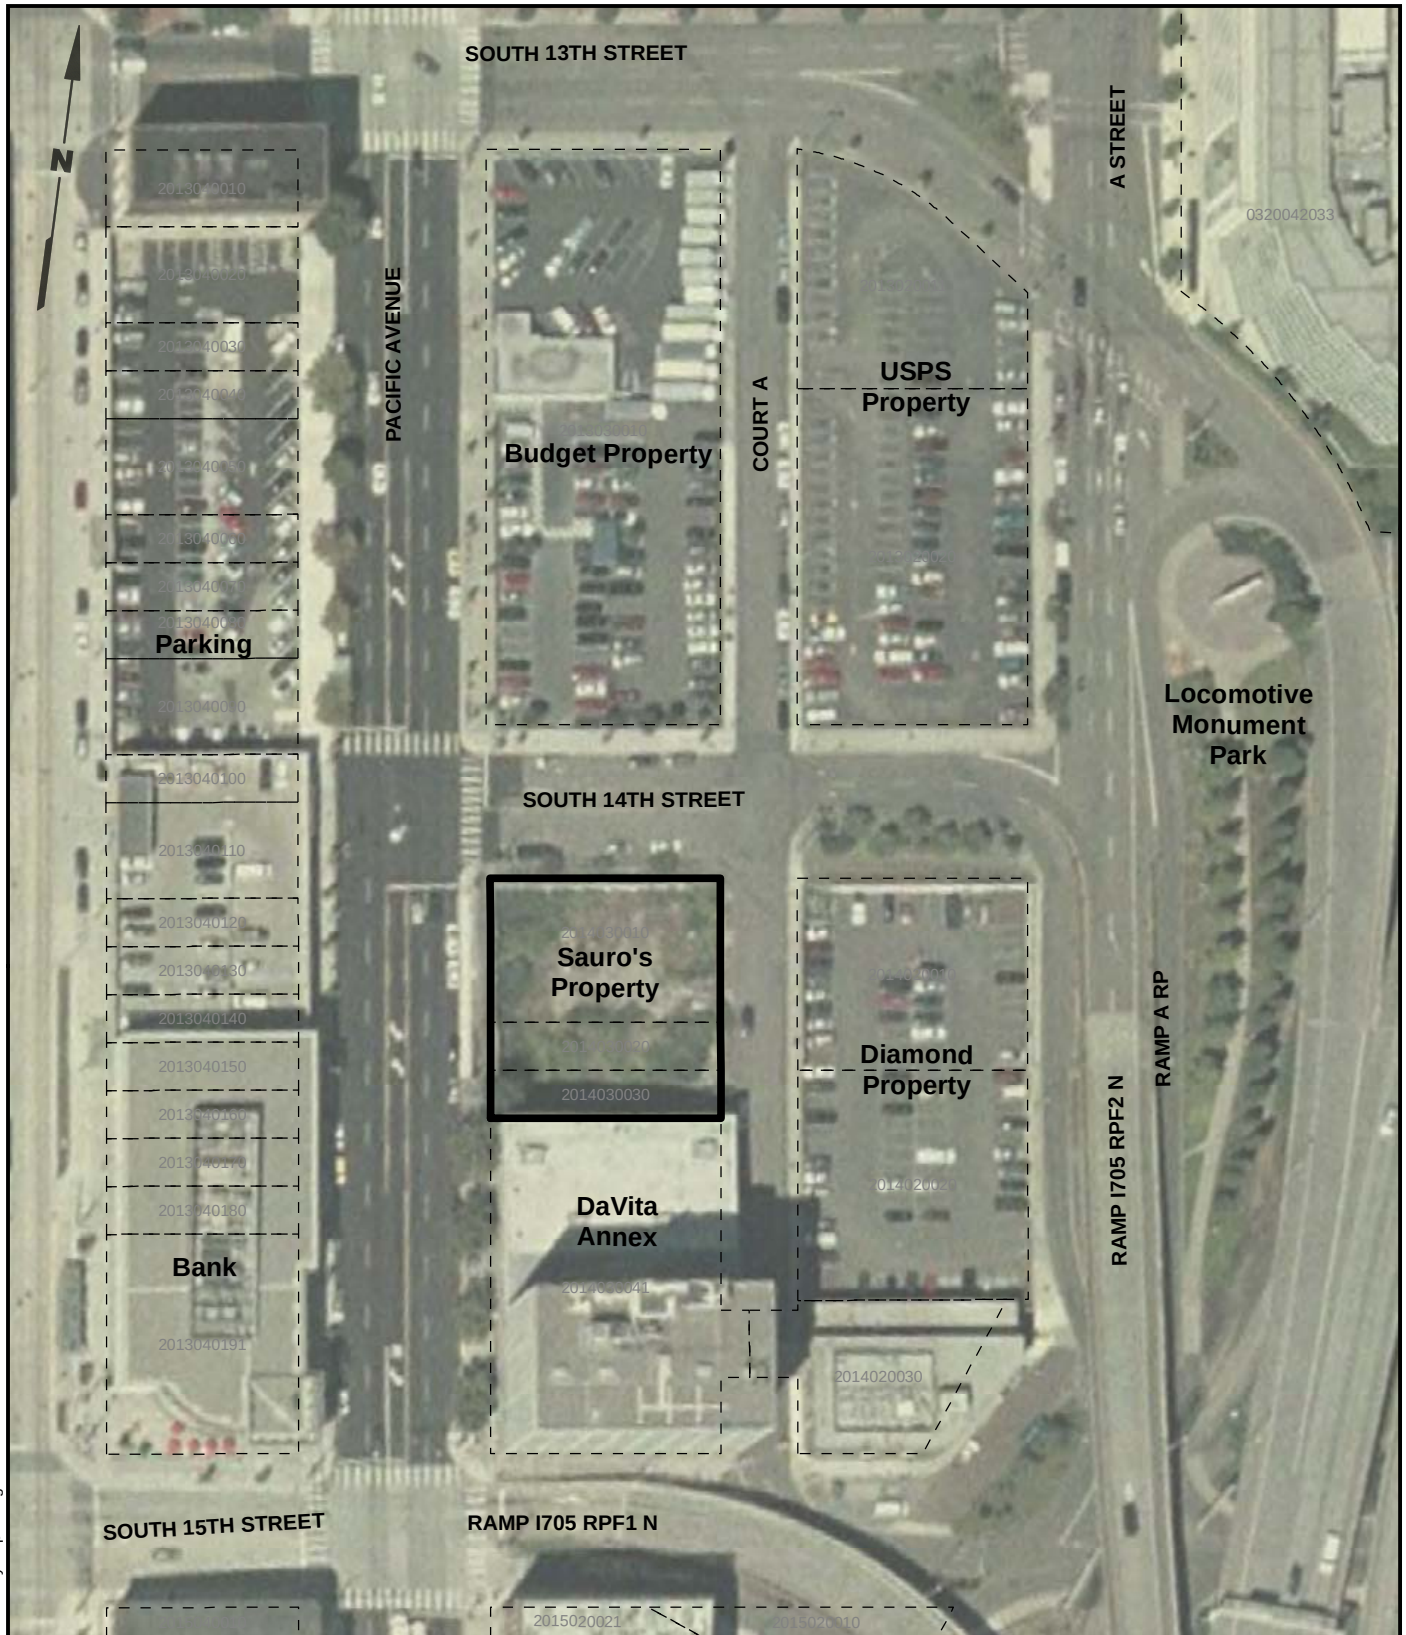
Figure  
2

Site Map

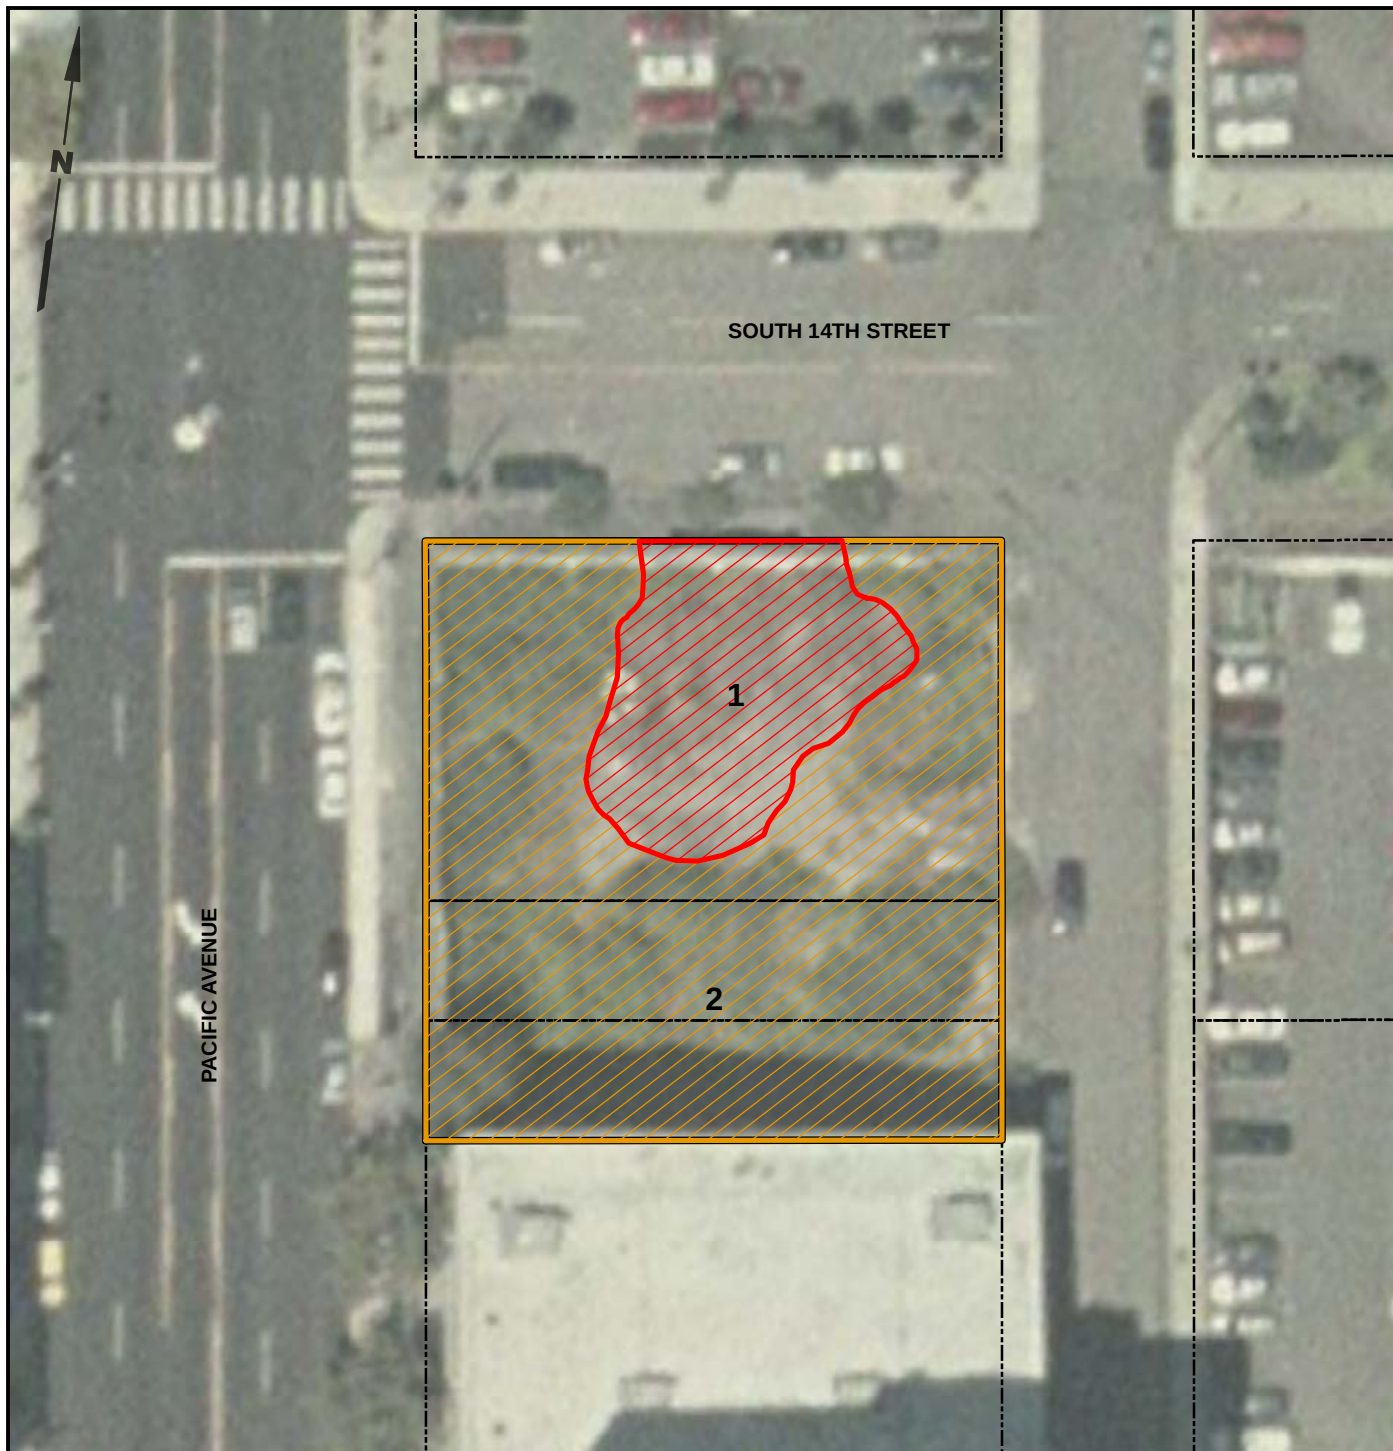
Y:\Projects\094048\Mapdocs\Summary Report\Fig18.mxd 4/27/2009

1. Categories are estimates based on three dimensional modeling results. Actual site conditions may vary.
2. Black and white reproduction of this color original may reduce its effectiveness and lead to incorrect interpretation.

The distribution of PCE in site soil has been characterized based on numerous borings and soil samples. These data are presented in Section 3. Based on the existing Sauro's property characterization, areas containing Category 1 and Category 2 soil have been identified. Figure 18 presents Sauro's property soil categories for the purpose of disposal. Soil from the stockpile along the west wall of the property will be considered Category 1<sup>9</sup>. Soil on top of the old ramp in the southeast corner will also be considered Category 1<sup>10</sup>.
