SITE HAZARD ASSESSMENT

Summary Score Sheet

Leo's Line Up & Tires Auto Express (aka L&L Exxon Service)
1315 Lee Blvd
Richland, WA 99352

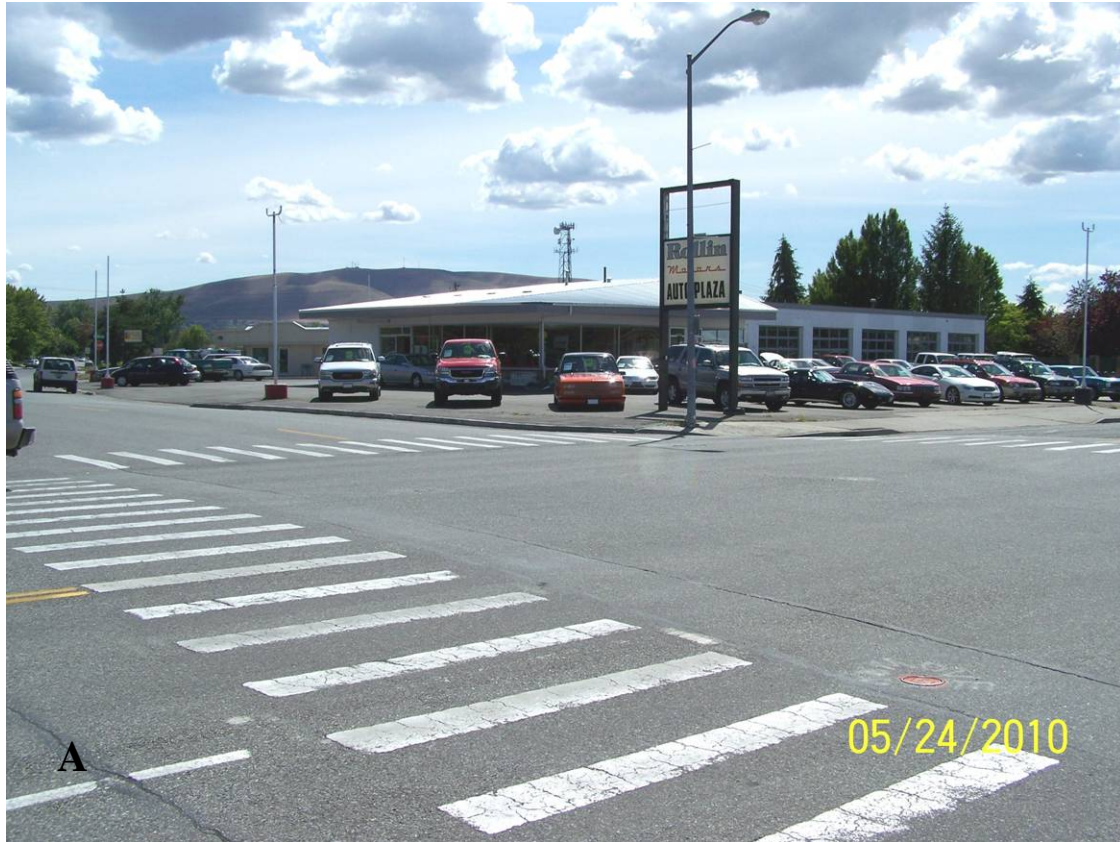
Photos of Leo's Line Up Taken During Site Visit on May 24, 2010. Plate A: Looking South West. Plate B: Ground Water Monitoring Well with Cap. Plate C: Ground Water Monitoring Well without Cap.

Mr. Davis pointed out where the four ground water monitoring wells were located. Three of them are aligned in a north-south direction slightly to the east of where the gasoline USTs were formally located (see Photo 2). Mr. Davis could not recall much information regarding the well depth, well installer, or sampling information. The two northern most wells had covers that were bolted down. The southern most well had a cover but no lid. The fourth well was located in the northwest corner of the property and did not have a cover or a lid.
