Final Draft Remedial Investigation Report

BNSF Parkwater Rail Yard Site
Spokane, Washington

BNSF Parkwater Company

August 11, 2010

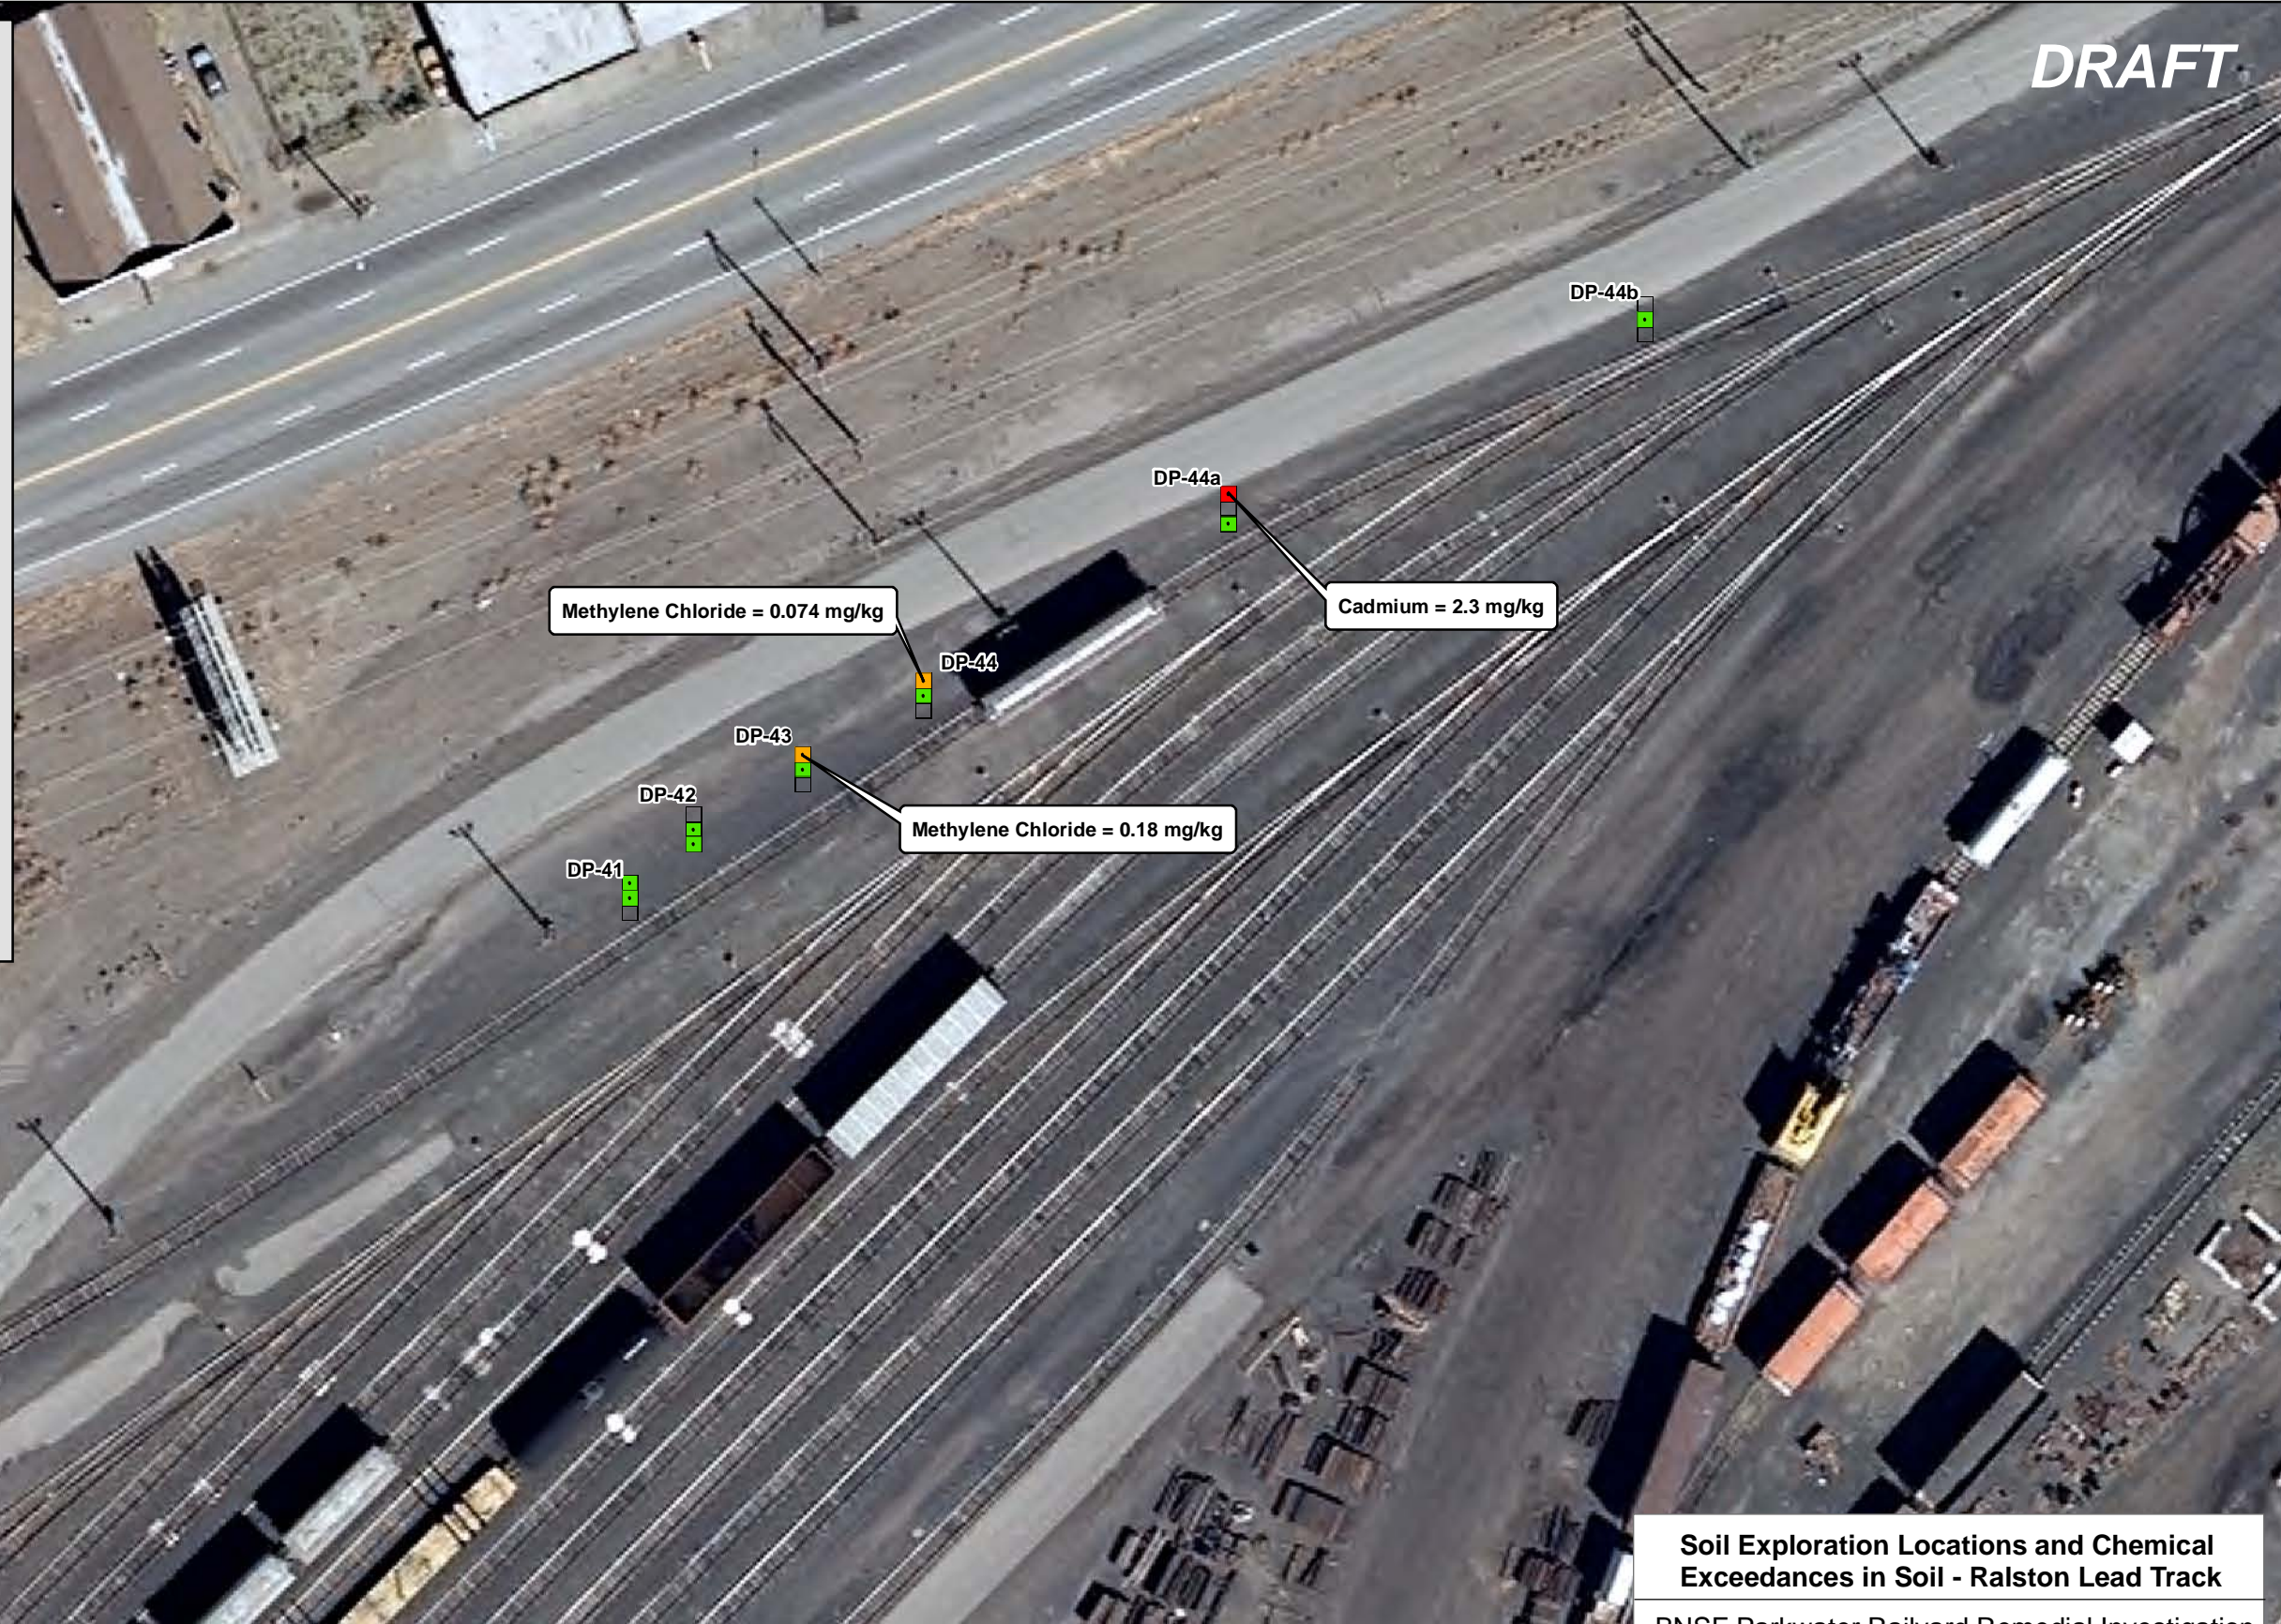
DP-41 = Labels for 2009 Explorations

Reference: Aerial photo (June 2007) from City of Spokane.
 Notes: 1. PAHs = Polycyclic Aromatic Hydrocarbons, DRPH = Diesel-range petroleum hydrocarbons, ORPH = Oil-range petroleum hydrocarbons, VOCs = Volatile Organic Compounds
 2. mg/kg = milligrams per kilogram
 3. The locations of all features shown are approximate.
 4. This drawing is for information purposes. It is intended to assist in showing features discussed in an attached document.
 GeoEngineers, Inc. cannot guarantee the accuracy and content of electronic files. The master file is stored by GeoEngineers, Inc. and will serve as the official record of this communication.

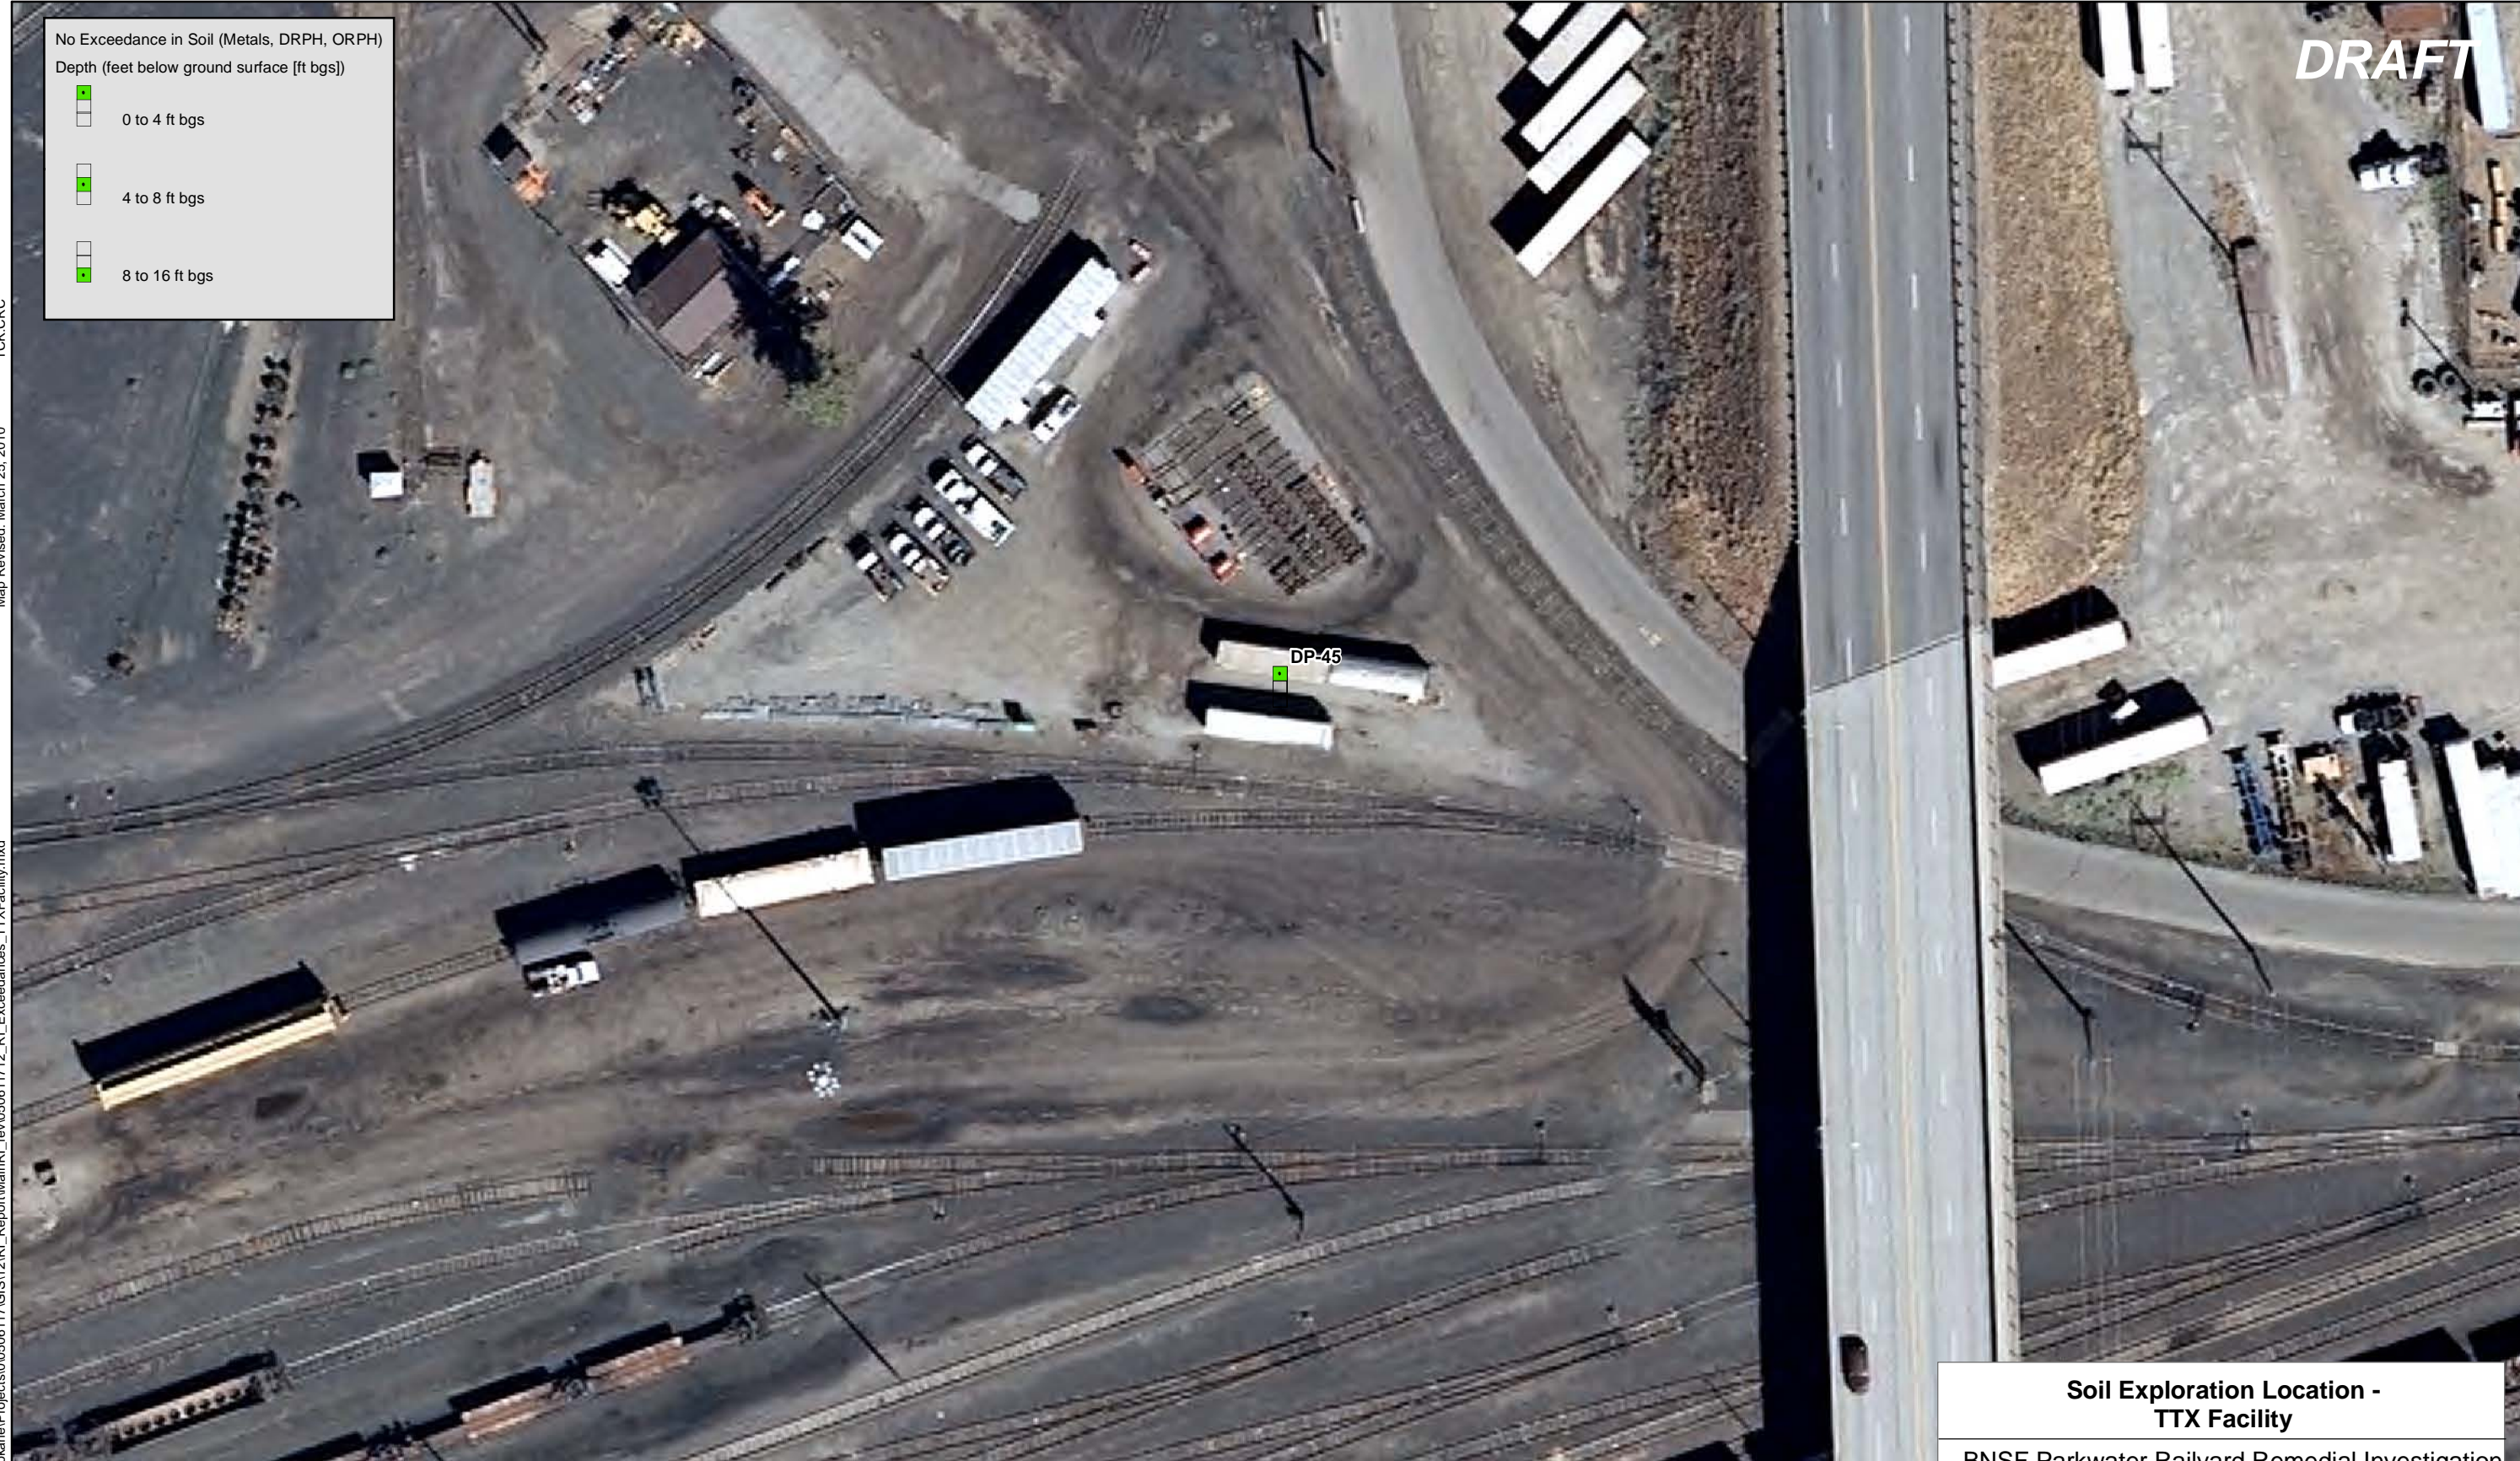
DP-45

Reference: Aerial photo (June 2007) from City of Spokane.

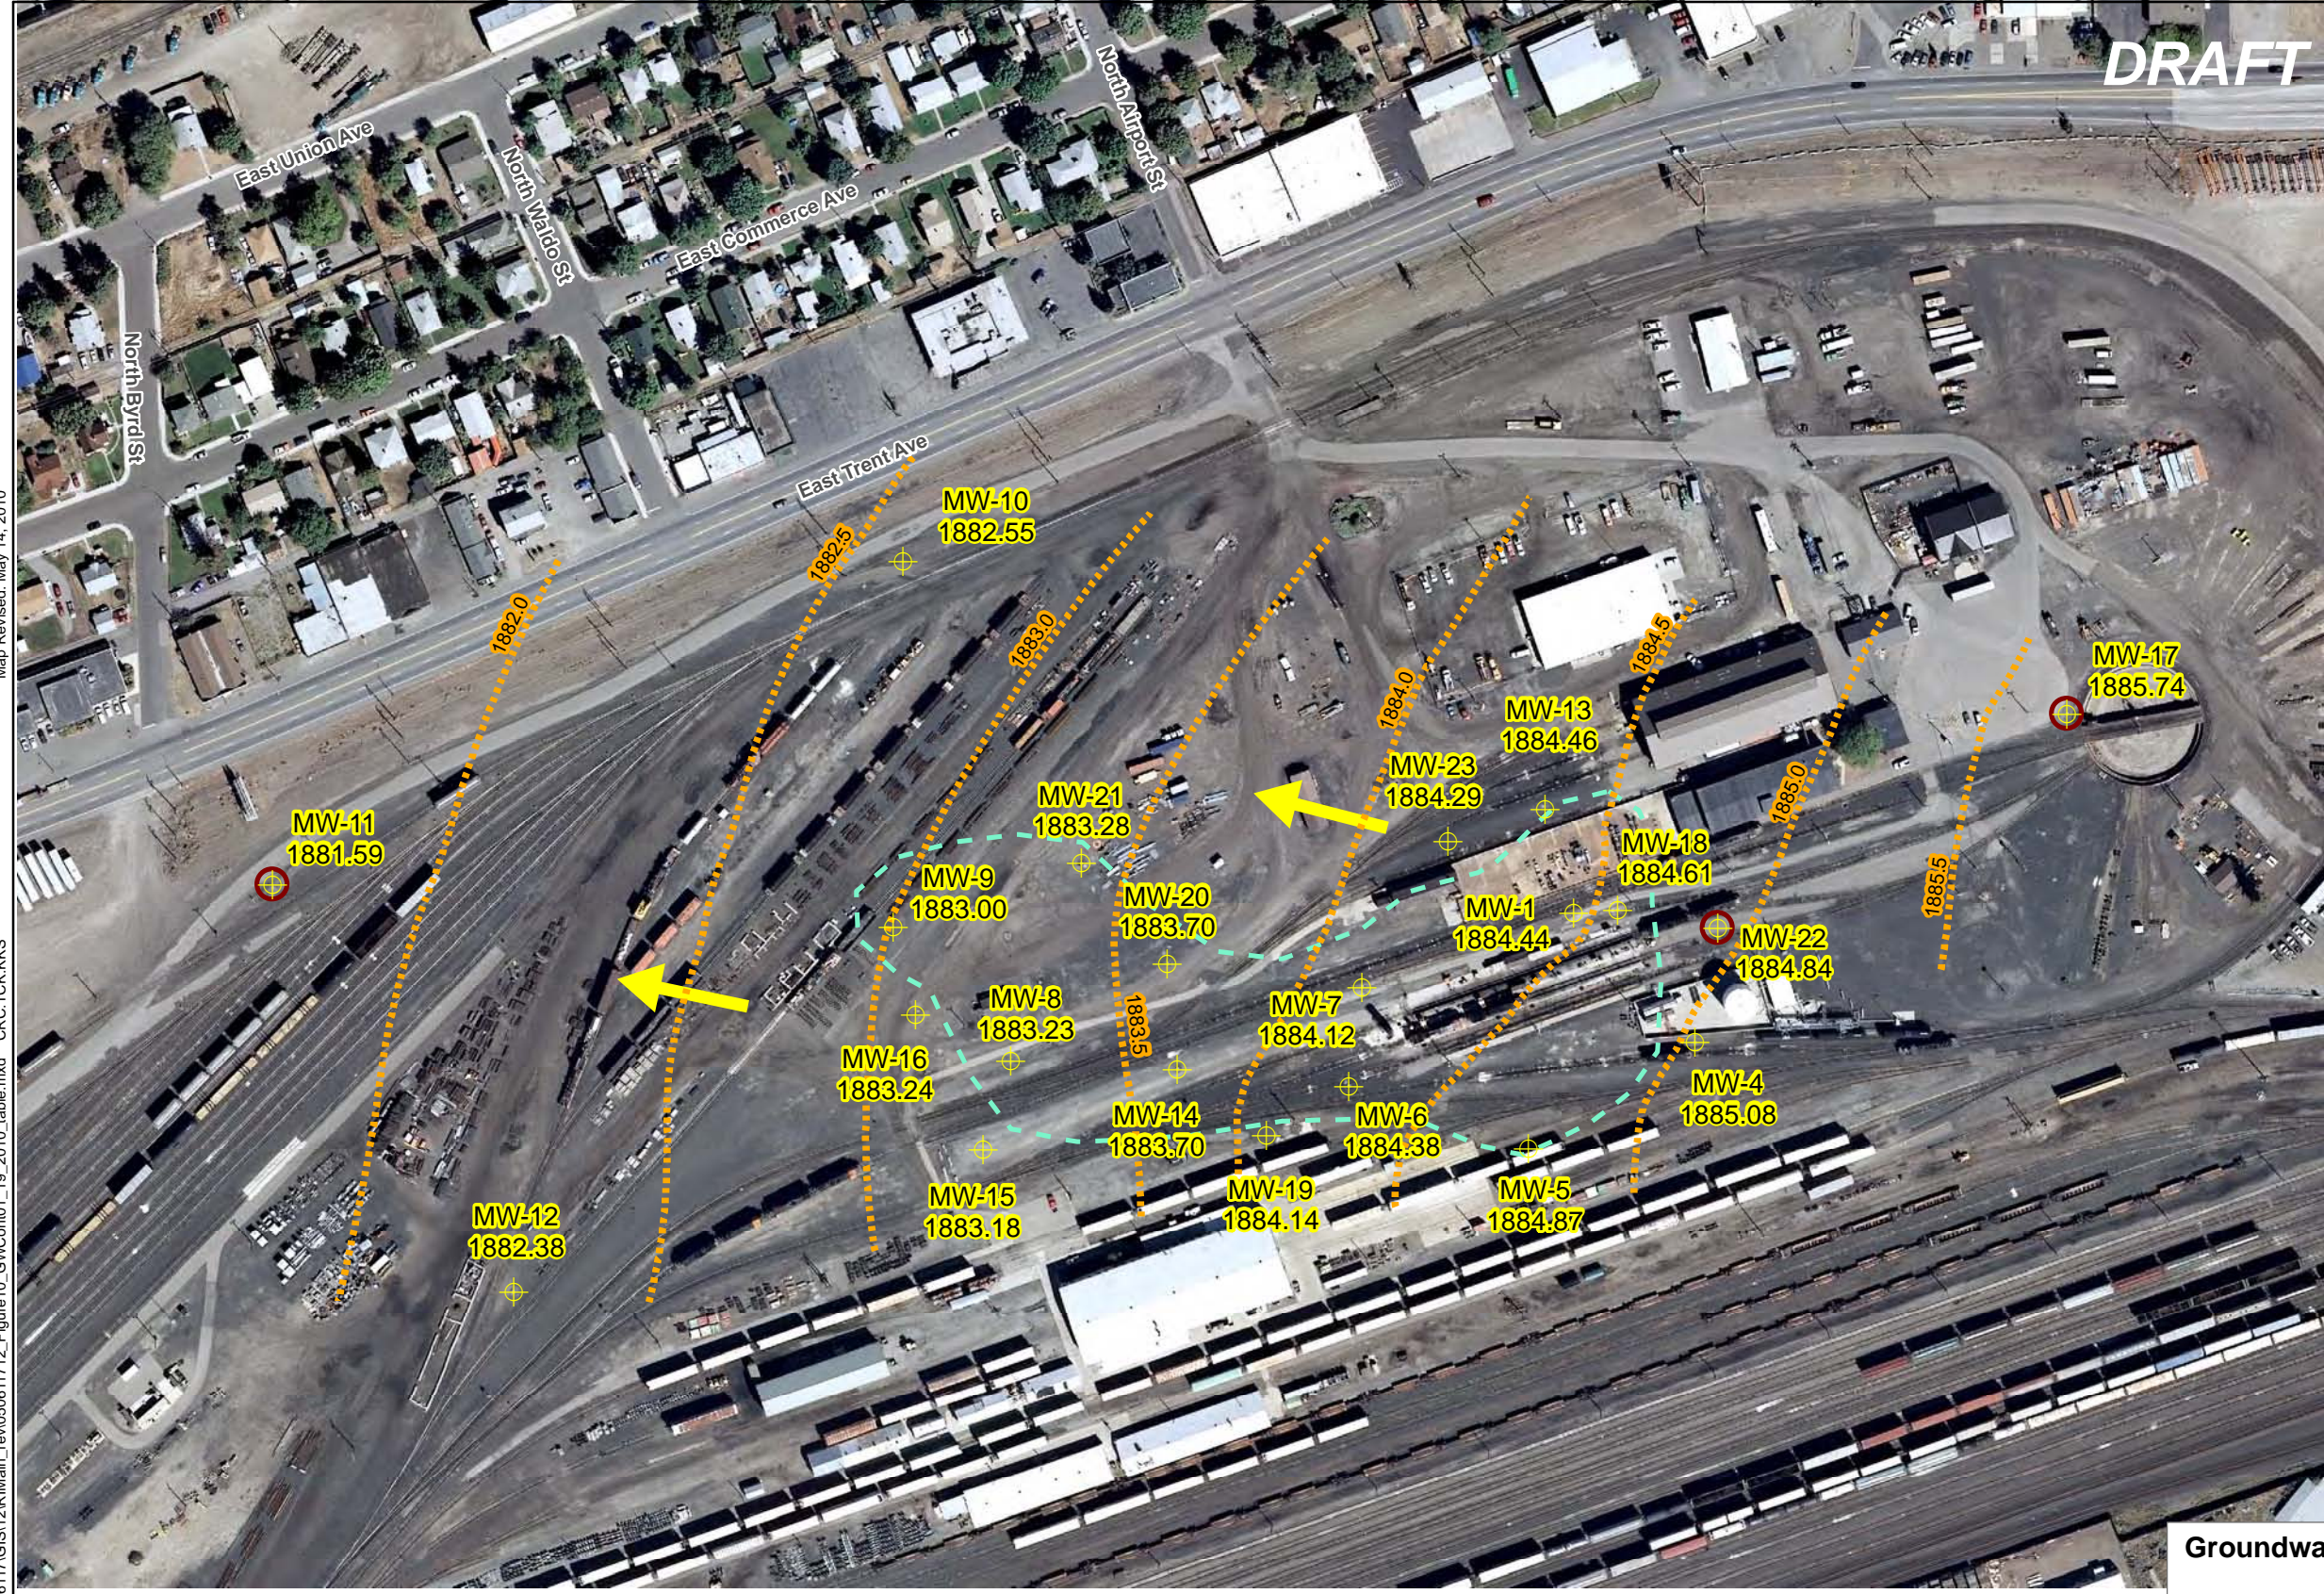
**Groundwater Elevations and Flow Direction
January 19, 2010**

Approximate Limit of Historic Diesel Plume

- Notes:
1. The locations of all features shown are approximate.
 2. This drawing is for information purposes. It is intended to assist in showing features discussed in an attached document. GeoEngineers, Inc. cannot guarantee the accuracy and content of electronic files. The master file is stored by GeoEngineers, Inc. and will serve as the official record of this communication.
 3. Groundwater elevations are relative to the NAVD 88 datum.
