Sediment Site Characterization
Evaluation of Bellingham Bay
Creosote Piling and Structure
Removal, Cornwall Avenue Landfill
Mapping, Boulevard Park Overwater
Walkway Feasibility, and Dioxin
Background Sampling and Analysis
Bellingham, Washington

Prepared for Washington State Department of Ecology

June 26, 2009 17330-17

Prepared by Hart Crowser, Inc.

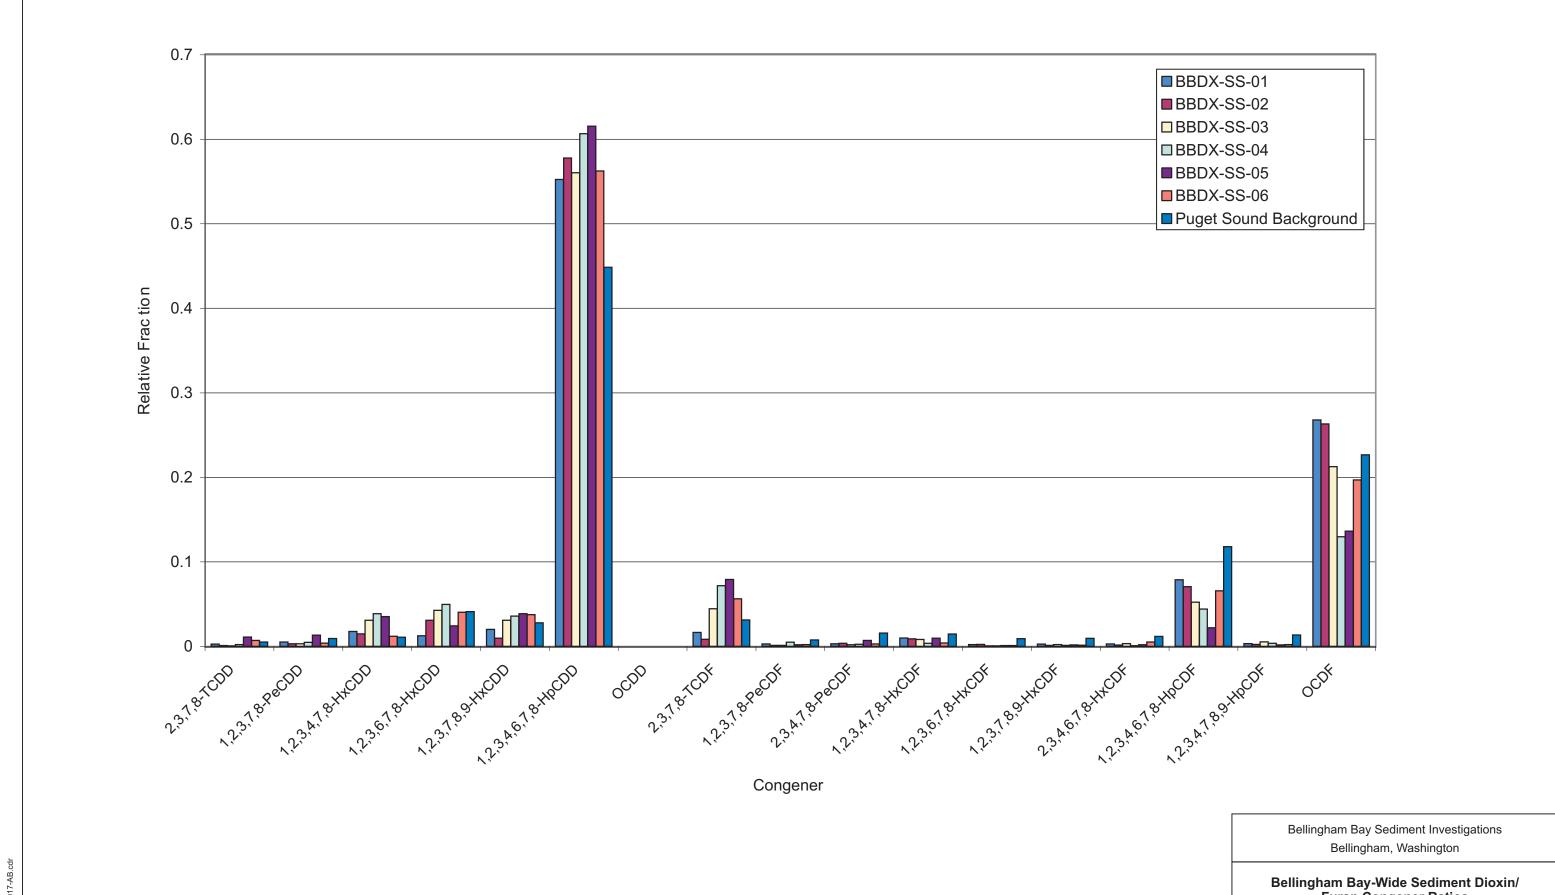
Figure 6

Furan Congener Ratios

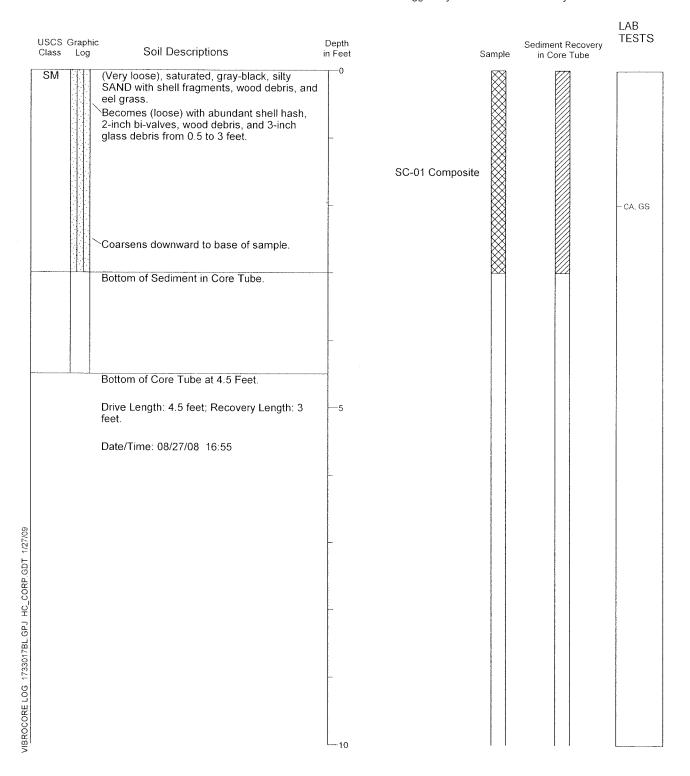
Location: See Figure 2.
Mudline Elevation in Feet (MLLW): -15.1 Feet Water Depth in Feet: 14.3 Feet

Type of Sample: Vibracore Core Diameter: 4 inches Northing: 637287.6 Easting: 1238685.9 Logged By: C. Rust Reviewed By: G. Both

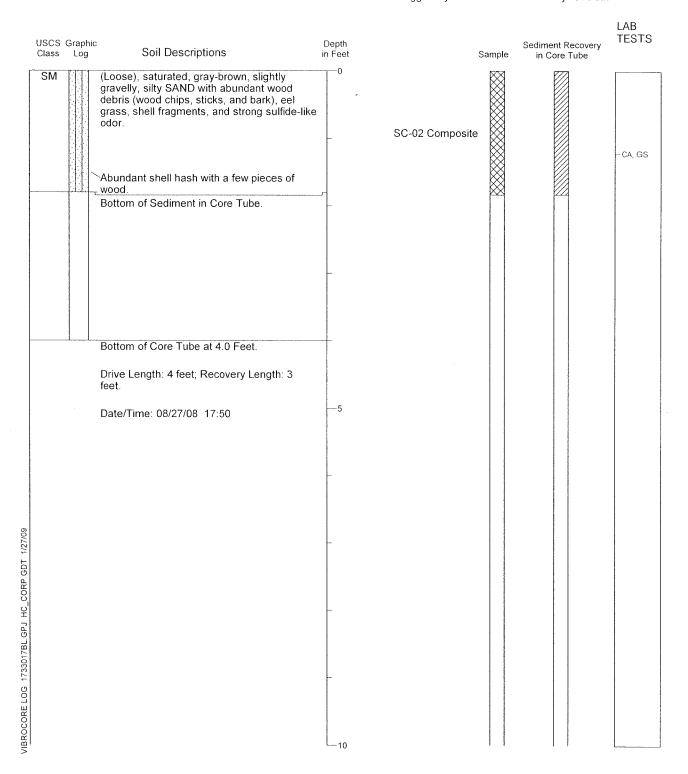
Location: See Figure 2. Mudline Elevation in Feet (MLLW): -12.4 Feet Water Depth in Feet: 12.6 Feet

Type of Sample: Vibracore Core Diameter: 4 inches Northing: 636748.6 Easting: 1238283.4 Logged By: C. Rust Reviewed By: G. Both

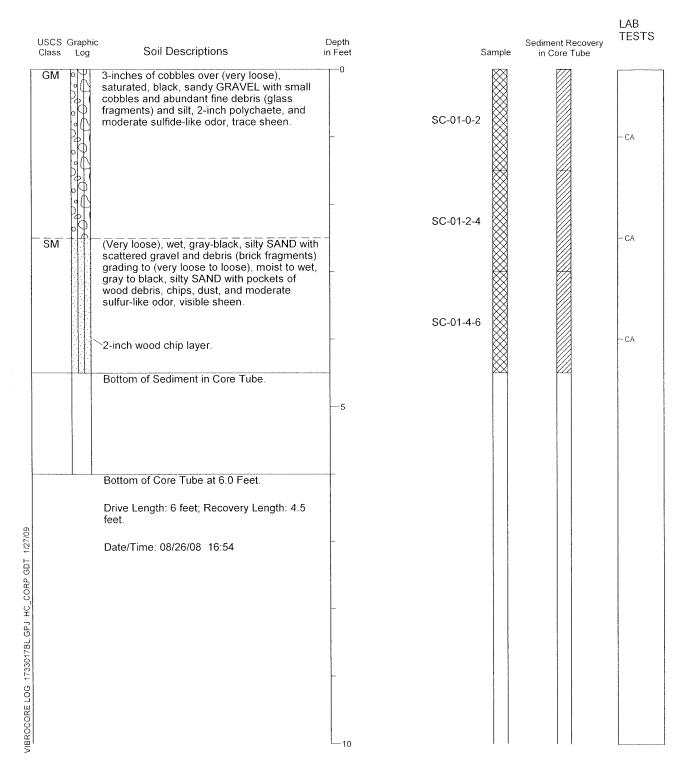
Location: See Figure 2. Mudline Elevation in Feet (MLLW): -8.7 Feet Water Depth in Feet: 8.8 Feet

Type of Sample: Vibracore Core Diameter: 4 inches Northing: 639752.2 Easting: 1240402.8 Logged By: M. Herrenkohl Reviewed By: G. Both

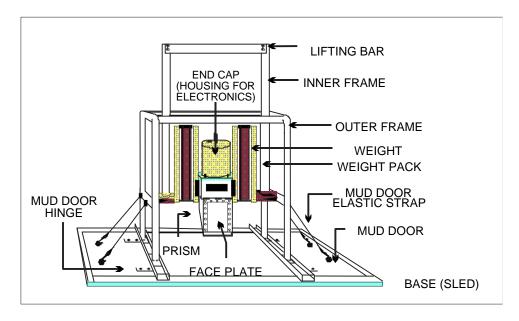
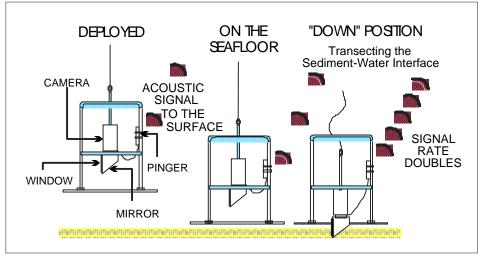
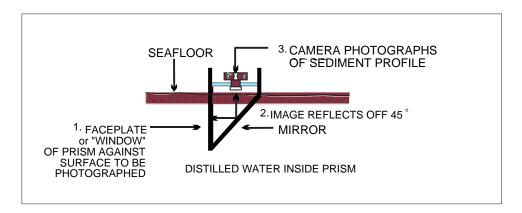
Figure 3. Schematic Diagram of Sediment-Profile Camera and Sequence of Operation on Deployment

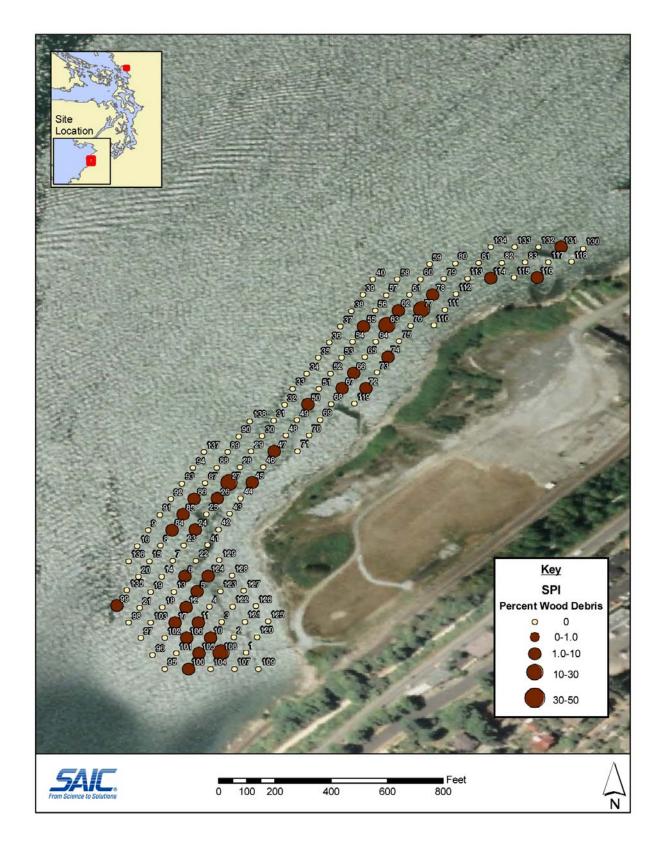
Figure 4. Distribution of Wood Debris Based on SPI Analysis

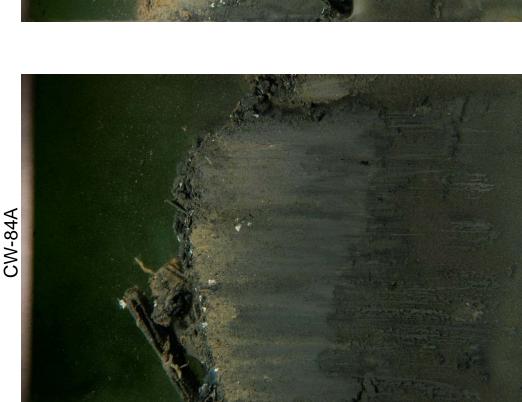
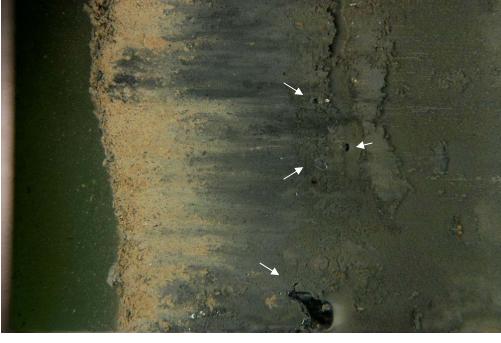
These images show the presence of fine wood debris on the sediment surface. Station CW-84A shows an accumulation of small wood particles that represent approximately 7 percent by area. Station CW-100A shows a small accumulation of fine wood particles (approximately 5 percent by area) on the sediment surface. Methane bubbles (arrows) are visible in the sediment column.

Figure 5. SPI Images from Stations CW-84 (Replicate A) and CW-100 (Replicate A)

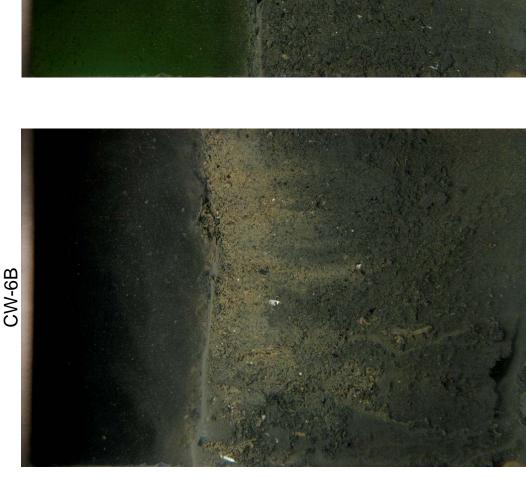
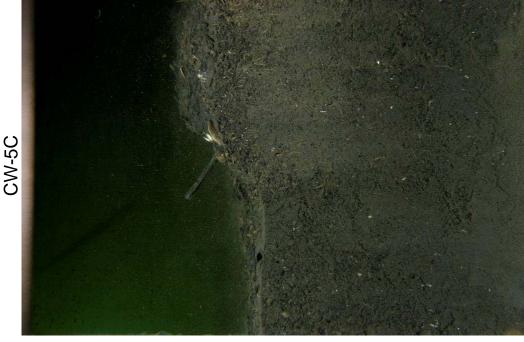
Images showing the presence of fine wood debris within surface sediments. Station CW-6B shows fine wood debris in the upper 6 cm of the sediment column (approximately 5 percent by area). Station CW-5C shows a higher accumulation of fine wood debris (25 percent by area) in the upper 4 cm of the sediment column. Fine wood debris from 4 to 13 cm in the sediment column is approximately 5 percent by area.

Figure 6. SPI Images from Stations CW-6B and CW-5C

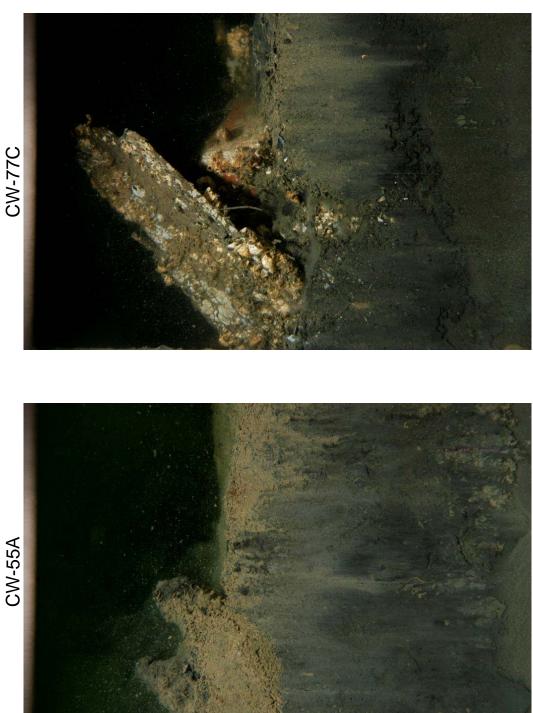
Both images show the presence of large wood debris on the sediment surface. Station CW-55A shows a piece of wood on the upper left (approximately 10 percent by area) draped with silt and fine organic particles. Station CW-77C shows a large piece of wood (approximately 20 percent by area) encrusted with barnacles and fine organic particles.

Figure 7. SPI Images from Stations CW-55A and CW-77C

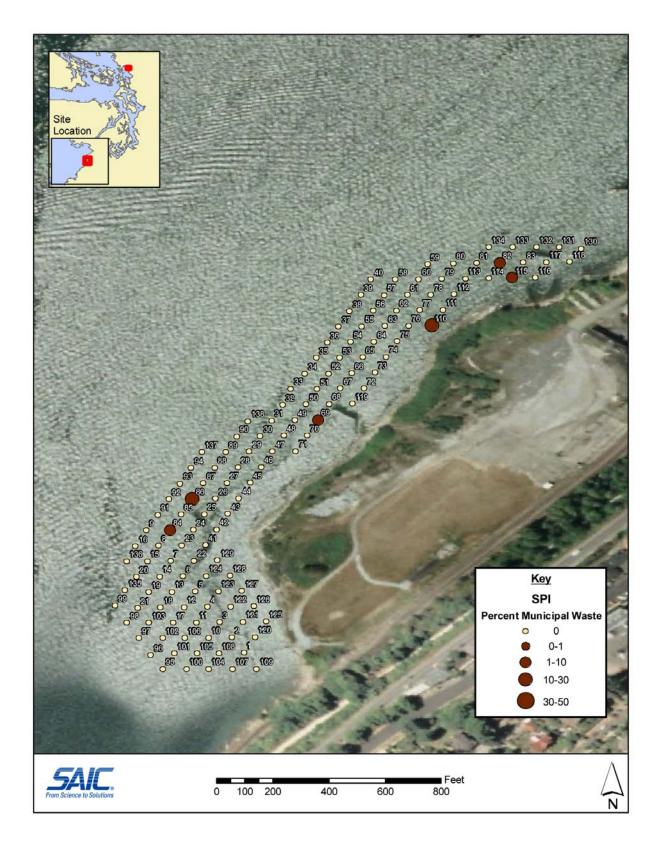
Figure 8. Distribution of Municipal Waste Based on SPI Analysis

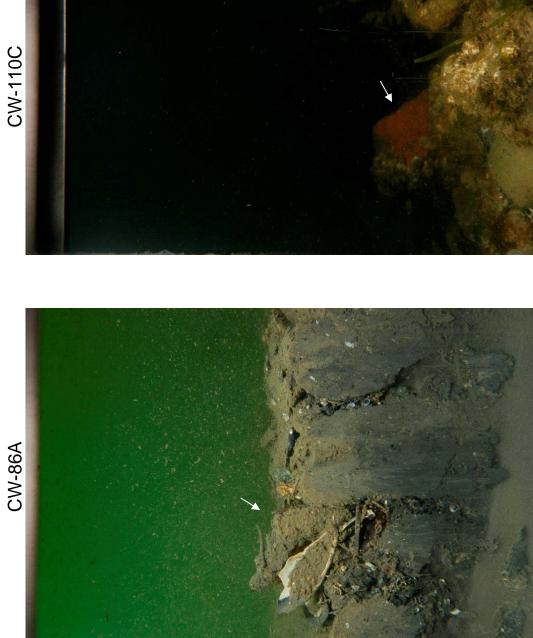
SPI images showing the presence of municipal waste. Station CW-86A shows a piece of brown glass (approximately 15 percent by area) near the sediment surface (arrow). The glass is obscured by sediment and shell debris. Station CW-110C shows a piece of brick (approximately 15 percent by area) that has been classified as municipal waste (construction debris).

Figure 9. SPI Images from Stations CW-86A and CW-110C

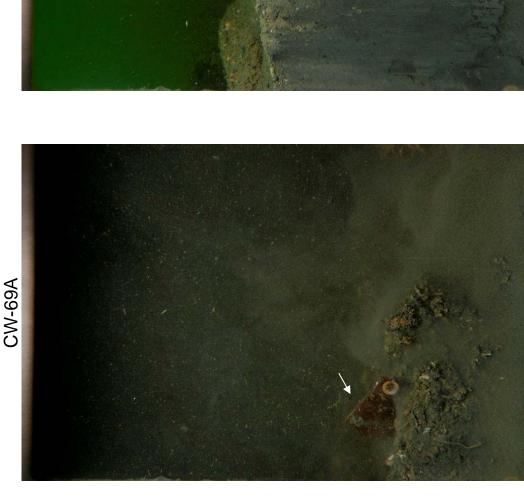
SPI images showing the presence of municipal waste (glass pieces). Station CW-69A shows a piece of brown glass (arrow) on the sediment surface (approximately 7 percent by area). Station CW-84B shows the neck of a glass bottle draped by a sea star (arrow) on the sediment surface (approximately 15 percent by area).

Figure 10. SPI Images from Stations CW-69A and CW-84B

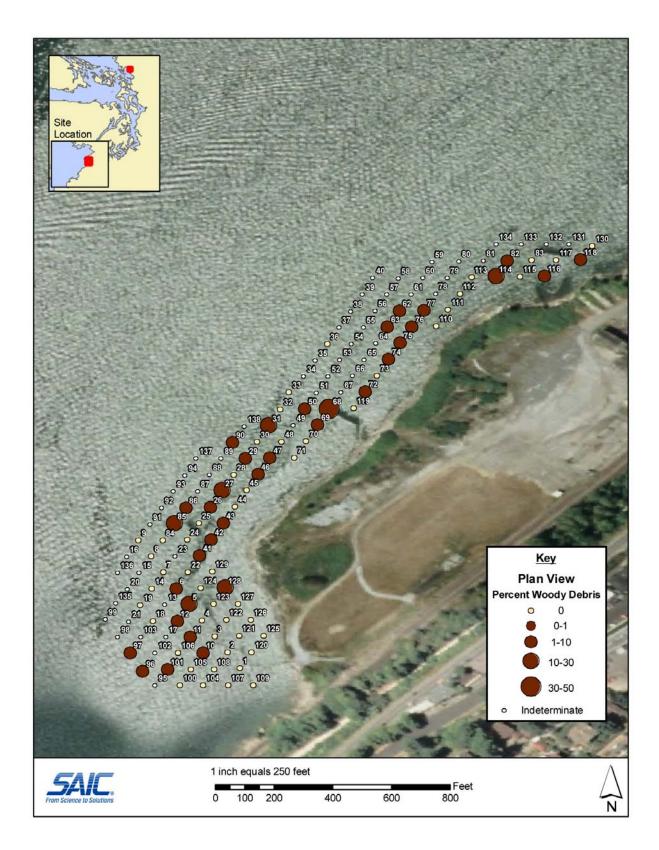
Figure 11. Distribution of Wood Debris Based on Plan View Image Analysis

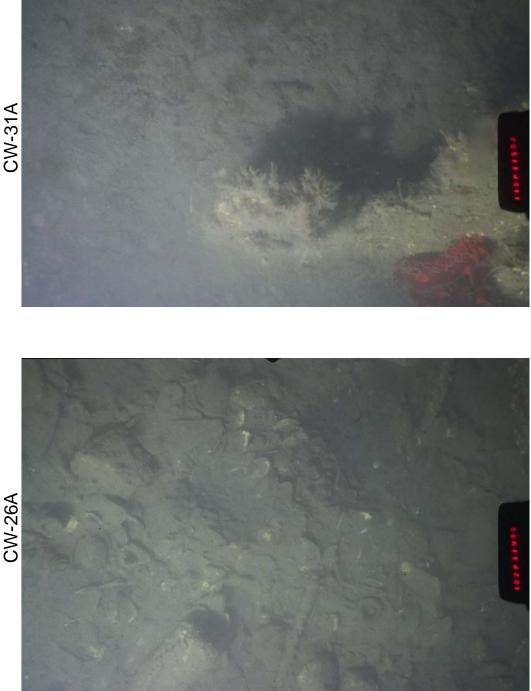
Plan view images showing the presence of large wood debris. Station CW-26A shows pieces of wood debris and shells on the sediment surface (approximately 10 percent by area). The wood debris and shells are draped by a layer of silt. Station CW-31A shows a large piece of wood encrusted with algae and bryozoans (approximately 25 percent by area). A sea cucumber is visible at the lower left of the image.

Figure 12. Plan View Images from Stations CW-26A and CW-31A

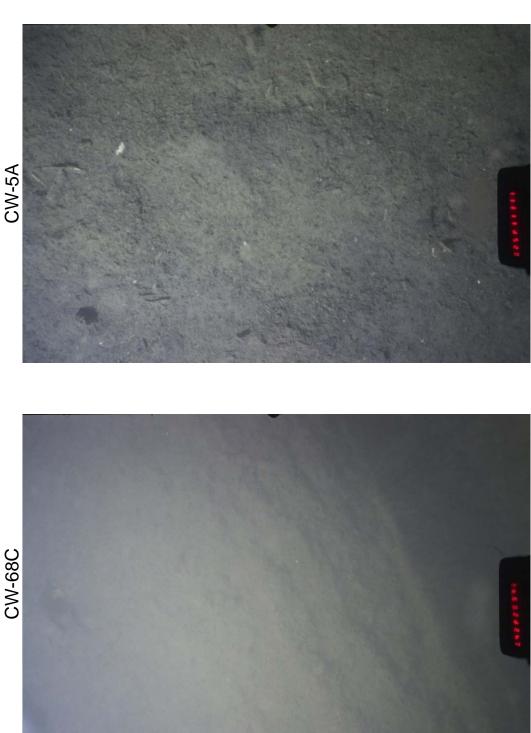
Plan view images showing the presence of wood debris on the sediment surface. Station CW-68C shows a large piece of wood/log on the sediment surface (approximately 40 percent by area). Station CW-5A shows accumulations of fine wood particles on the sediment surface (approximately 25 percent by area).

Figure 13. Plan View Images from Stations CW-68C and CW-5A

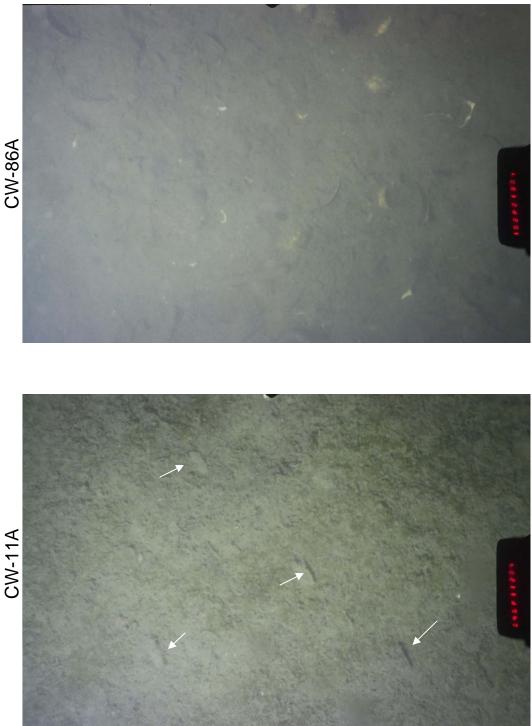
Plan images showing the presence of fine wood debris on the sediment surface. Station CW-11A shows small wood particles (arrows) lying on fine grained surface sediments (approximately 3 percent by area). Station CW-86A shows small wood pieces and particles with shells on the sediment surface (approximately 5 percent by area).

Figure 14. Plan View Images from Stations CW-11A and CW-86A

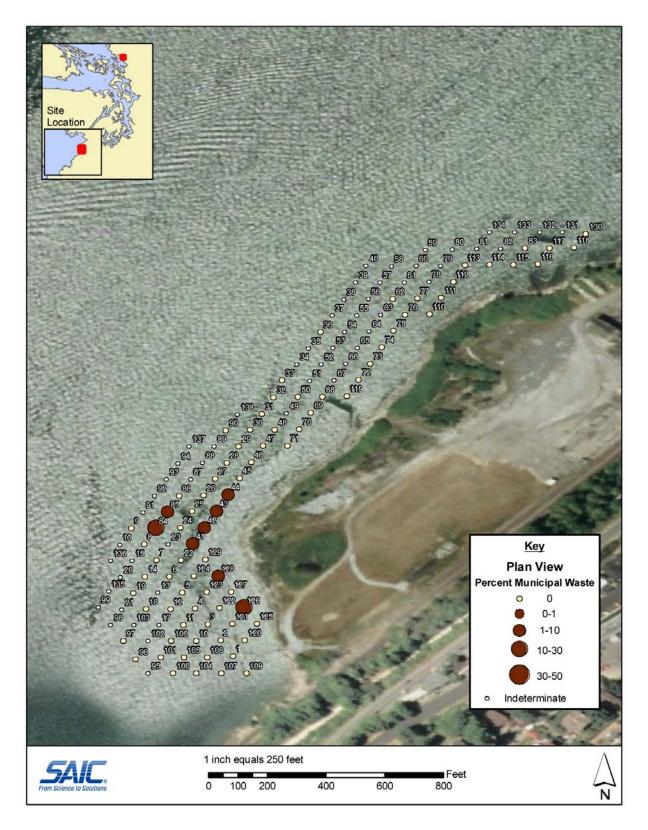
Figure 15. Distribution of Municipal Waste Based on Plan View Image Analysis

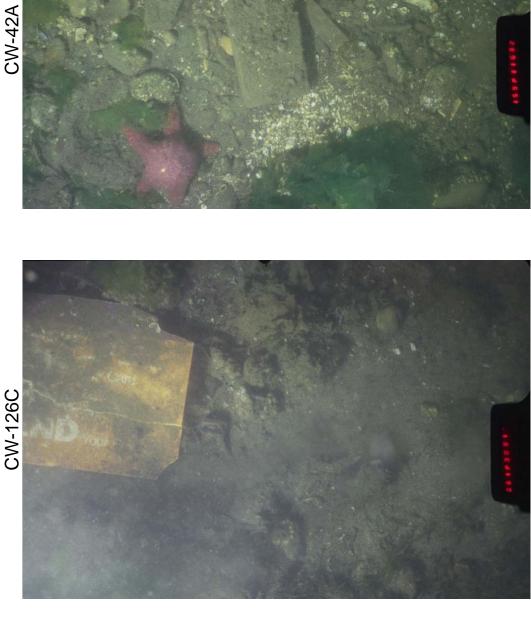
Plan view images showing municipal waste on the sediment surface. Station CW-126C shows a metal or plastic sign piece on the sediment surface (approximately 20 percent by area). Station CW-42A shows a piece of brick (approximately 10 percent by area) along the right side of the image (arrow) and wood pieces on the sediment surface.

Figure 16. Plan View Images from Stations CW-126C and CW-42A

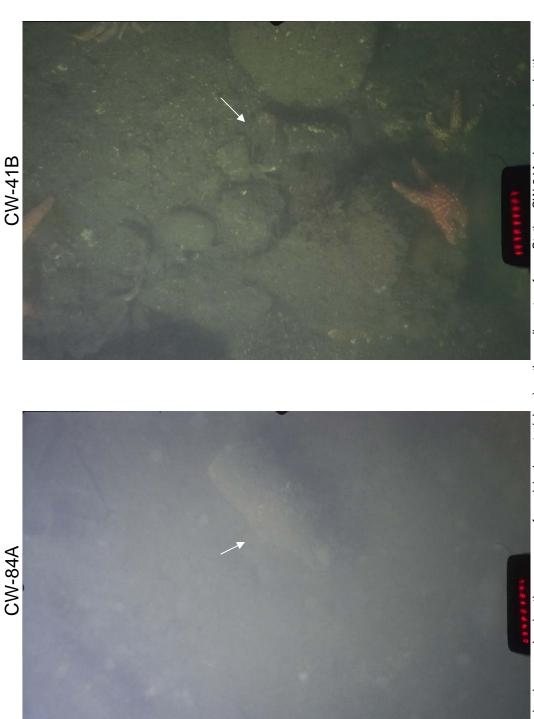
Plan view images showing the presence of municipal waste (glass) on the sediment surface. Station CW-84A shows a glass bottle (arrow) resting on the sediment surface (approximately 15 percent by area). Station CW-41B shows the presence of a broken glass bottle neck (arrow) on a rocky and sandy bottom (approximately 3 percent by area).

Figure 17. Plan View Images from Stations CW-84A and CW-41B

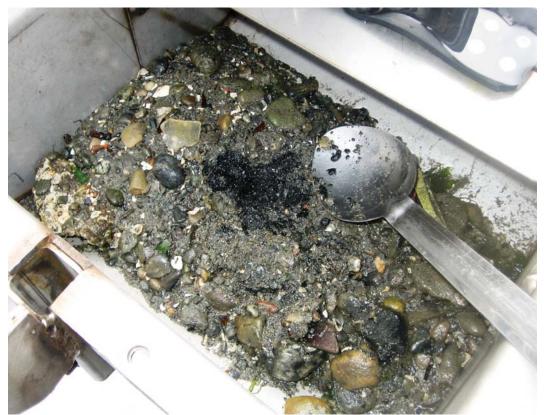
Photograph 1 - Surface sediment grab sample RGH-SS-02. Silty, sandy GRAVEL (GM) with moderate cobbles.

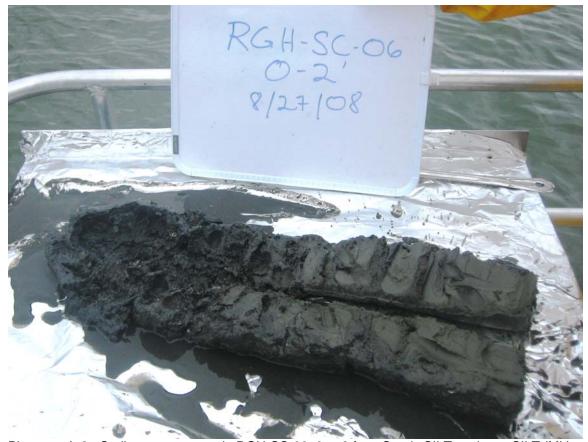
Photograph 2 - Sediment core sample RGH-SC-06, 0 to 2 feet. Sandy SILT to clayey SILT (ML).

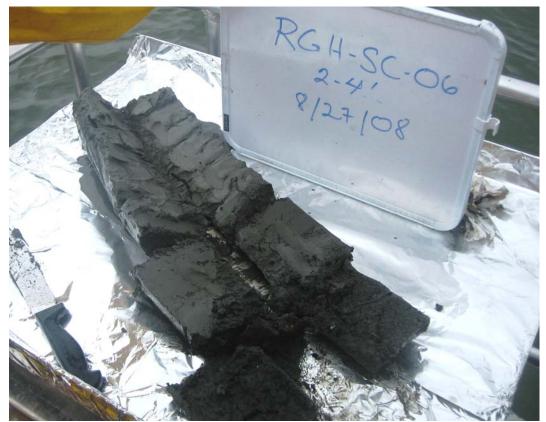
Photograph 3 - Sediment core sample RGH-SC-06, 2 to 4 feet. Layers of wood chips/fragments (1- to 3-cm thick) with shell hash.

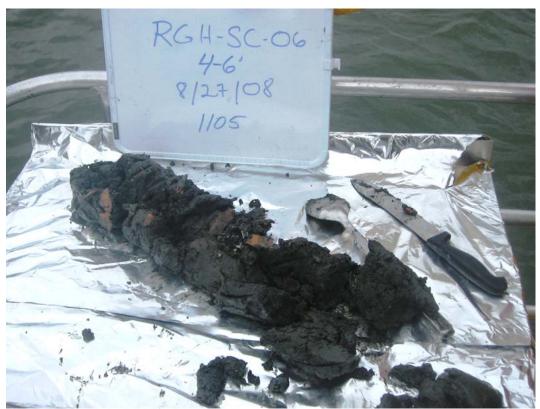
Photograph 4 - Sediment core sample RGH-SC-06, 4 to 6 feet. Layers of wood chips/fragments (1- to 3-cm thick) with shell hash.

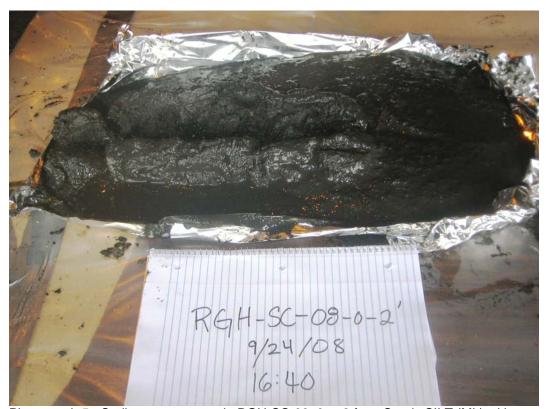
Photograph 5 - Sediment core sample RGH-SC-08, 0 to 2 feet. Sandy SILT (ML) with some wood chips.

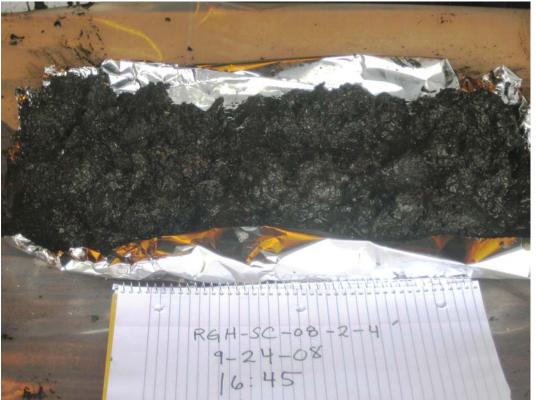
Photograph 6 - Sediment core sample RGH-SC-08, 2 to 4 feet. Sandy SILT (OL) with increased wood chips/sawdust with depth.

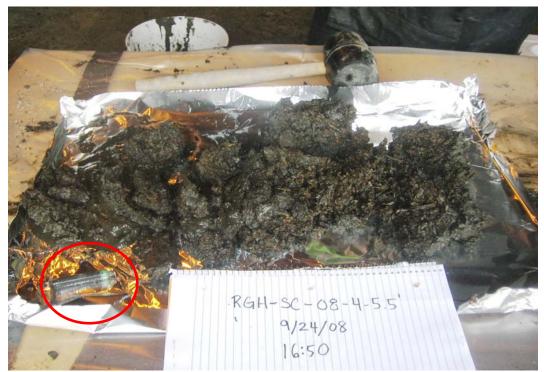
Photograph 7 - Sediment core sample RGH-SC-08, 4 to 5.5 feet. Silty PEAT (PT) with wood pieces (0.5- to 2-inch), with a plastic syringe in shoe (lower left corner of photograph).

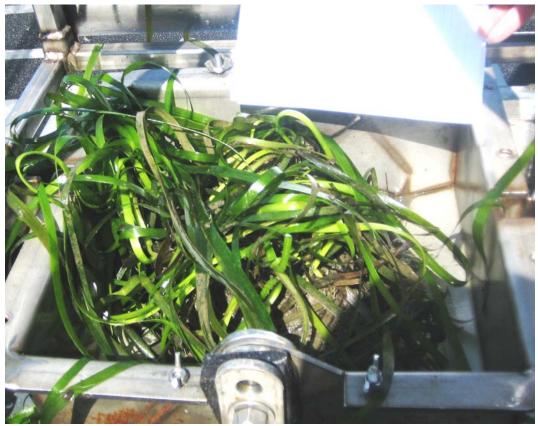
Photograph 8 - Sediment surface grab sample BBP-SS-02. Silty SAND (SM) with scattered gravel and cobbles, moderate shell fragments, and abundant eel grass.

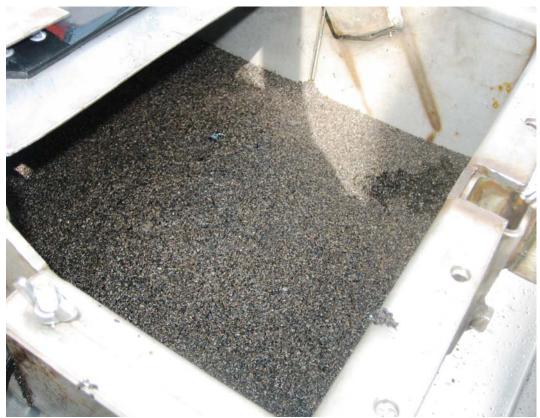
Photograph 9 - Sediment surface grab sample BBP-SS-03. Fine organic PEAT (PT) with sand and scattered gravels and shell fragments.

Diesel-range petroleum hydrocarbons concentrations ranged from 10 to 61 mg/kg, with the highest detection in sample BBP-SS-03 located directly north of Boulevard Park (Figure 13). Heavy oil-range petroleum hydrocarbons concentrations ranged from 15 to 180 mg/kg, with the highest detection in sample BBP-SS-03. An oily sheen was observed in samples BBP-SS-01 and BBP-SS-03.

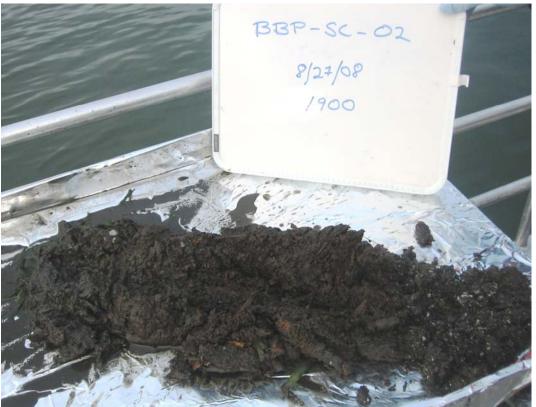
Photograph 10 - Sediment core sample BBP-SC-02, 0 to 3 feet. Slightly gravelly, silty SAND (SM) with abundant wood debris (wood chips, sticks, and bark).

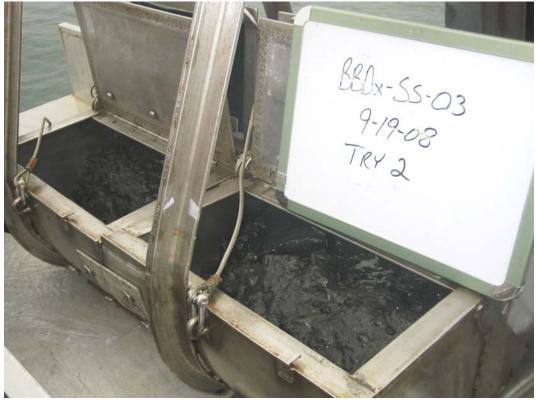
Photograph 11 - Sediment surface grab sample BBDx-SS-03. Clayey SILT (CL) with sand.

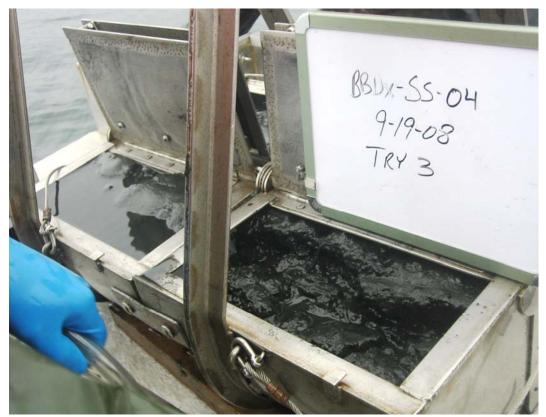
Photograph 12 - Sediment surface grab sample BBDx-SS-04. Clayey SILT (CL) with sand.
