HEGLAR KRONQUIST SITE

Heglar & Kronquist Roads
Mead, WA

DEPARTMENT OF
ECOLOGY
State of Washington

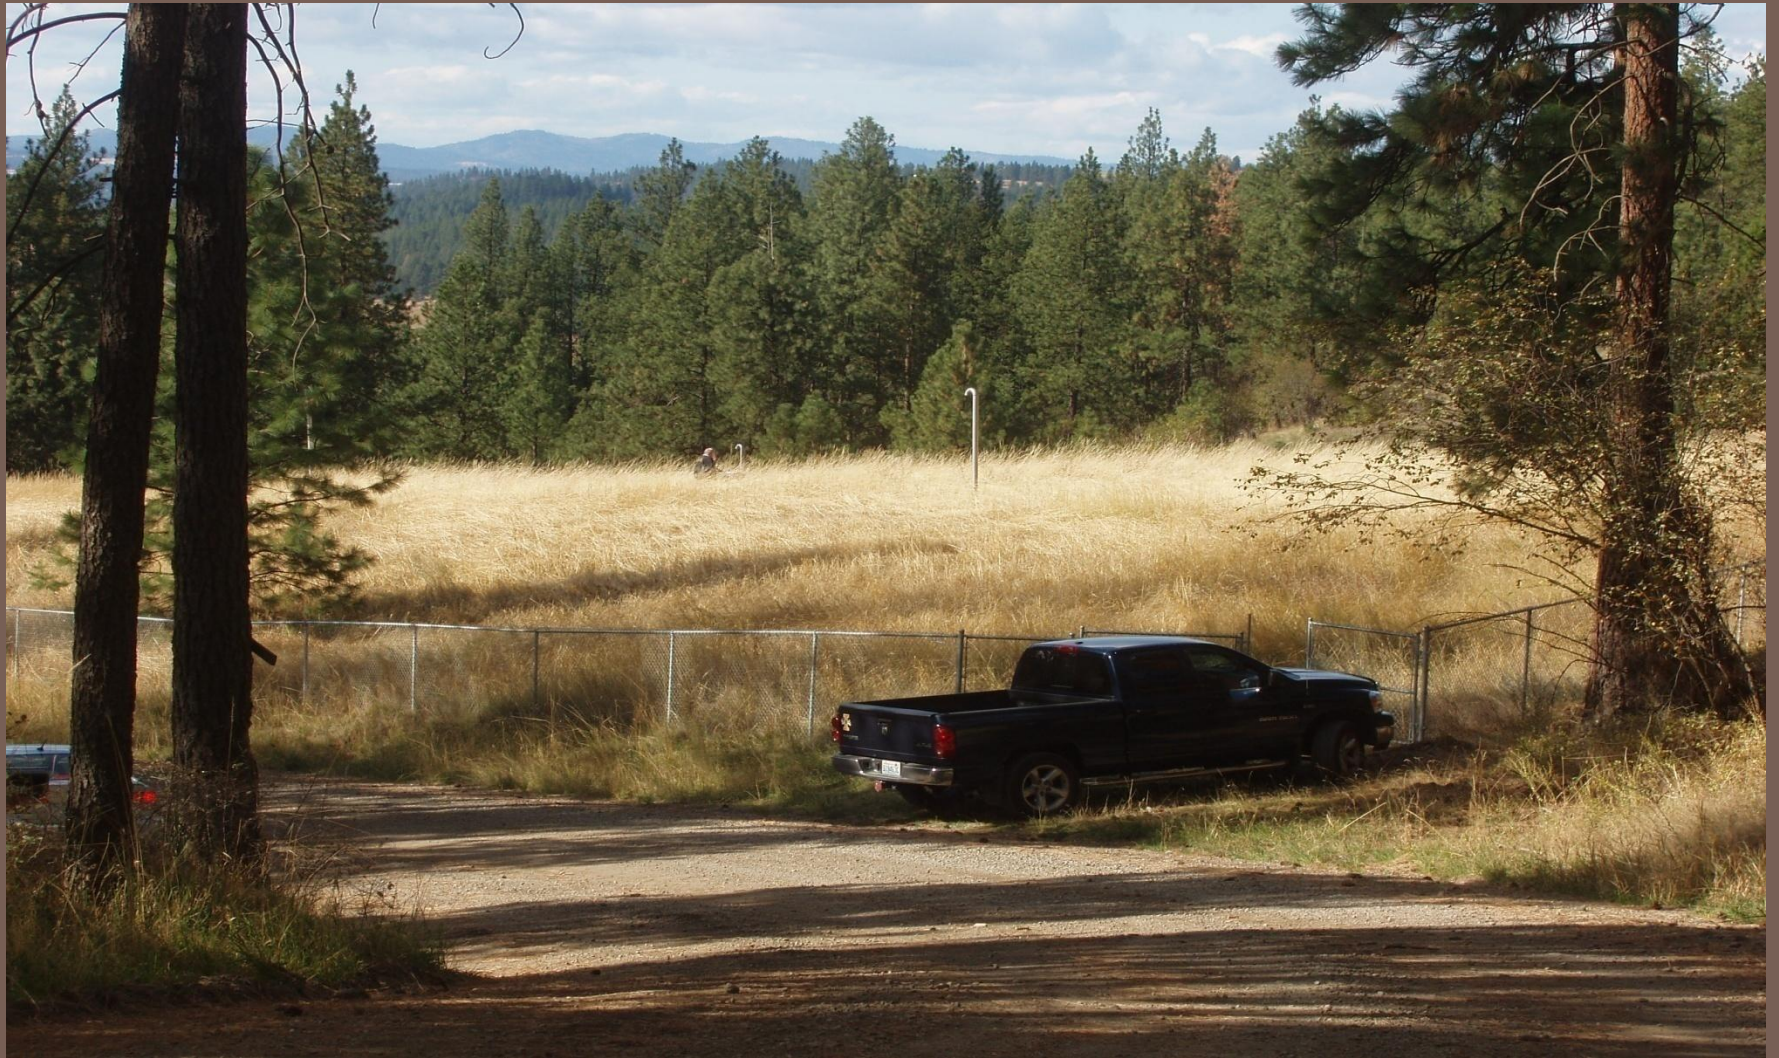
THE LANDFILL (DROSS SITE)

- Site was originally a gravel pit - ceased operations in 1969
- Operated as a landfill by Gemini Management
- Received black dross from Kaiser Trentwood Plant from 1969 to 1974 (~55,000 cubic yards)

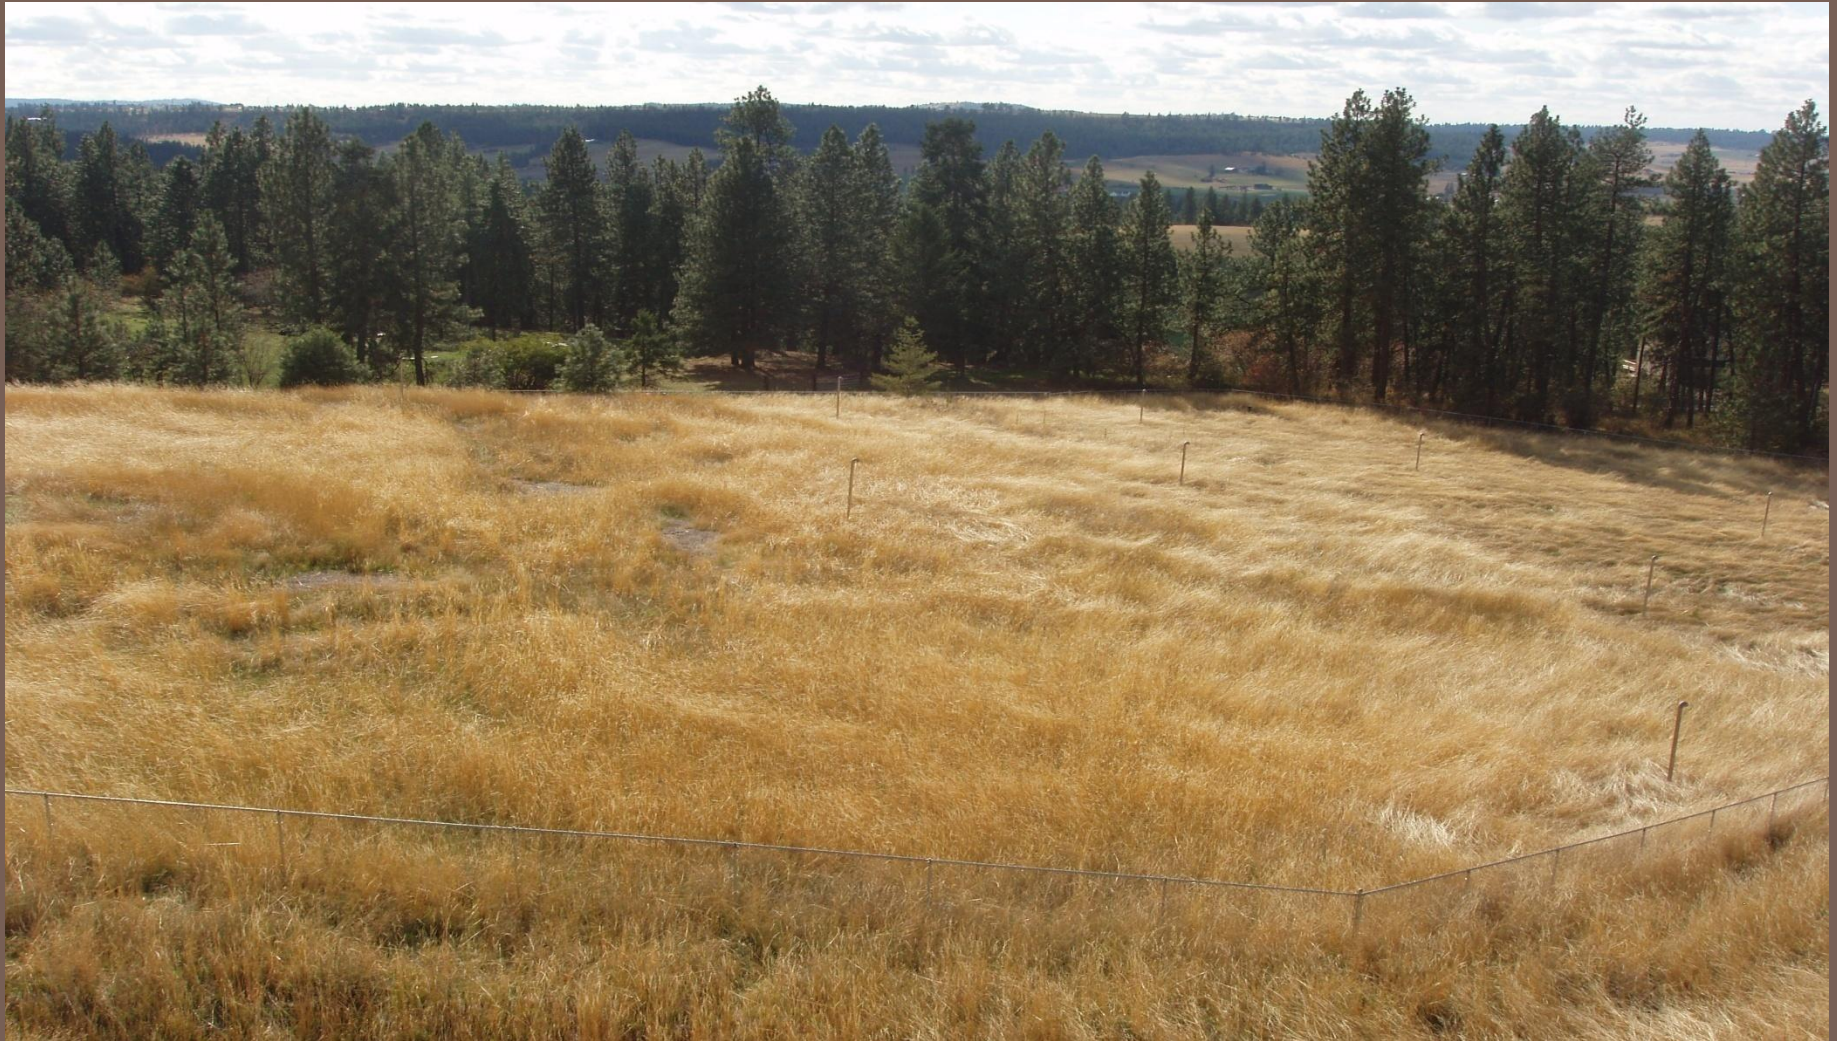
EXISTING COVER

- 1984--Kaiser installed:
 - clay cover over the dross
 - gas venting system
 - drainage control ditches
 - fence
 - and began monitoring groundwater
- Kaiser later purchased the property

- 1987--Ecology staff inspected the cover and found it to be intact
- 1993--EPA inspection report recommended No Further Action for the site - with continued monitoring
- Up to 2004--Kaiser conducted monitoring of nearby spring:
 - ▣ Data showed decreasing nitrate and chloride levels, but still above acceptable/recommended levels

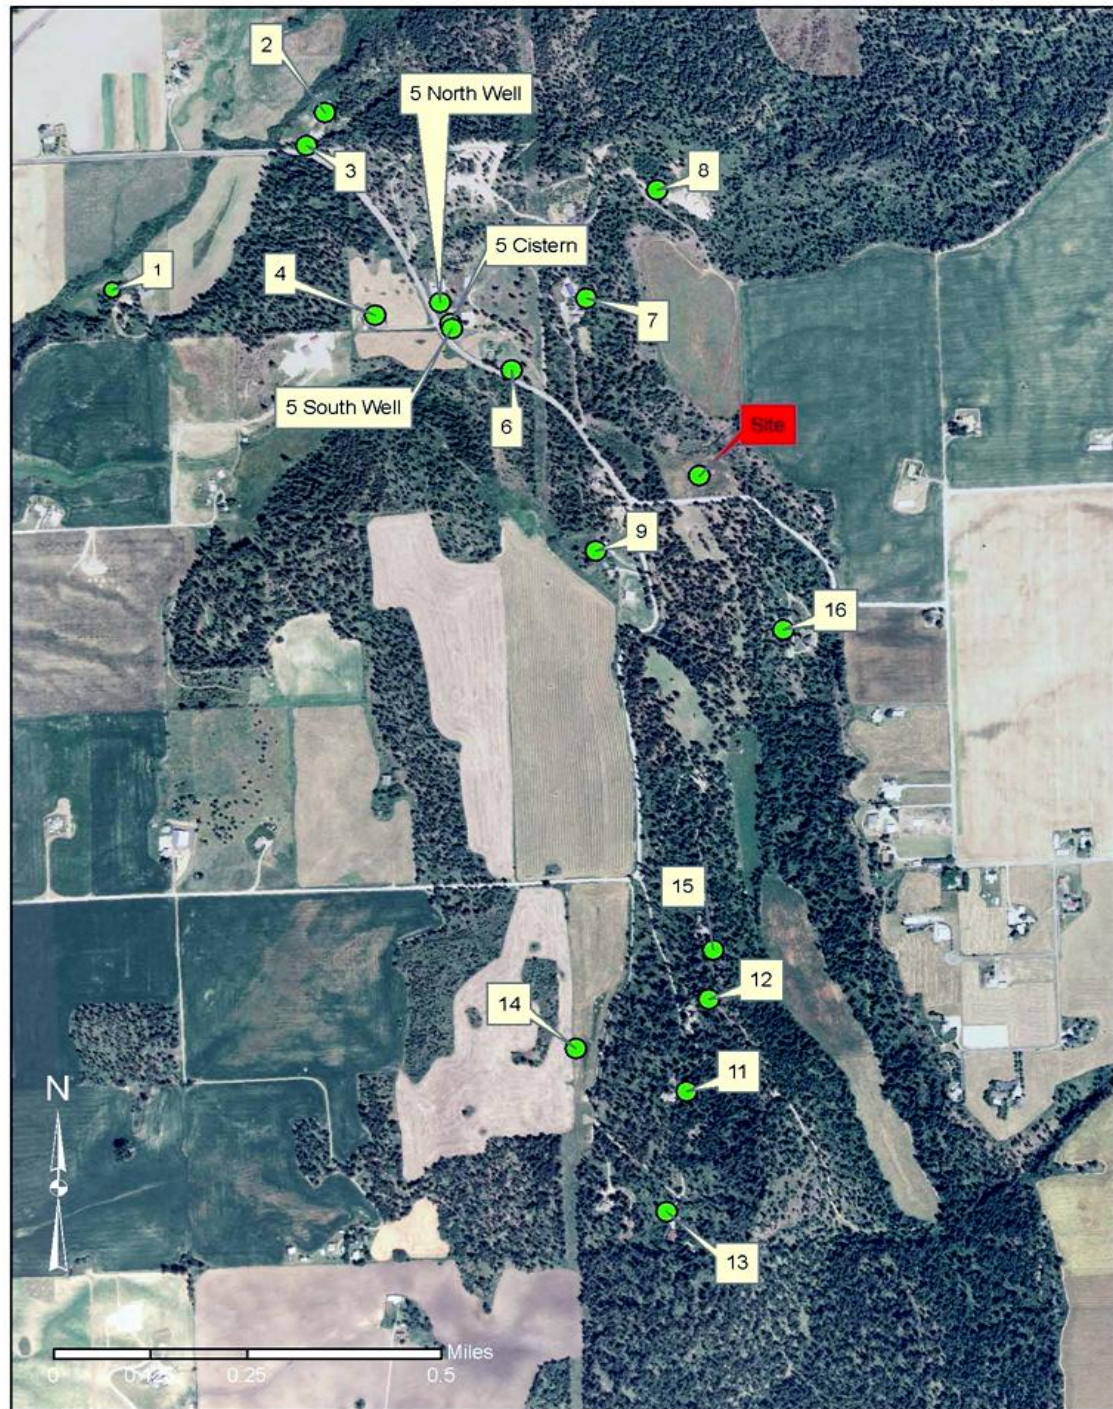
DOMESTIC WELL SAMPLING RESULTS

Chemicals of Interest	Drinking Water Standards		Well No. 1	Well No. 16	Spring	Range in Other Wells
	Primary MCLs	Secondary MCLs				
Metals in ug/l (ppb)						
Aluminum	N/A	50 - 200	50 U	50 U	8.8	50 U
Potassium	N/A	N/A	2550	3930	10,900	869-6,040
Sodium	N/A	N/A	11,600	35,500	106,000	7,560-19,400
Others in mg/l (ppm)						
Chloride	N/A	250	1.9	19.3	242	0.7-12.5
Fluoride	N/A	2	0.3	0.5	0.8 U	0.087-0.5
Ammonia as Nitrogen	N/A	N/A	0.05 U	0.05 U	0.8 U	0.05
Nitrate	10	N/A	0.2 UX	13.5 X	15.9	0.008-8.7
Nitrite	1	N/A	0.1 UX	0.1 X	0.023 T	0.1
pH	N/A	6.5 – 8.5	7.86	7.41	7.45	6.78-7.5
Add. Metal > MCL						
Arsenic	10	N/A	11.6	1.1	2	0.5 U – 2.4
