FINAL
SOURCE CONTROL EVALUATION
ADDENDUM REPORT
JORGENSEN FORGE FACILITY
8531 EAST MARGINAL WAY SOUTH
SEATTLE, WASHINGTON

March 2011

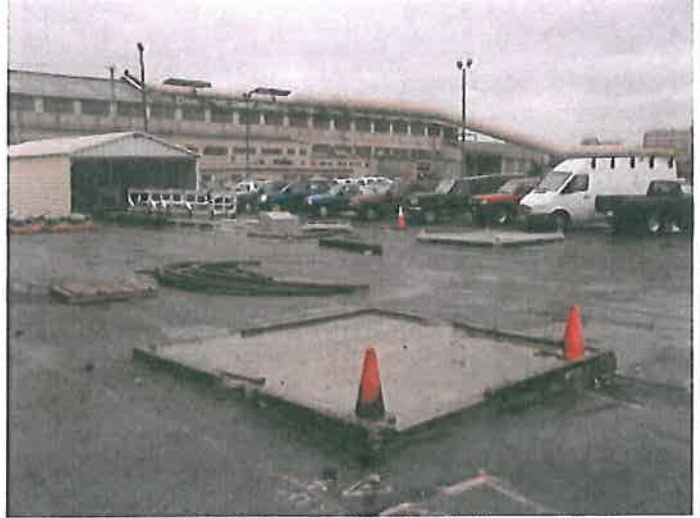
#2. **DESCRIPTION:** The Duwamish River is beyond the large tan overhead ducting. The facility has no overwater structures or any water-side operations.

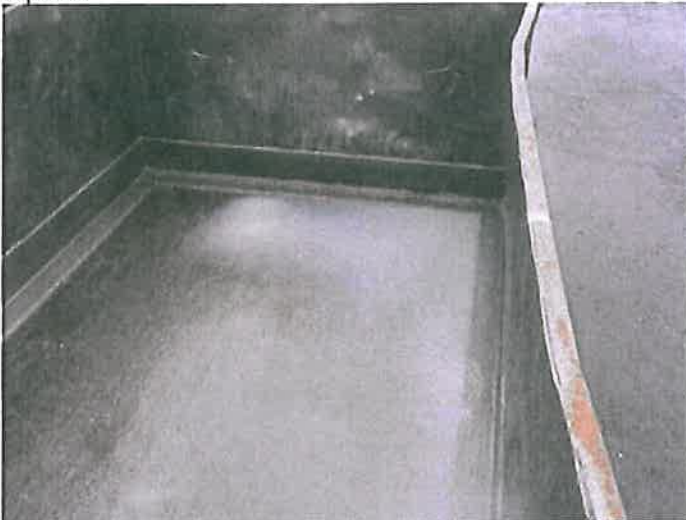
#3. **DESCRIPTION:** The facility stores a lot of scrap metal outside in various types of bins and dumpsters. A whitish cutting oil/coolant can be seen at the bottom of this scrap metal storage bin.

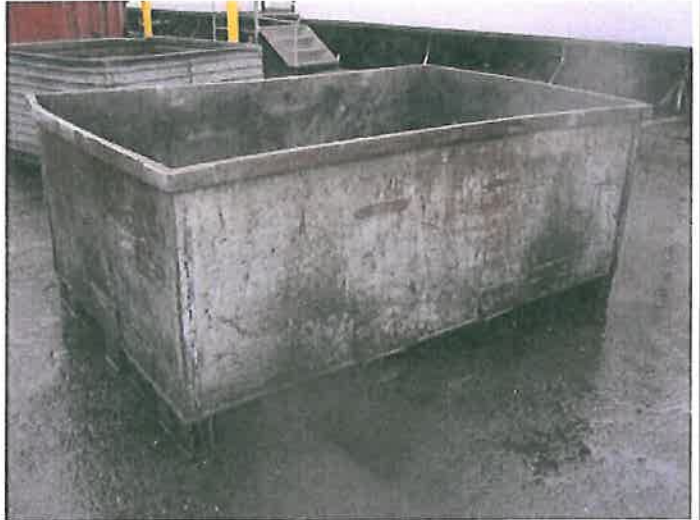
#4. **DESCRIPTION:** Cutting oil/coolant could be seen on the pavement near this scrap metal bin. Scrap metal stored in bins or dumpsters outside must be provided with proper cover.

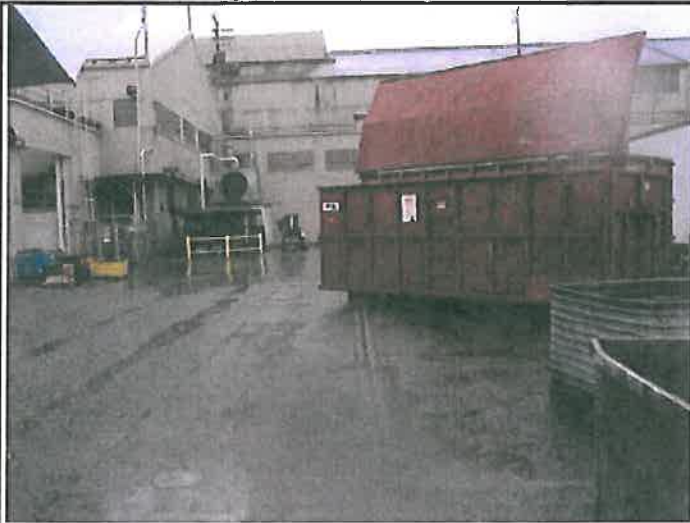
#5. DESCRIPTION: Of these two dumpsters, one has a lid and one does not. Procedures must be developed to ensure the lid is closed when access is not necessary.

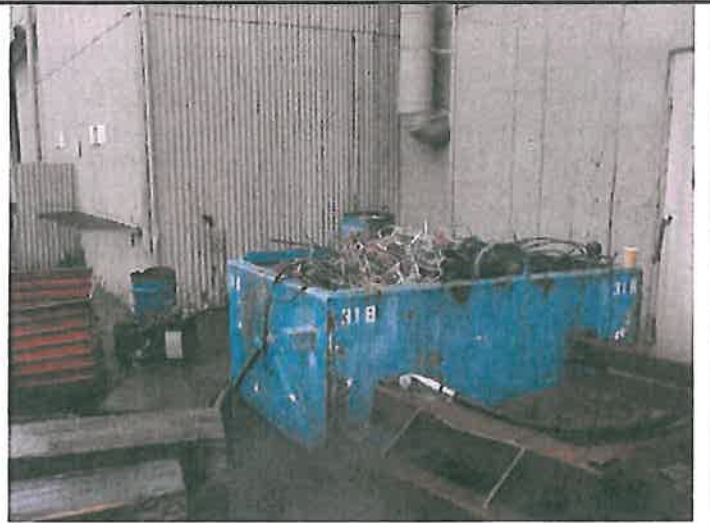
#6. DESCRIPTION: Miscellaneous scrap materials and wastes should be inventoried and stored inside or covered as necessary.

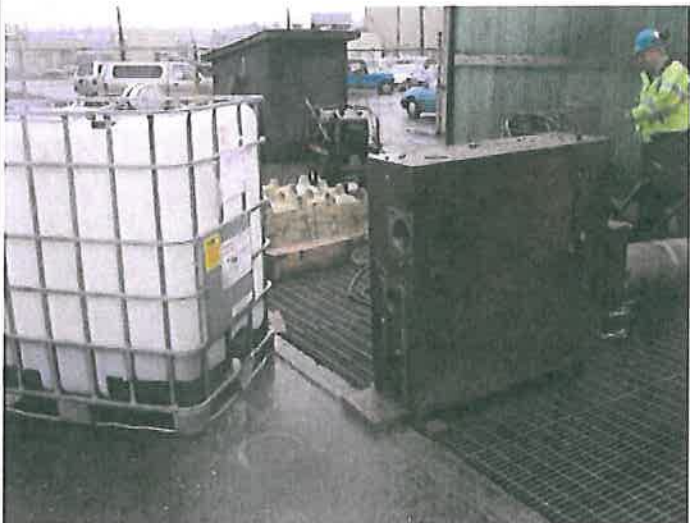
#7. DESCRIPTION: The grated area is for pressure washing and steam cleaning. The grated area is plumbed to the sanitary sewer. Chemicals and petroleum products must be provided with proper containment.

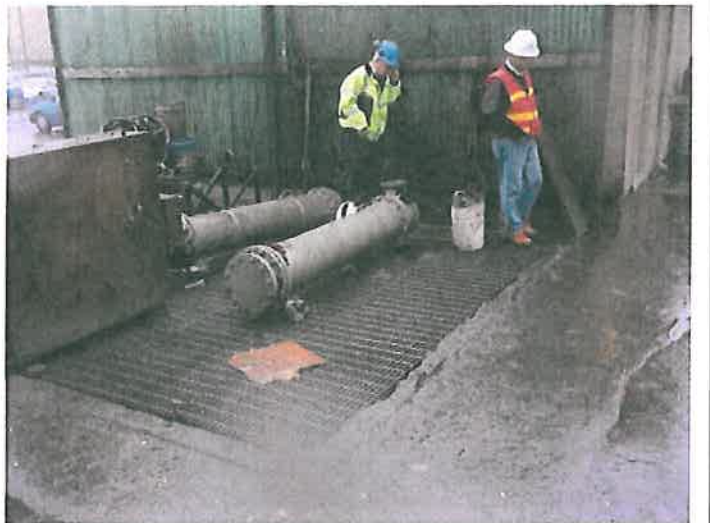
#8. DESCRIPTION: All wash-water is defined as process wastewater and cannot be discharged to the storm drainage system. Some of the area around the grating flows to the storm drainage system. The facility must clearly mark the "footprint" of the area that flows to the sanitary sewer. The Site Map in the SWPPP should be updated to clarify which areas are tributary to the sanitary sewer and which go to the storm drainage system in this area.

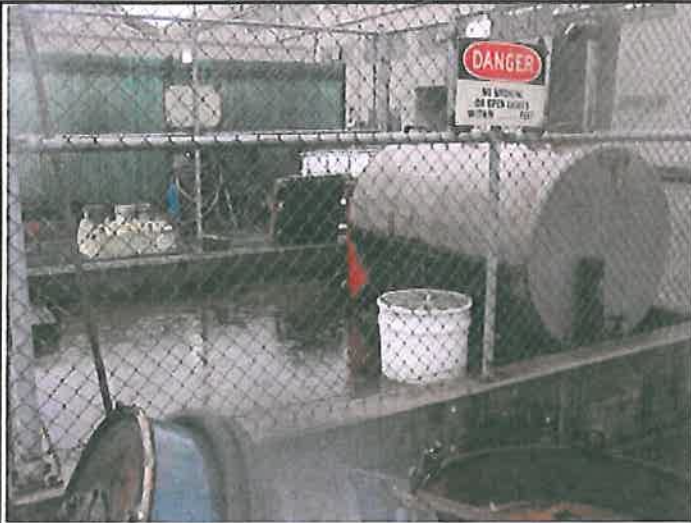
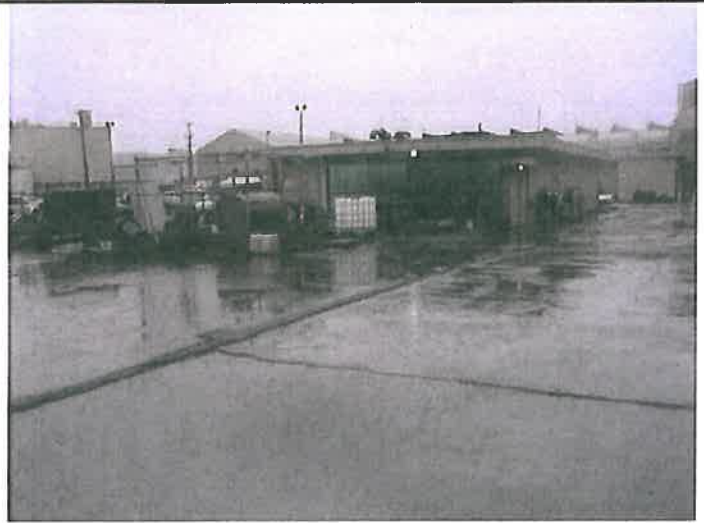
#9. DESCRIPTION: The facility must provide adequate cover and containment for all liquid petroleum and chemical products and wastes stored outside.

#10. DESCRIPTION: The footprint of the area tributary to the sanitary sewer needs to be clearly delineated so staff knows if wastewater may be flowing to storm drains.

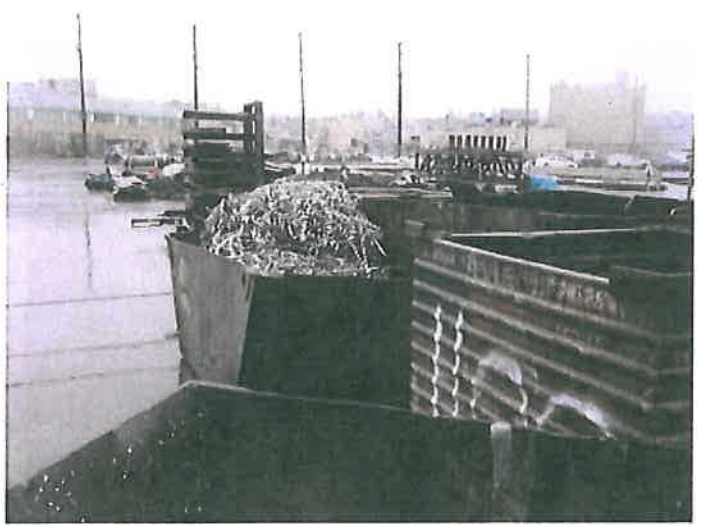
#11. DESCRIPTION: Metal turnings and cuttings must be stored in bins or dumpsters with a cover.

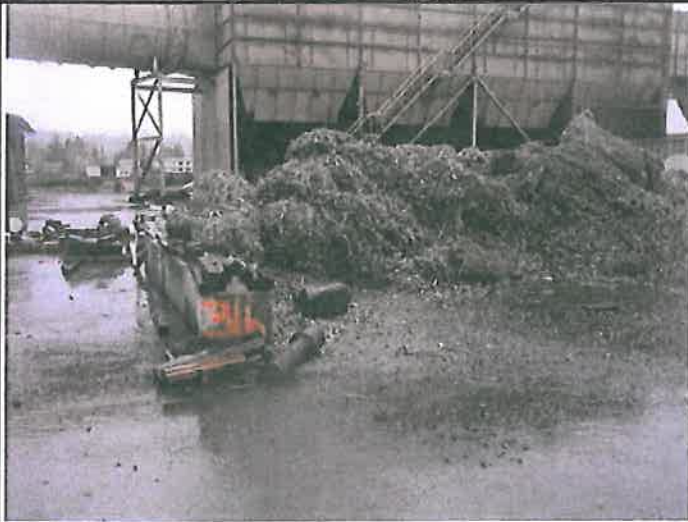
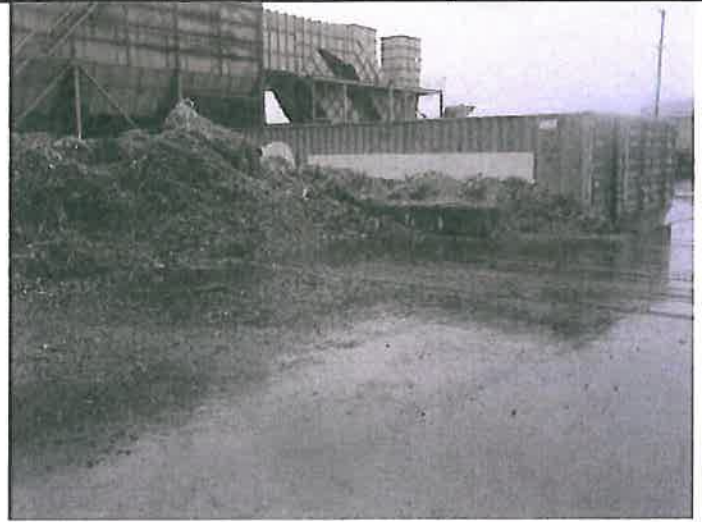
#13. DESCRIPTION: Stormwater run-off from this area is likely to be contaminated. This area is within the Outfall 003 drainage basin. The facility must determine where stormwater from this area goes. This pile of metal turnings/cuttings must be provided with adequate source control.

#14. DESCRIPTION: This scrap metal storage area must be provided with more adequate source control. It is not clear where stormwater from this area flows. Infiltrating contaminated stormwater near the river with a high groundwater table is problematic.

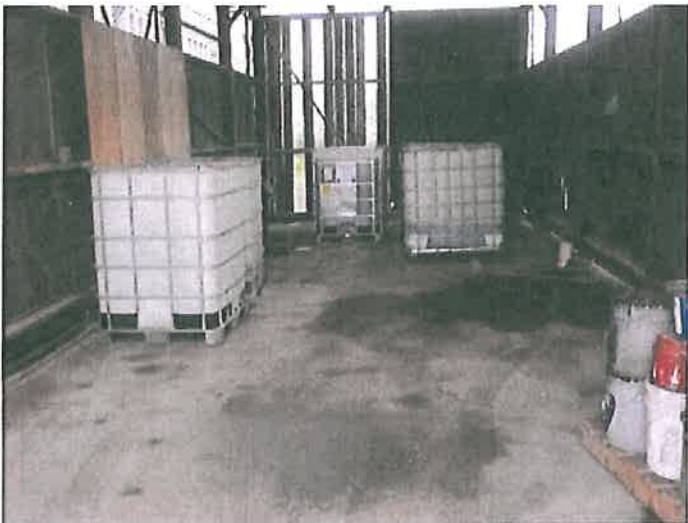
#15. DESCRIPTION: All liquid products and wastes must be provided with adequate cover and containment. The concrete floor of this storage area is recessed and has a lip around it.

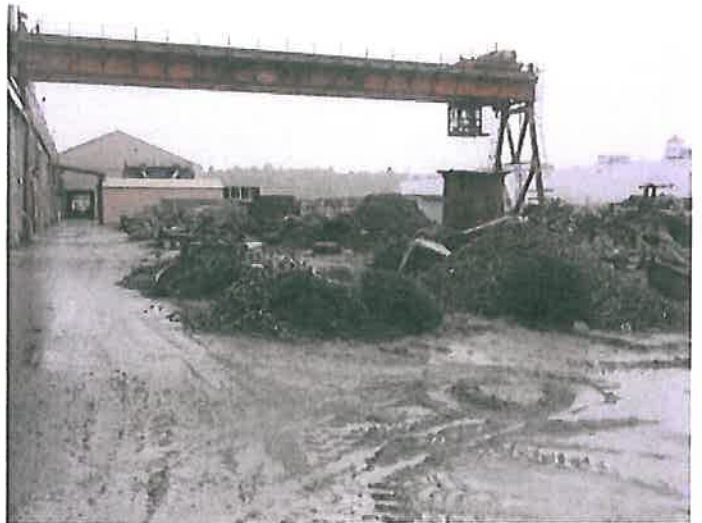
#16. DESCRIPTION: The southern portion of the facility is partially paved and is used to store scrap metals and waste materials. Stormwater from this area either flows to Outfall 001 or Outfall 002 or infiltrates into the ground.

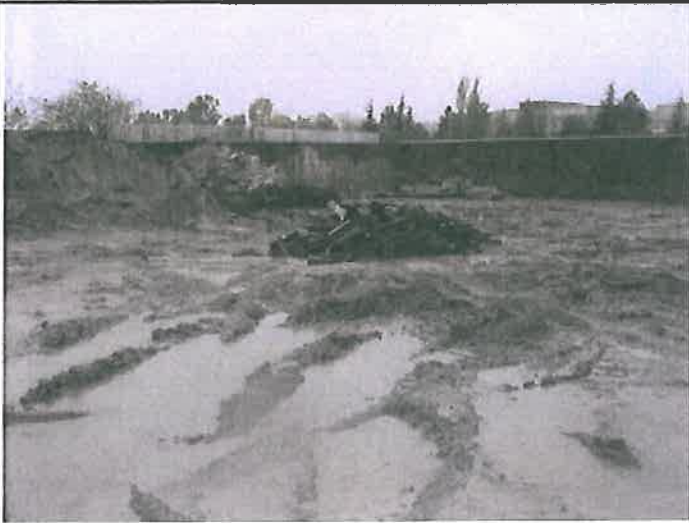
#17. DESCRIPTION: The southwest corner of the facility is unpaved. There are no storm drains in the vicinity and most stormwater infiltrates into the ground. The Duwamish River is on the other side of the concrete wall.

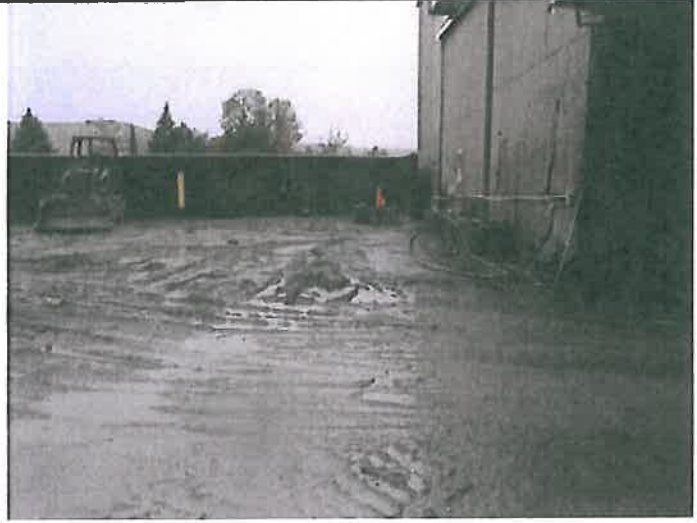
#18. DESCRIPTION: Storm drain lines 001 and 002 flow under this area. The facility must ensure that stormwater cannot flow overland towards the river between the concrete wall and the building (just to right of orange cone). Contaminated stormwater may infiltrate and then flow along the outside of storm drain lines 001 or 002.

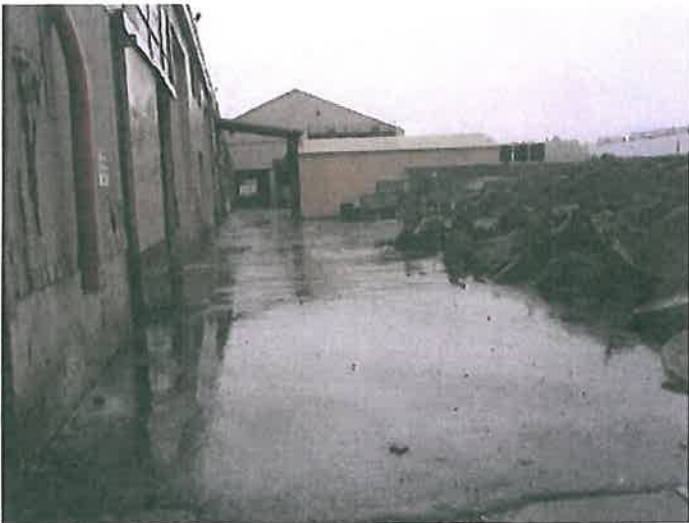
#19. DESCRIPTION: The southern portion of the facility is called the scrap storage area. A variety of scrap metals and solid wastes are stored here out in the open. Source control measures must be re-evaluated in this area. During rainy periods, stormwater from this area will flow towards storm drains or infiltrate in the ground.

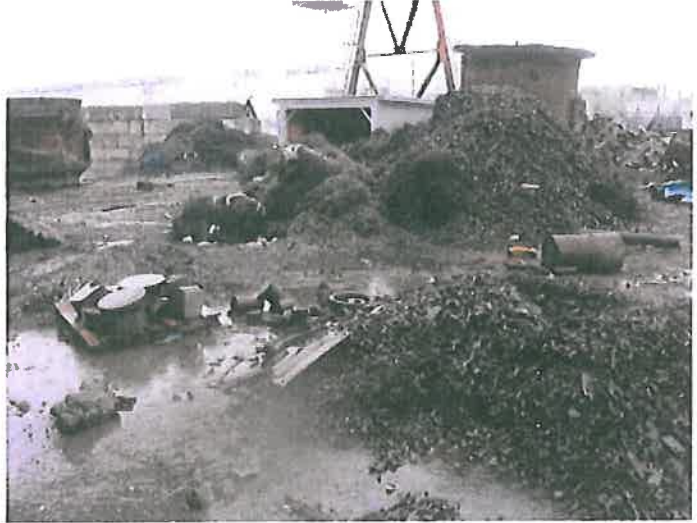
#20. DESCRIPTION: The Site Map shows there is at least one catch basin in the scrap storage area. The facility must inventory wastes stored along the southern portion of the facility and implement necessary source control measures for pollutants that will mobilize during storm events.

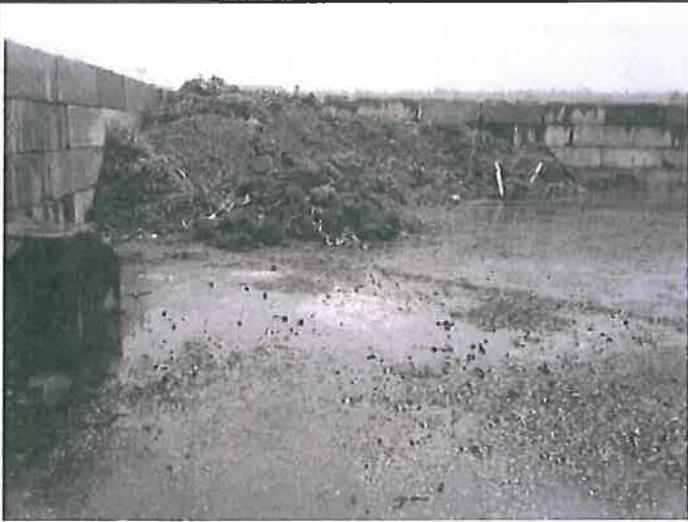
#21. DESCRIPTION: Scrap metal is stored in ecology block bunkers. This material is metal chips (or turnings or cuttings) and should be provided with cover.

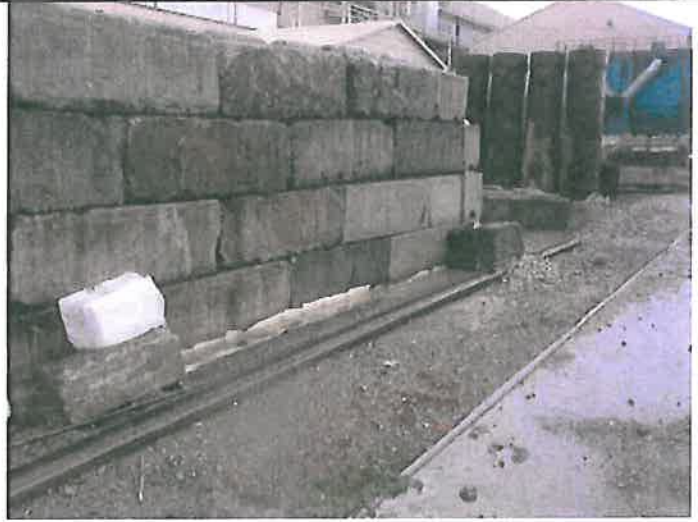
#22. DESCRIPTION: The scrap metal seen in photo # 21 is on the other side of this ecology block wall. Apparently the metal chips have enough petroleum on them to warrant the use of absorbent pads to control petroleum in the stormwater.

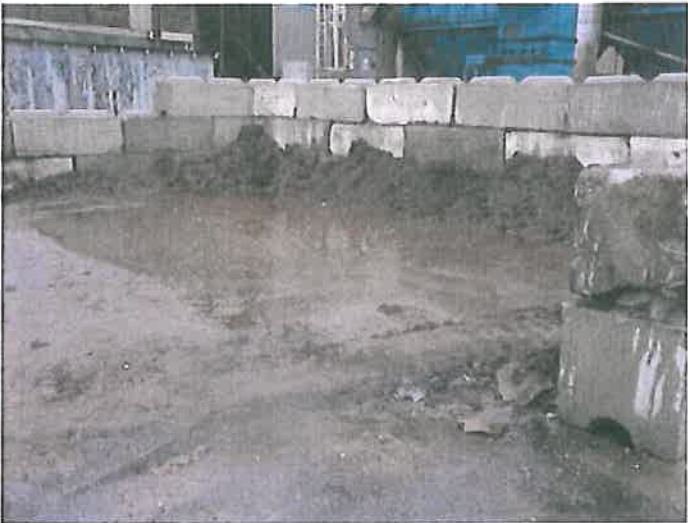
#23. DESCRIPTION: Materials stored outside in the scrap storage area must be covered.

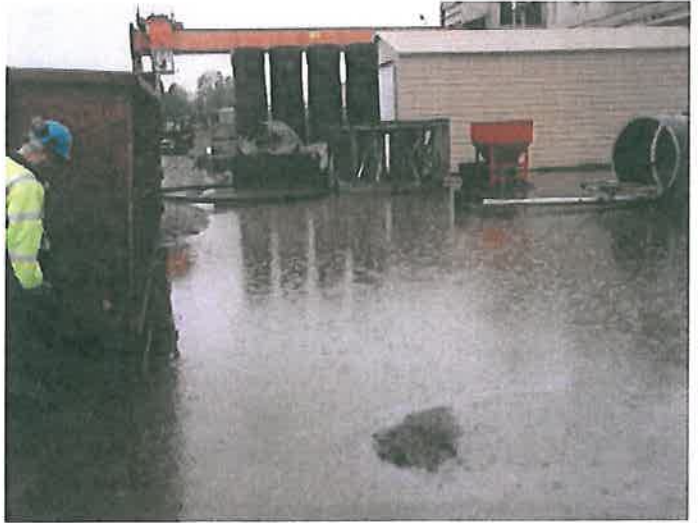
#24. DESCRIPTION: Stormwater will pool in areas without adequate drainage. Stormwater from this area may eventually find an avenue to flow towards the river. The stormwater pooling in this area was reddish brown and had a petroleum sheen visible on it.

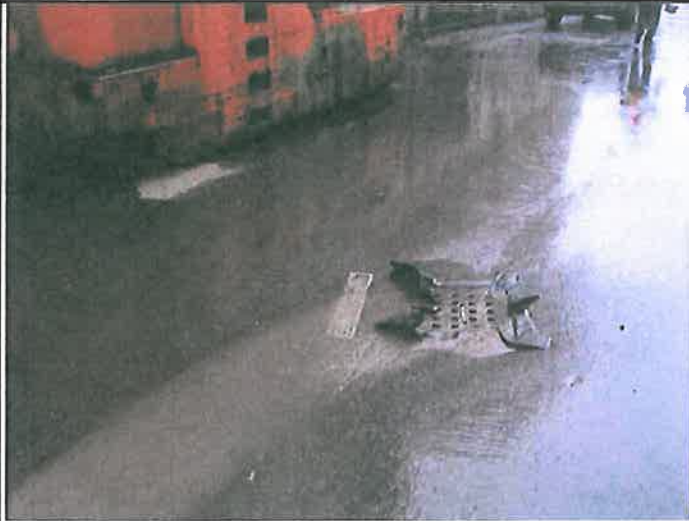
#25. DESCRIPTION: This storm drain is tributary to the Outfall 002. The nearby unpaved area was contributing very turbid stormwater to this catch basin. This area is at the southeast corner near the Aluminum Heat Treat building.

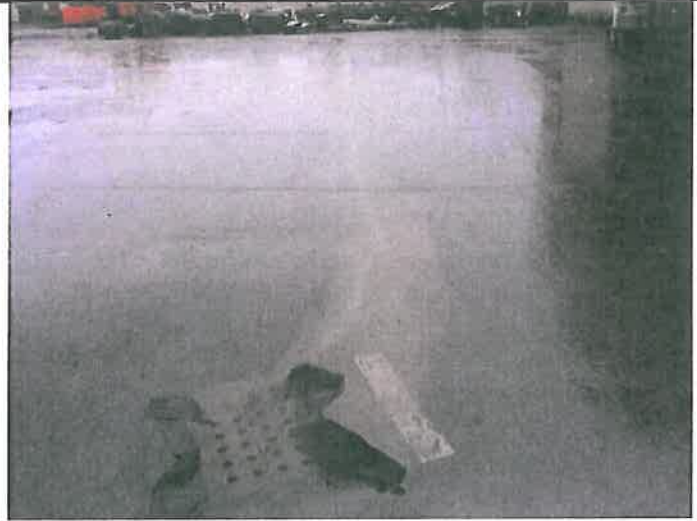
#26. DESCRIPTION: The turbid stormwater flowing to the storm drain catch basin had a visible petroleum sheen on it. A visible petroleum sheen on stormwater flowing to a catch basin tributary to the Duwamish River must elicit an investigation to determine the source.

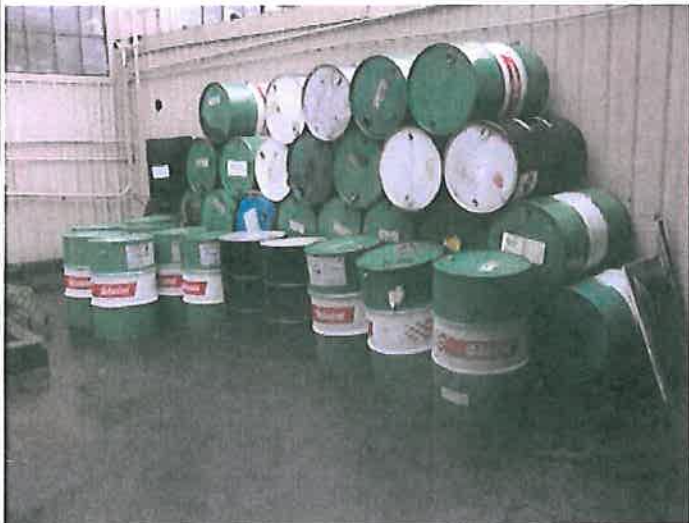
#27. DESCRIPTION: Most of these drums were empty but residual petroleum and/or chemicals may mobilize if left out in the rain.

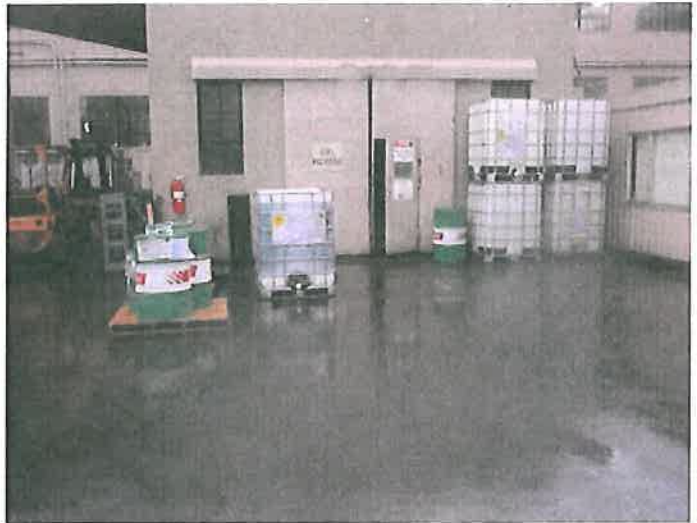
#28. DESCRIPTION: All liquid products and wastes stored outside must be provided with adequate cover and containment.

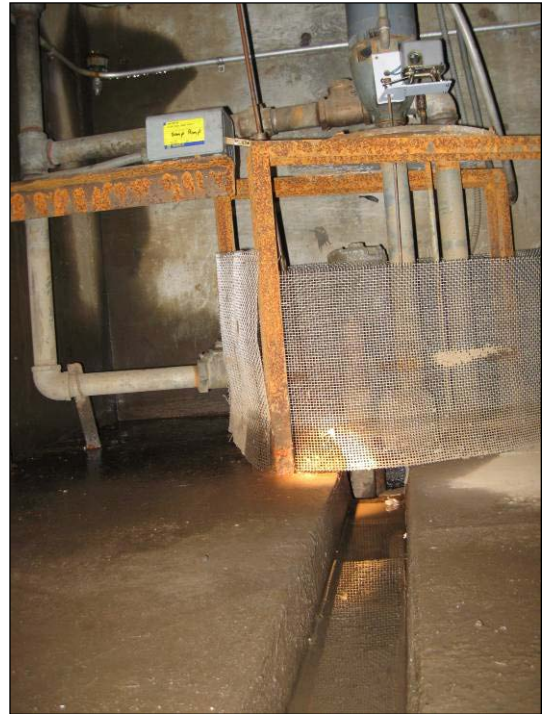
Photo 1
AOD Pit (Dry)

Sampling was not conducted within the Railroad Scale Vault or the AOD Scale Pit. The Railroad Scale Vault was damp but did not contain standing water. The AOD Scale Pit was completely dry with no signs of moisture entering the pit (Appendix D).
