SUBJECT: PUGET SOUND TRUCK LINES LONGVIEW VCP APPLICATION

**Groundwater Compliance
Well Installation and Monitoring Results**

**Groundwater Compliance Well
Installation and Monitoring Results
Puget Sound Truck Lines Site
Longview, Washington**

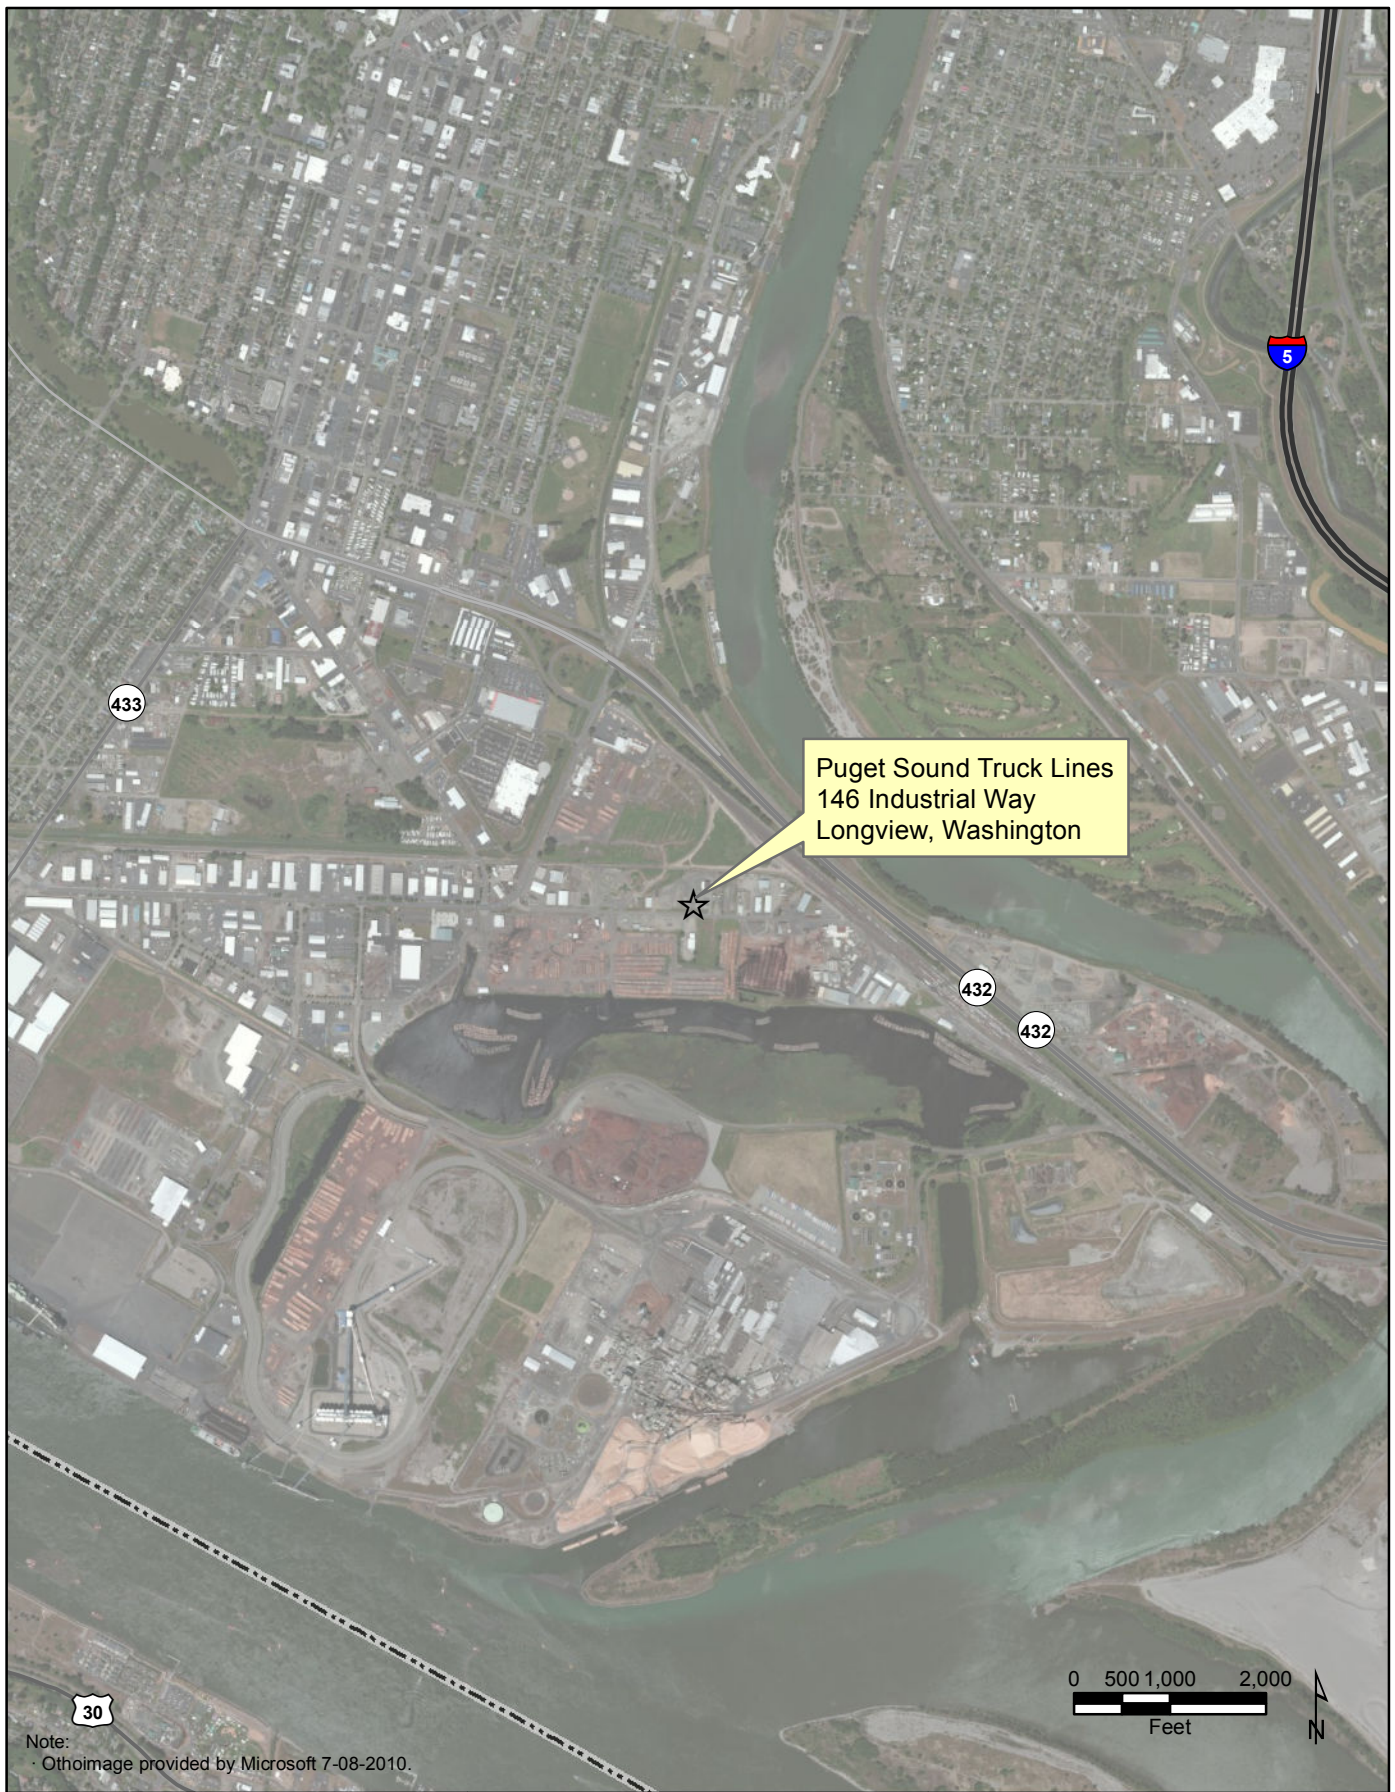
Figure 2 Proposed Monitoring Well Locations

As a result of this additional characterization, 3 Kings recommends the installation of at least 4 permanent groundwater monitoring wells with a program of quarterly monitoring for the site. The wells would bracket the affected area to include a hydraulically up-gradient point, one placement within the excavation area, and 2 wells down gradient spaced along the southern edge of the main site.
