Lower Duwamish Waterway River Mile 0.0-0.1 East (Spokane Street to Ash Grove Cement)

Source Control Action Plan

June 2009

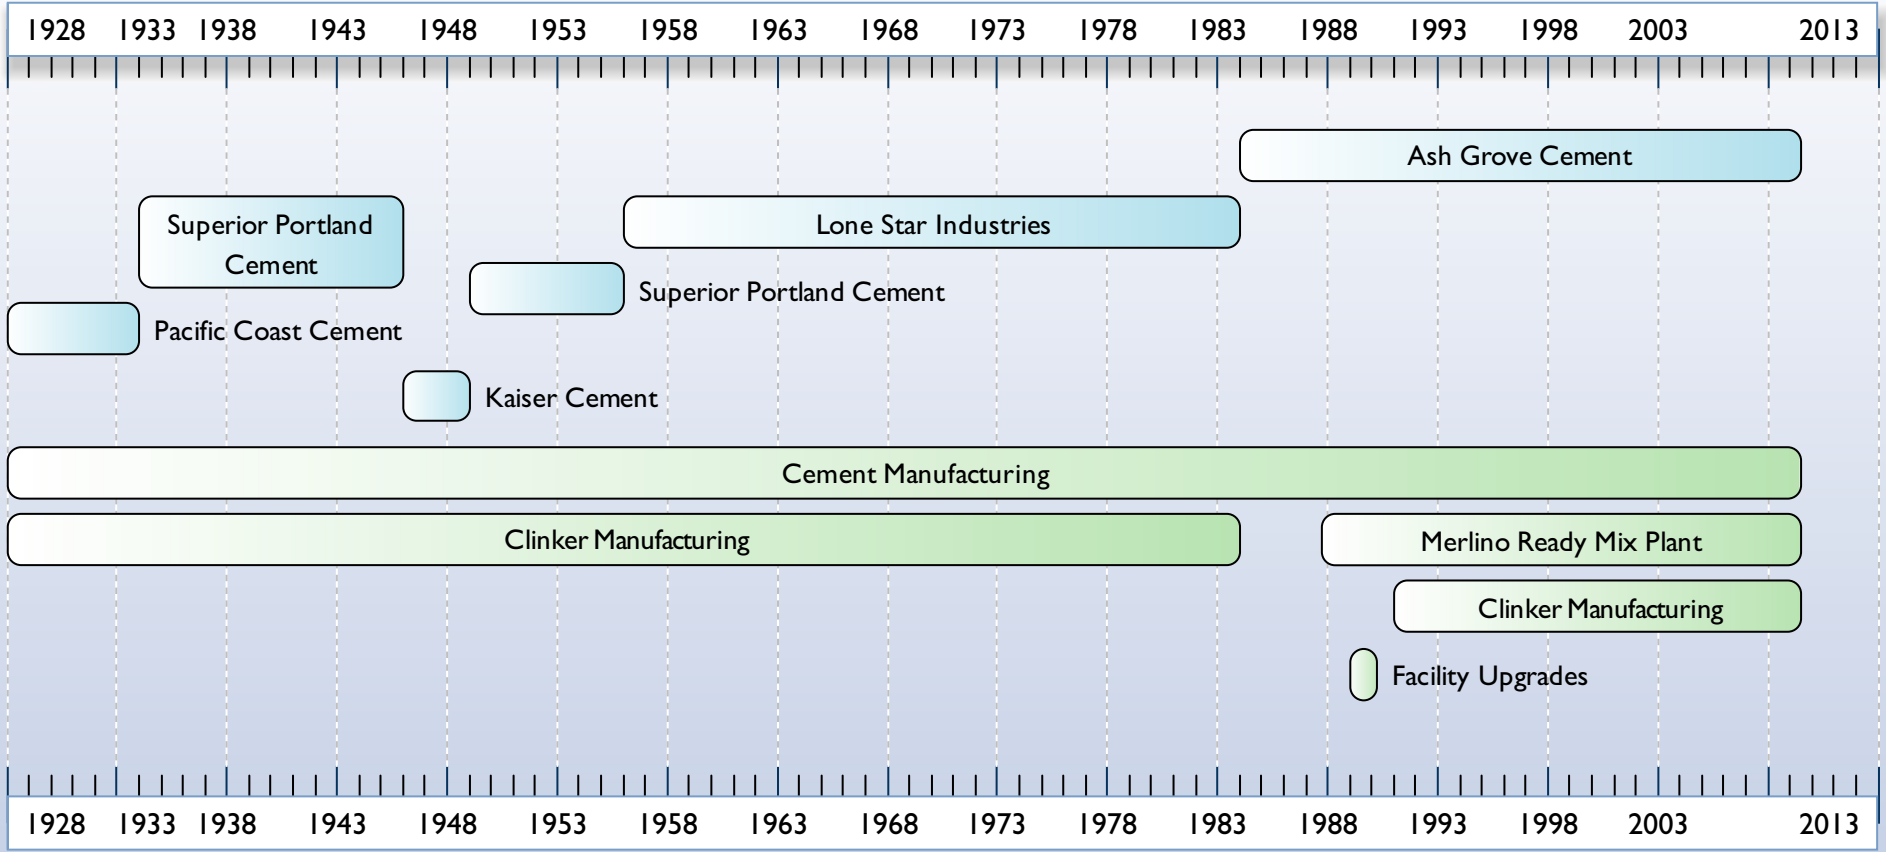
Figure 19
OWNERSHIP & OPERATIONS HISTORY

Ownership & Operations History

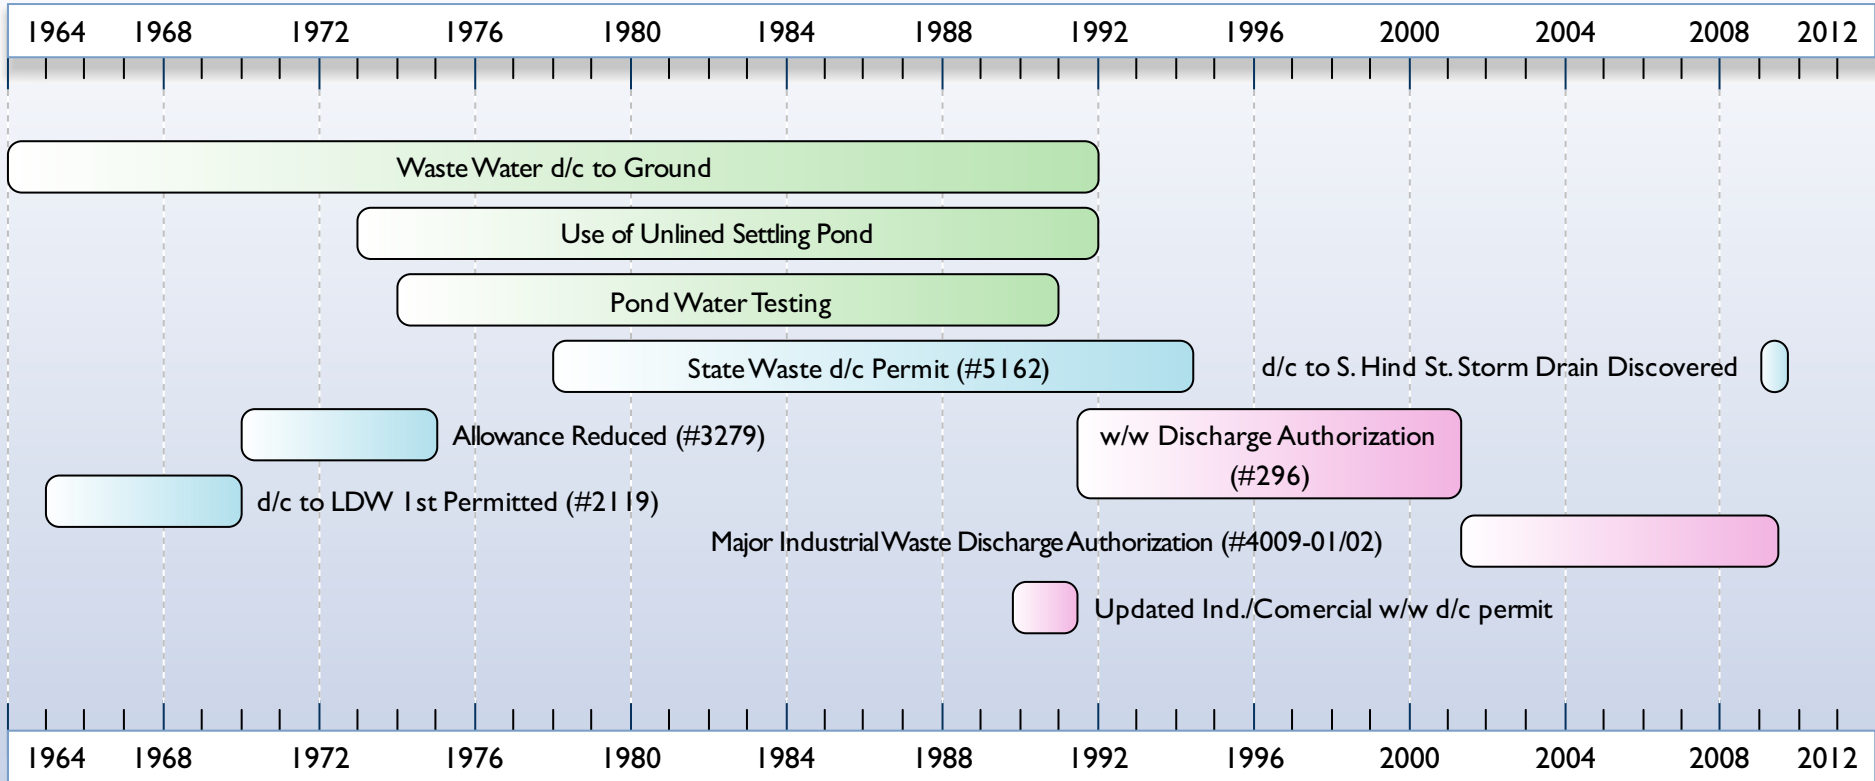
10:002330WD1405\fig 22

Waste Water Discharge History

The report from the January 14, 2009 inspection states that most of the site's stormwater is directed to a large underground horseshoe shaped vault that reportedly connects to the sewer; however, a current stormwater drainage map was not available to the inspectors. The report cites several instances of inadequately contained materials observed on site, including totes and drums of liquid products and/or wastes. The inspectors could not discern whether stormwater in certain areas was being directed to the collection system or allowed to runoff into the LDW. The report states that Ash Grove has an active water right to pump groundwater from a well and use it for cooling in their process. A large oil/water separator unit is in use but maintenance records and design information were not available to the inspectors. The inspection report calls for more enhanced stormwater treatment and an updated Stormwater Pollution Prevention Plan (SWPPP) (Ecology 2009). A timeline summary of the wastewater handling practices is shown in Figure 22.
