# **Lower Duwamish Waterway Source Control Status Report October 2010 through December 2011**

# **Lower Duwamish Waterway Source Control Status Report October 2010 through June 2011**

Toxics Cleanup Program  
Northwest Regional Office  
Washington State Department of Ecology  
Bellevue, Washington

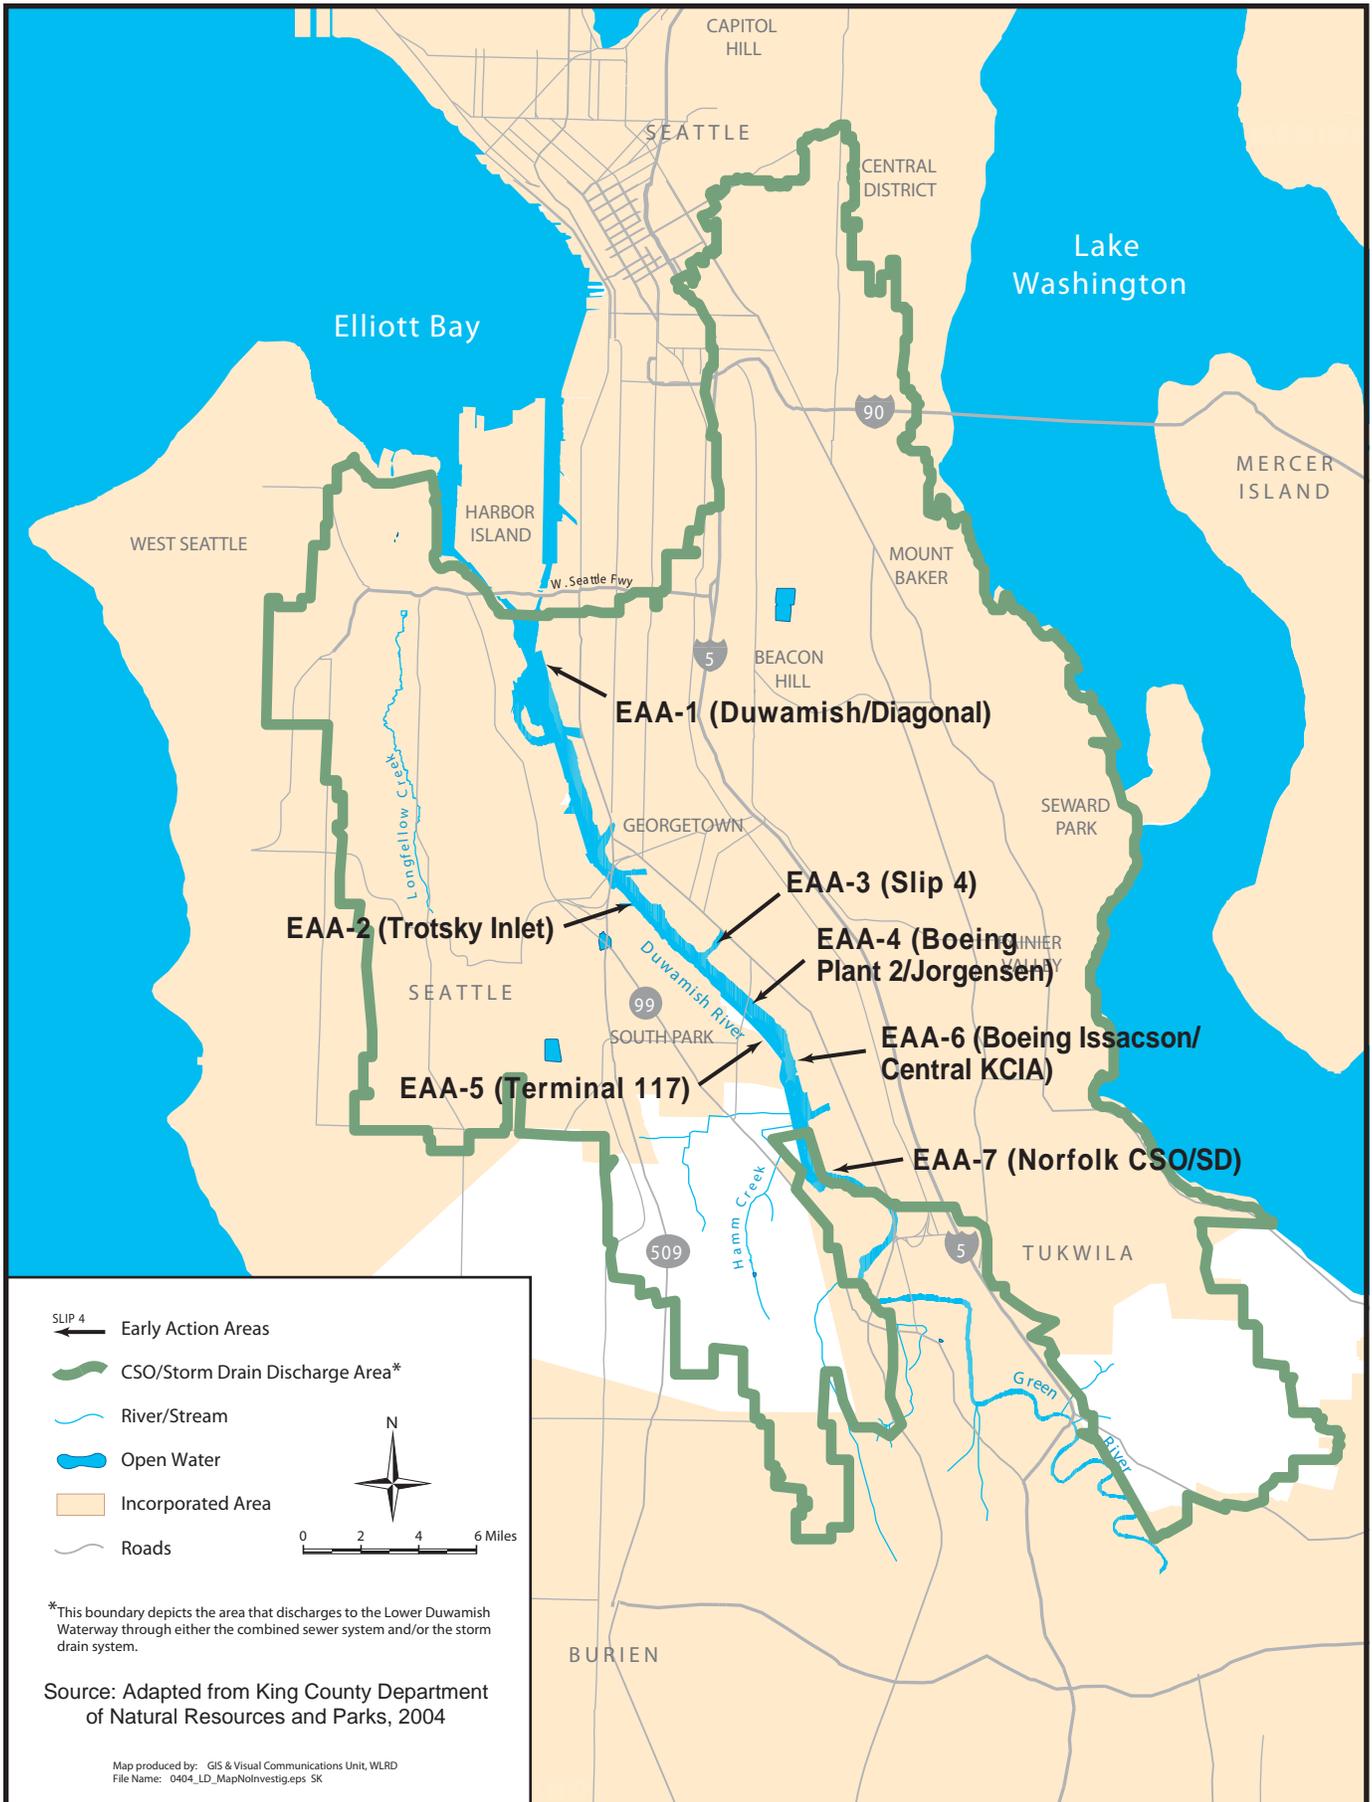
**Figure 1-1. Lower Duwamish Waterway Site**

The LDW is the downstream portion of the Duwamish River, which extends from the southern tip of Harbor Island to just south of the Norfolk Combined Sewer Overflow (CSO)/Storm Drain (SD) (Figure 1-1).

The *Technical Memorandum: Data Analysis and Candidate Site Identification*, issued in June 2003, described seven candidate sites for early sediment cleanup action (Windward 2003a). The seven sites, shown in Figure 1-1 and identified as EAAs, as listed in the *Technical Memorandum*, are the following:<sup>1</sup>

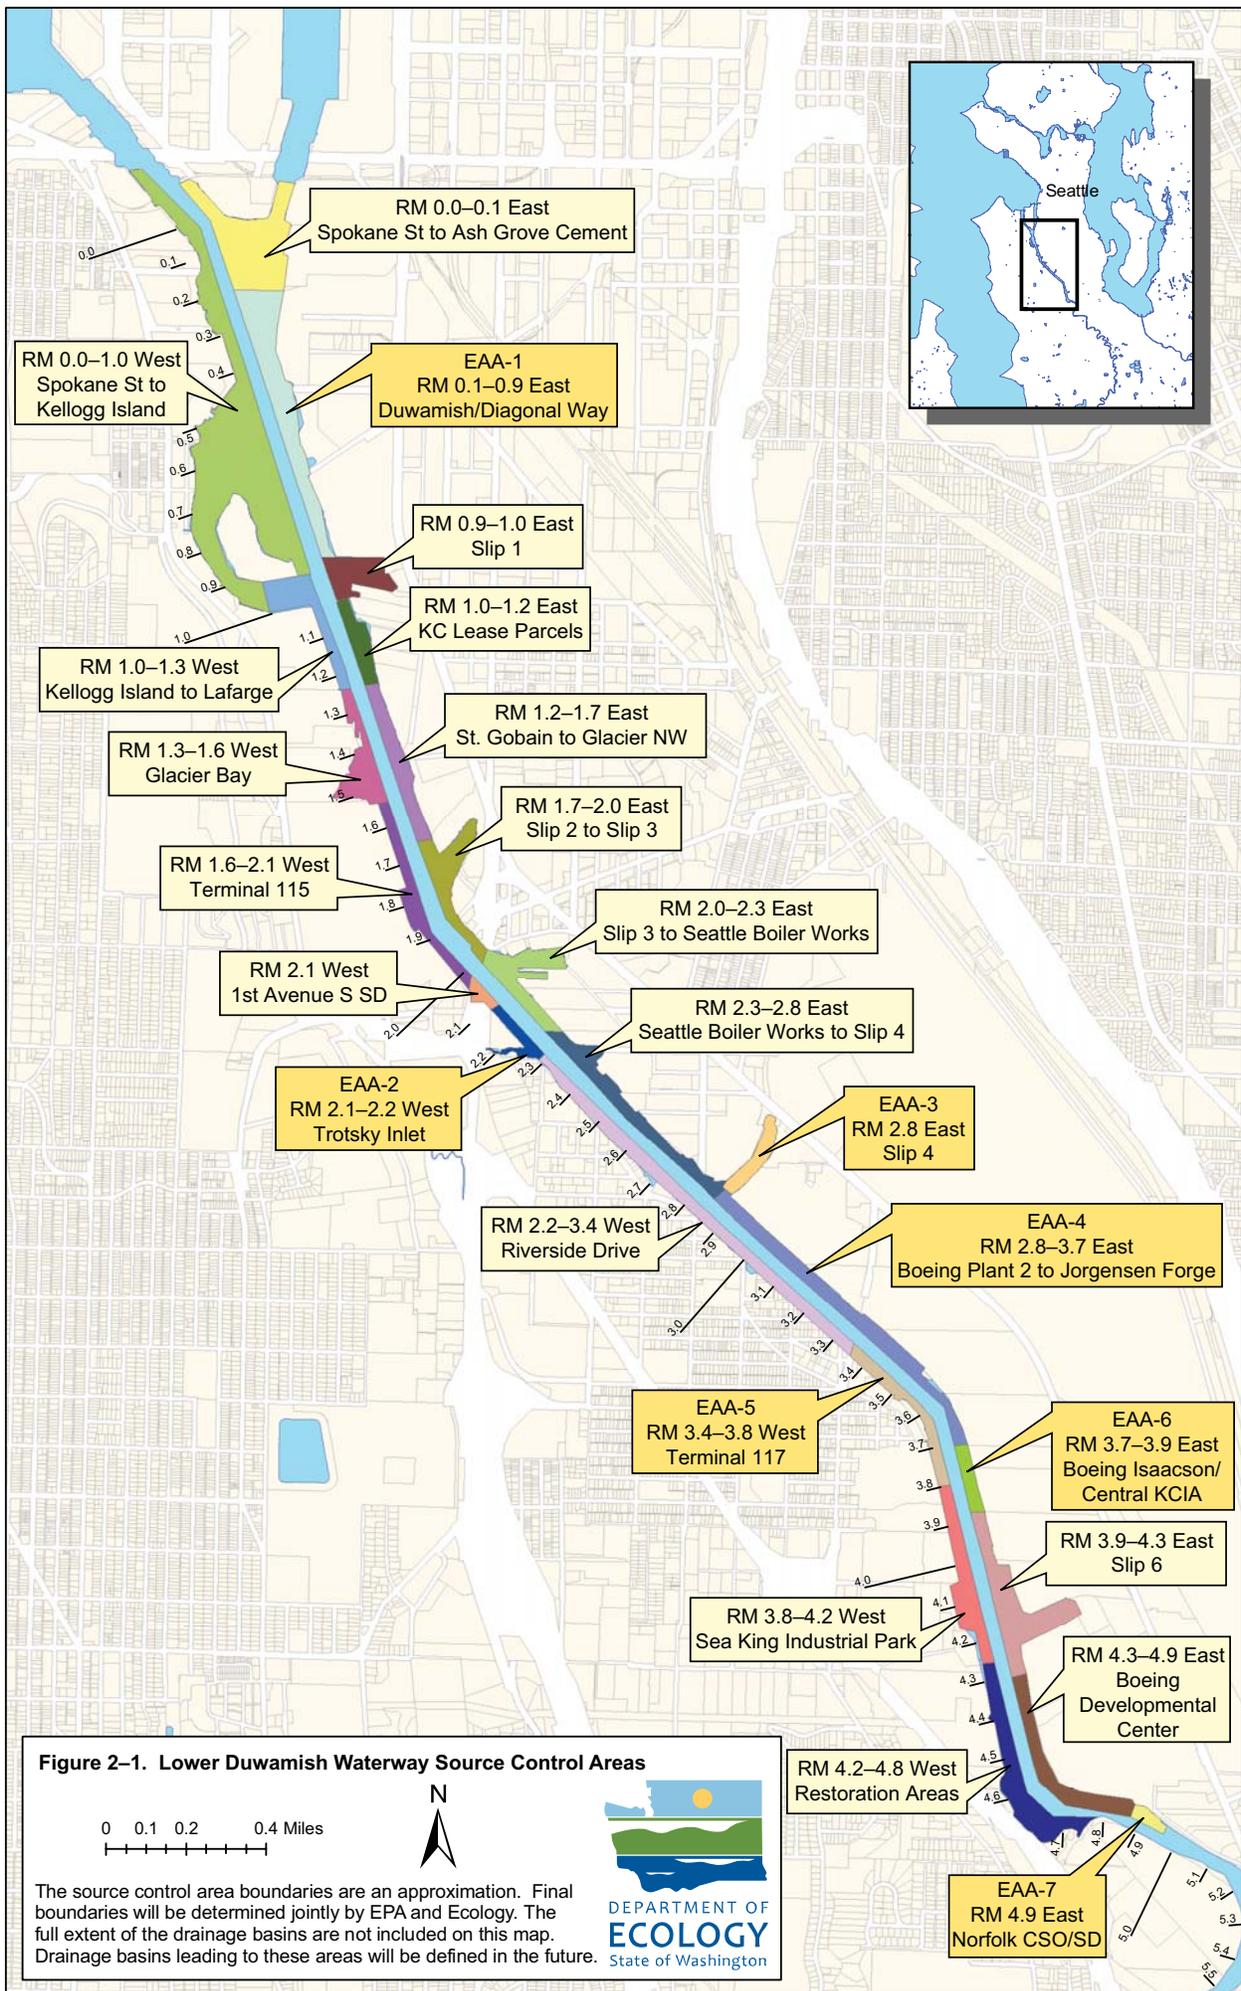
**Figure 2-1. Lower Duwamish Waterway Source Control Areas**

The source control area boundaries are an approximation. Final boundaries will be determined jointly by EPA and Ecology. The full extent of the drainage basins are not included on this map. Drainage basins leading to these areas will be defined in the future.

Ecology will conduct source control evaluations for each of these areas, including review of existing information, identification of data gaps, and preparation of a SCAP. The 17 Tier 2 and Tier 3 areas and the seven candidate EAAs (a total of 24 source control areas) are shown in Figure 2-1.

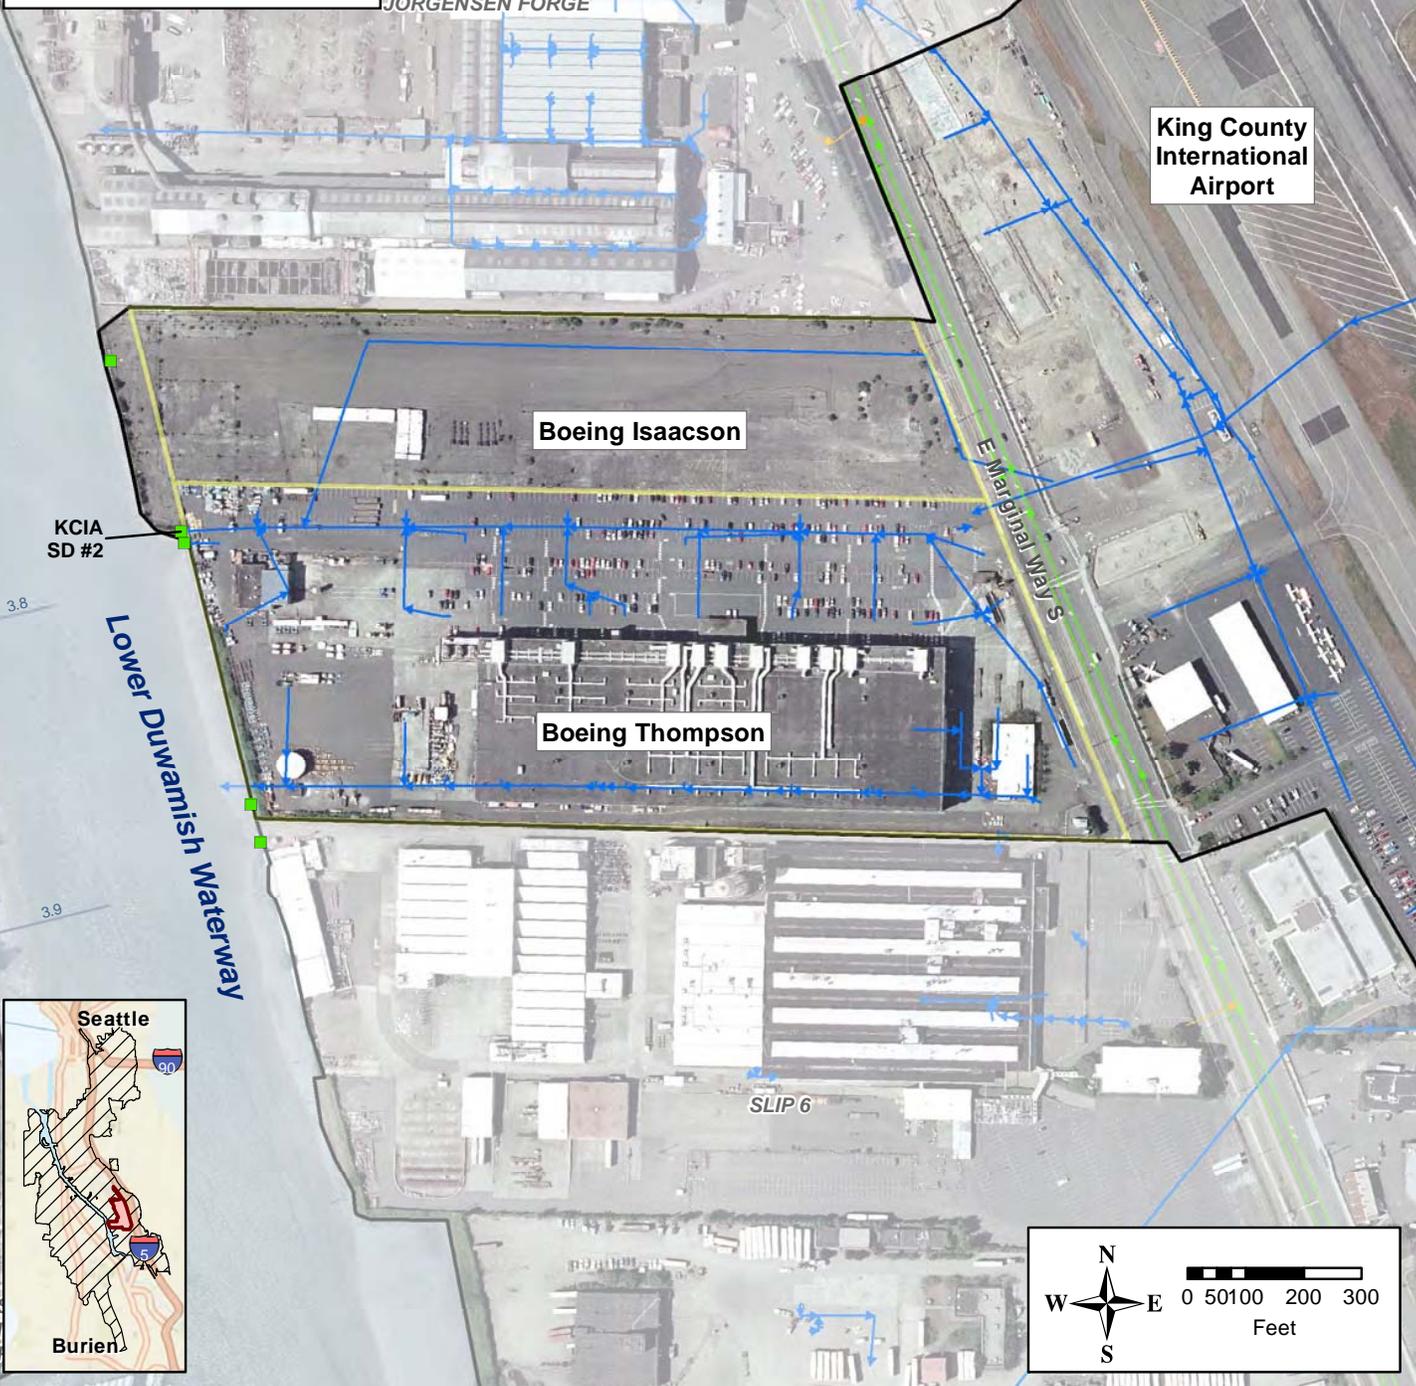
**Figure 9-1. Early Action Area 6:  
RM 3.7-3.9 East (Boeing Isaacson/Central KCIA)  
Boeing Thompson and Isaacson Properties**

- Outfall Location
- Utility Lines**
- Storm Drain
- Combined Sewer
- King County Interceptor
- Parcel Boundary
- Source Control Area Boundary

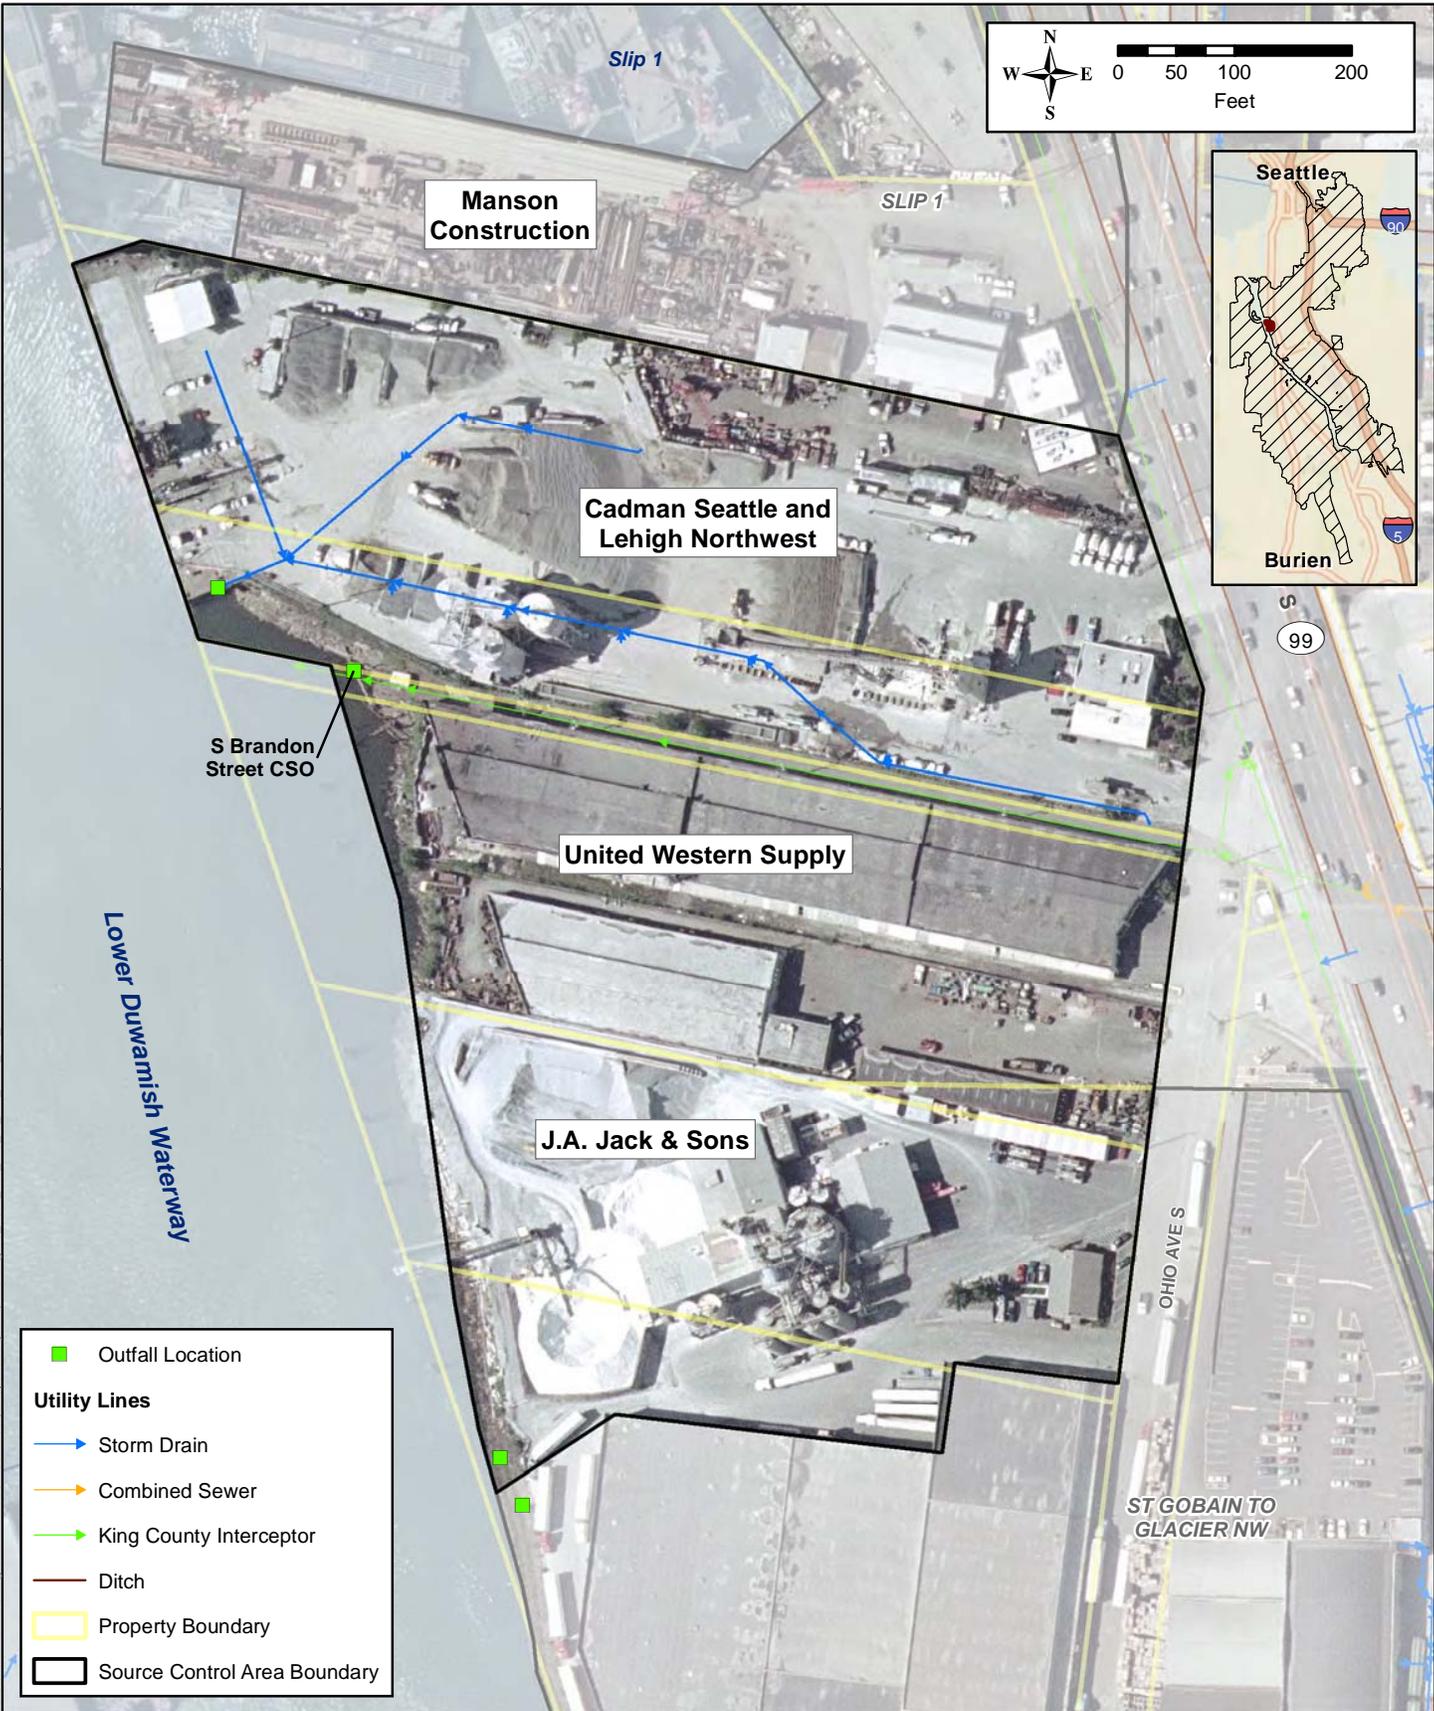
Figure 13-1. RM 1.0-1.2 East: King County Lease Parcels Source Control Area

The RM 1.0-1.2 East (King County Lease Parcels) source control area is shown in Figure 13-1. This source control area includes discharges from the S Brandon Street CSO and stormwater from two other storm drain outfalls within RM 1.0-1.2 East. In addition to properties adjacent to the LDW, this source control area includes 128 facilities that are located within the S Brandon Street basin. A SCAP was finalized for this source control area in January 2011. Action items for the King County Lease Parcels source control area are listed in Table 3-3.

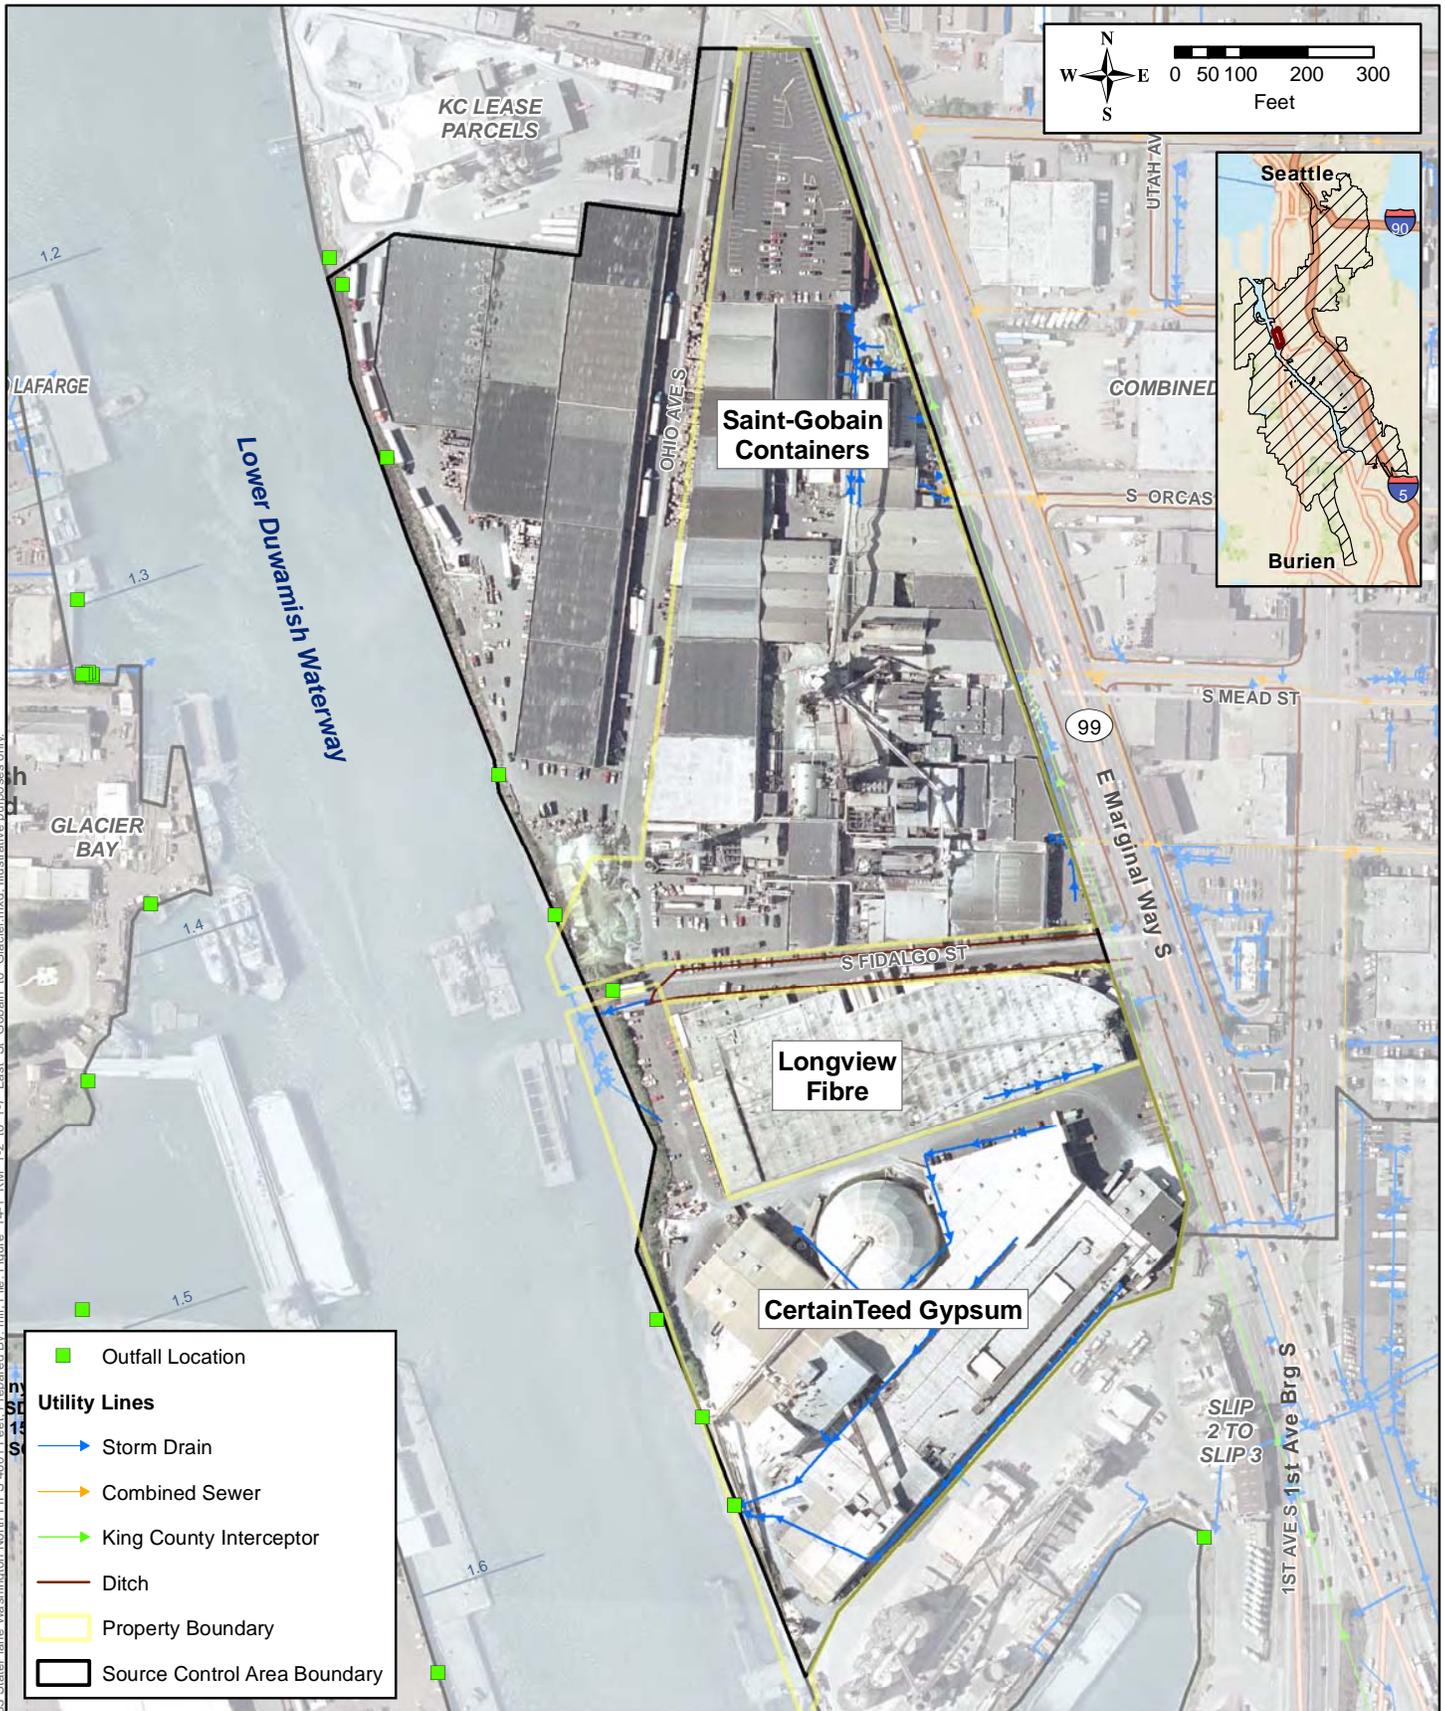
Coordinate System: NAD 1983 StatePlane Washington North FIPS 4601 Feet. Prepared By: mlf. File: Figure 14-1\_RM\_1-2 to 1-7\_East\_St. Gobain to Glacier.mxd. Illustrative purposes only.

- Outfall Location
- Utility Lines**
- Storm Drain
- Combined Sewer
- King County Interceptor
- Ditch
- Property Boundary
- Source Control Area Boundary

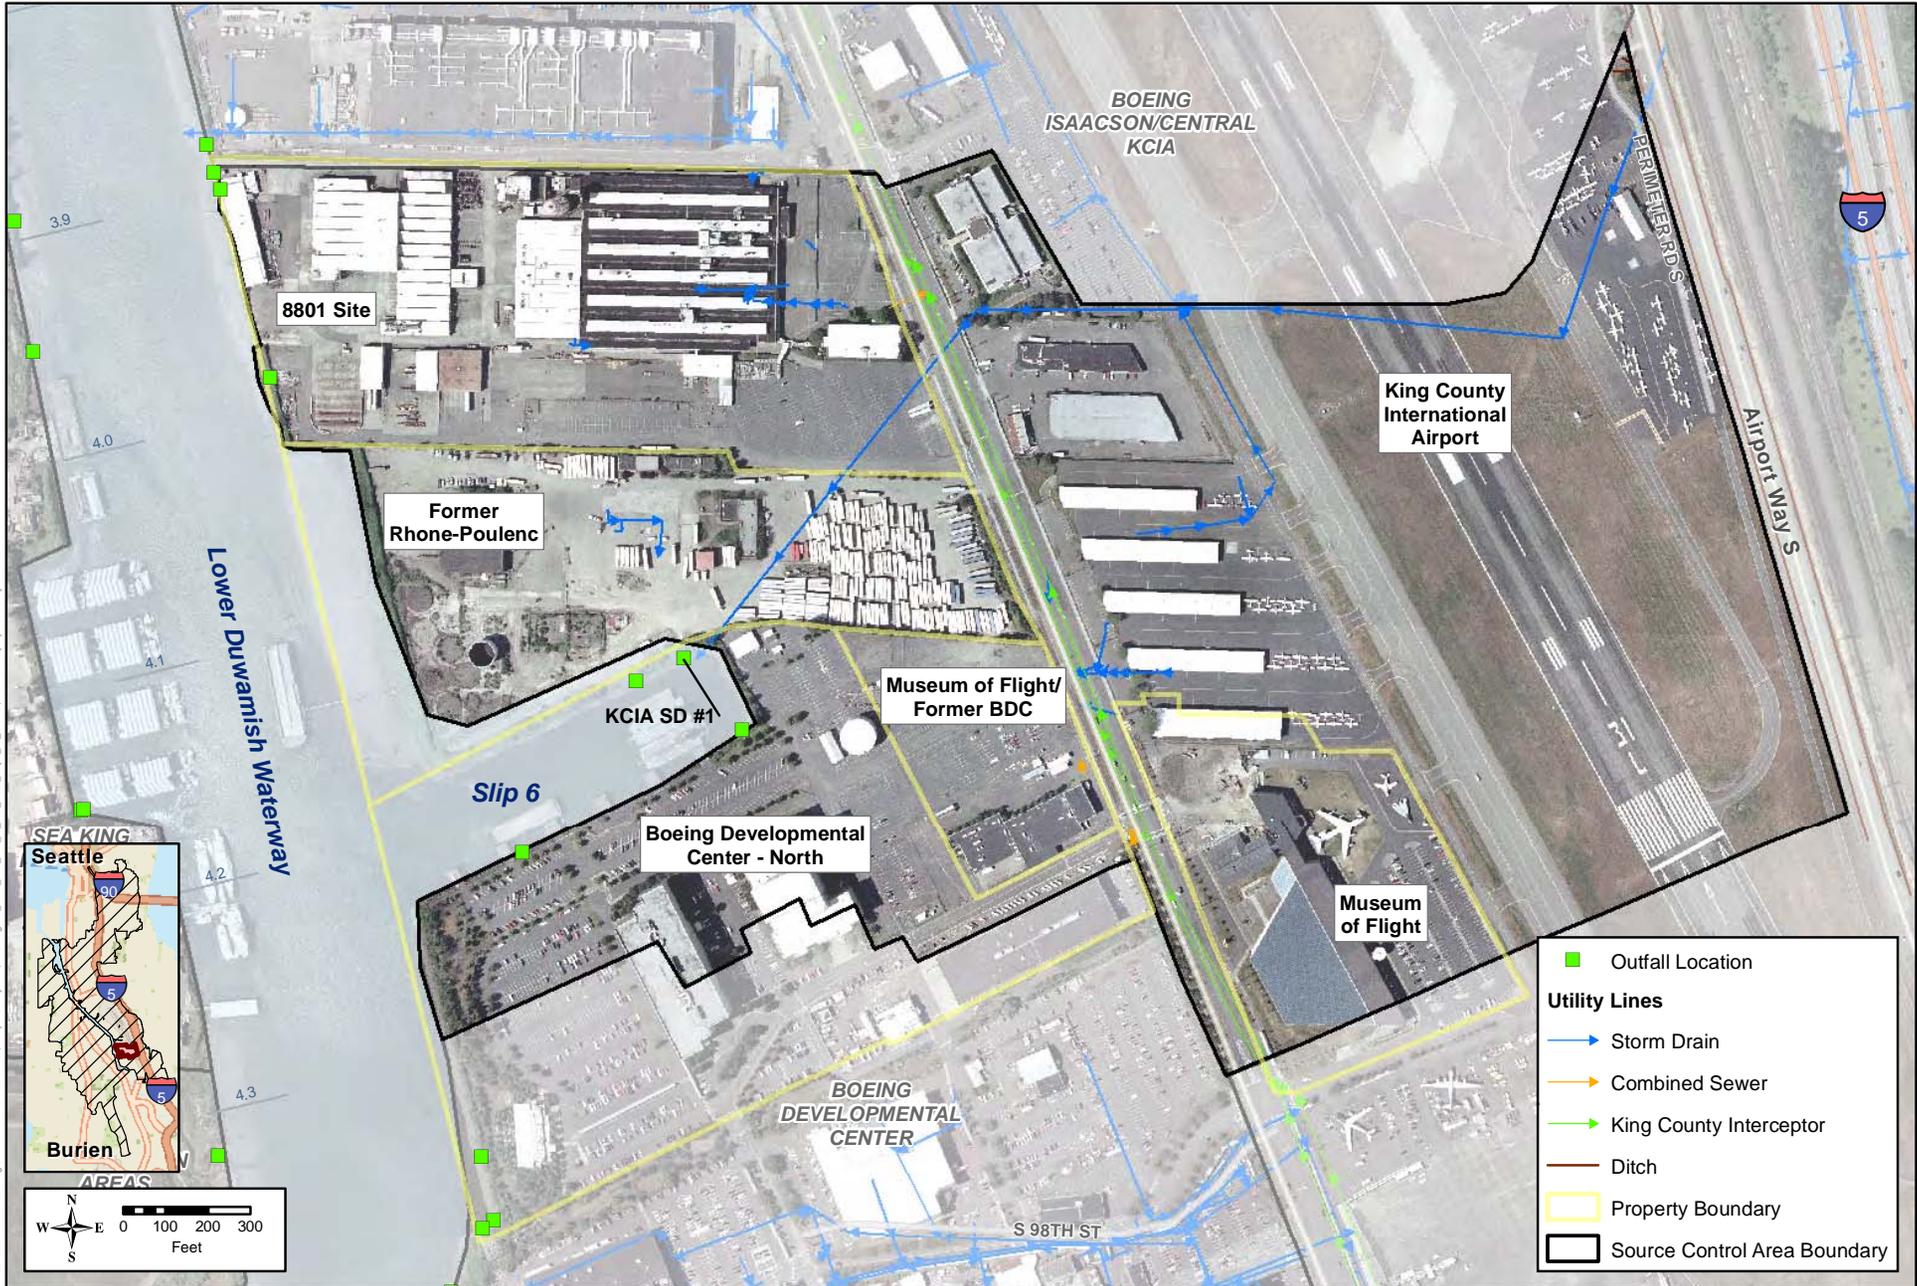
Figure 18-1. RM 3.9-4.3 East:  
Slip 6 Source Control Area

The RM 3.9-4.3 East (Slip 6) source control area is shown in Figure 18-1. It includes stormwater drainage from the south-central portion of KCIA, which discharges to the LDW through KCIA SD#1. It also includes the northern portion of the Boeing Developmental Center (BDC). Source control action items for this source control area are listed in Table 3-3.

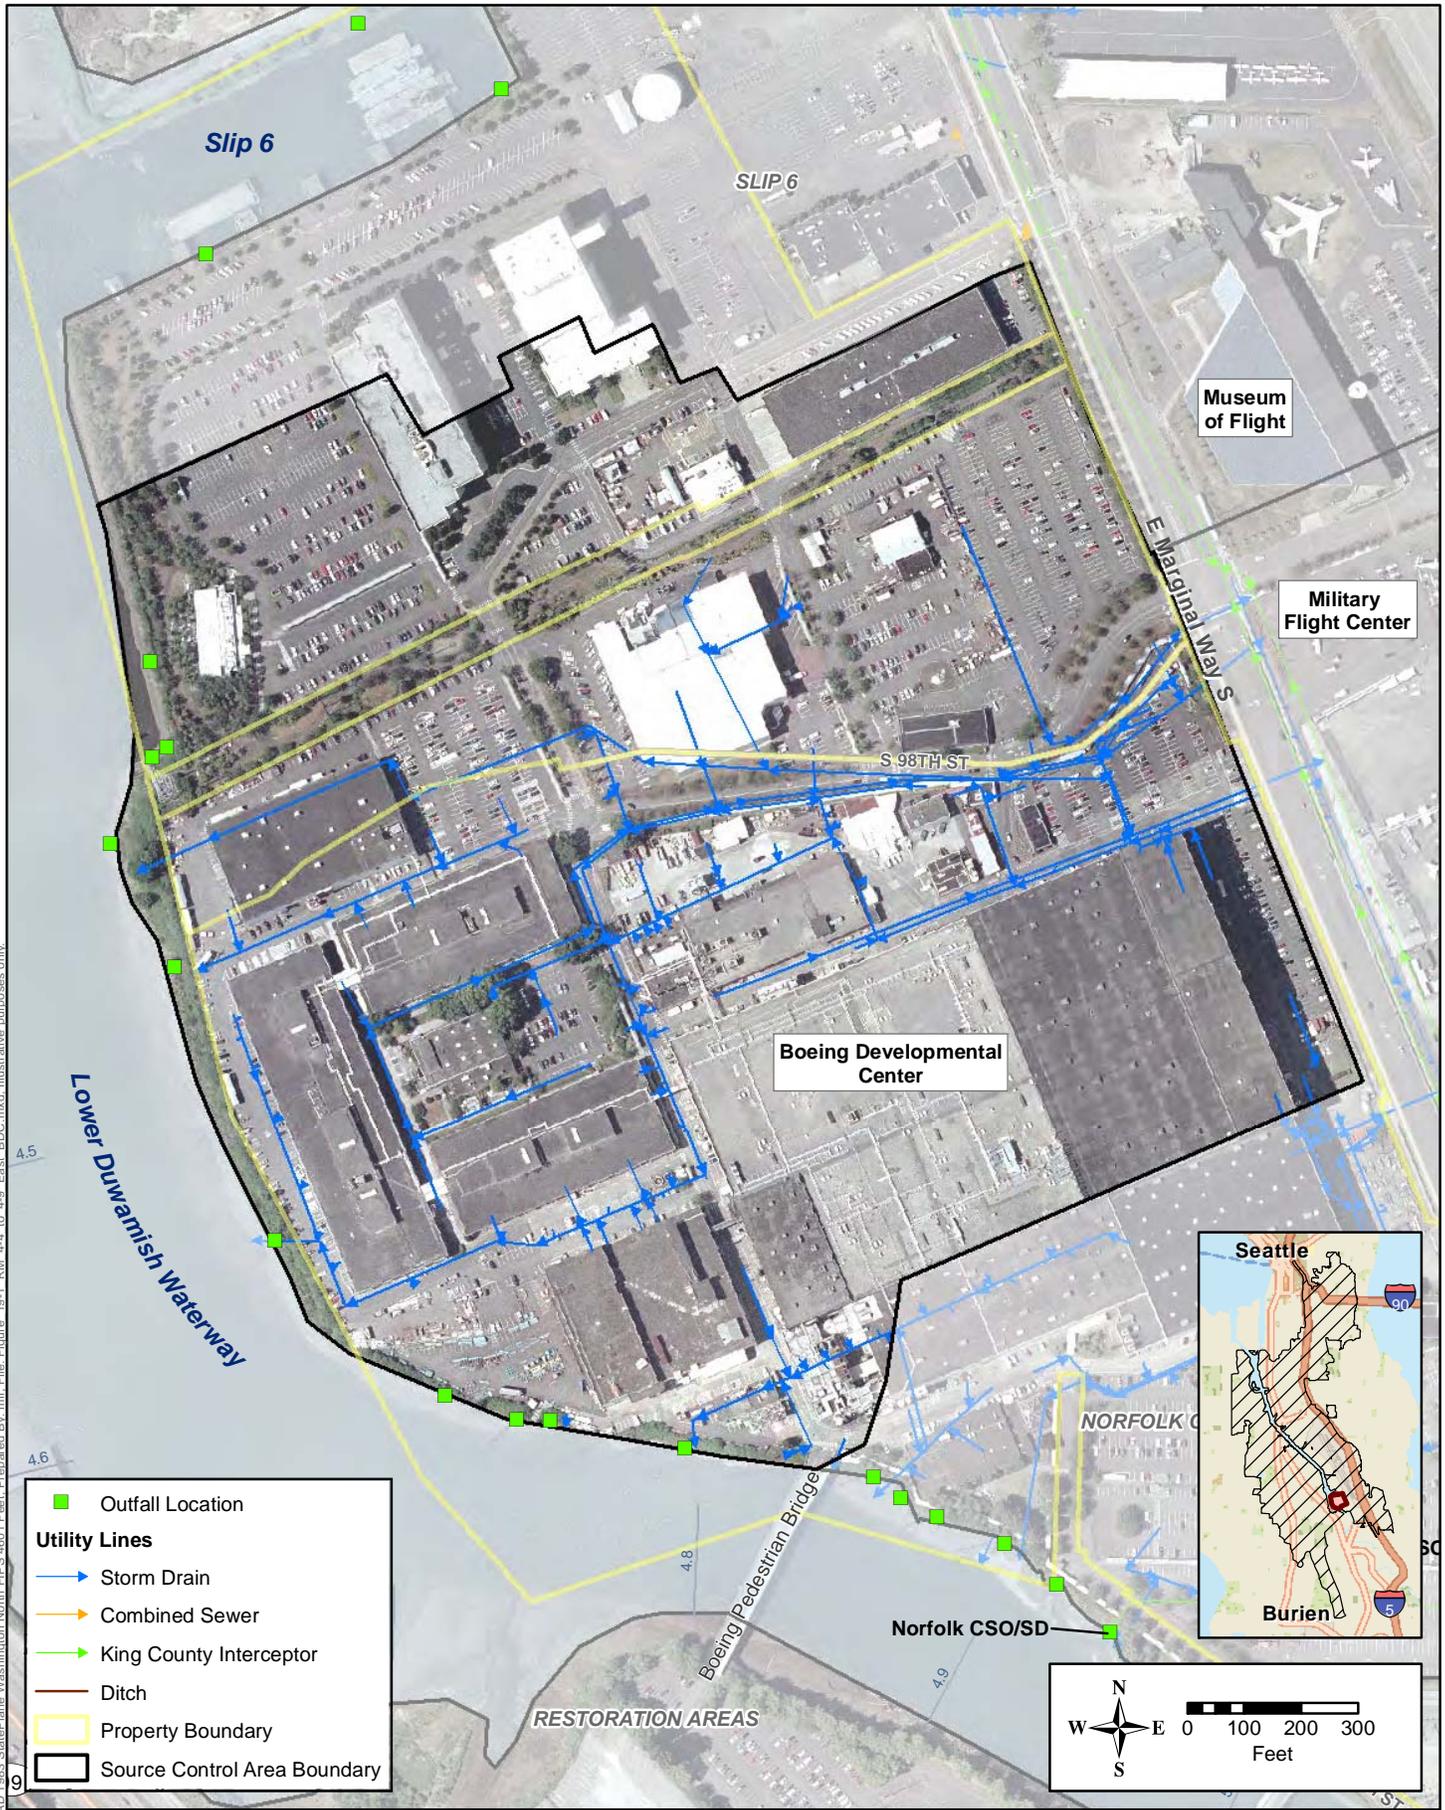
**Figure 19-1. RM 4.3-4.9 East:  
Boeing Developmental Center  
Source Control Area**

The RM 4.3-4.9 East (Boeing Developmental Center) source control area is shown in Figure 19-1. This source control area includes drainage from 10 private outfalls located in the central portion of the BDC. There are no public storm drain outfalls located within RM 4.3-4.9 East. Source control actions items for this source control area are listed in Table 3-3.
