# Lower Duwamish Waterway RM 1.7 to 2.0 East (Slip 2 to Slip 3)

## Summary of Existing Information and Identification of Data Gaps

February 2009

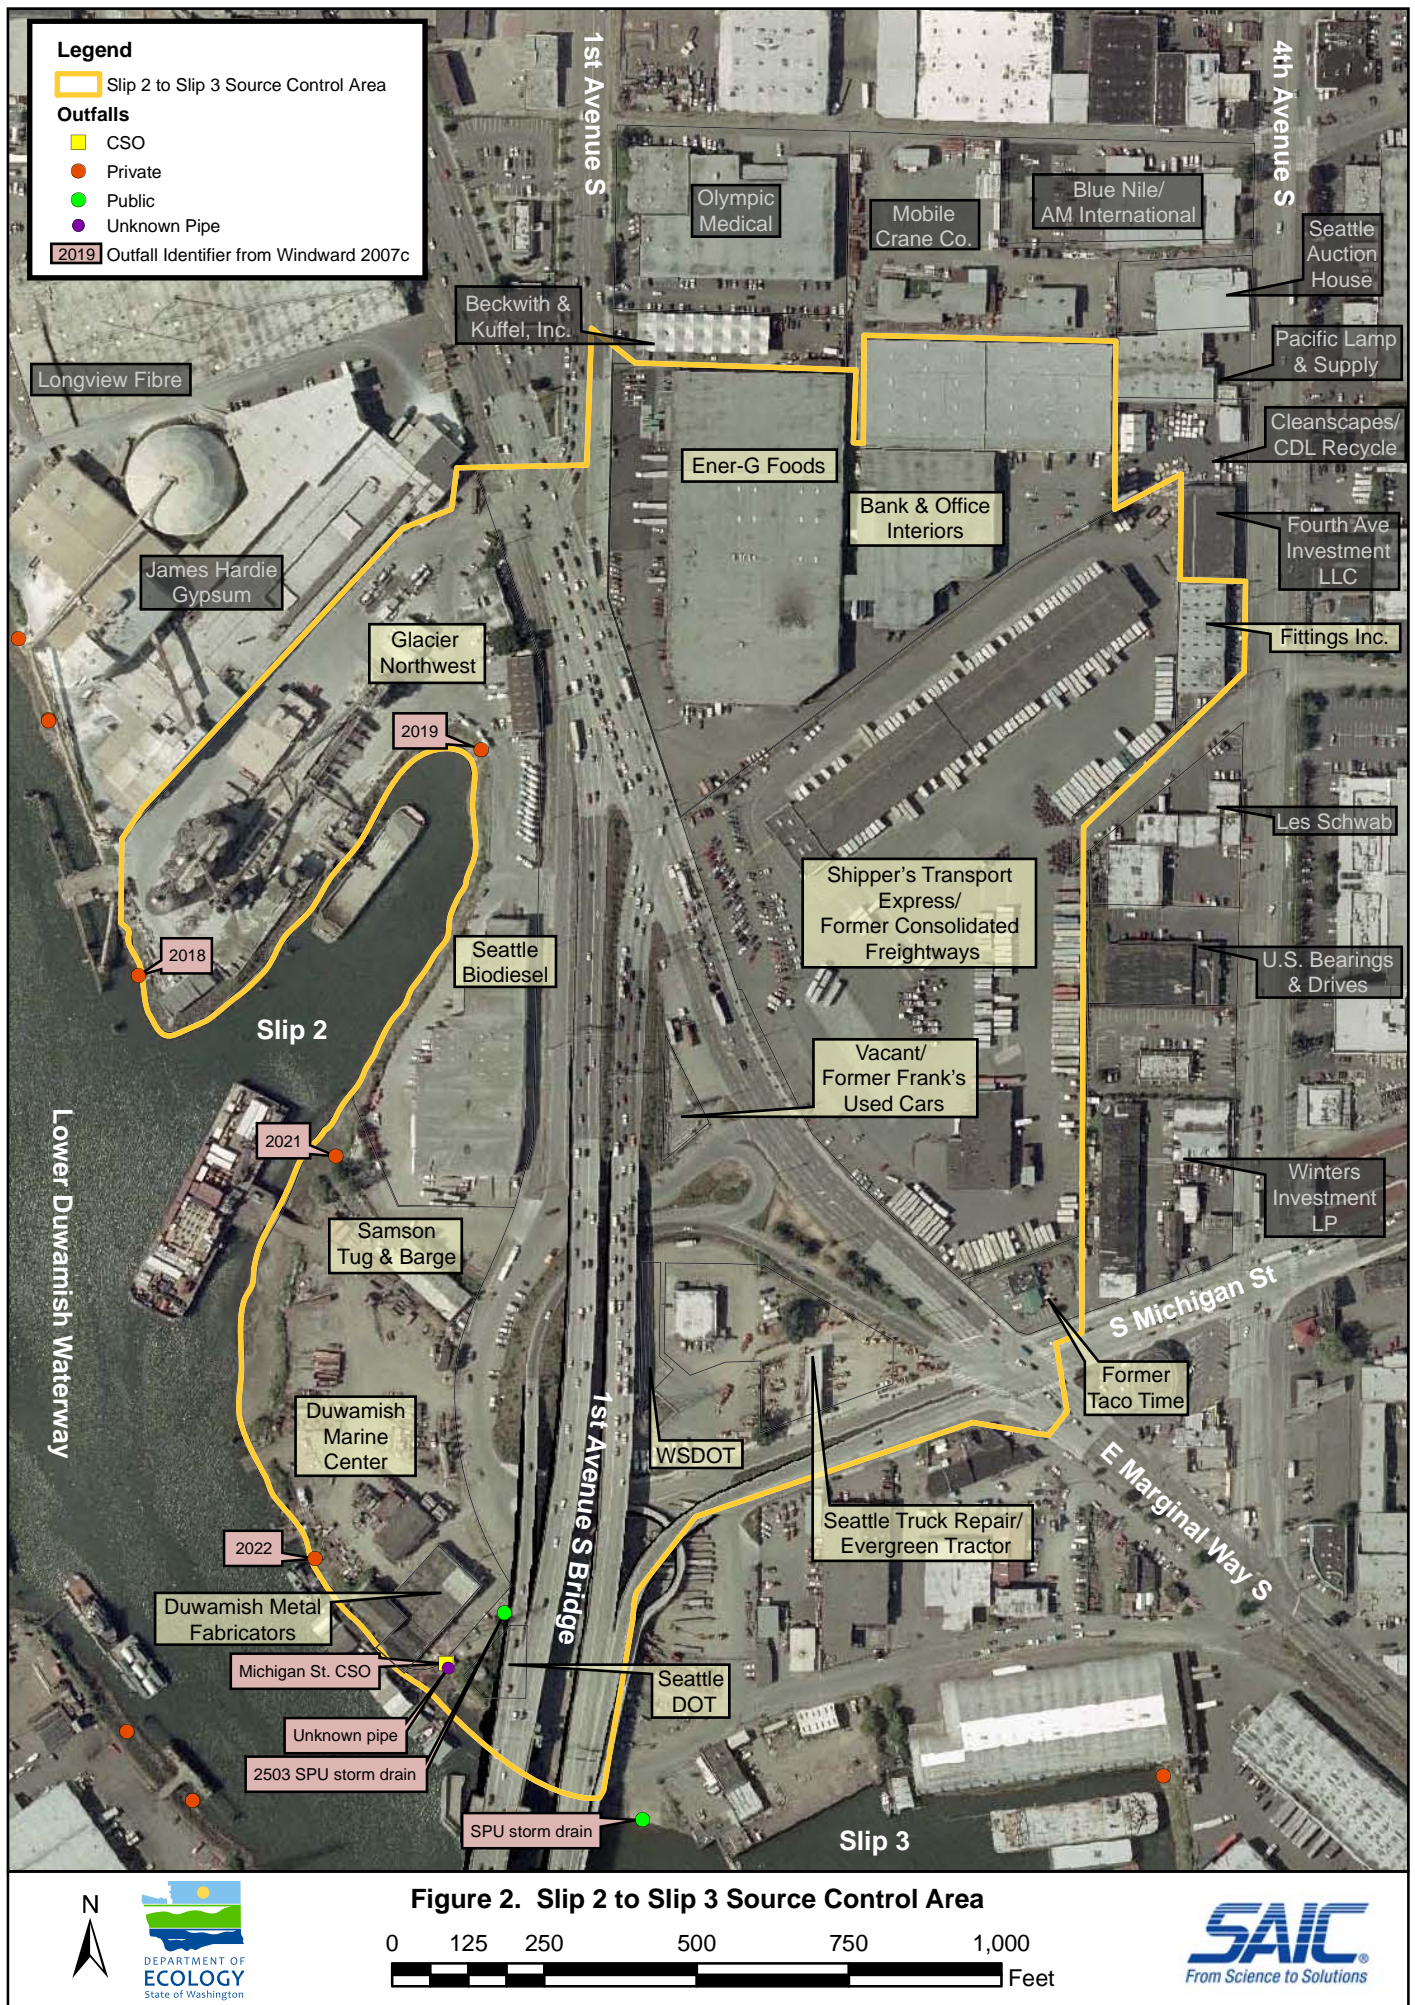
**Figure 1. Lower Duwamish Waterway Source Control Areas**

The source control area boundaries are an approximation. Final boundaries will be determined jointly by EPA and Ecology. Drainage basins leading to these areas will be defined in the future.

This *Summary of Existing Information and Identification of Data Gaps* report (Data Gaps report) pertains to River Mile (RM) 1.7-2.0 East<sup>1</sup> (Slip 2 to Slip 3), one of several source control areas identified as part of the overall cleanup process for the Lower Duwamish Waterway (LDW) Superfund Site (Figure 1). It summarizes readily available information regarding properties in the Slip 2 to Slip 3 source control area. The purpose of the Data Gaps report is to:

The Slip 2 to Slip 3 source control area, also referred to as the RM 1.7 to 2.0 East source control area, is located along the eastern side of the LDW Superfund Site between RM 1.7 and 2.0 as measured from the southern end of Harbor Island (Figure 1). Several facilities are located directly adjacent to the LDW within the Slip 2 to Slip 3 source control area (Figure 2). From north to south, these facilities are:

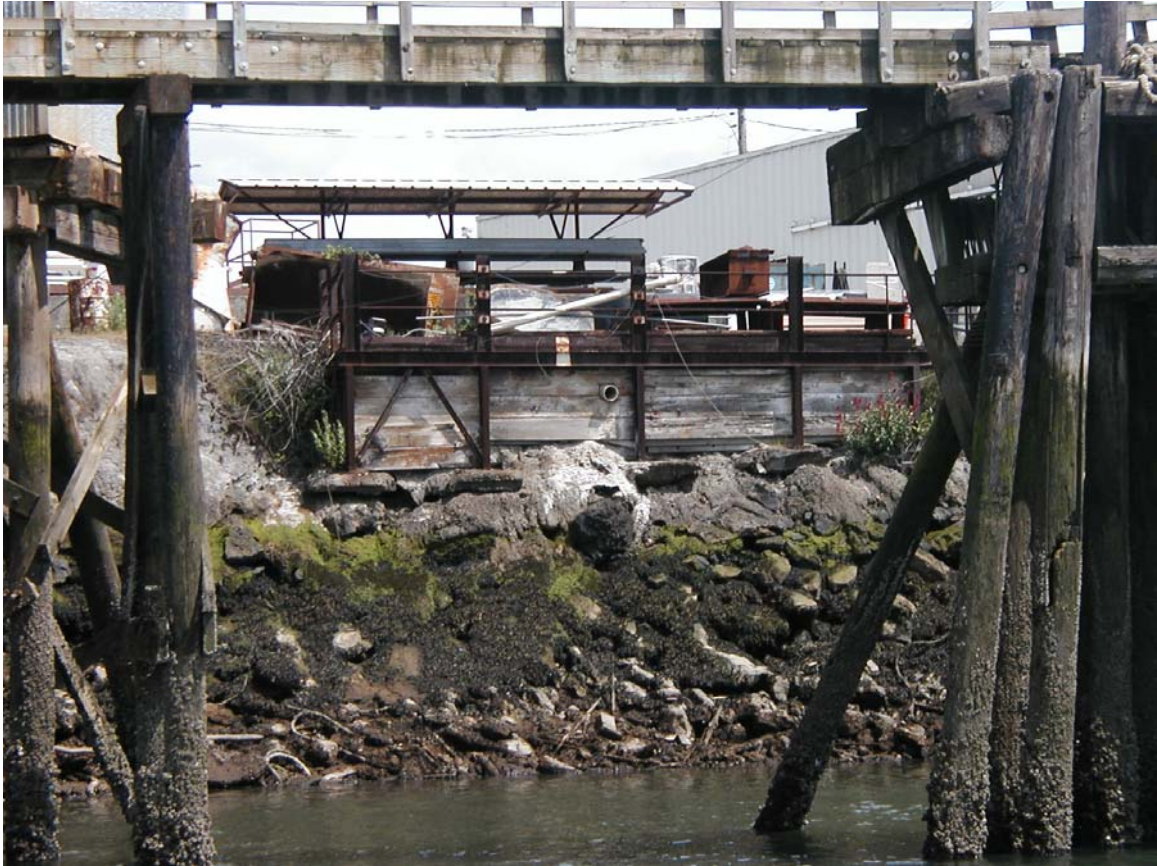
Outfall 2018, west side of Glacier Northwest, Inc., 5975 East Marginal Way S. (Schmoyer 2008b)
