# Lower Duwamish Waterway RM 1.0 to 1.2 East (King County Lease Parcels)

## Summary of Existing Information and Identification of Data Gaps

June 2010

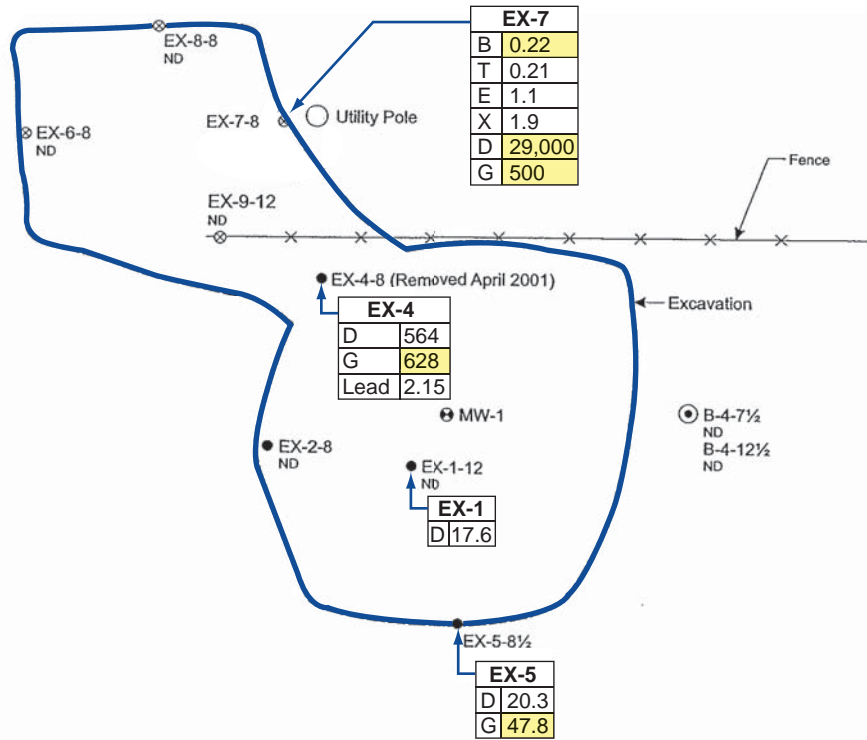
**Figure C-8. Former Air Tec Property  
Historical Maximum Chemical Concentrations in Soil**

- EX-4-8 ● April 2000 soil sample location ID and depth below grade in feet
- EX-6-8 ⊗ April 2001 soil sample location ID and depth below grade in feet
- B-4-7½ ⊙ June 1994 phase II boring and sample depth below grade in feet
- MW-1 ⊕ Groundwater monitoring well
- ND TPH not detected

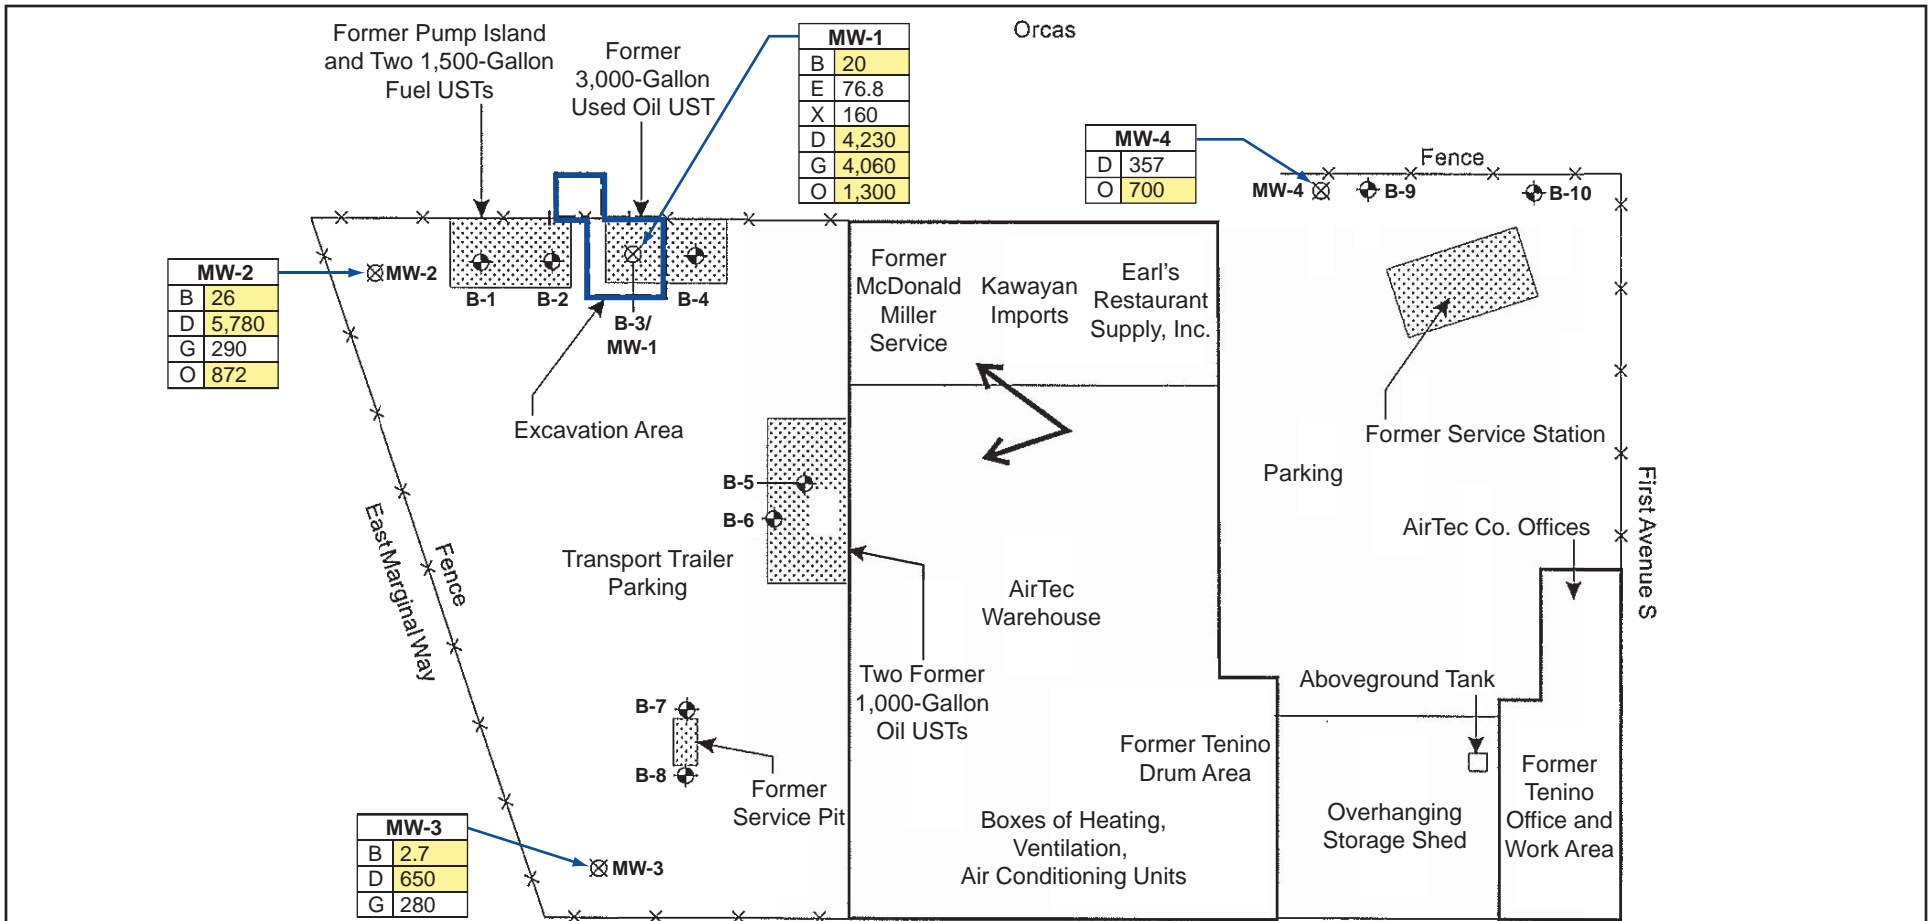
**Figure C-9. Former Air Tec Property  
Historical Maximum Chemical Concentrations in Groundwater**

MW-1	
B	20
E	76.8
X	160
D	4,230
G	4,060
O	1,300

MW-2	
B	26
D	5,780
G	290
O	872
