Lower Duwamish Waterway RM 0.0 to 1.0 West (Spokane Street to Kellogg Island)

Summary of Existing Information and Identification of Data Gaps

Volume 1: Main Text, Figures, and Tables

September 2012

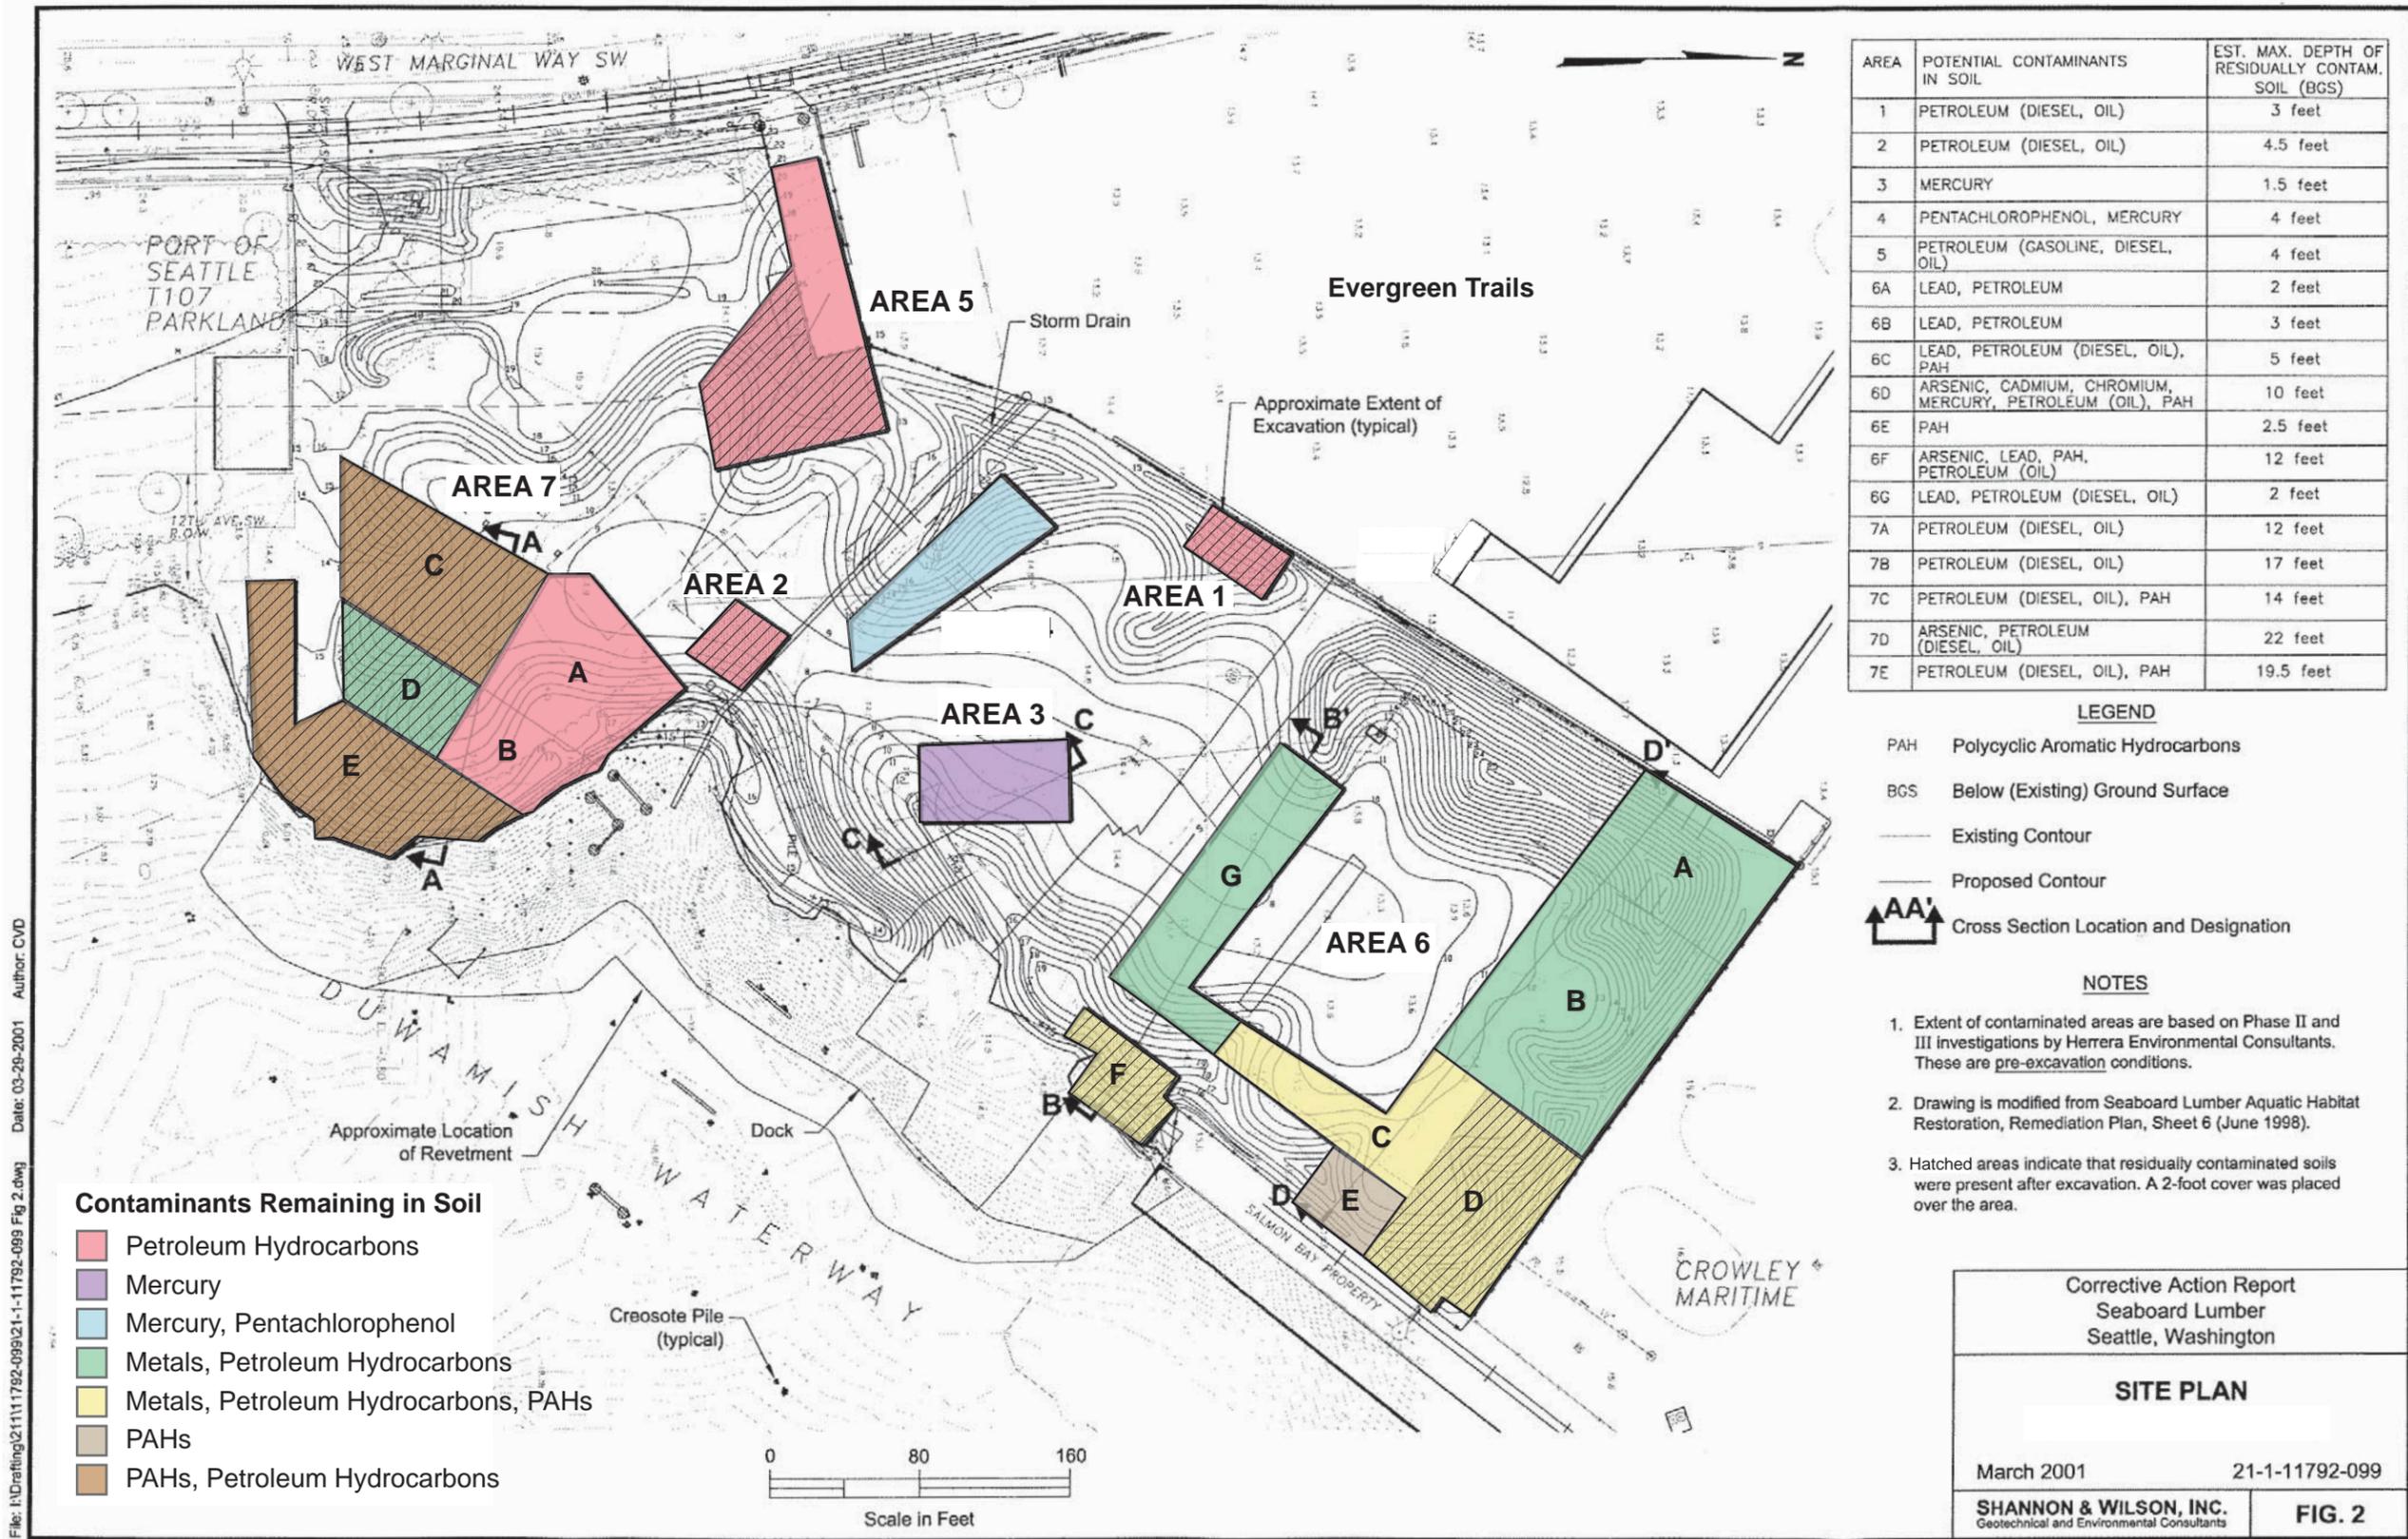
Figure 25. Remedial Investigation Former Seaboard Lumber/Herring's House Park

Figure 4. Sediment sampling locations at Seaboard Lumber site.

— Evergreen Trails Property Boundary
 — Former Seaboard Lumber Property Boundary

Approximately 15,590 tons of impacted soil were excavated and disposed of at the Olympic View Landfill. After completion of the habitat restoration, soil contaminated with arsenic, cadmium, chromium, lead, mercury, PAHs, pentachlorophenol, and petroleum hydrocarbons was left in place. A 2-foot cap of clean material was installed above the contaminated soil (Shannon & Wilson 2001). These areas are shown on Figure 25.

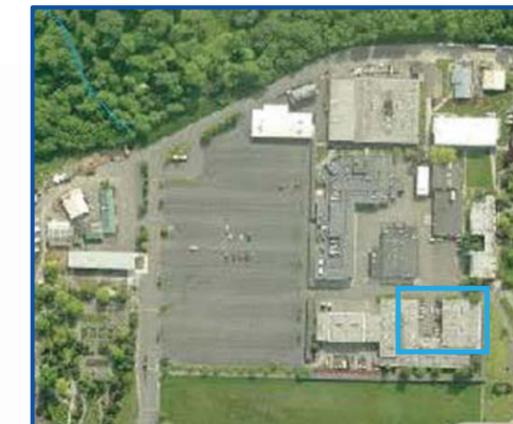
South Seattle Community College Campus, Area 4

- Hydraulic Cylinders
- ⊗ Sample Location
- ** Overexcavated Sample
- ⌋ Excavation Limits

NOTE: hoists removed
last week of february 1994
& 1st week of march 1994

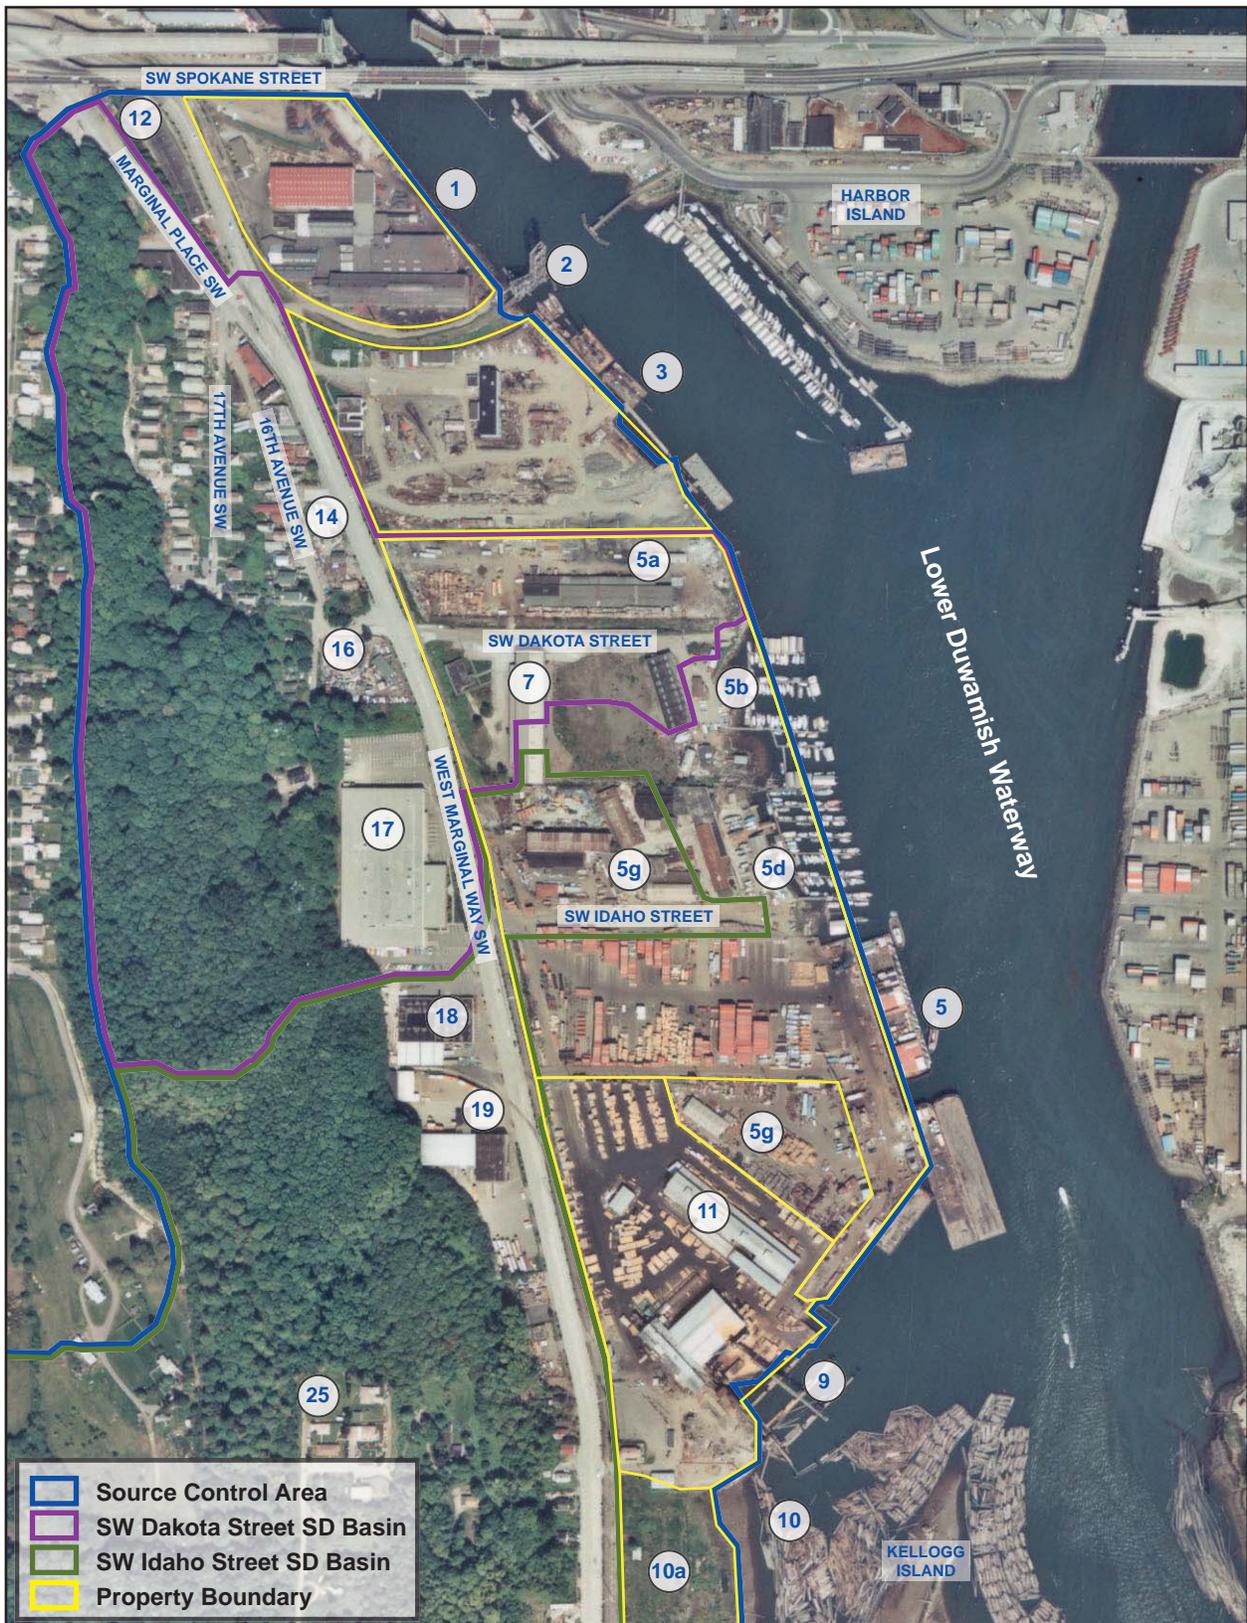
Figure B-7a. RM 0.0 to 1.0 West
(Spokane Street to Kellogg Island):
1980 Aerial Photo, Northern Portion

1. Bethlehem Steel
2. BNSF Railroad Right-of-Way
3. General Construction
5. Port of Seattle Terminal 105
 - a. Liquid Disposal Corporation, Duroboat Manufacturing
 - b. Riverside Marina
 - d. Pioneer Marina
 - g. Puget Sound Tug & Barge
7. Bird Johnson
9. Former Seaboard Lumber
10. Port of Seattle Terminal 107 (includes Kellogg Island)
 - a. Terminal 107 Park
 - b. Alaska Marine Lines or other tractor-truck storage
11. Manganese Products Manufacturing/Alaska Freight Building
12. Former Fraser Properties
14. Former Concrete Restoration
16. D&K Auto and Truck Salvage/Aable Auto
17. Seafirst Bank/Bank of America
18. New Finishes/Pacifica
19. Continental Van Lines
21. Former Central Painting
22. Fog Tite
23. Evergreen Building Products
24. Heath Landscape Services
25. West Seattle Estates
27. Puget Park and the McFarland Property
28. Washington Federal Savings & Loan Property

Development in the northern portion of the source control area has not changed significantly from the 1974 photograph (Figure B-7a). The log storage yard north of the Seaboard Lumber property (9) has been replaced by a container-storage facility, Puget Sound Tug & Barge (5g) (Kennedy/Jenks 1991b).
