# **Lower Duwamish Waterway Source Control Status Report January 2012 through December 2012**

June 2013

Toxics Cleanup Program  
Northwest Regional Office  
Washington State Department of Ecology  
Bellevue, Washington

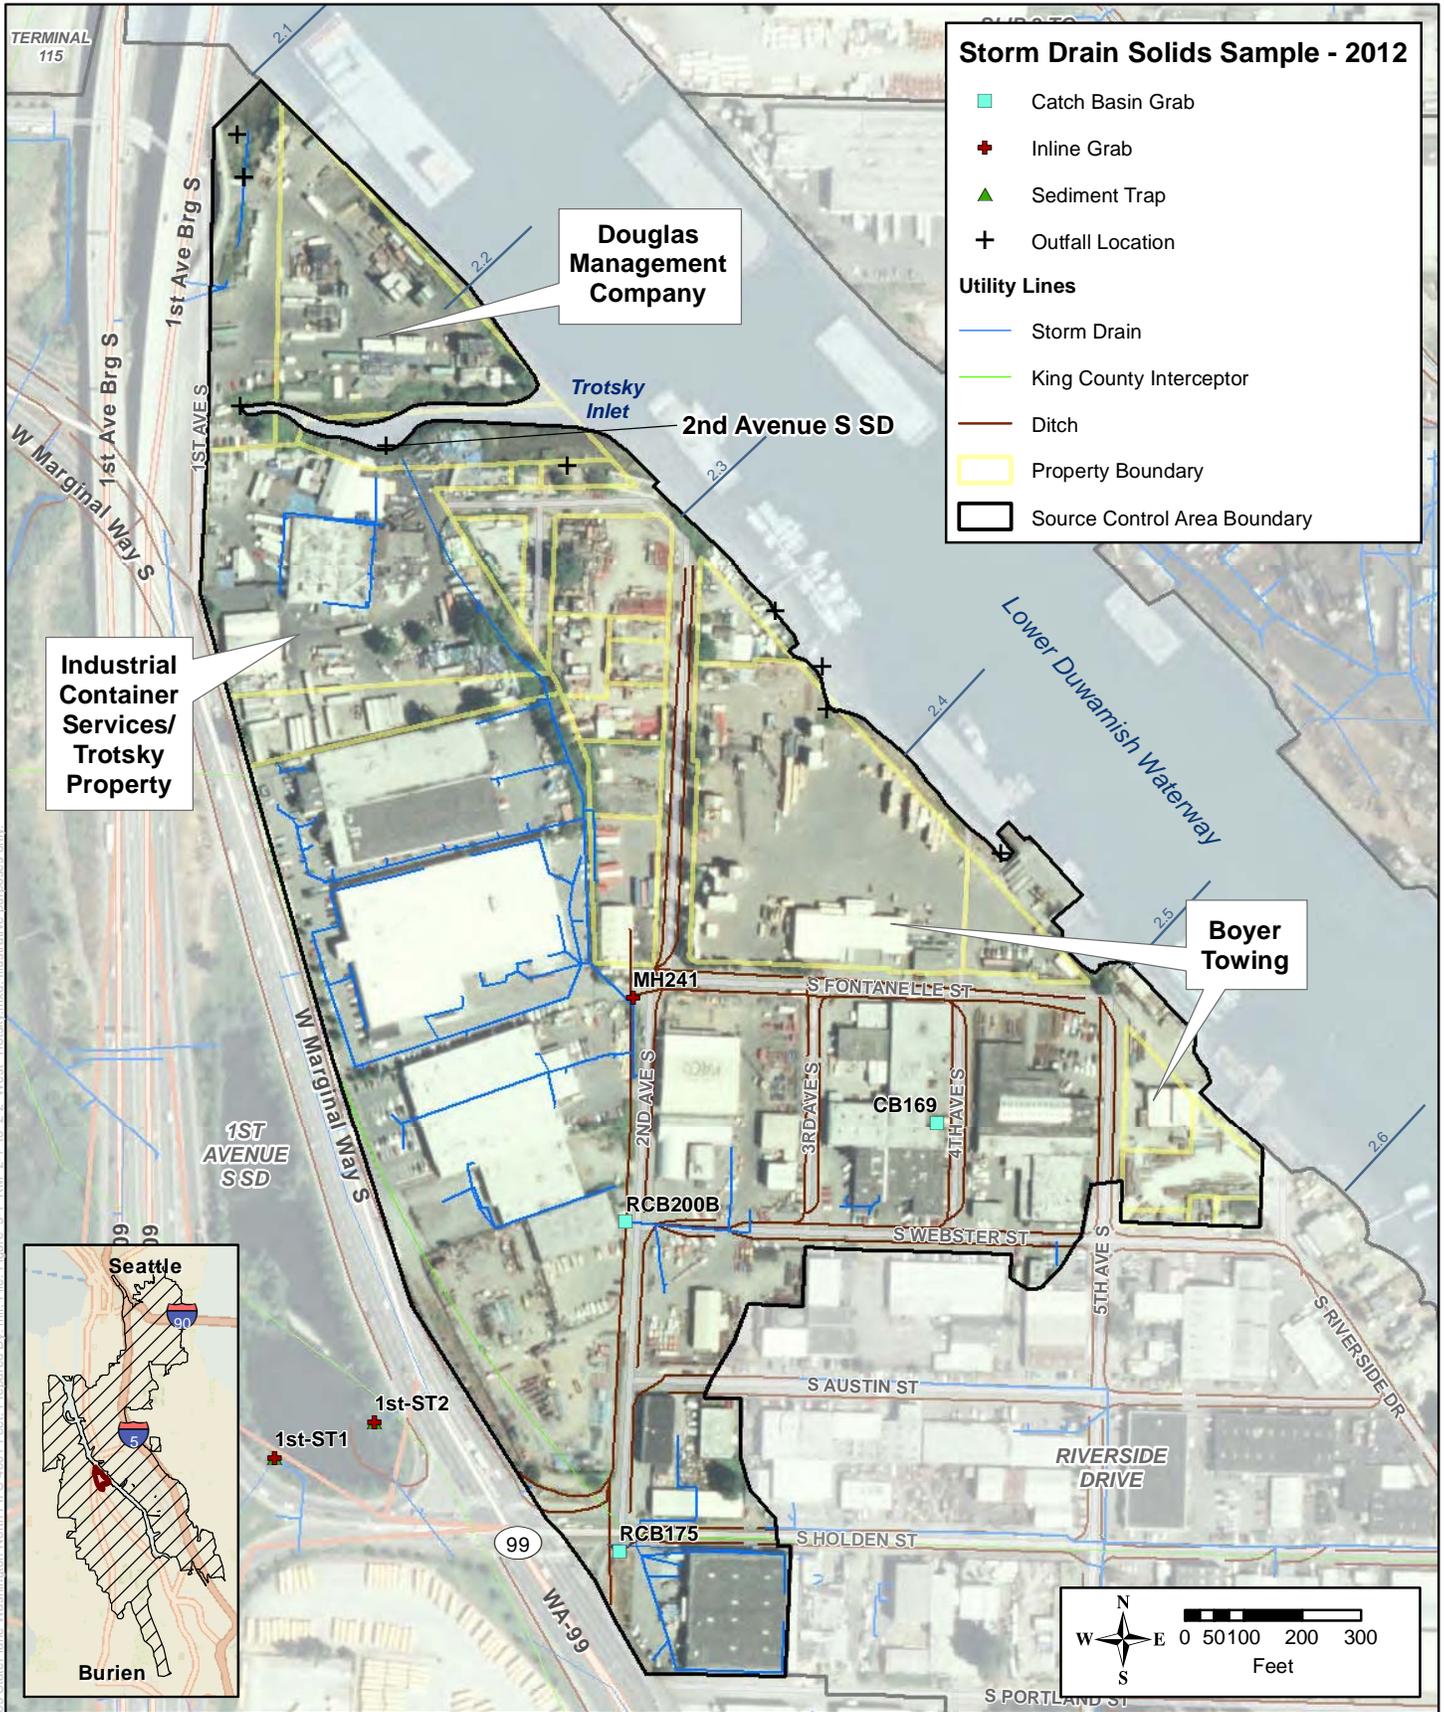
### Storm Drain Solids Sample - 2012

- Catch Basin Grab
- + Inline Grab
- ▲ Sediment Trap
- + Outfall Location

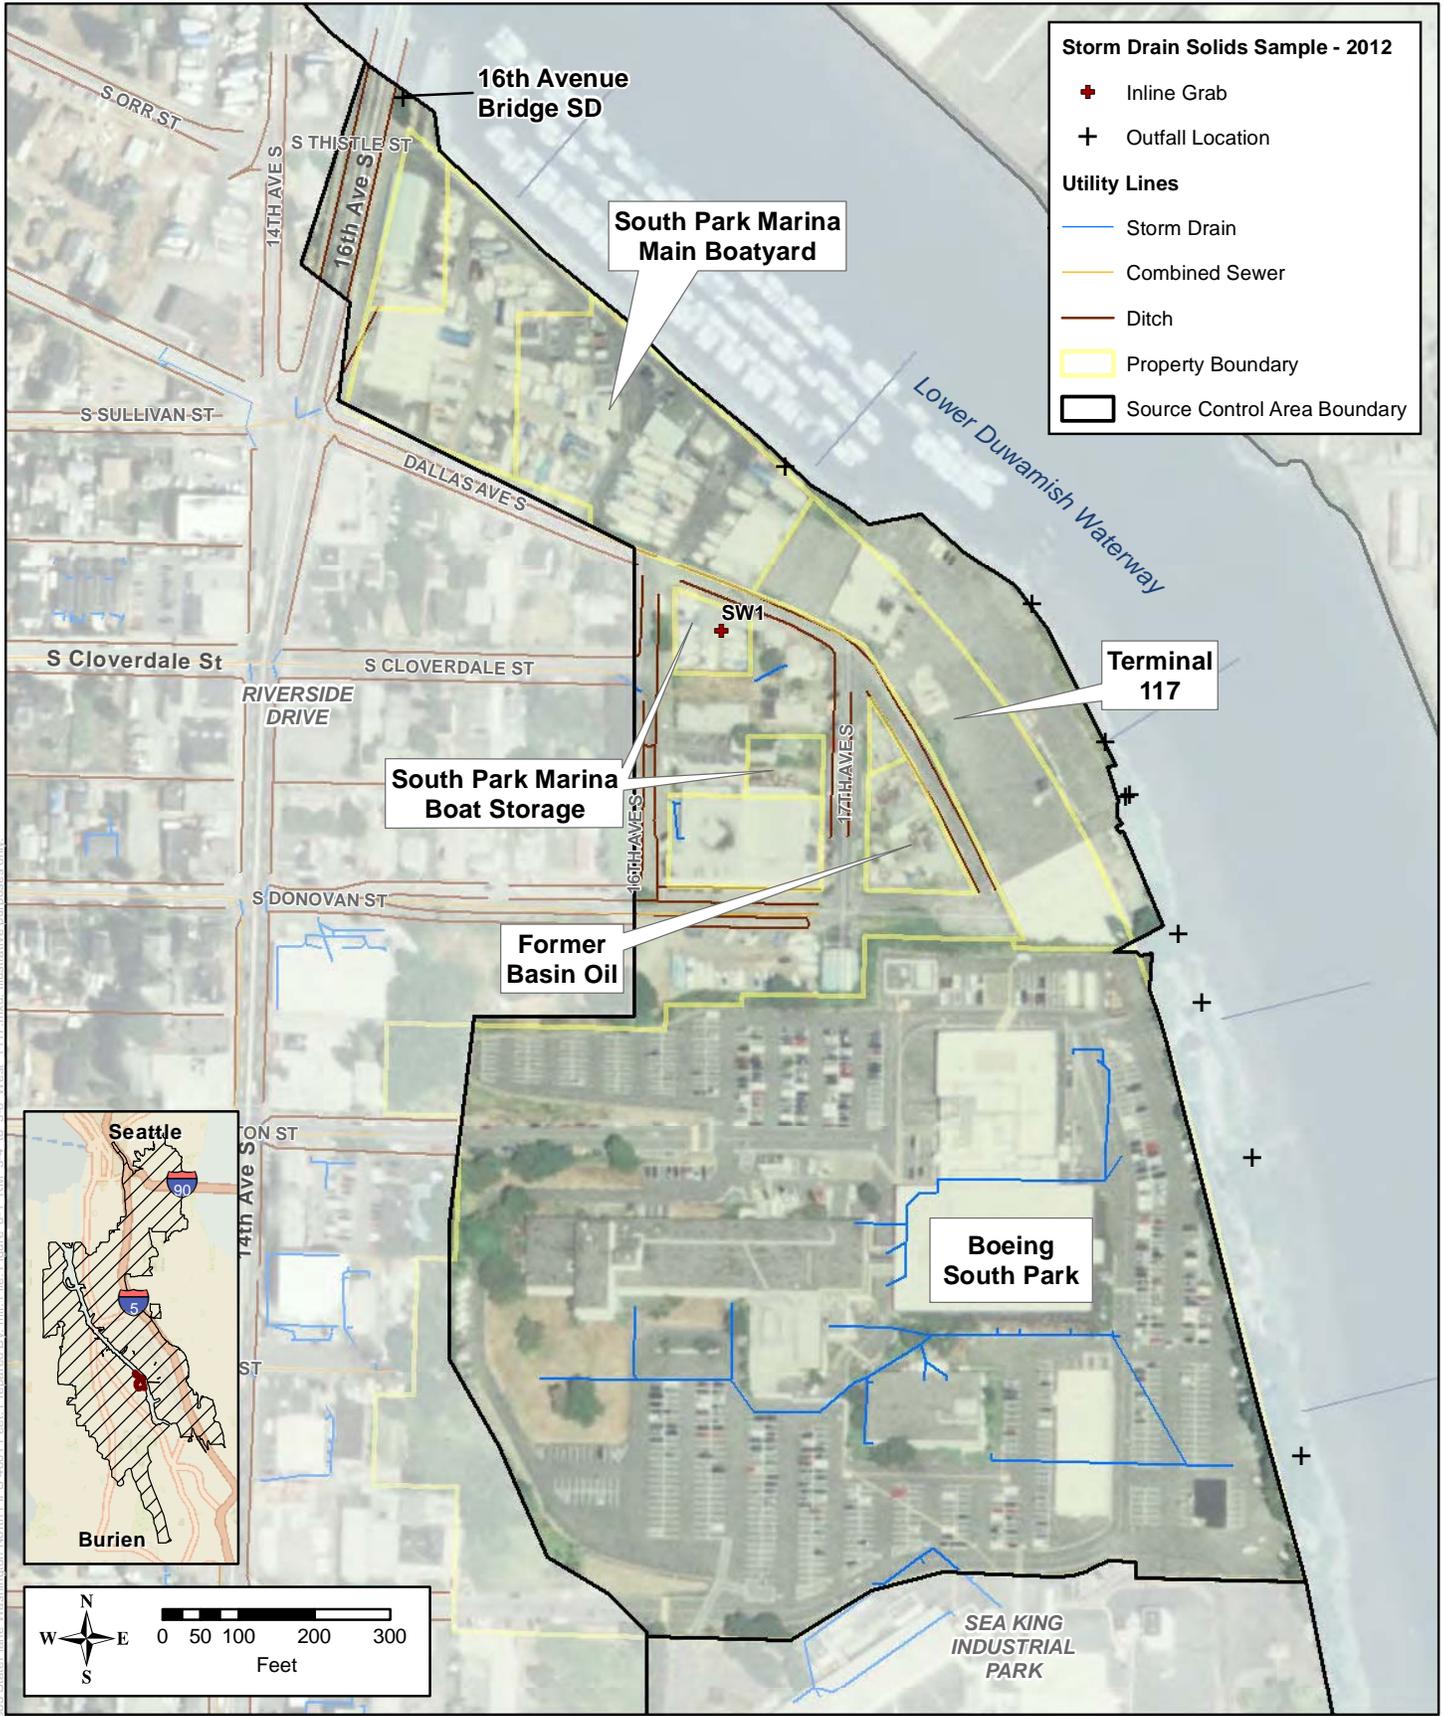
**Figure 8-1. Early Action Area 5:  
RM 3.4-3.8 West (Terminal 117)**

The RM 3.4-3.8 West (EAA-5; Terminal 117) source control area is shown in Figure 8-1. This source control area includes Port of Seattle's Terminal 117, South Park Marina, and Boeing's South Park facility.

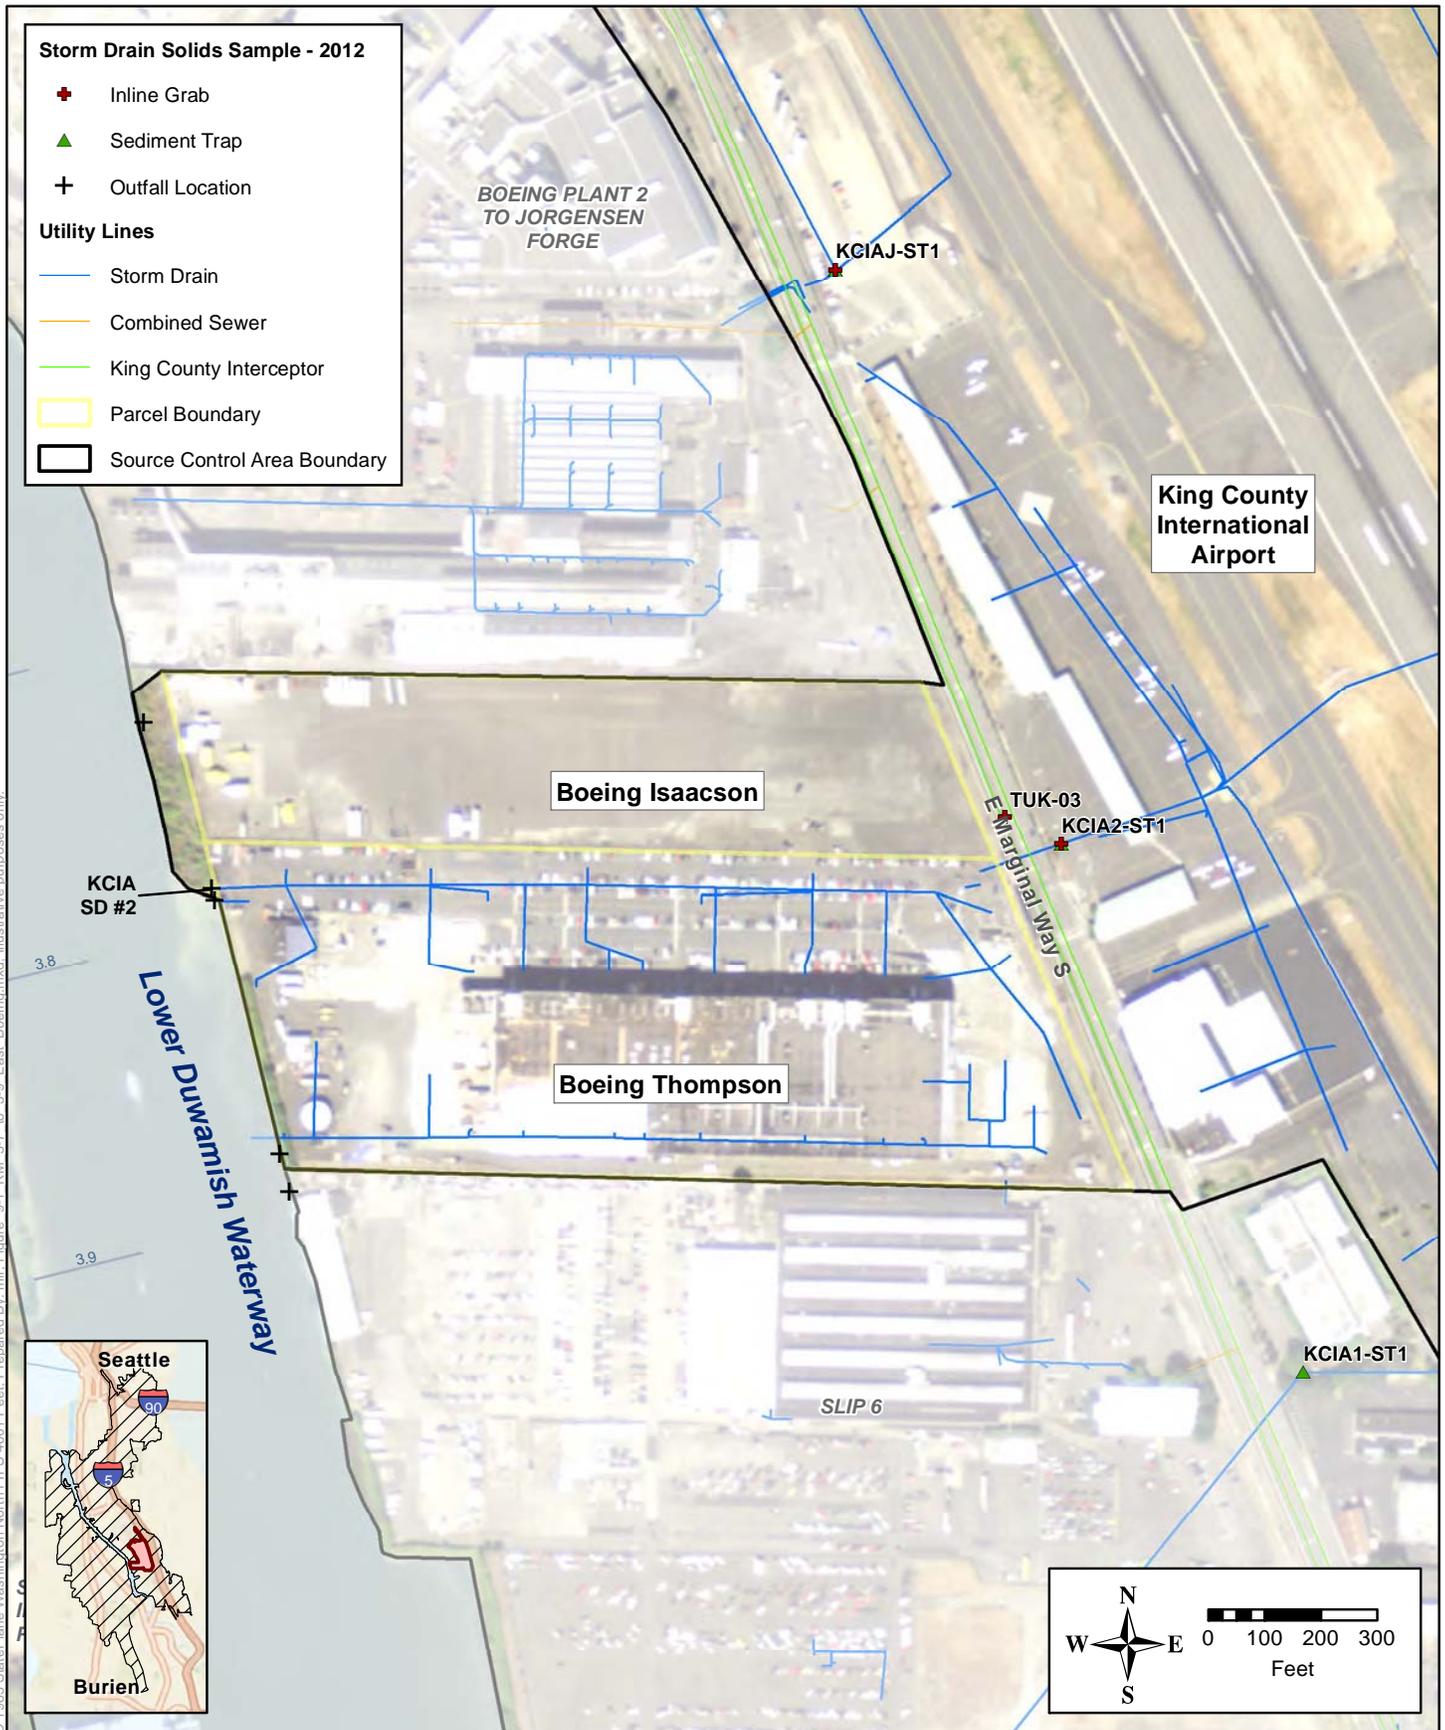
- Storm Drain Solids Sample - 2012**
- ✚ Inline Grab
  - ▲ Sediment Trap
  - ✚ Outfall Location
- Utility Lines**
- Storm Drain
  - Combined Sewer
  - King County Interceptor
  - ▭ Parcel Boundary
  - ▭ Source Control Area Boundary

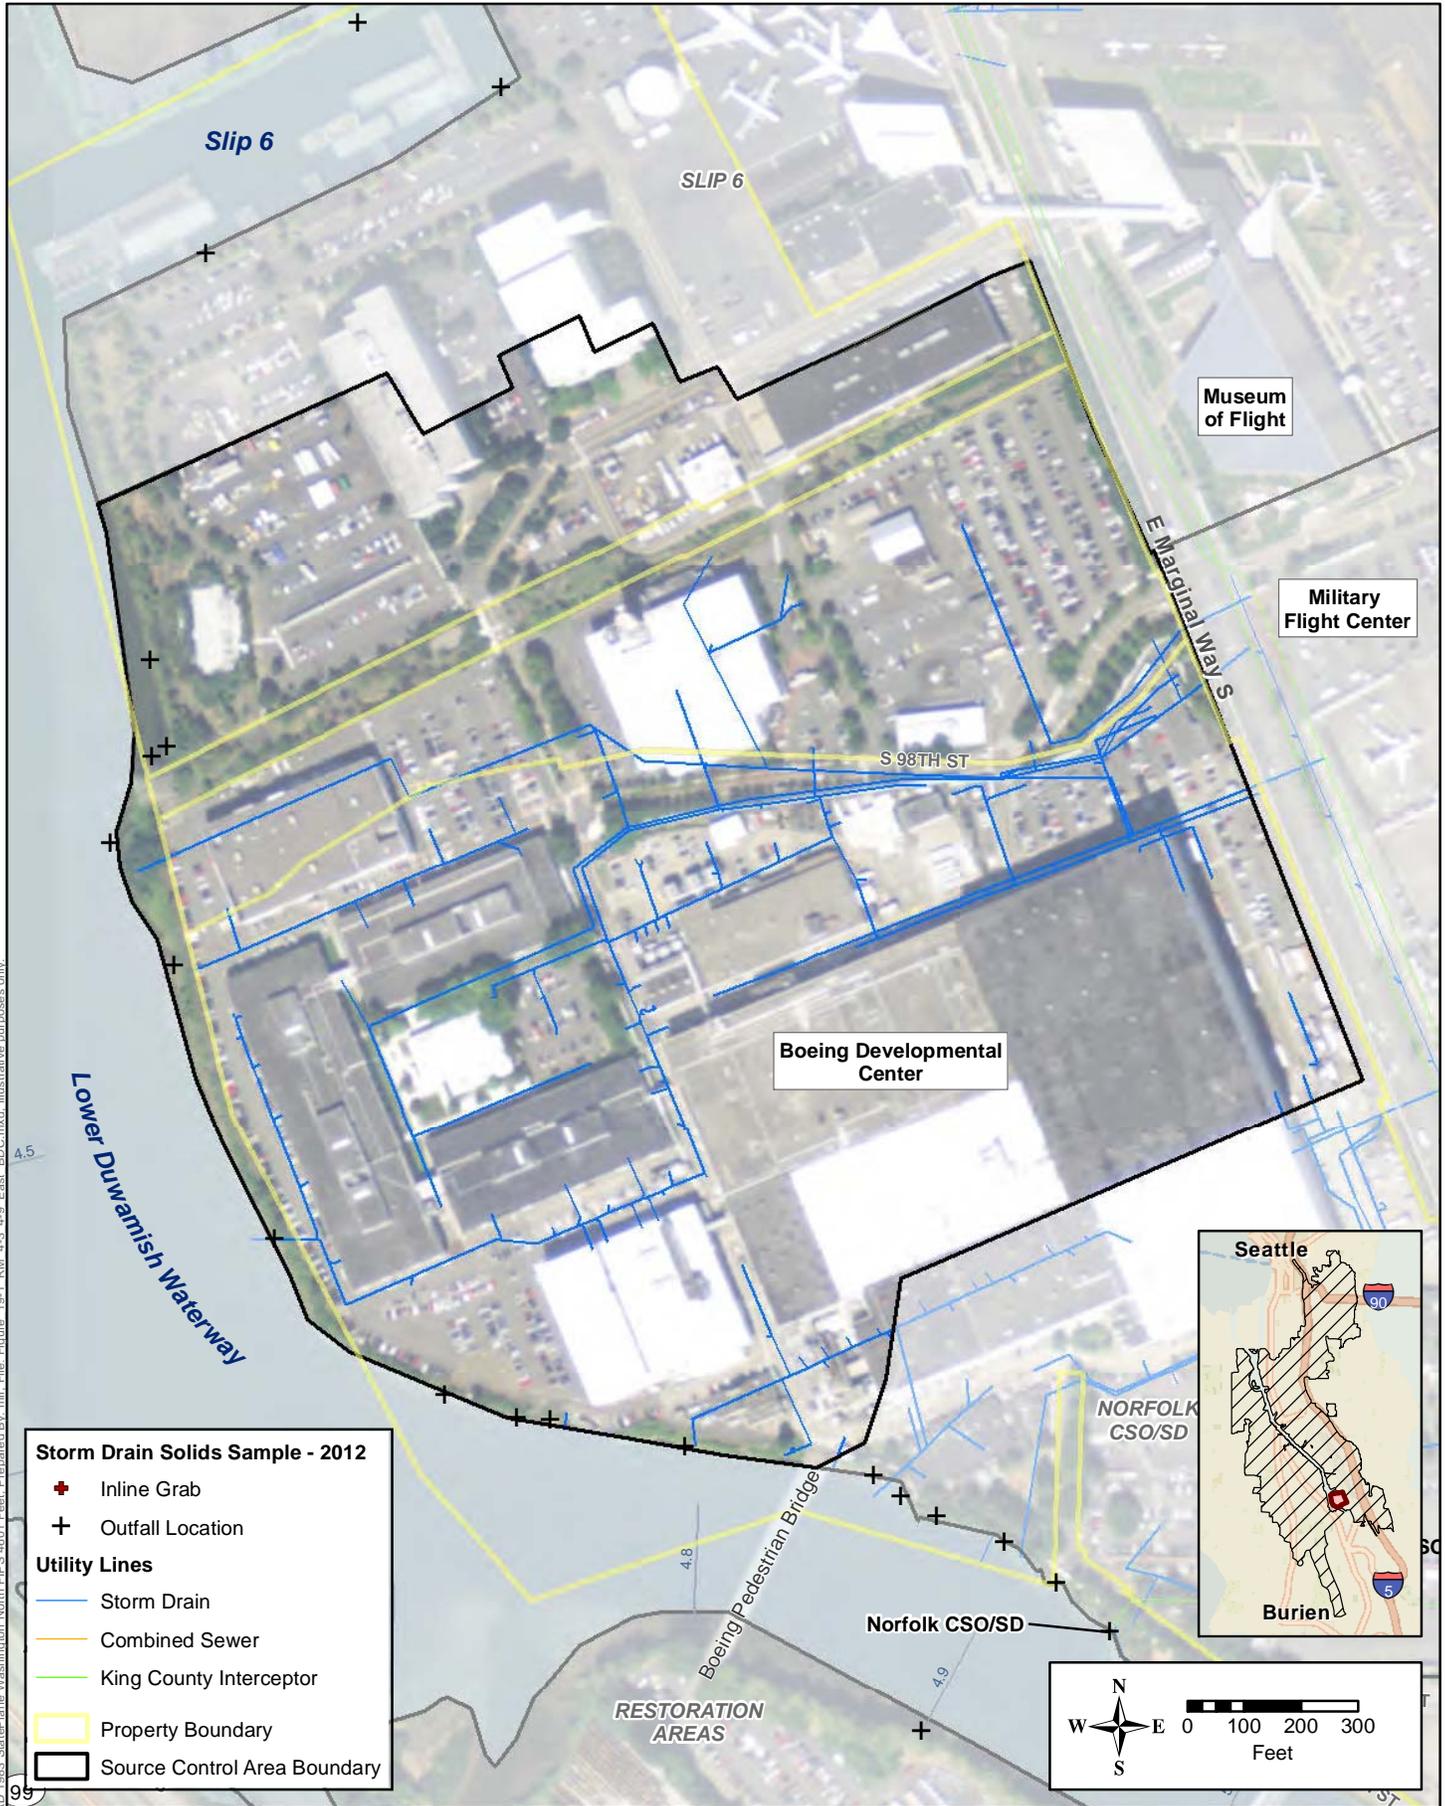
**Figure 19-1. RM 4.3-4.9 East:  
Boeing Developmental Center  
Source Control Area**

The RM 4.3-4.9 East (BDC) source control area is shown in Figure 19-1. This source control area includes stormwater drainage from 10 private outfalls located in the central portion of the BDC. There are no public storm drain outfalls located within RM 4.3-4.9 East. Source control action items for this source control area are listed in Table 3-3.
