Subject: Response to Comments Provided in Ecology's 3 January 2014 Letter  
*Augmented Remedial Investigation and Feasibility Study Report*  
Former Tacoma Metals Site – Tacoma, Washington  
Agreed Order DE 97-5435, Facility No. 1257, Cleanup Site ID 3910  
K/J 996098.00

Attachments: A: Technical Memorandum, Former Tacoma Metals Site, Boring B-36  
B: Technical Memorandum, Asphalt Cap  
C: Log for Test Pit TP-5 (as presented in the 2001 RI/FS)

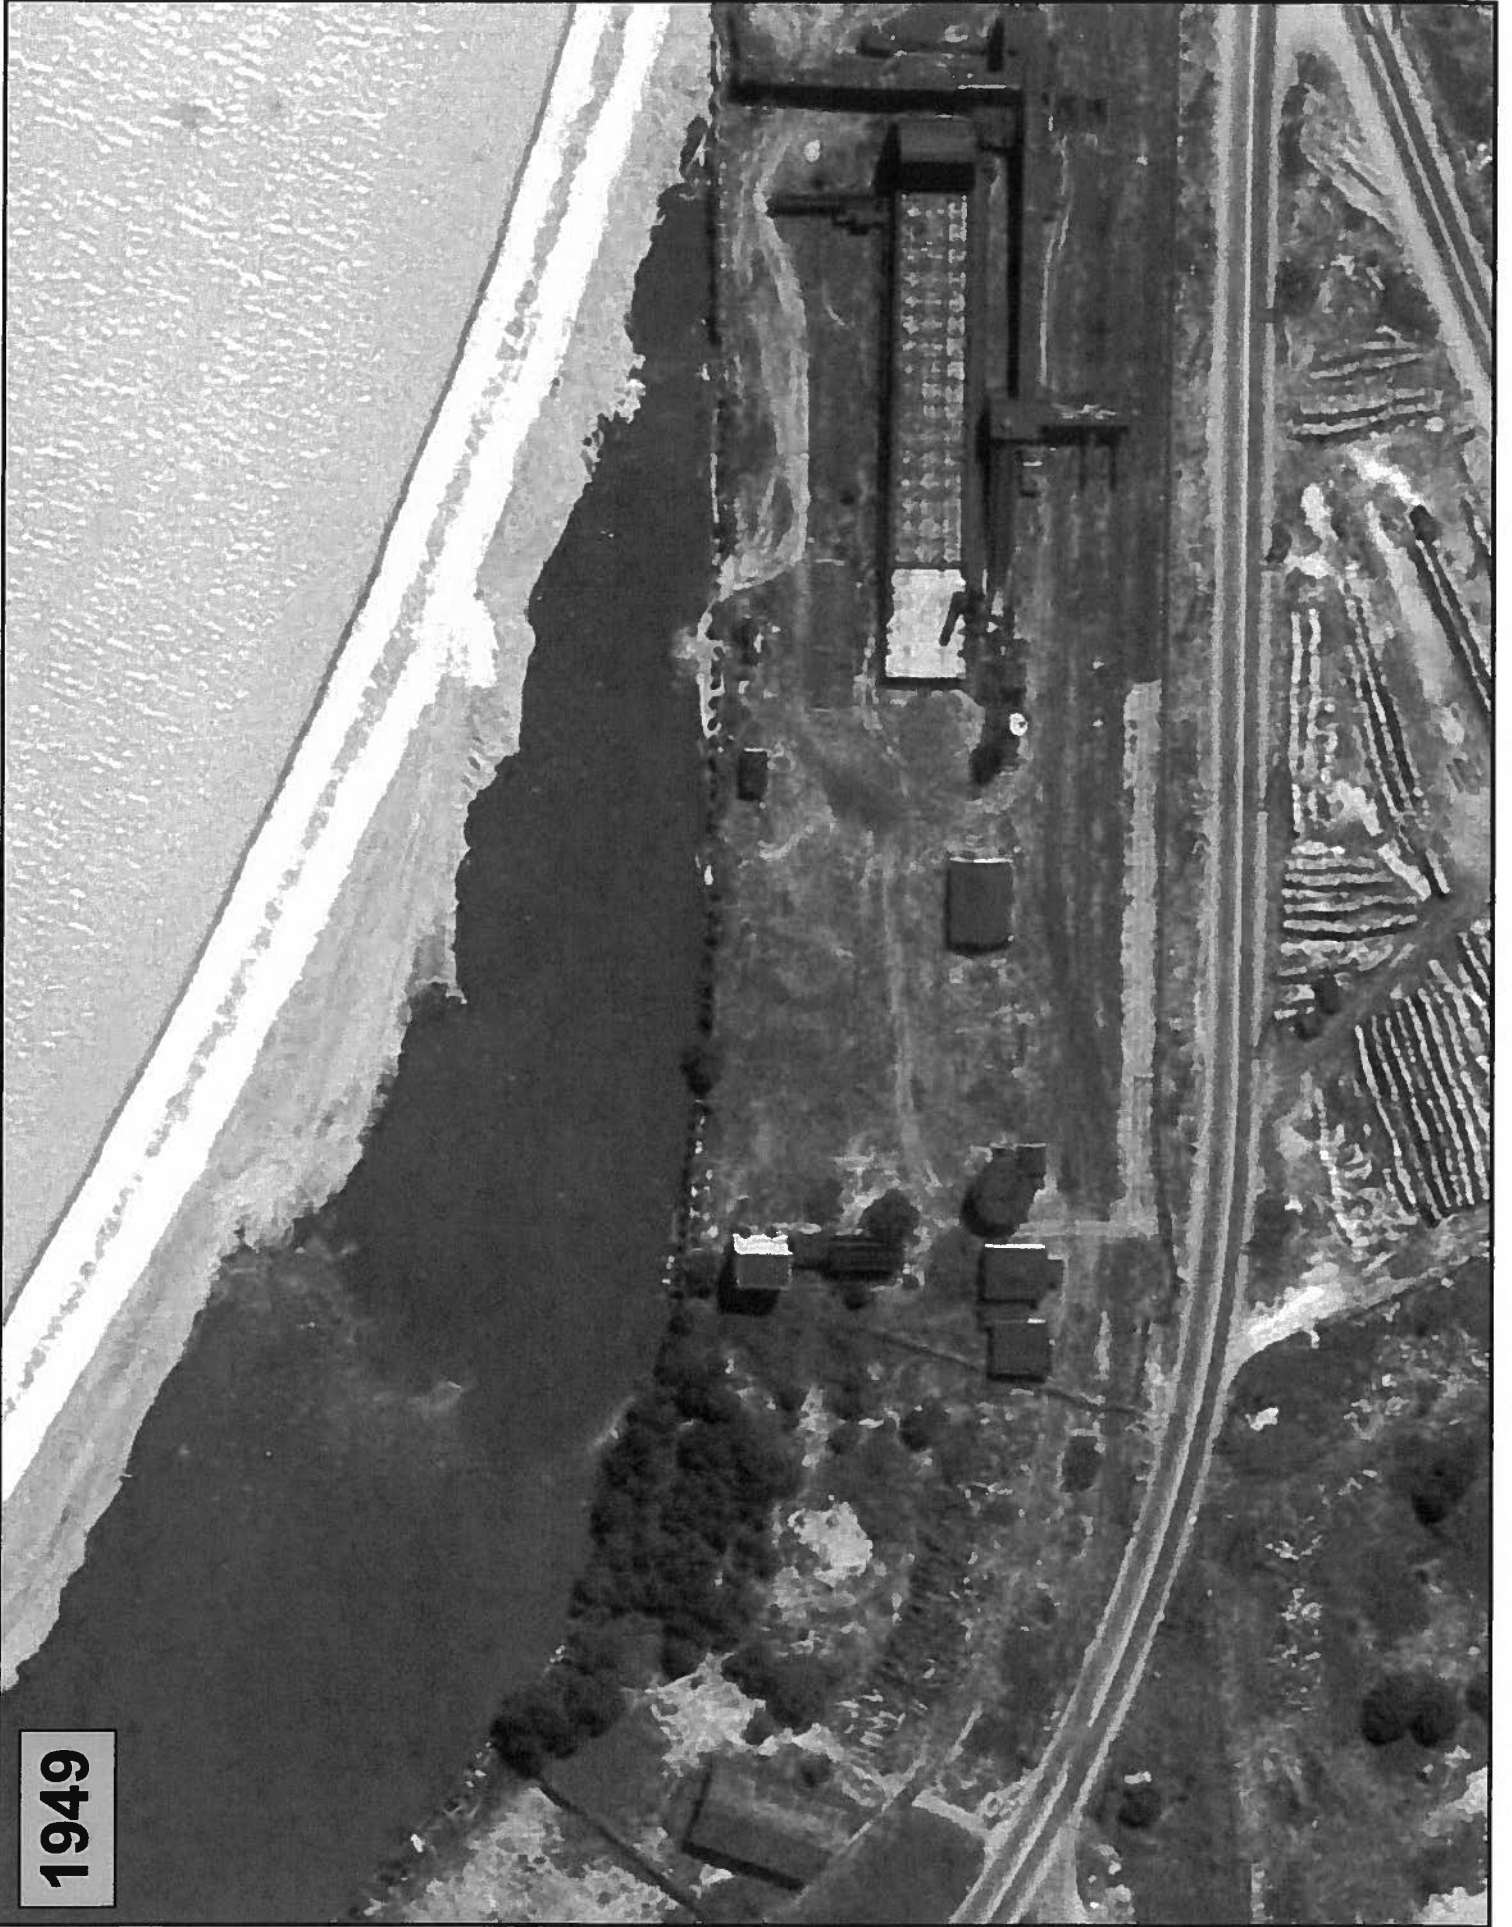
On the 1949 photograph (Figure 6), a pile of linear objects is visible on the western portion of the Simpson Property, including the boring B-36 area. These objects could not be specifically identified, but could be wooden poles or pilings, or possibly disassembled components of the former crane towers or elevated wood chip tramway. Regardless, the pile is uncovered, and if any of these materials included treated wood, shallow soil contaminants could have been introduced to the boring B-36 area by infiltration of rainwater through the piled materials into the underlying soil. These objects also appear to be present on the 1940 photograph, but farther west than on the 1949 photograph.
