REPORT OF VOLUNTARY REMEDIAL ACTION NORTH STAR LODGE 808 North 39th Avenue Yakima, Washington

Project Number 98921.1

March 25, 2002

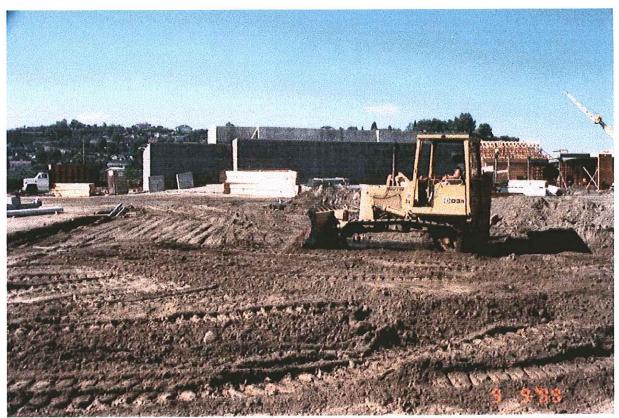
Picture 1: View from west looking east. Completion of vegetation removal.

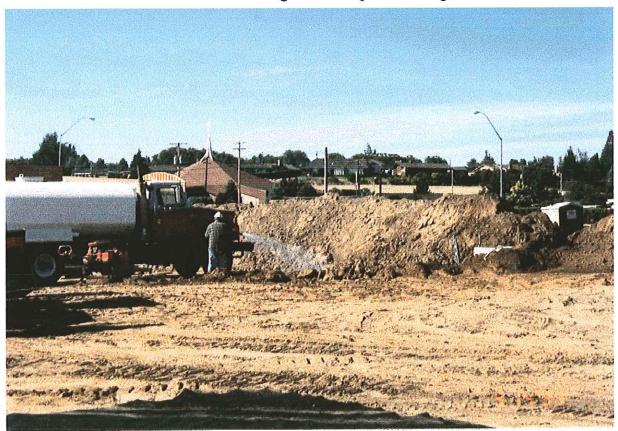
Picture 2: View from the east looking west. Dust suppression activities.

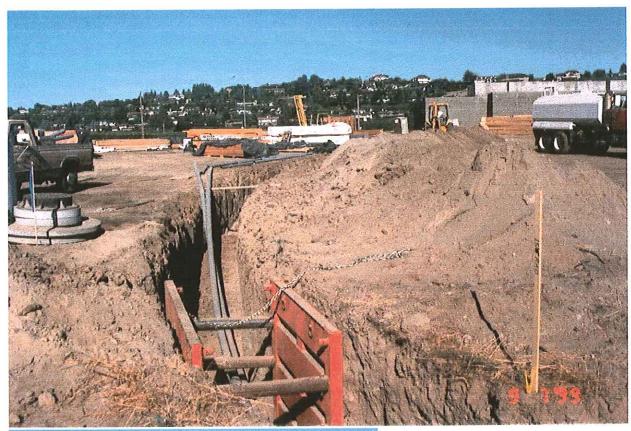
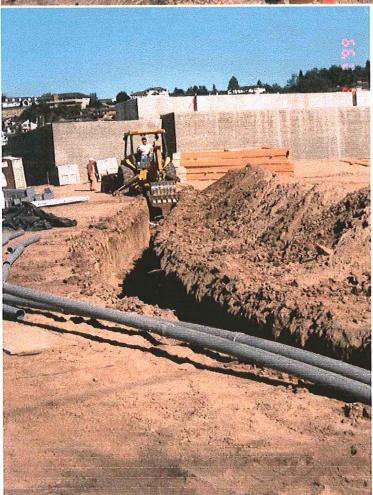
Pictures 3&4: View from the west looking east. Water main installation.

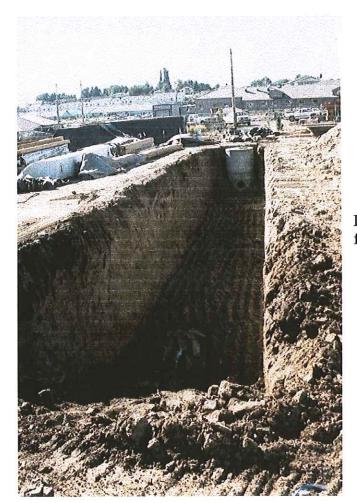
Picture 5: View to the south. Trench for water main installation.

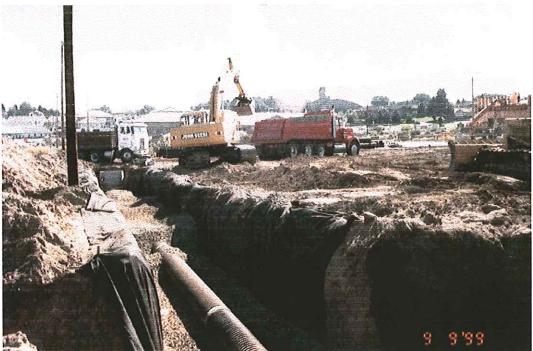
Picture 6: View to the southeast. Trench closure over water main installation.
