22-1-11288-001

**RE: REMEDIAL INVESTIGATION, COLUMBIA PARK WEST MARINA, ECOLOGY
SITE 84244226, RICHLAND, WASHINGTON**

**REMEDIAL INVESTIGATION
COLUMBIA PARK WEST MARINA
RICHLAND, WASHINGTON**

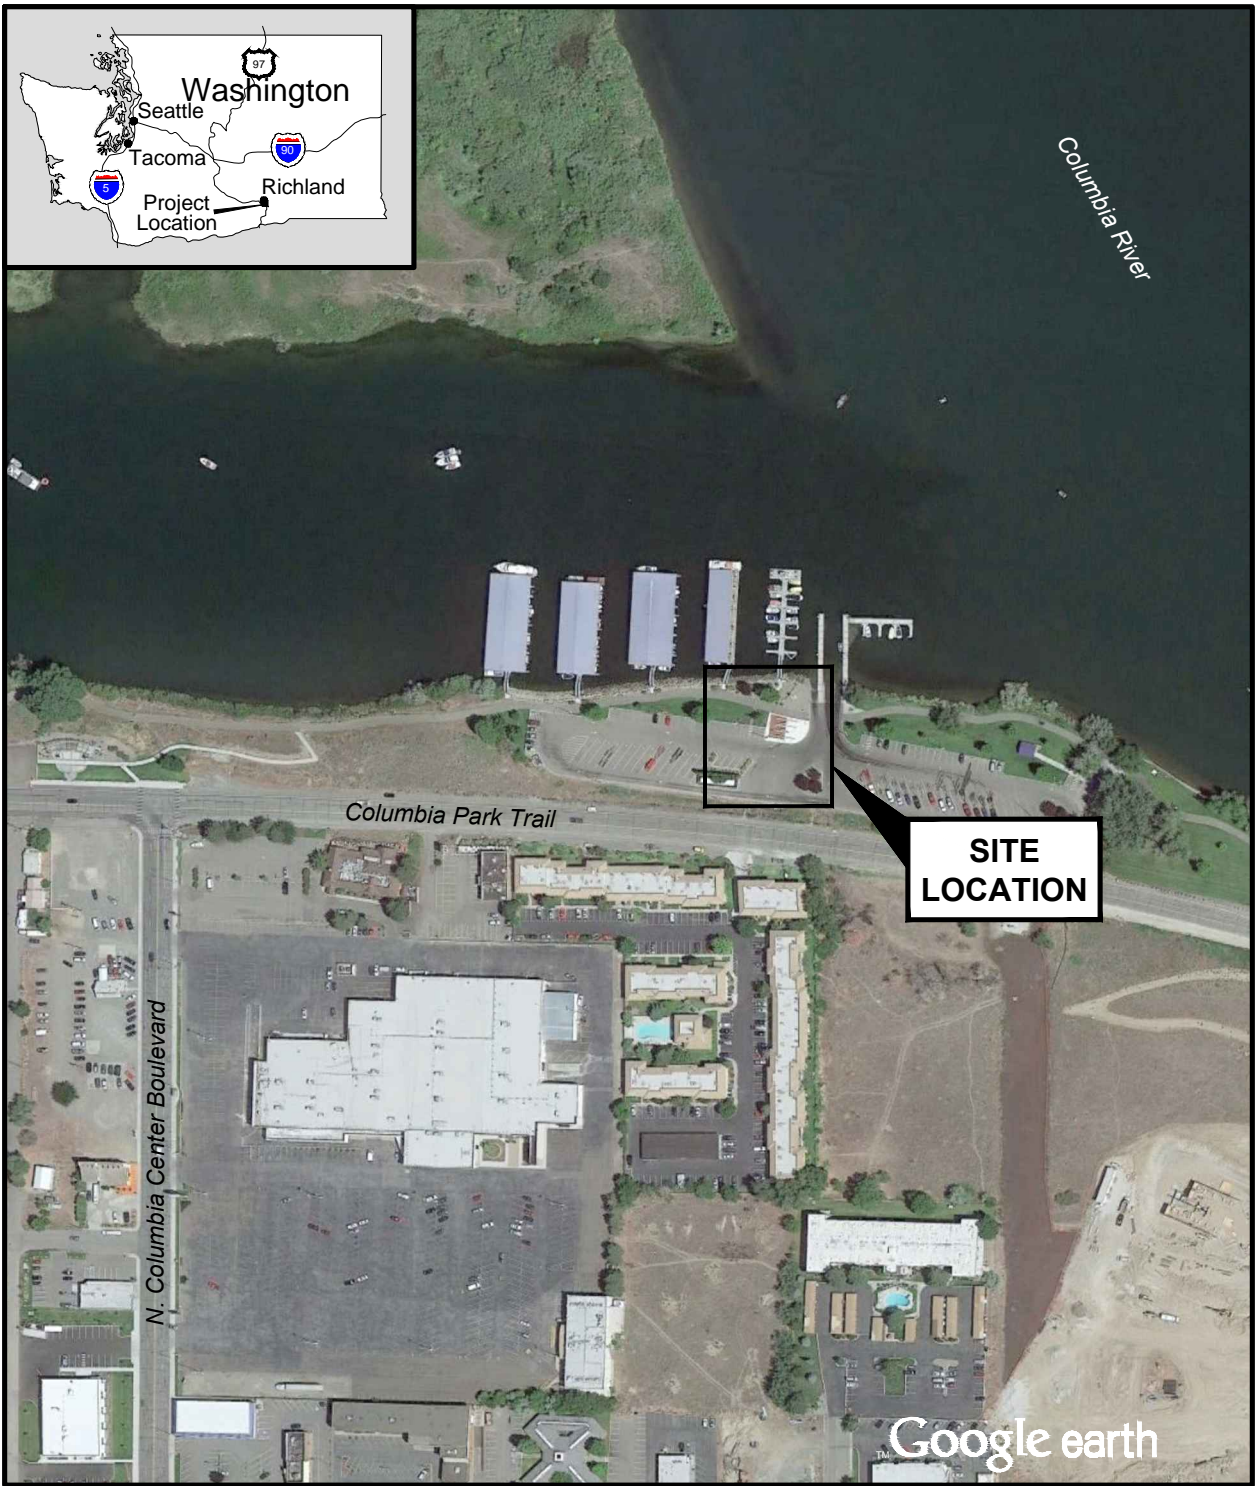
FIG. 1

SITE LOCATION MAP

The site is identified in Ecology's records as Columbia Park Marina, Facility ID #84244226. It is located at 1776 Columbia Park Trail in Richland, Washington. The Marina is approximately 950 feet east of the Columbia Center Boulevard and Columbia Park Trail intersection. The site's location is shown on a vicinity map on Figure 1, and Figure 2 is a site plan.

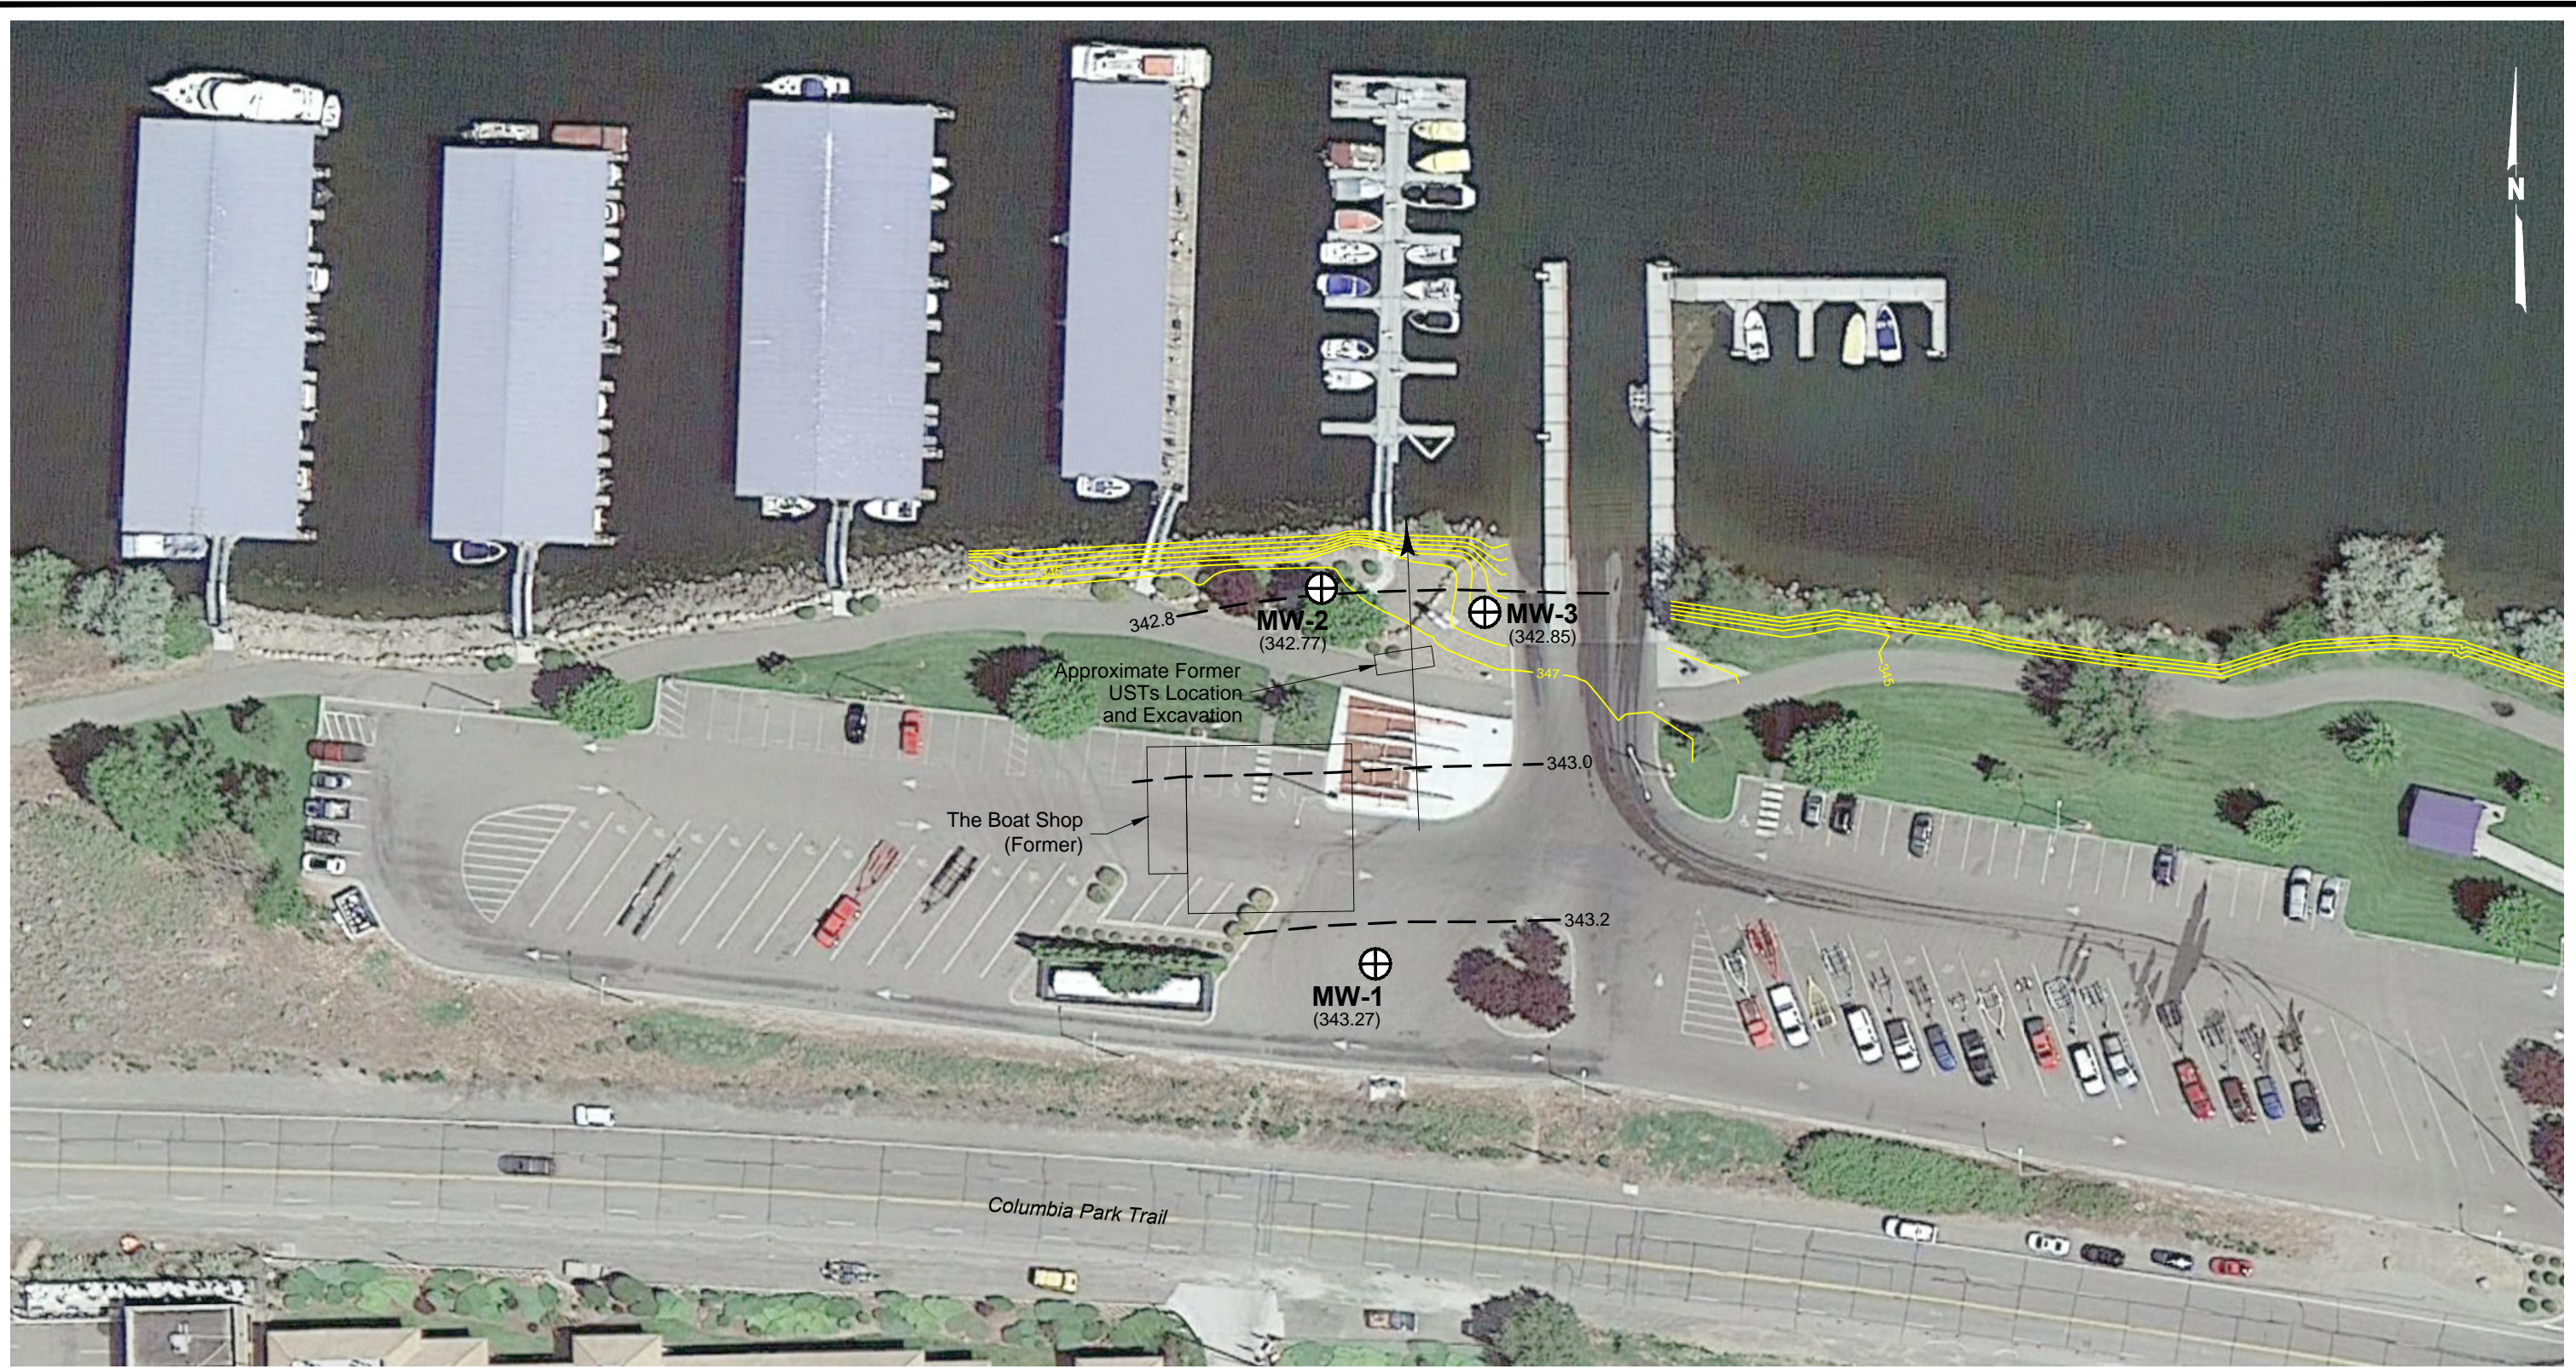
- MW-1** ⊕ Monitoring Well Designation and Approximate Location (Groundwater Elevation in Feet, 2-26-14)
- 342.8 — — Approximate Groundwater Elevation
- ← — — Approximate Groundwater Flow Direction

According to a tank closure report (White Shield, 1994) two 1,000-gallon leaded gasoline USTs were removed from the site in April 1994. Based on drawings and descriptions in the report, the tanks and dispensers were located approximately 40 feet south of the Columbia River and west of the boat launch ramp. The estimated former UST and The Boat Shop locations are shown on Figure 2.

Relative to the former tank basin, monitoring well MW-1 is located to the south, MW-2 is located northwest and MW-3 is located northeast. The well locations are shown on Figure 2.

On February 26, the water surface elevation was higher at the south well, indicating a groundwater flow direction toward the river, or toward the north. Figure 2 shows approximate groundwater elevation contours and the groundwater flow direction on February 26, 2014.
