# Site Hazard Assessment

**Chevron Station 98944**  
**1323 Lee Blvd**  
**Richland, WA 99352**

**Ecology Facility Site ID No.: 27223439**  
**Cleanup Site ID: 5798**  
**December 17, 2014**

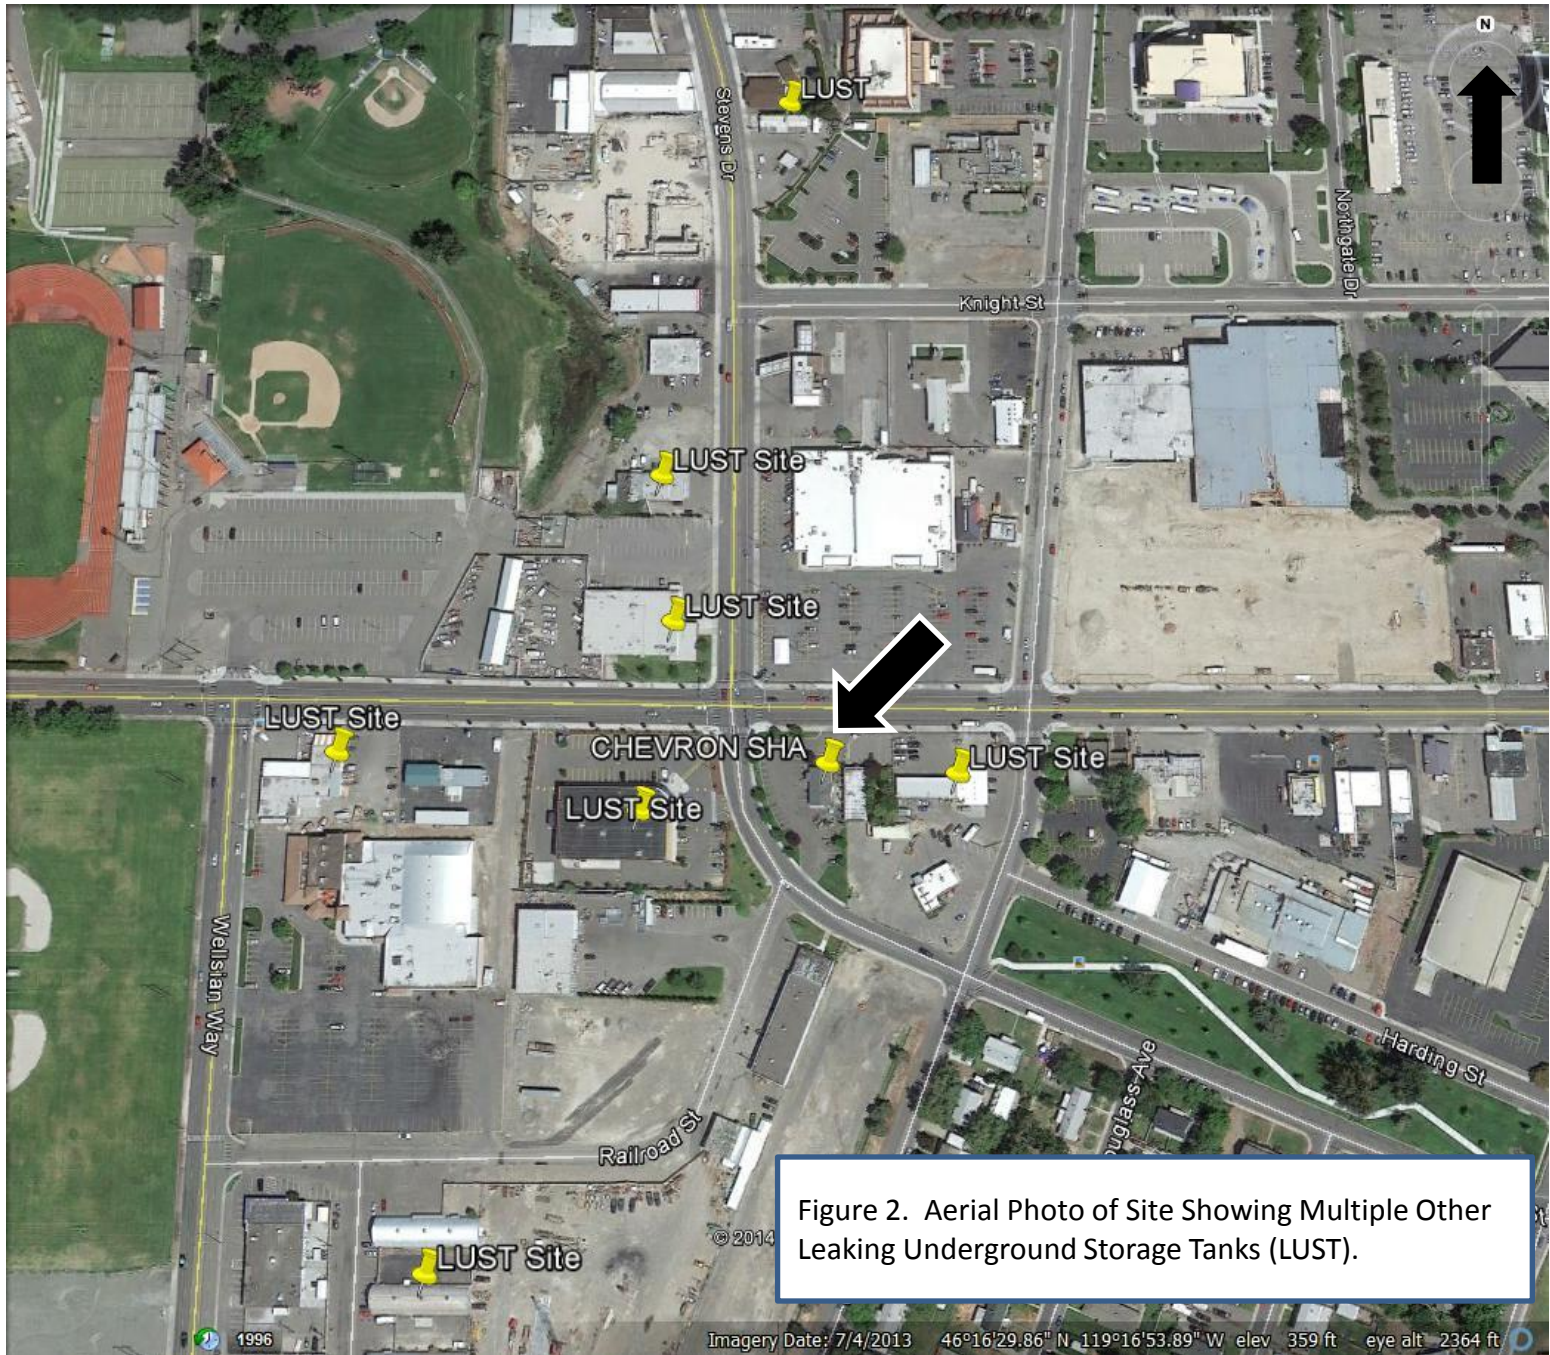
Figure 2. Aerial Photo of Site Showing Multiple Other Leaking Underground Storage Tanks (LUST).

The site is currently occupied by a Subway restaurant which is located in the northeast portion of the lot. The site is in close proximity to three other LUST sites (Figure 2). P&K Auto (Facility #38448497) is located approximately 100 feet due west of the Chevron site. P&K Auto site ranked as a “2” in August 2005 and later given a “No Further Action” in December 2008. The site is now a Rite Aid drug store. Approximately 170 feet to the northwest is the US Bank Facility (Facility #44976422) which was given a ranking of “3” in December 2005. There is no documentation of an official cleanup at the site. Leo’s Line Up (aka L&L Exxon Service, Facility #78835792) is located approximately 130 feet due east. It was given a ranking of “2” in August 2010 and final cleanup was completed in September 2014.

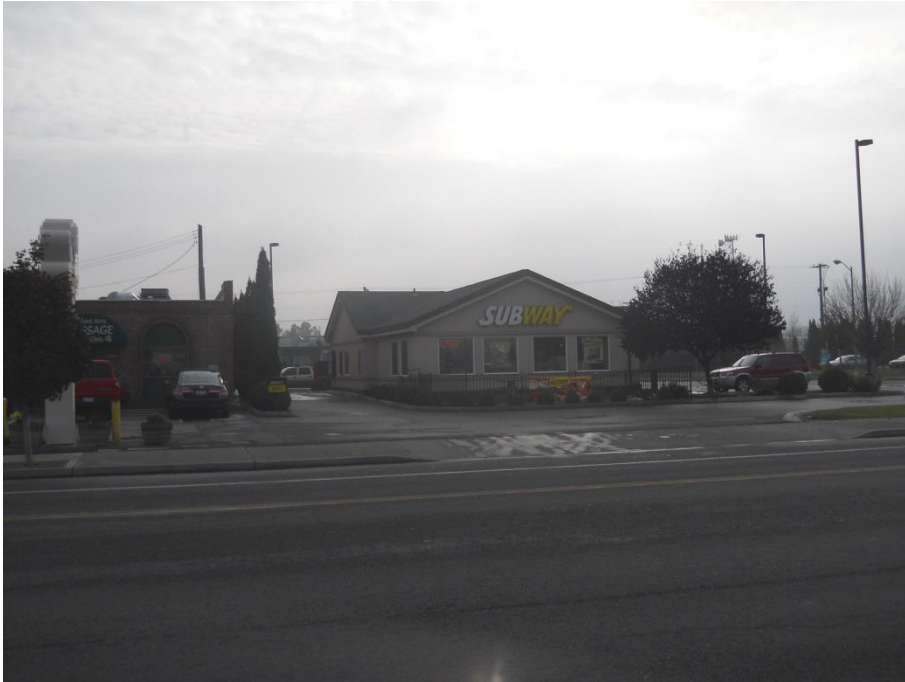
**Photo 1: View of Subway Restaurant, Photo taken looking to south**

The site is level and the entrances and parking lot are covered in asphalt (see Figure 7, Photos 1-4). The perimeter of the site has some landscaping and city sidewalks. The current business directly to the east is Ancient Arts Massage. The rear of this property is covered with gravel. The six monitoring wells (MW-4 through MW-8) shown in Figure 6 were still present. A photo of MW-6 was taken. Storm drains were present in the parking area. Soils at the site are described as were fine sandy silt to about 7 feet bgs and sandy gravel from 7 to 15 feet bgs (3).

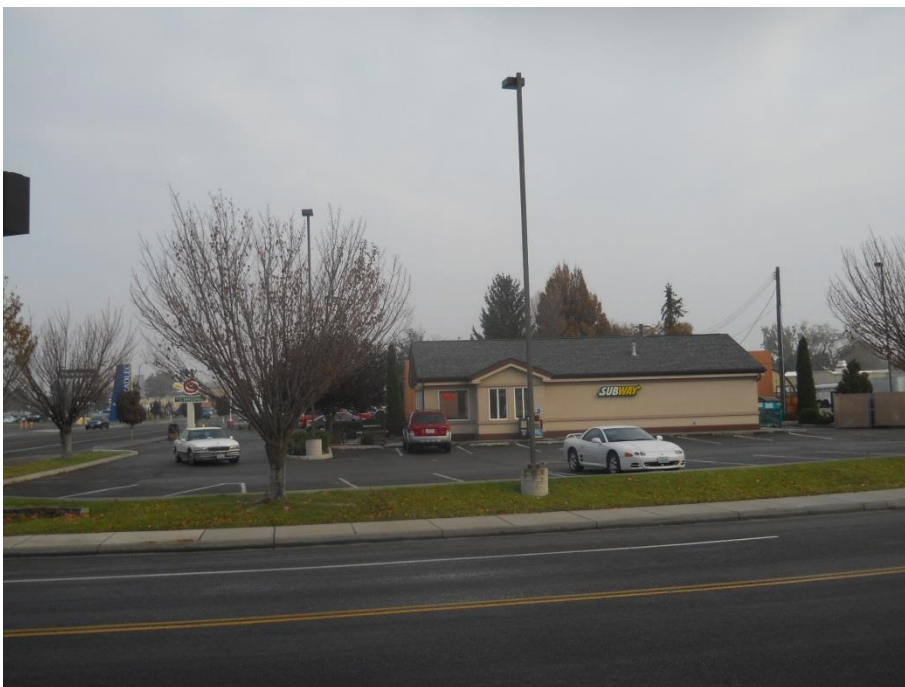
**Photo 2: View of Subway Restaurant. Photo taken looking to the east.**

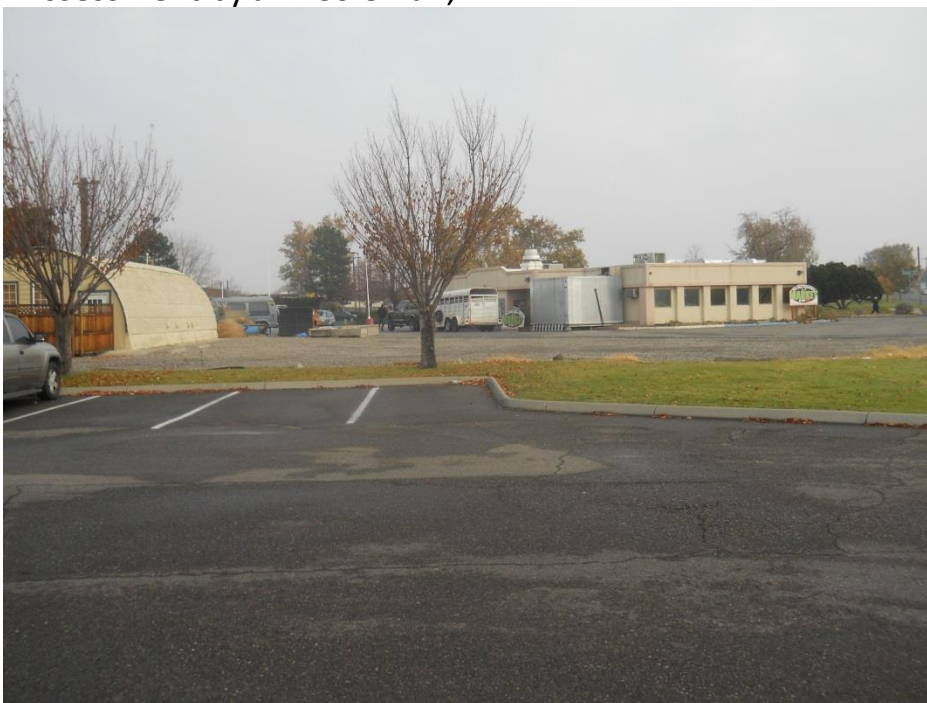
**Photo 3: A portion of the rear parking lot and non-asphalt (gravel) area on adjoining property to the southeast of the Subway Restaurant.**

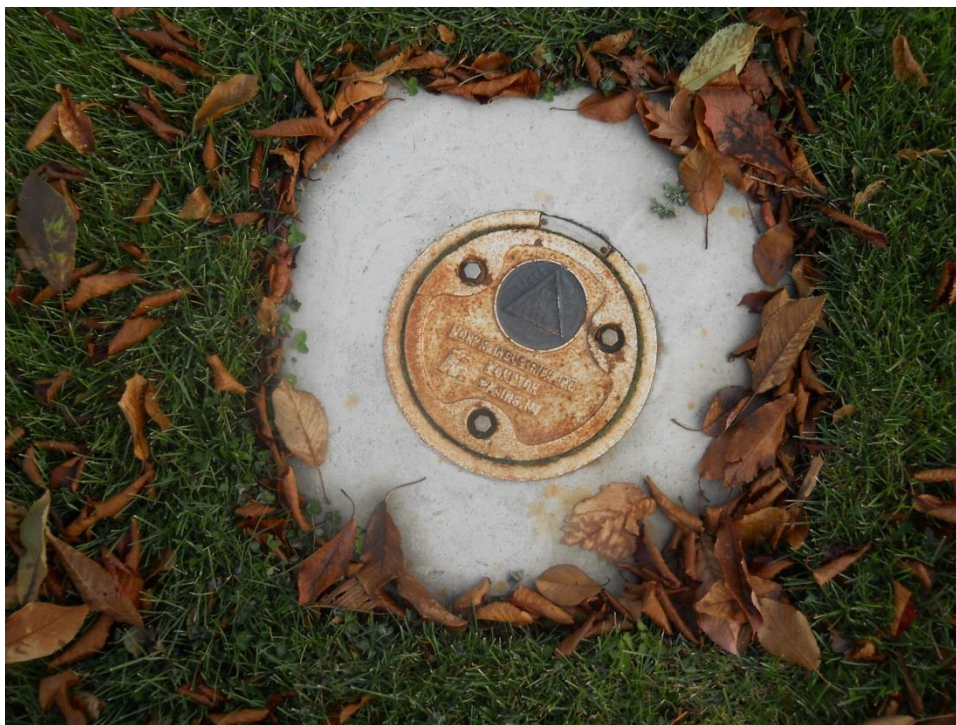
**Photo 4: Photo of access port to monitoring well 6, typical of all MW on site.**
