## Surveys and As-Built Drawings

# NORTHLAKE SHIPYARD SAND BLAST GRIT DREDGING INTERIM ACTION

## Multibeam Pre-Dredge Survey - Phase 1

APPENDIX B  
Selected Site Photographs

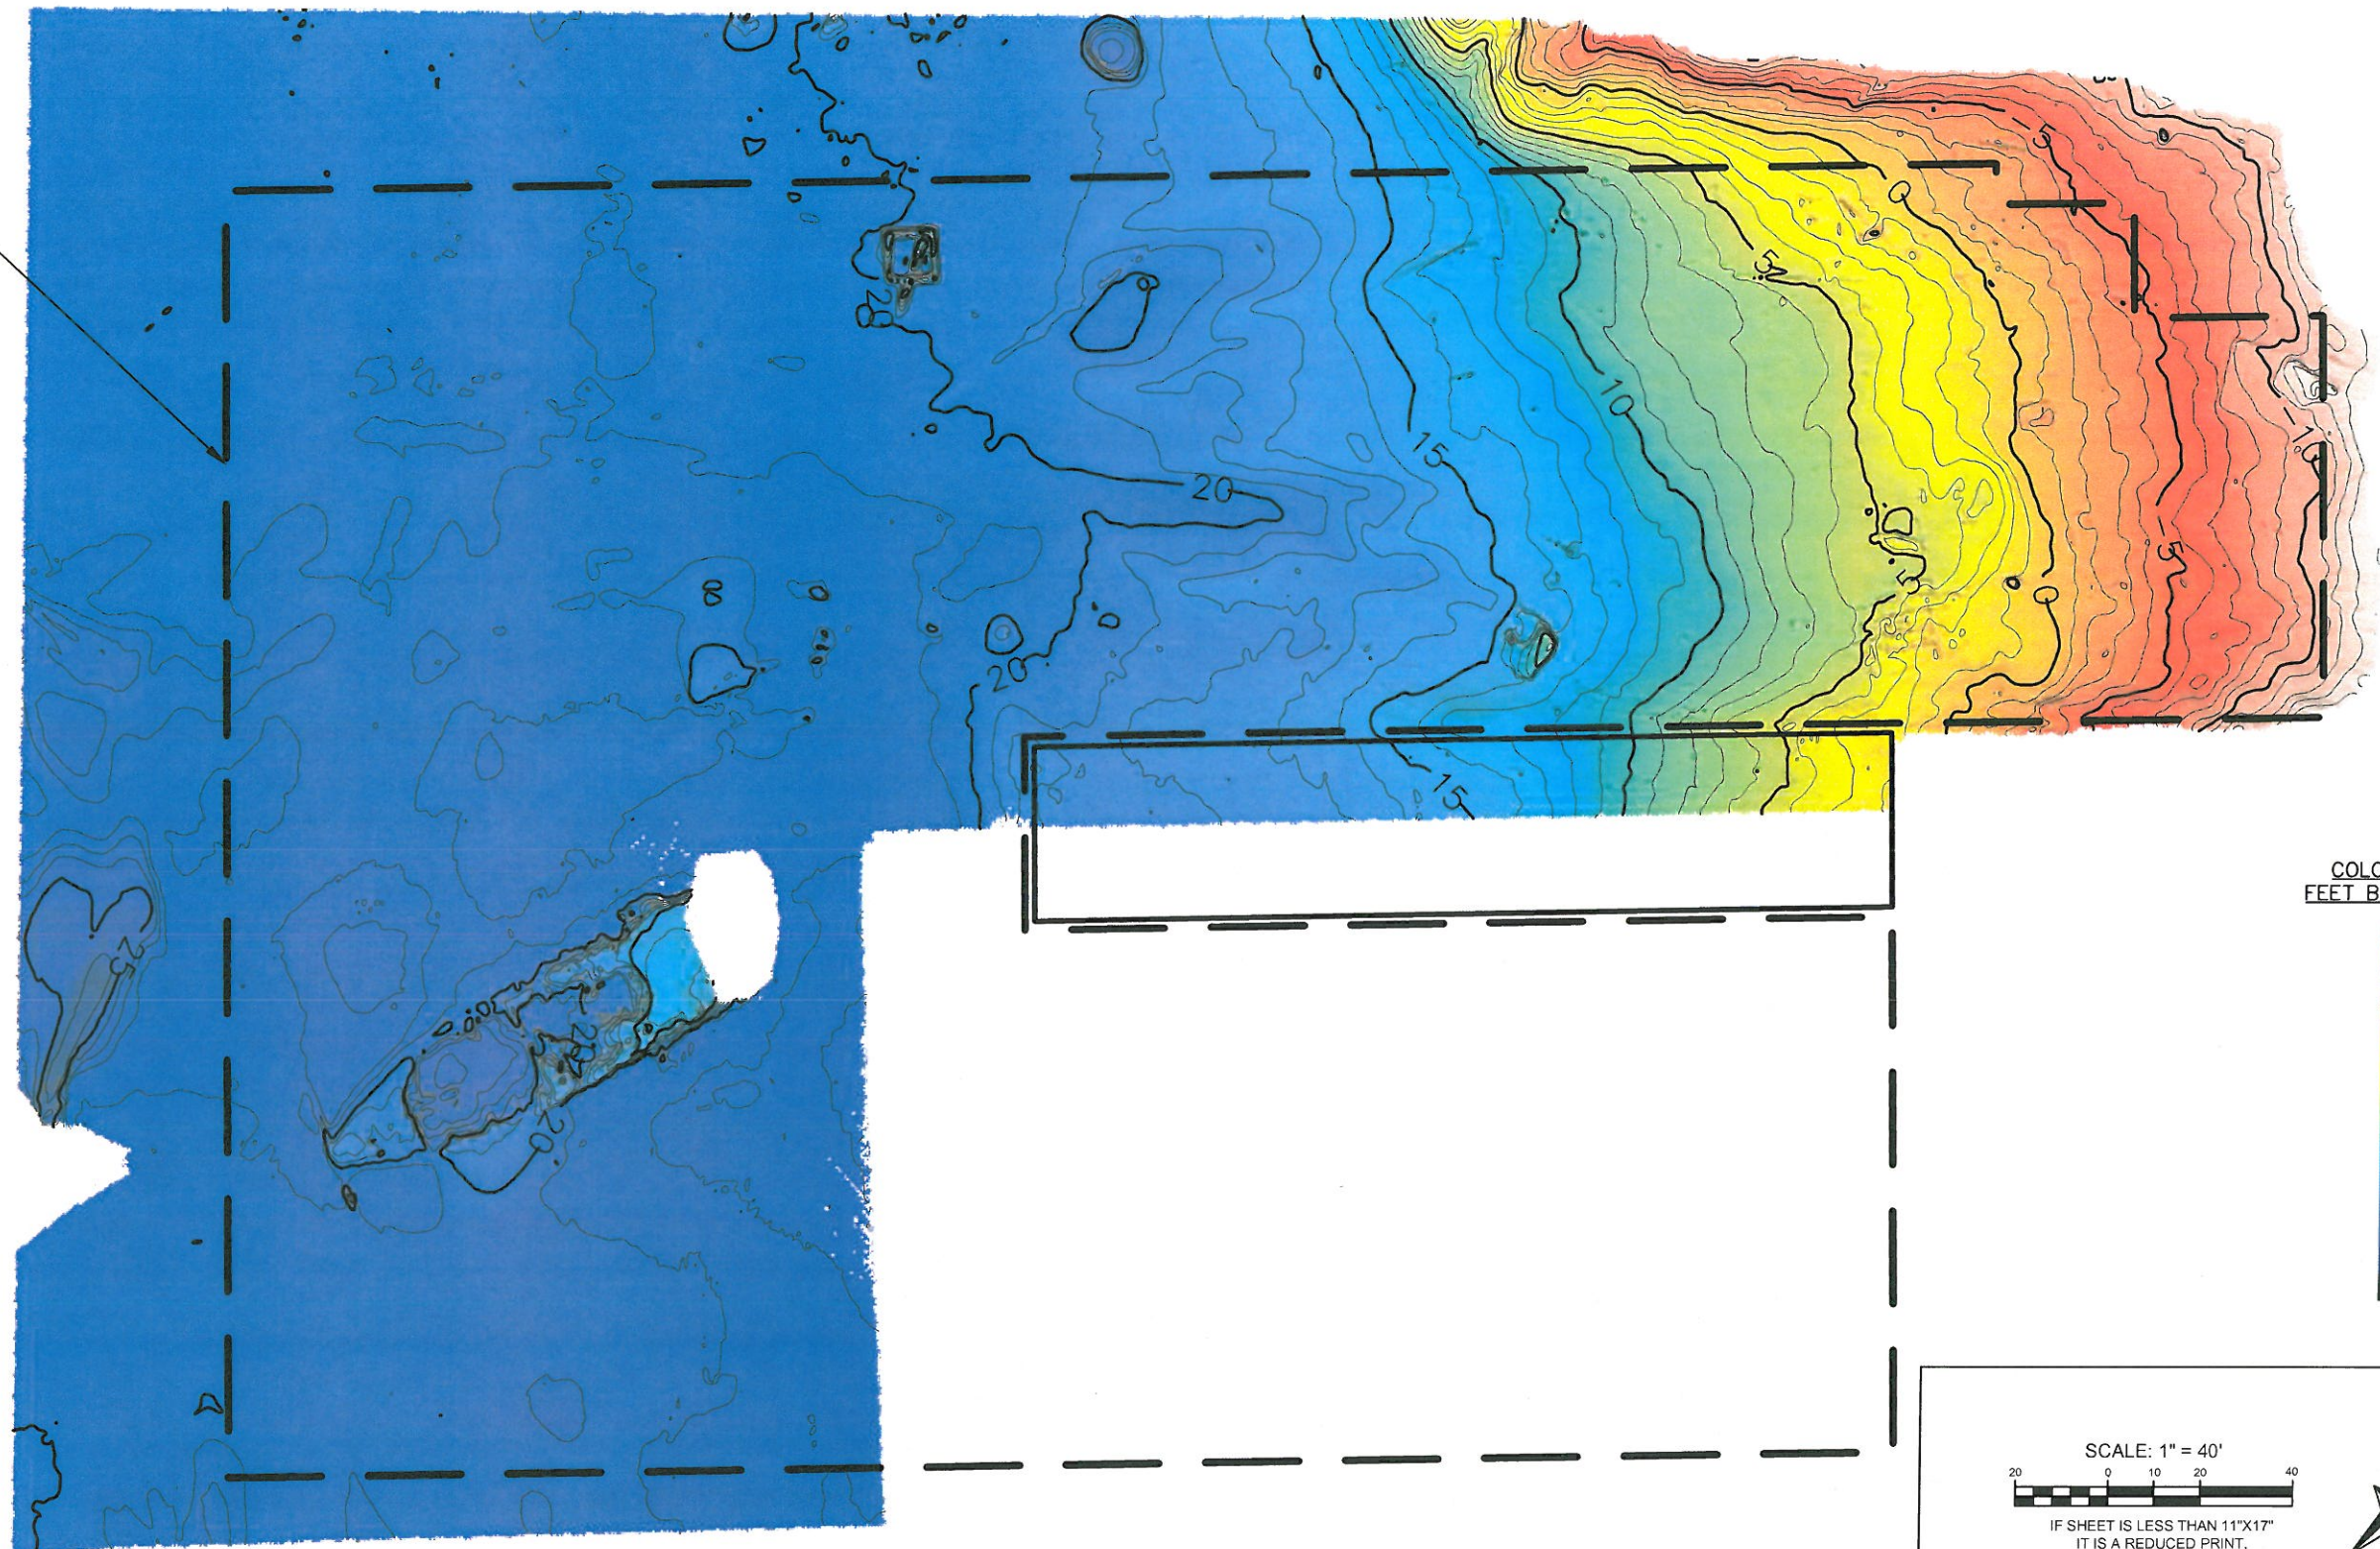
Reference  
Number:  
**S2**

Approximate  
Extent of  
Dredging

NORTHLAKE SHIPYARD  
SAND BLAST GRIT DREDGING  
INTERIM ACTION  
Multibeam Imagery and Contours

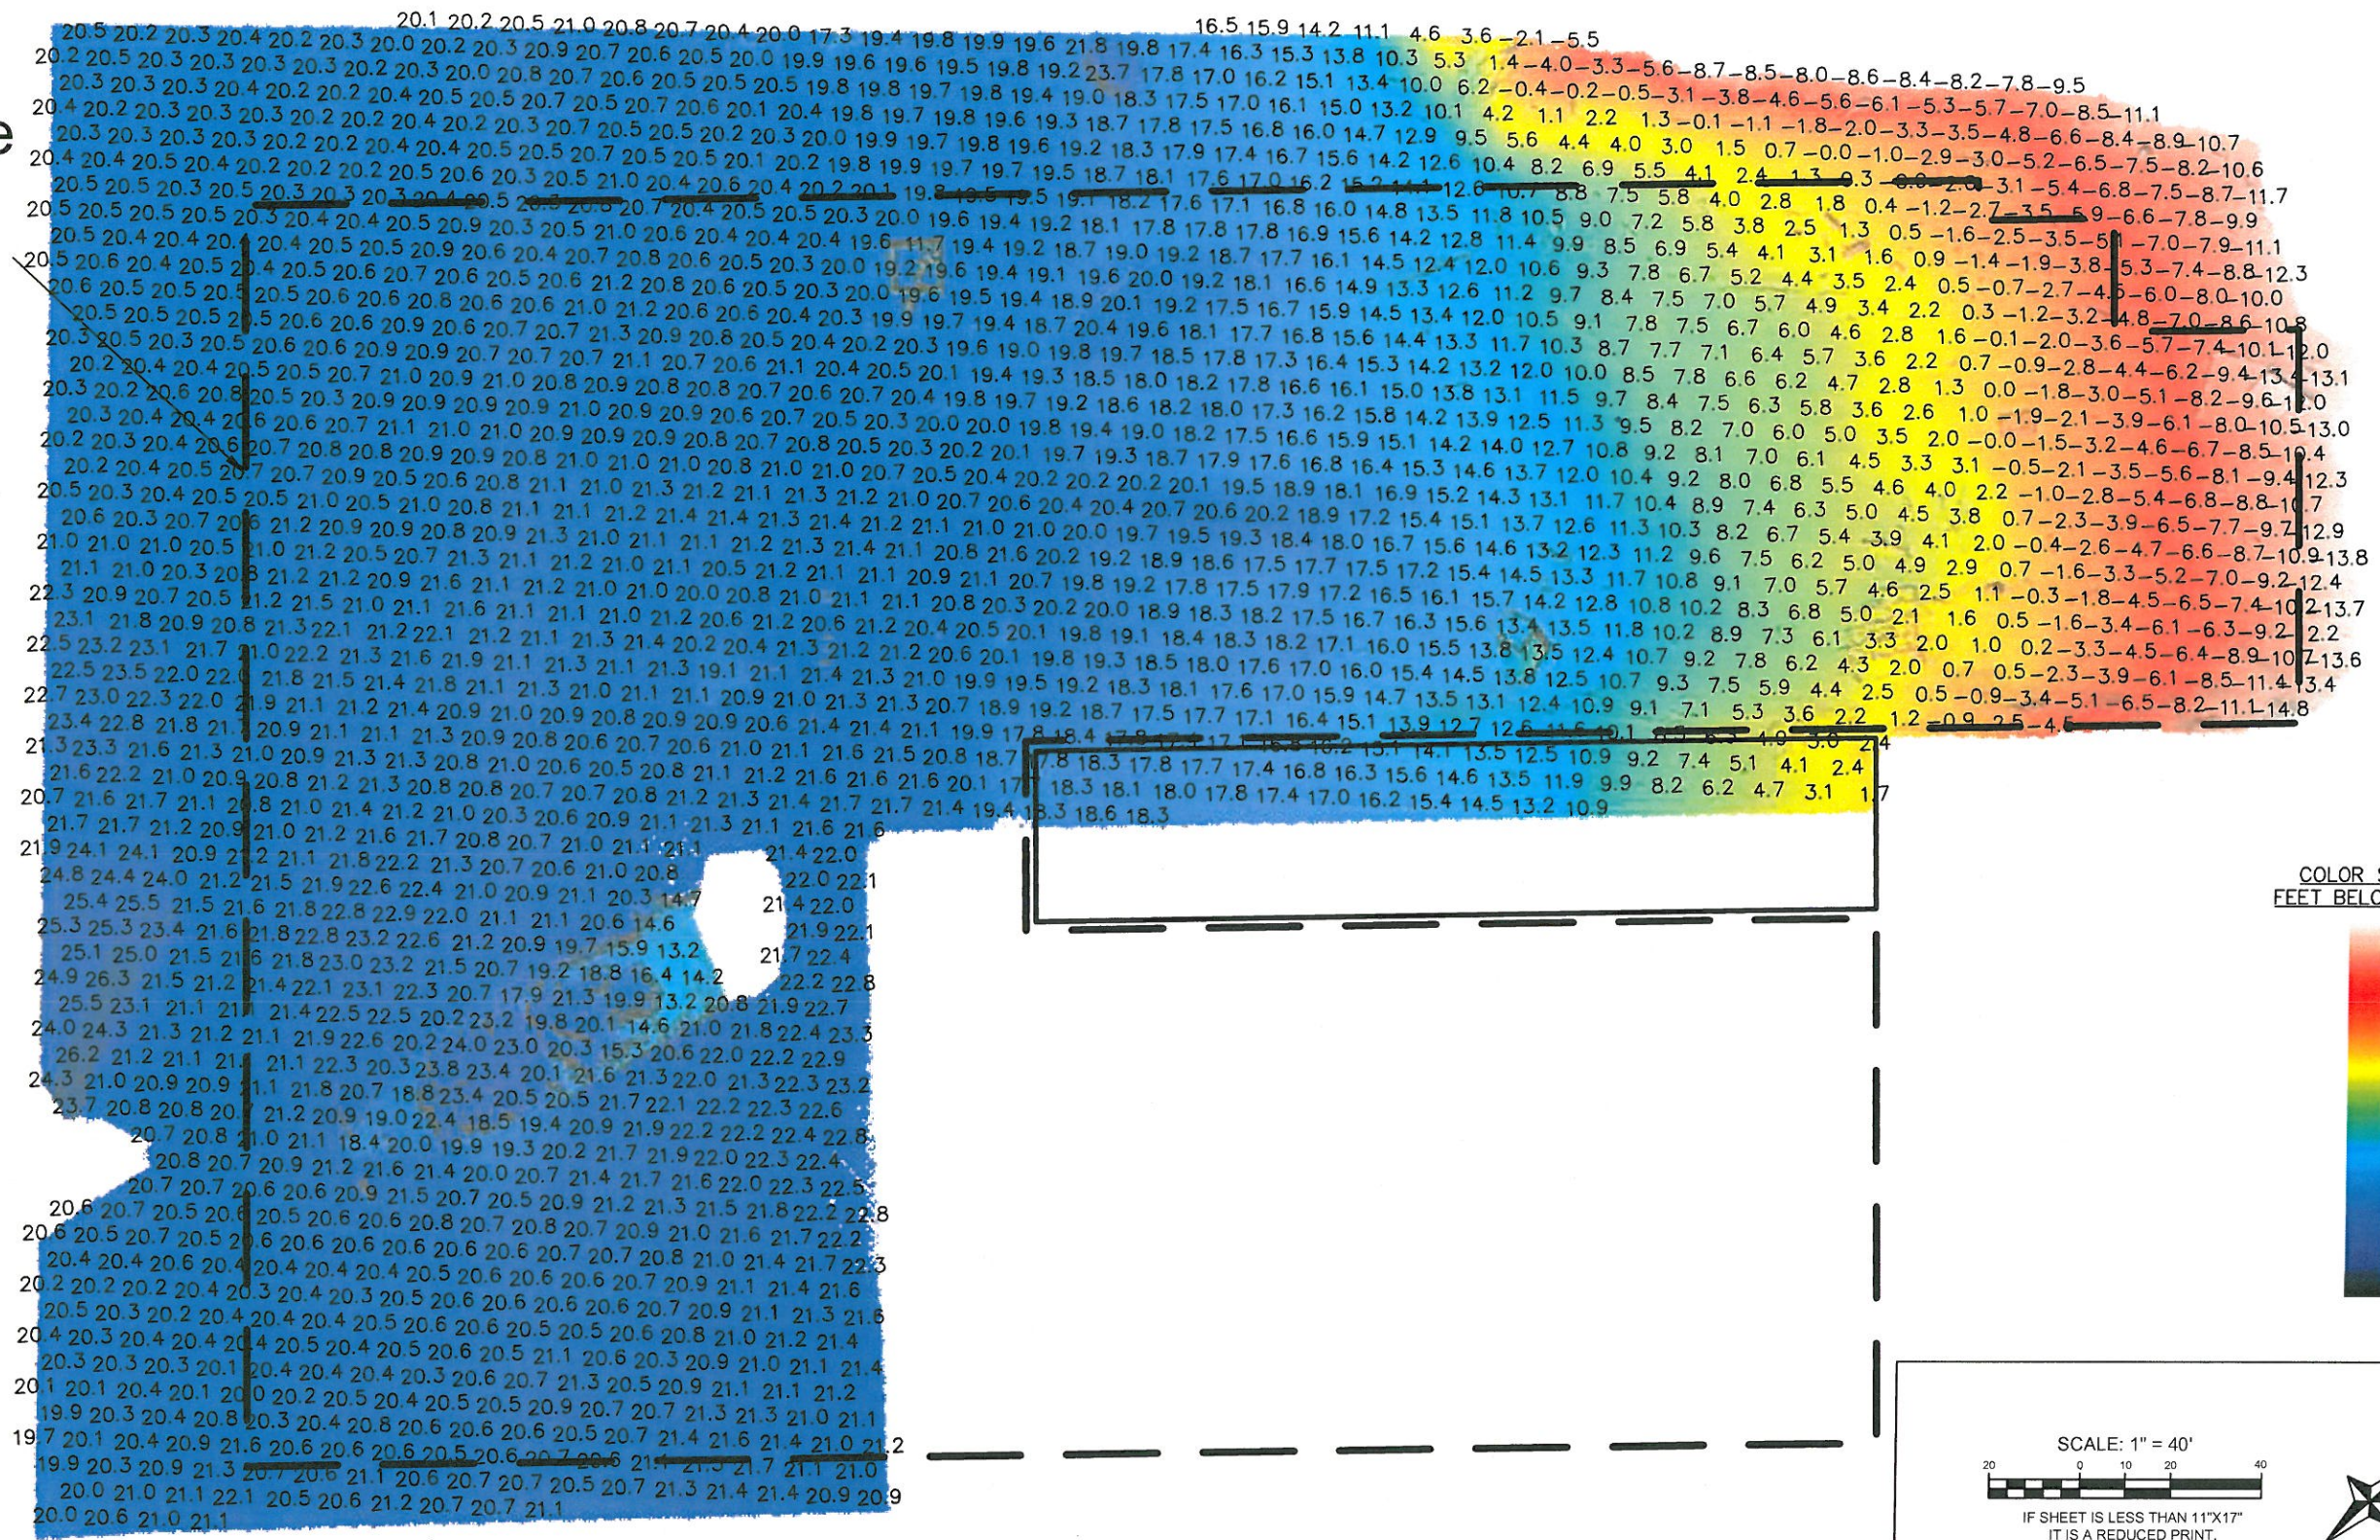
Reference  
Number:  
**S3**

Approximate  
Extent of  
Dredging

NORTHLAKE SHIPYARD  
SAND BLAST GRIT DREDGING  
INTERIM ACTION  
Soundings

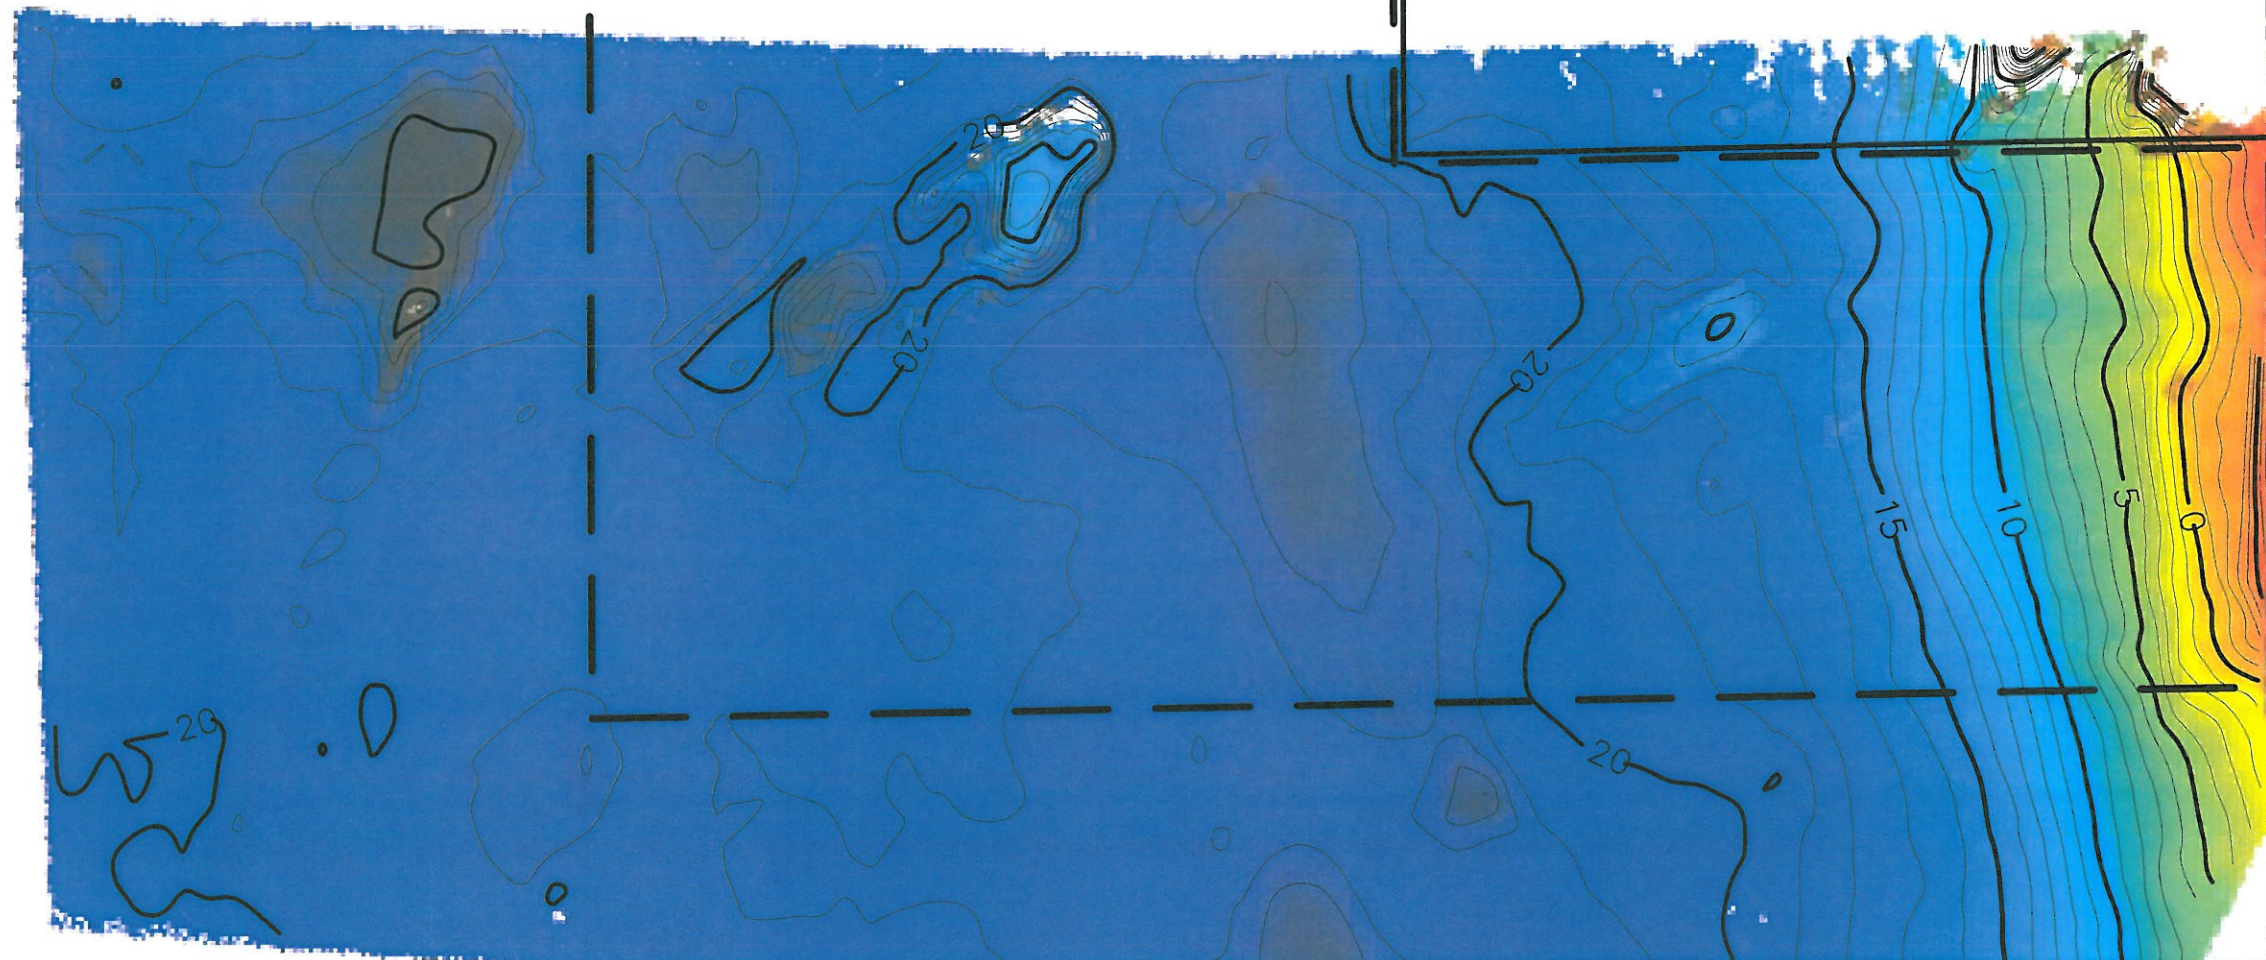
Reference  
Number:  
**S2**

Approximate  
Extent of  
Dredging

NORTHLAKE SHIPYARD  
SAND BLAST GRIT DREDGING  
INTERIM ACTION  
Multibeam Imagery and Contours

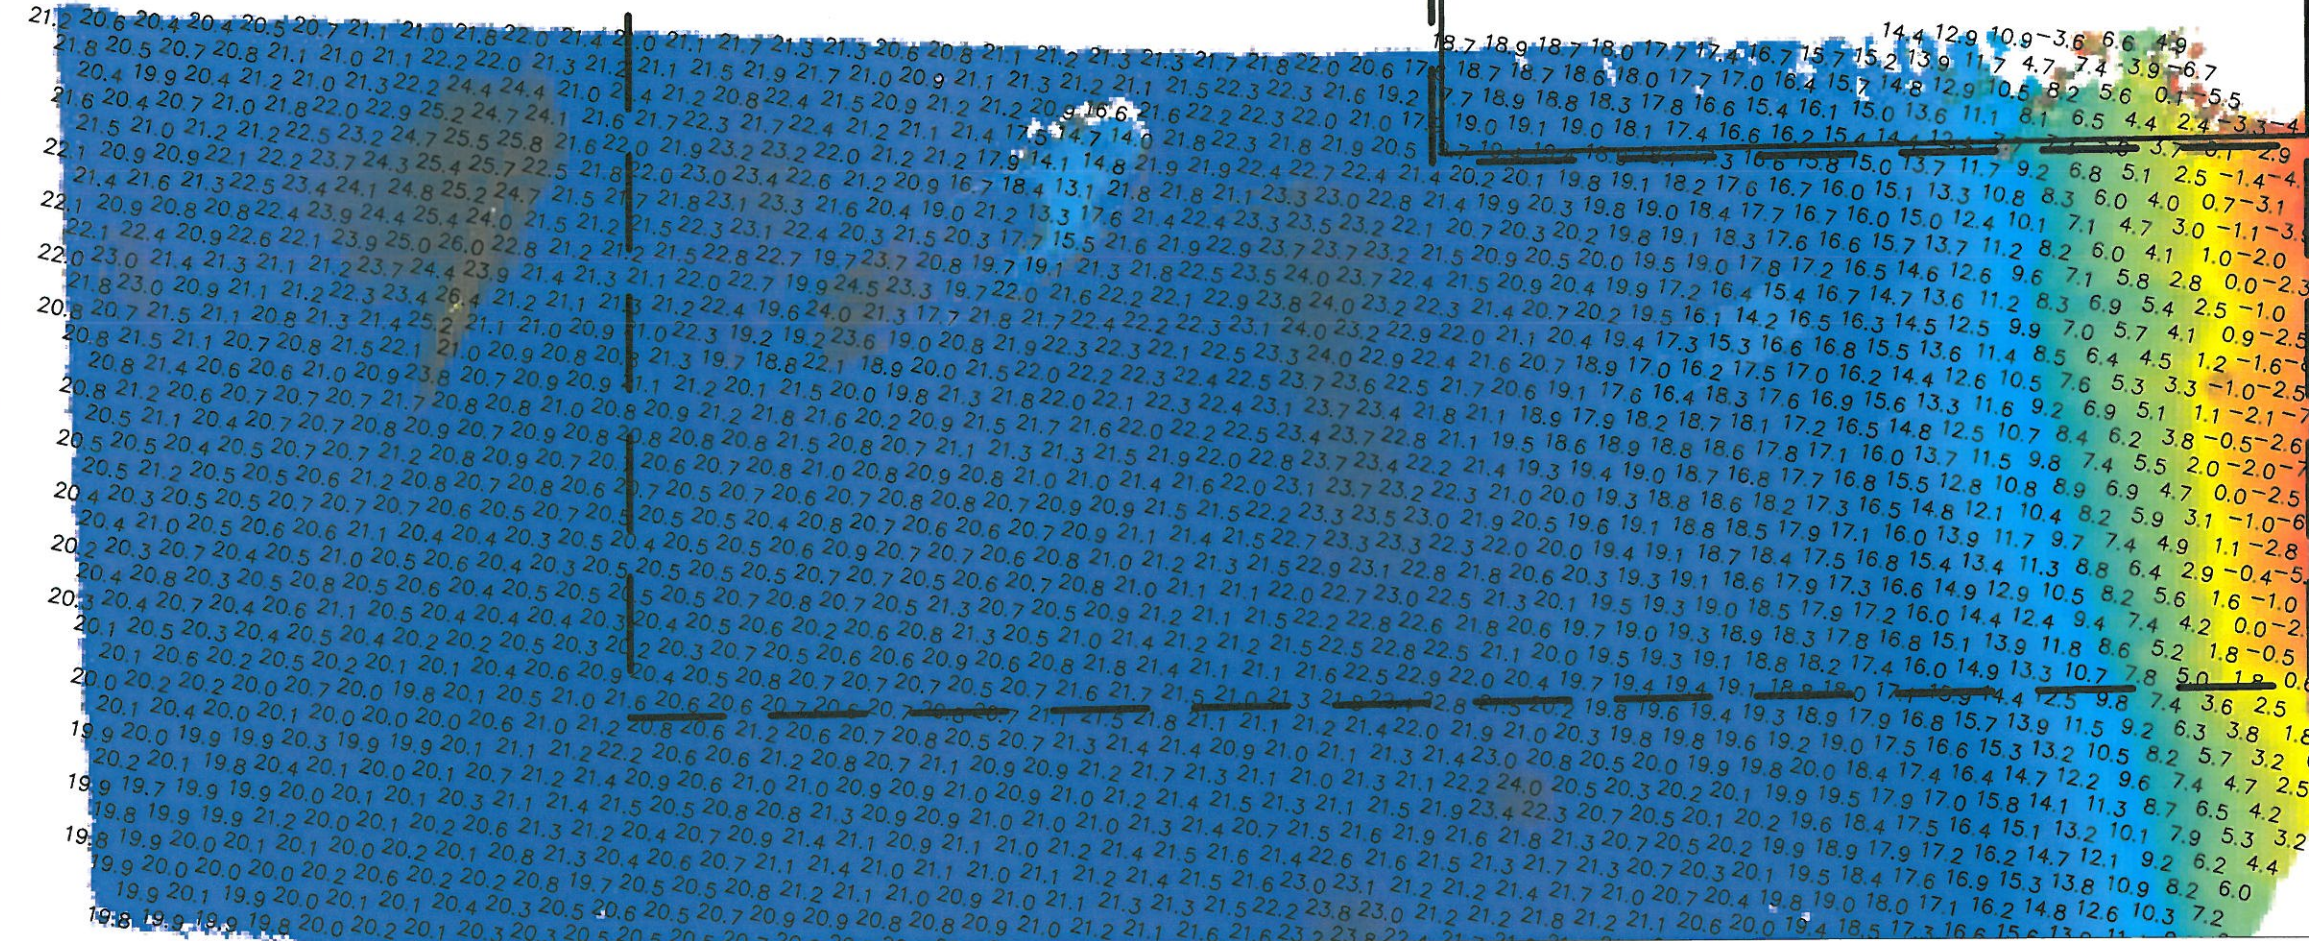
Reference  
Number:  
**S3**

Approximate  
Extent of  
Dredging

**NORTHLAKE SHIPYARD  
SAND BLAST GRIT DREDGING  
INTERIM ACTION**  
Soundings

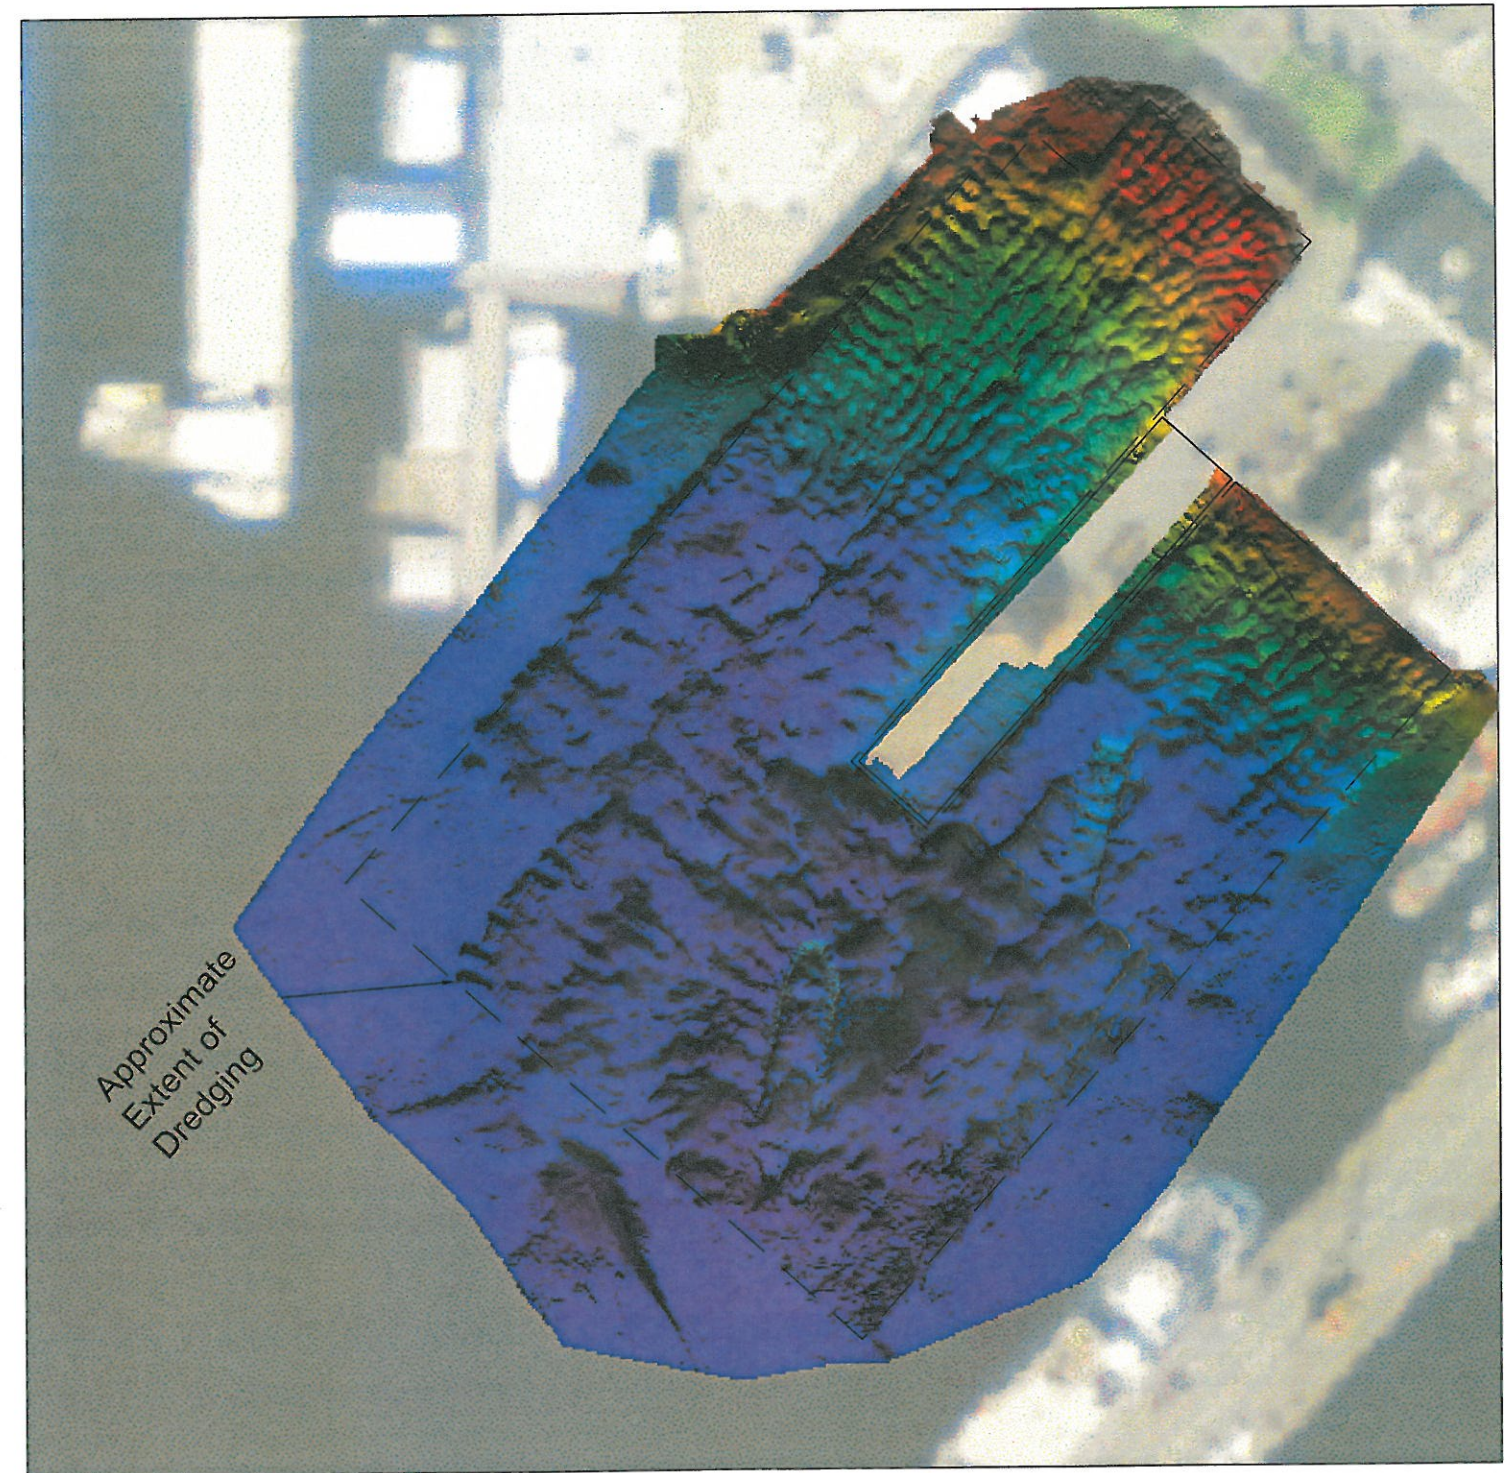
Reference  
Number:  
**S1**

| NORTHLAKE SHIPYARD<br>DREDGING VOLUMES - REMOVED |
| SURFACE TO SURFACE COMPARISON |
| PRE-DREDGE SURVEY: 11/12/13 AND 01/23/14<br>POST-DREDGE SURVEY: 03/05/14 AND 03/22/14 |
| MATERIAL REMOVED: 8,320 CYDS |

NORTHLAKE SHIPYARD  
SAND BLAST GRIT DREDGING  
INTERIM ACTION  
Project Information

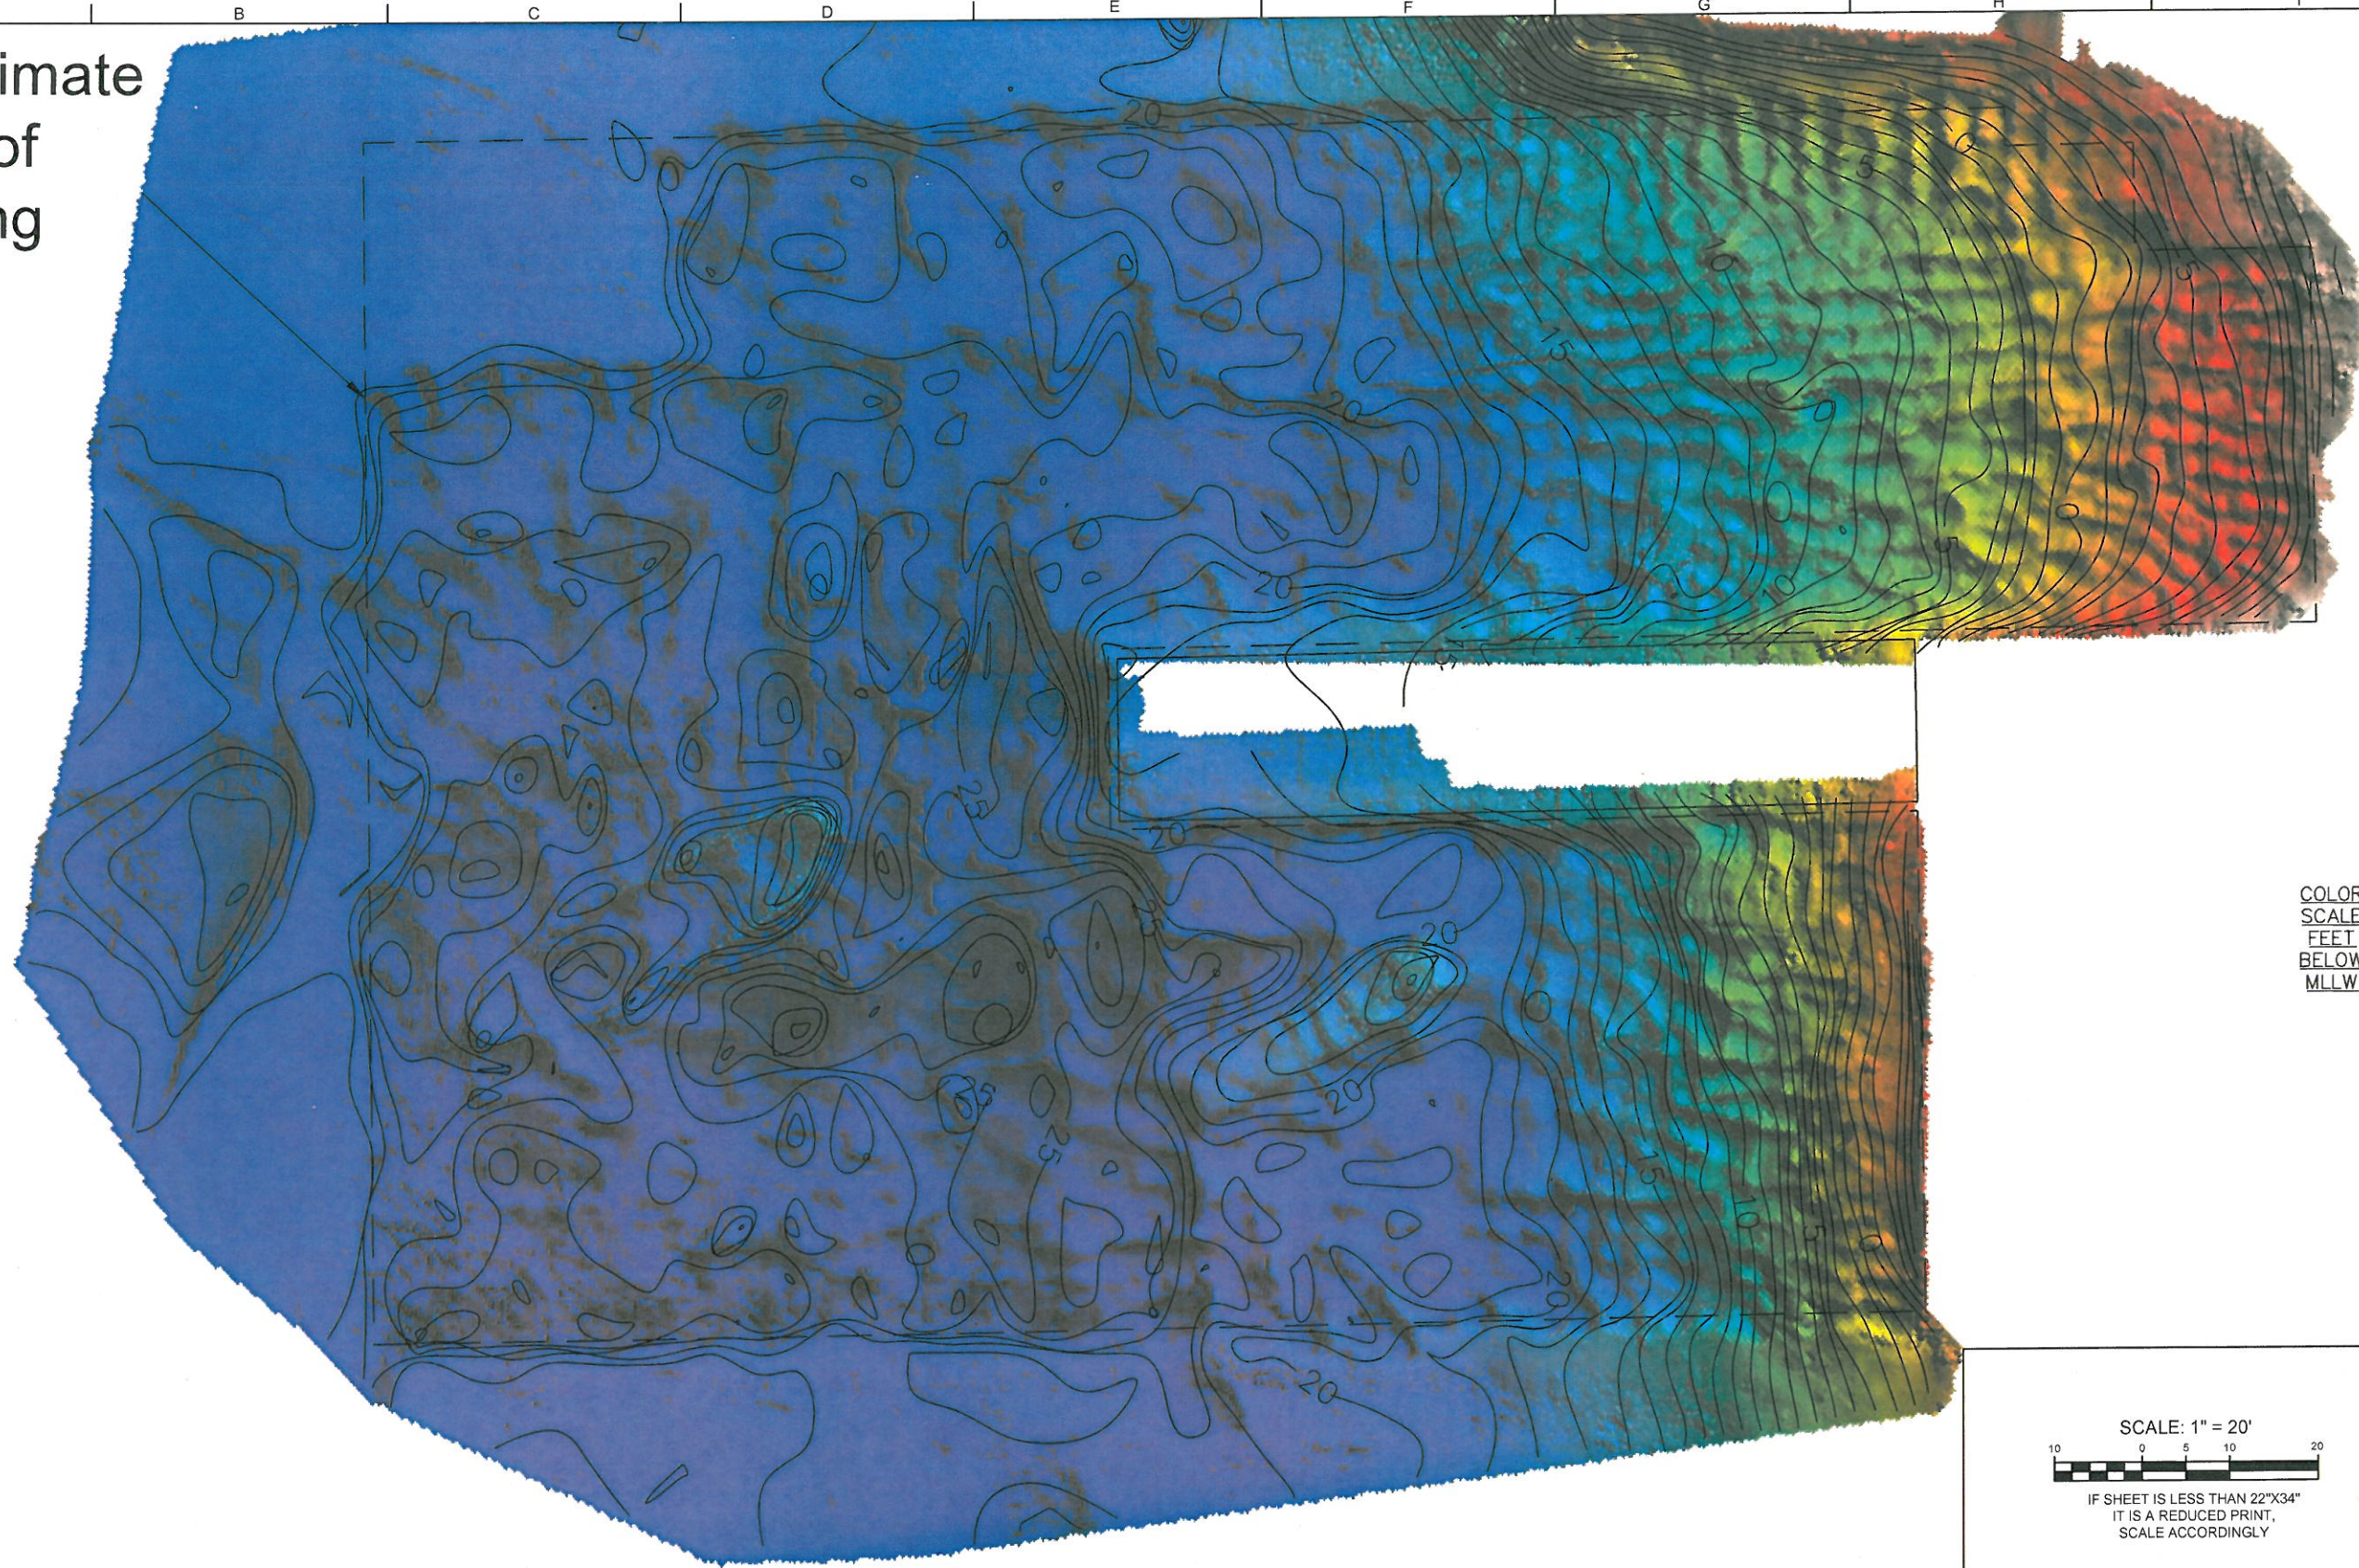
Reference  
Number:  
**S2**

Approximate  
Extent of  
Dredging

Multibeam Imagery and Contours

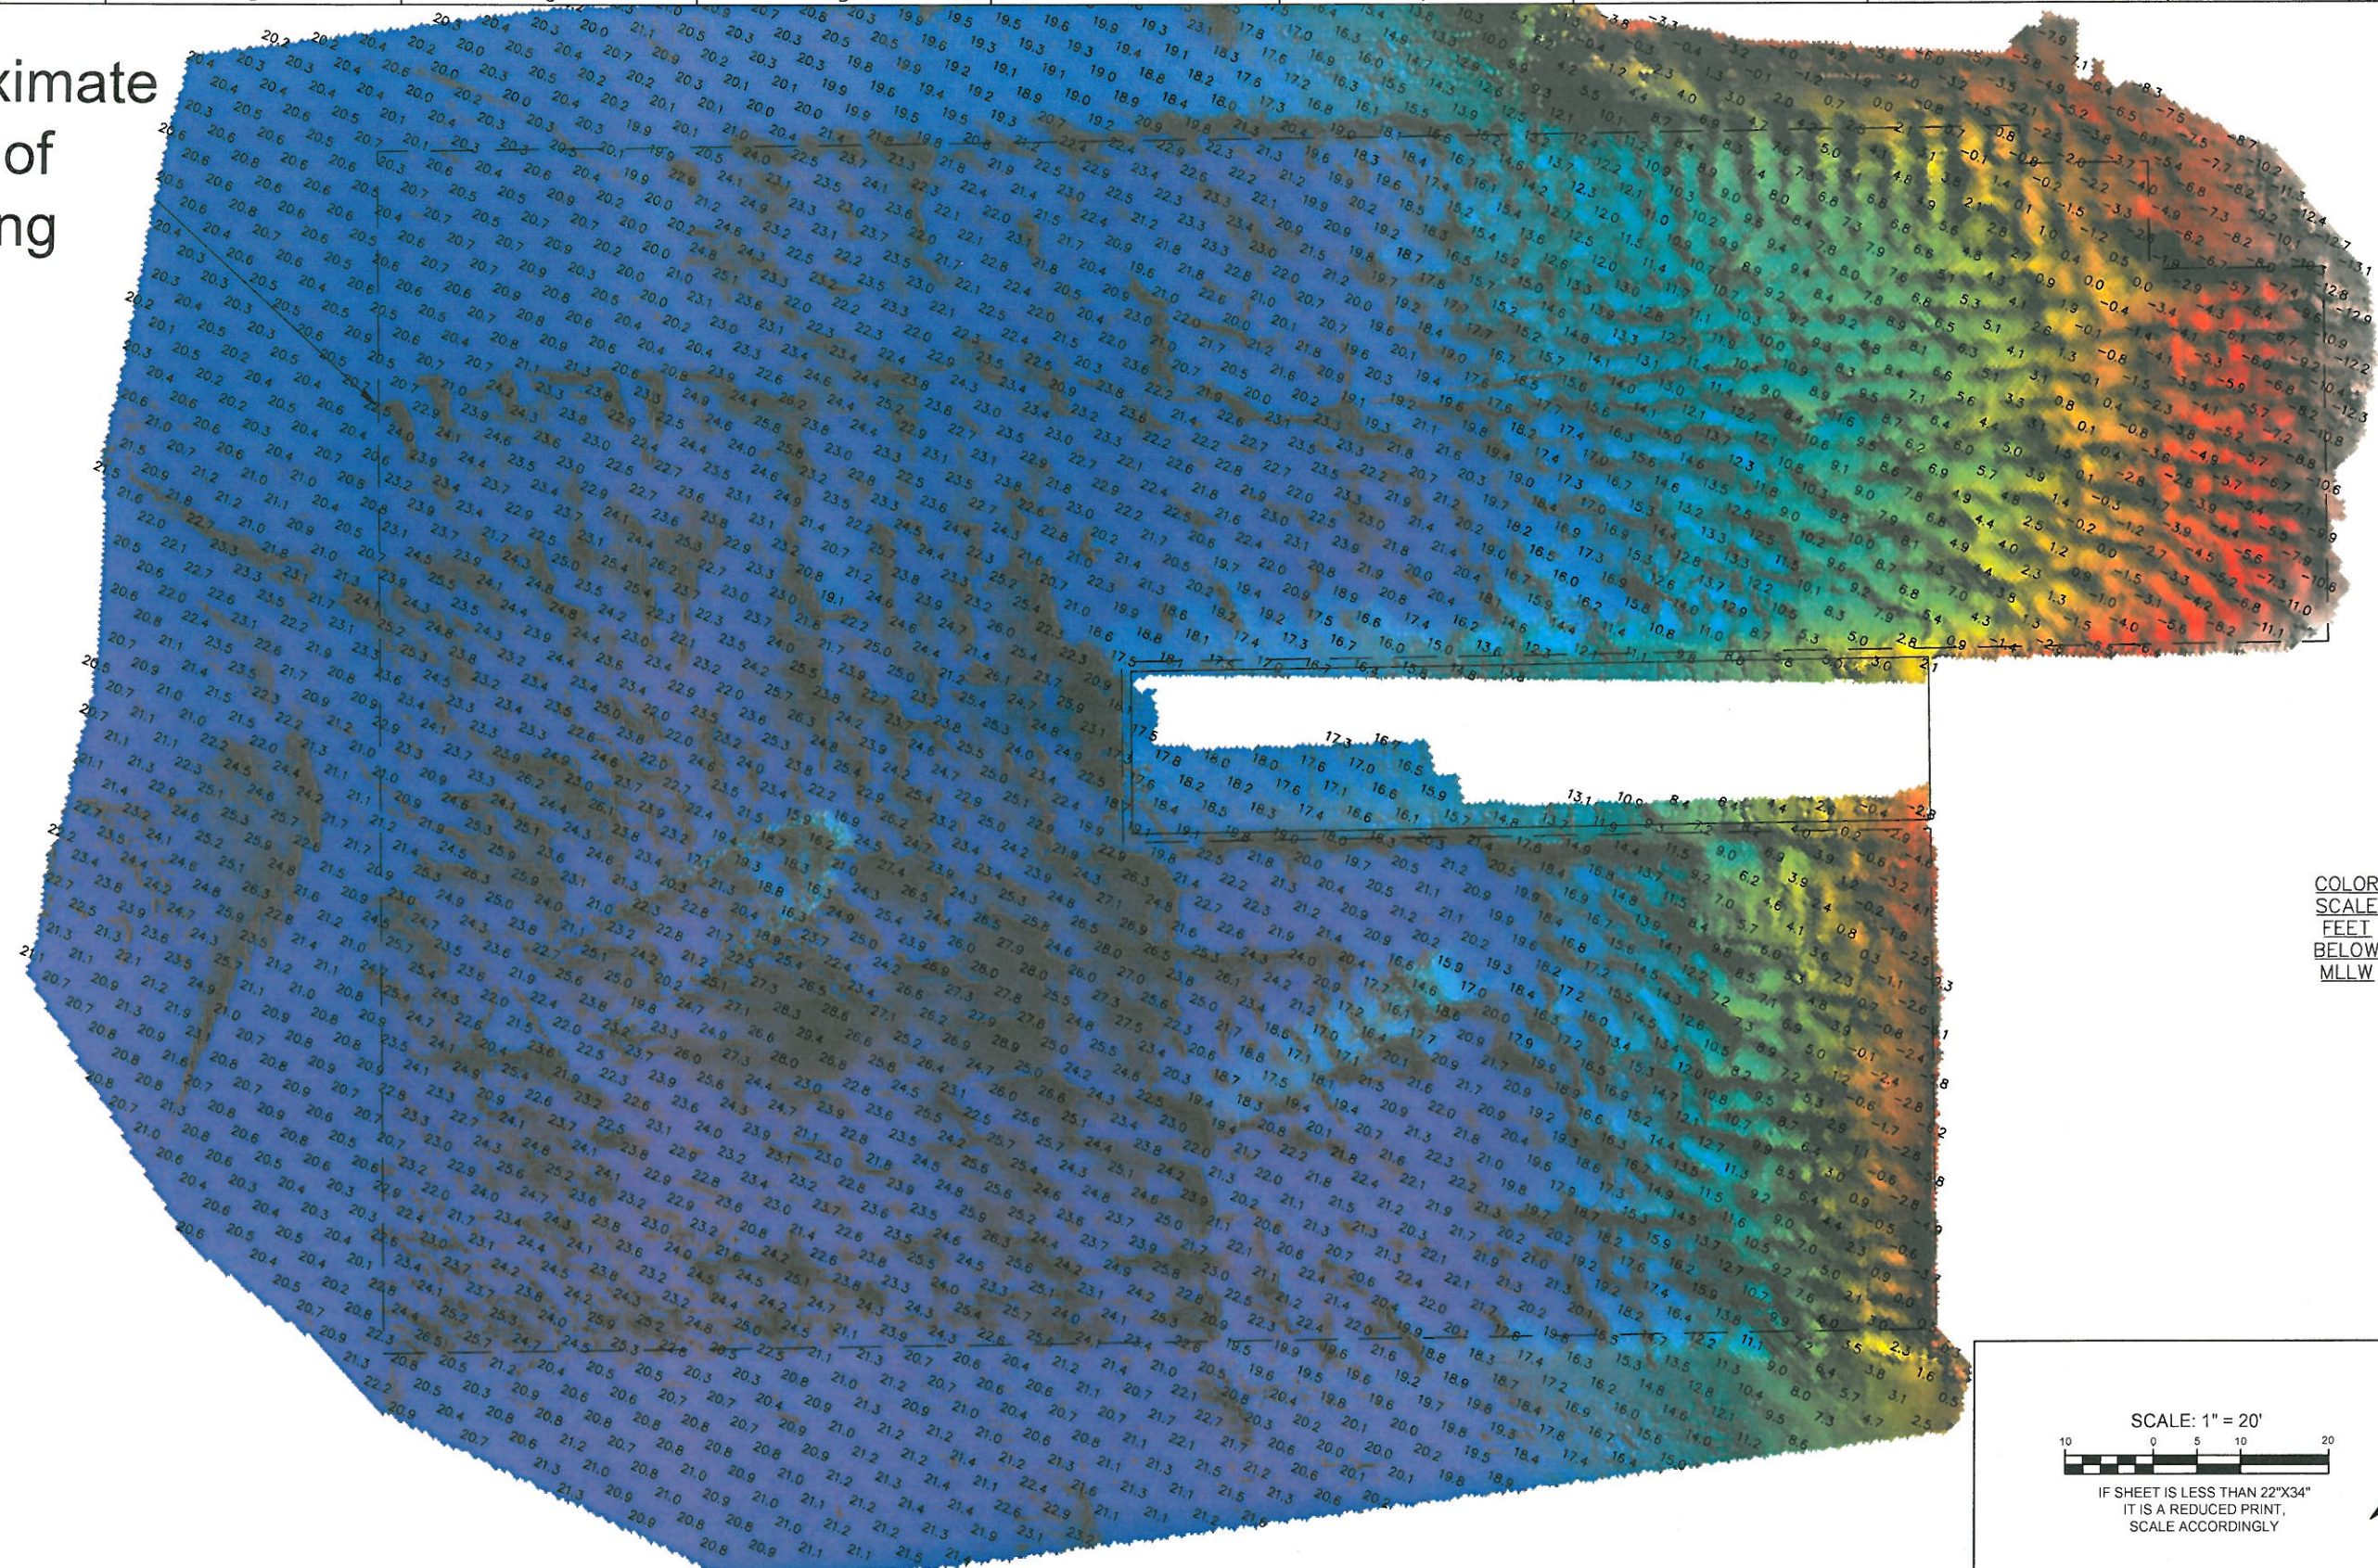
Reference Number:  
**S3**

Approximate  
Extent of  
Dredging

NORTHLAKE SHIPYARD  
SAND BLAST GRIT DREDGING  
INTERIM ACTION  
Soundings
