## Surveys and As-Built Drawings

# NORTHLAKE SHIPYARD SAND BLAST GRIT DREDGING INTERIM ACTION

## Multibeam Pre-Dredge Survey - Phase 1

APPENDIX B  
Selected Site Photographs

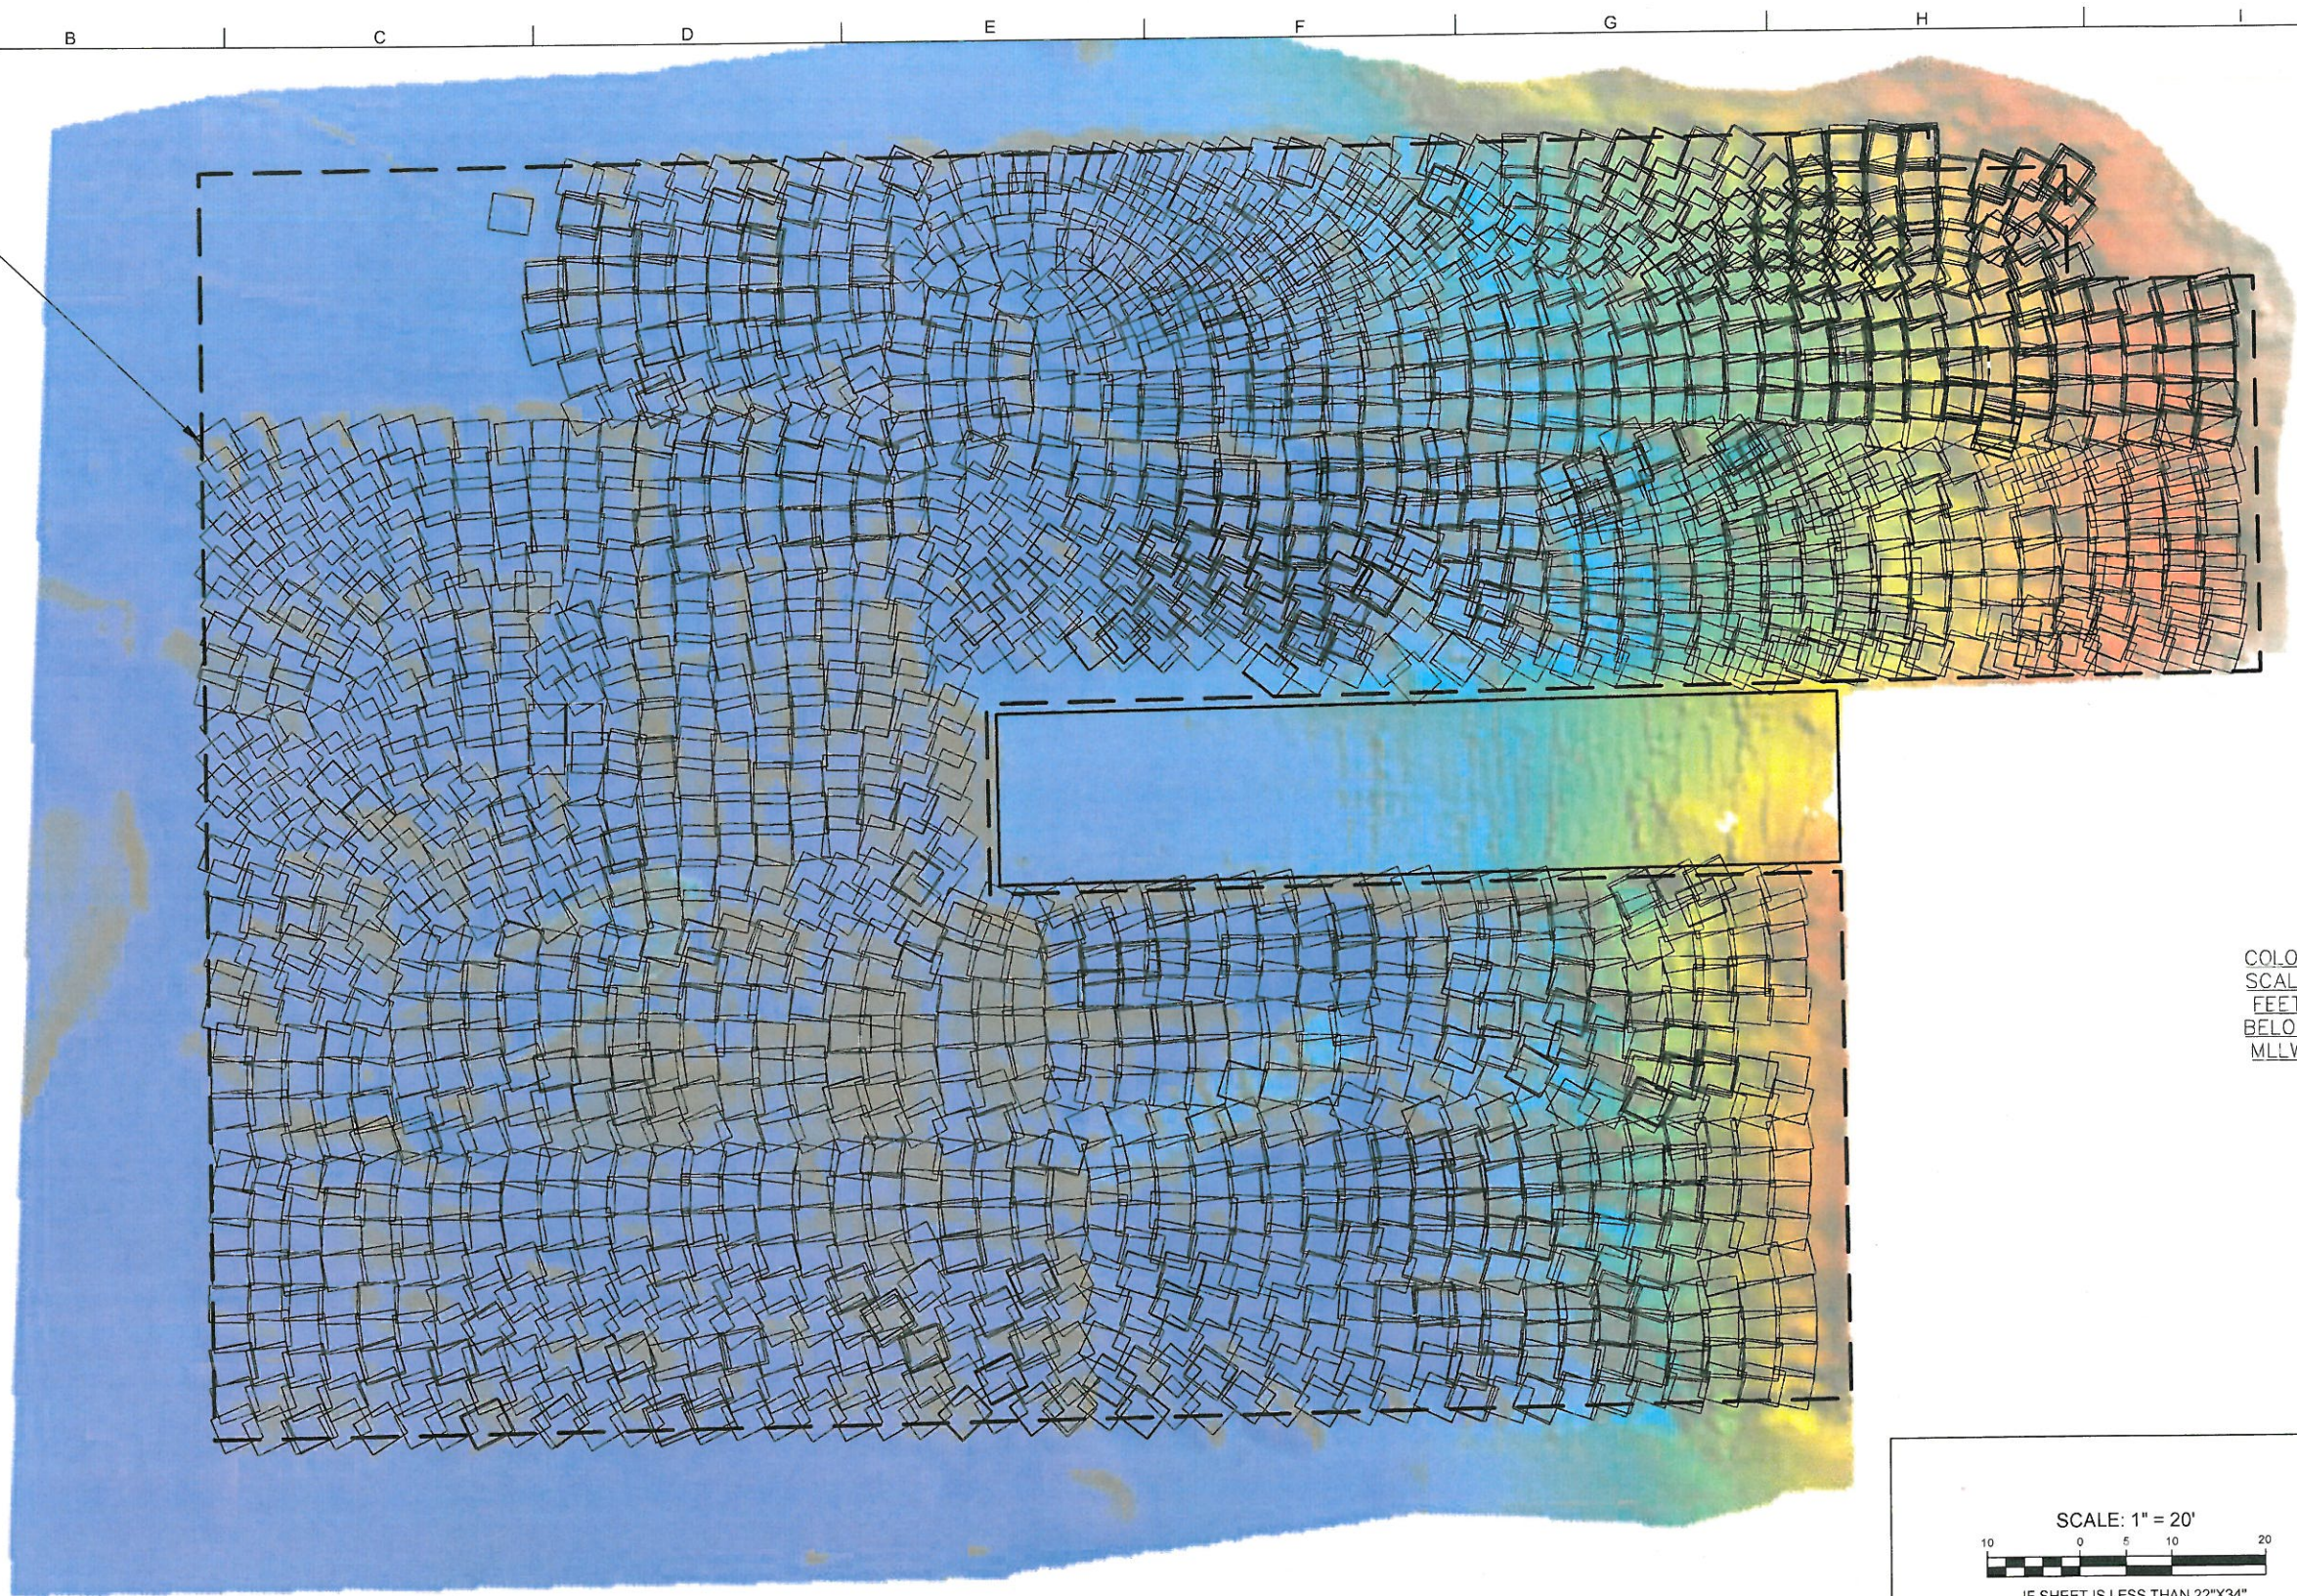
Note: Density of "bucket prints" is not necessarily representative of dredged depth.

NORTHLAKE SHIPYARD  
SAND BLAST GRIT DREDGING  
INTERIM ACTION  
Multibeam Imagery and Bucket Prints

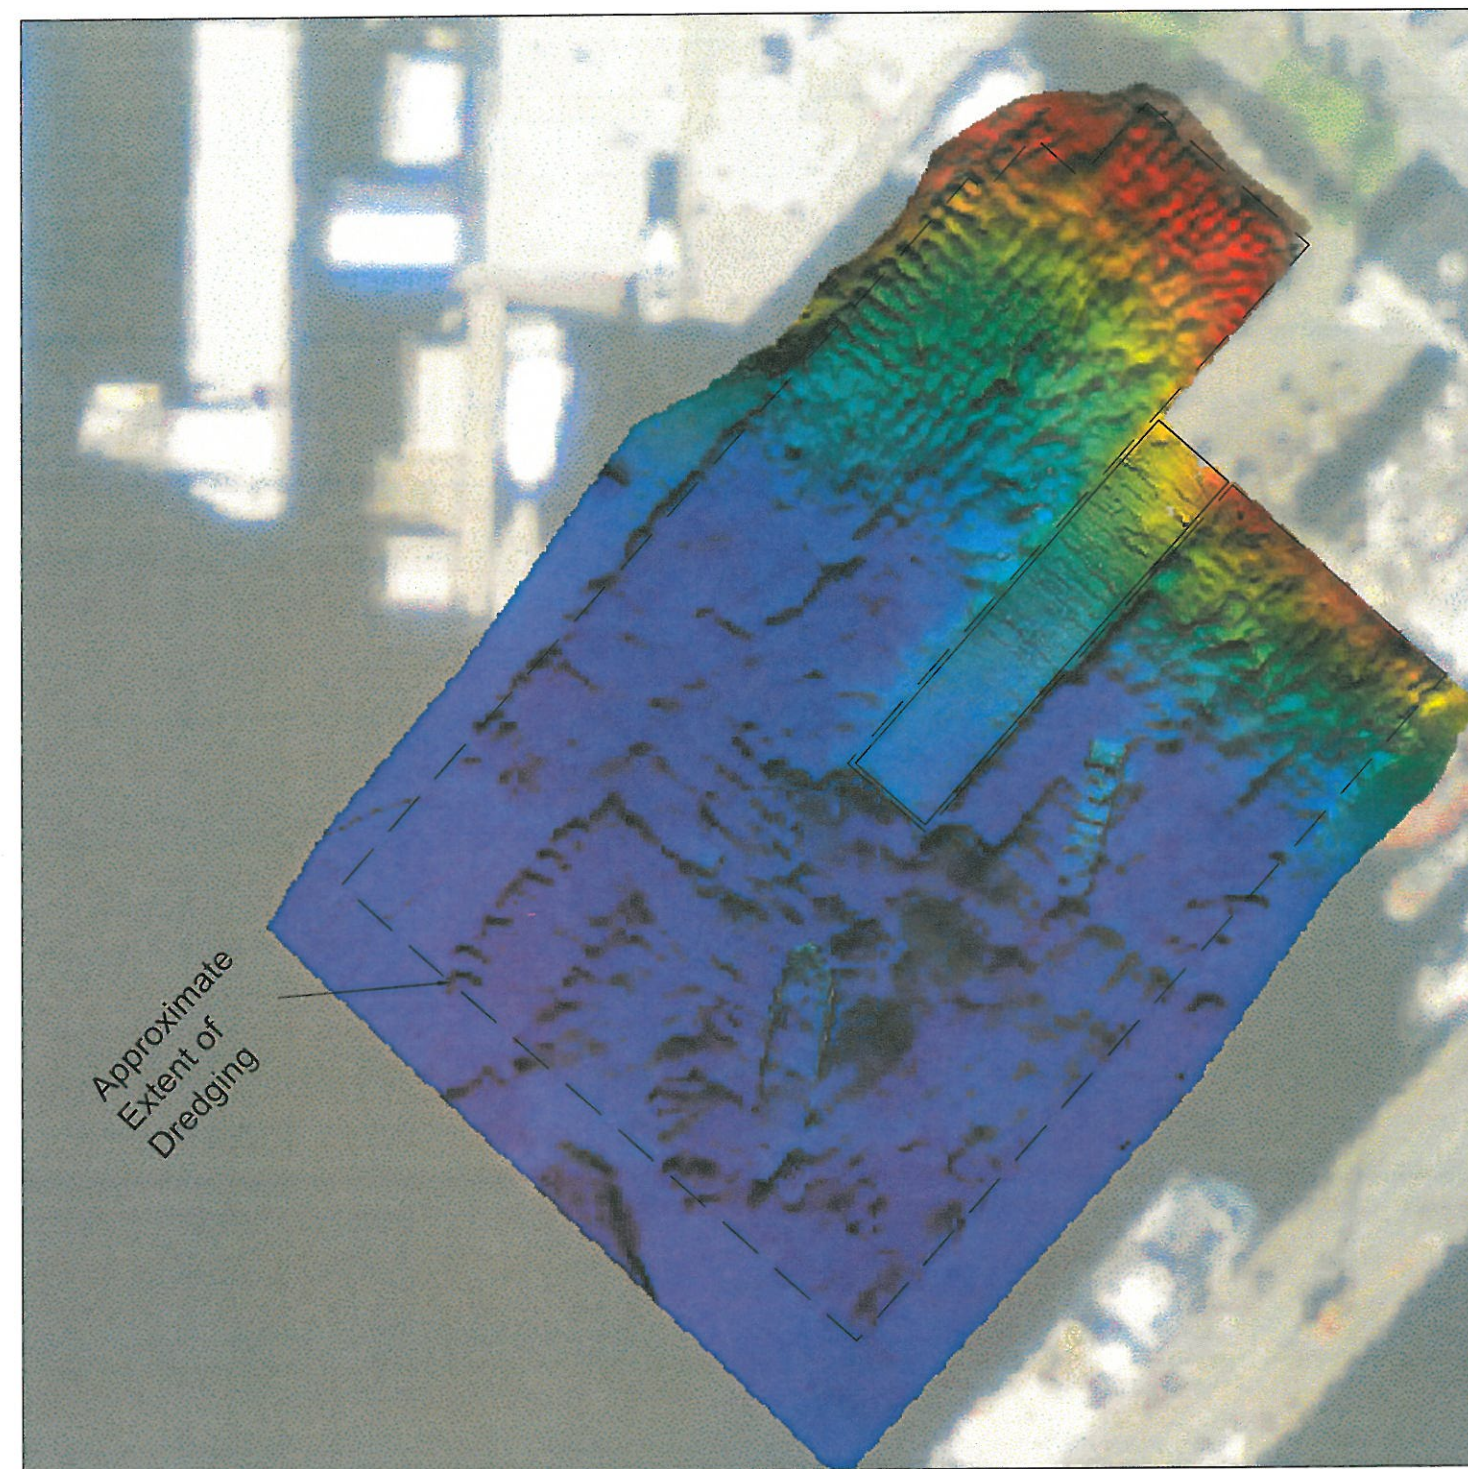
| Reference<br>Number:<br><b>S1</b> |

| NORTHLAKE SHIPYARD<br>DREDGING VOLUMES - PLACED |
| SURFACE TO SURFACE COMPARISON |
| POST-DREDGE SURVEY: 03/05/14 AND 03/22/14<br>POST-CAP SURVEY: 03/27/14 |
| MATERIAL PLACED: 1,342 CYDS |

| Project Information |

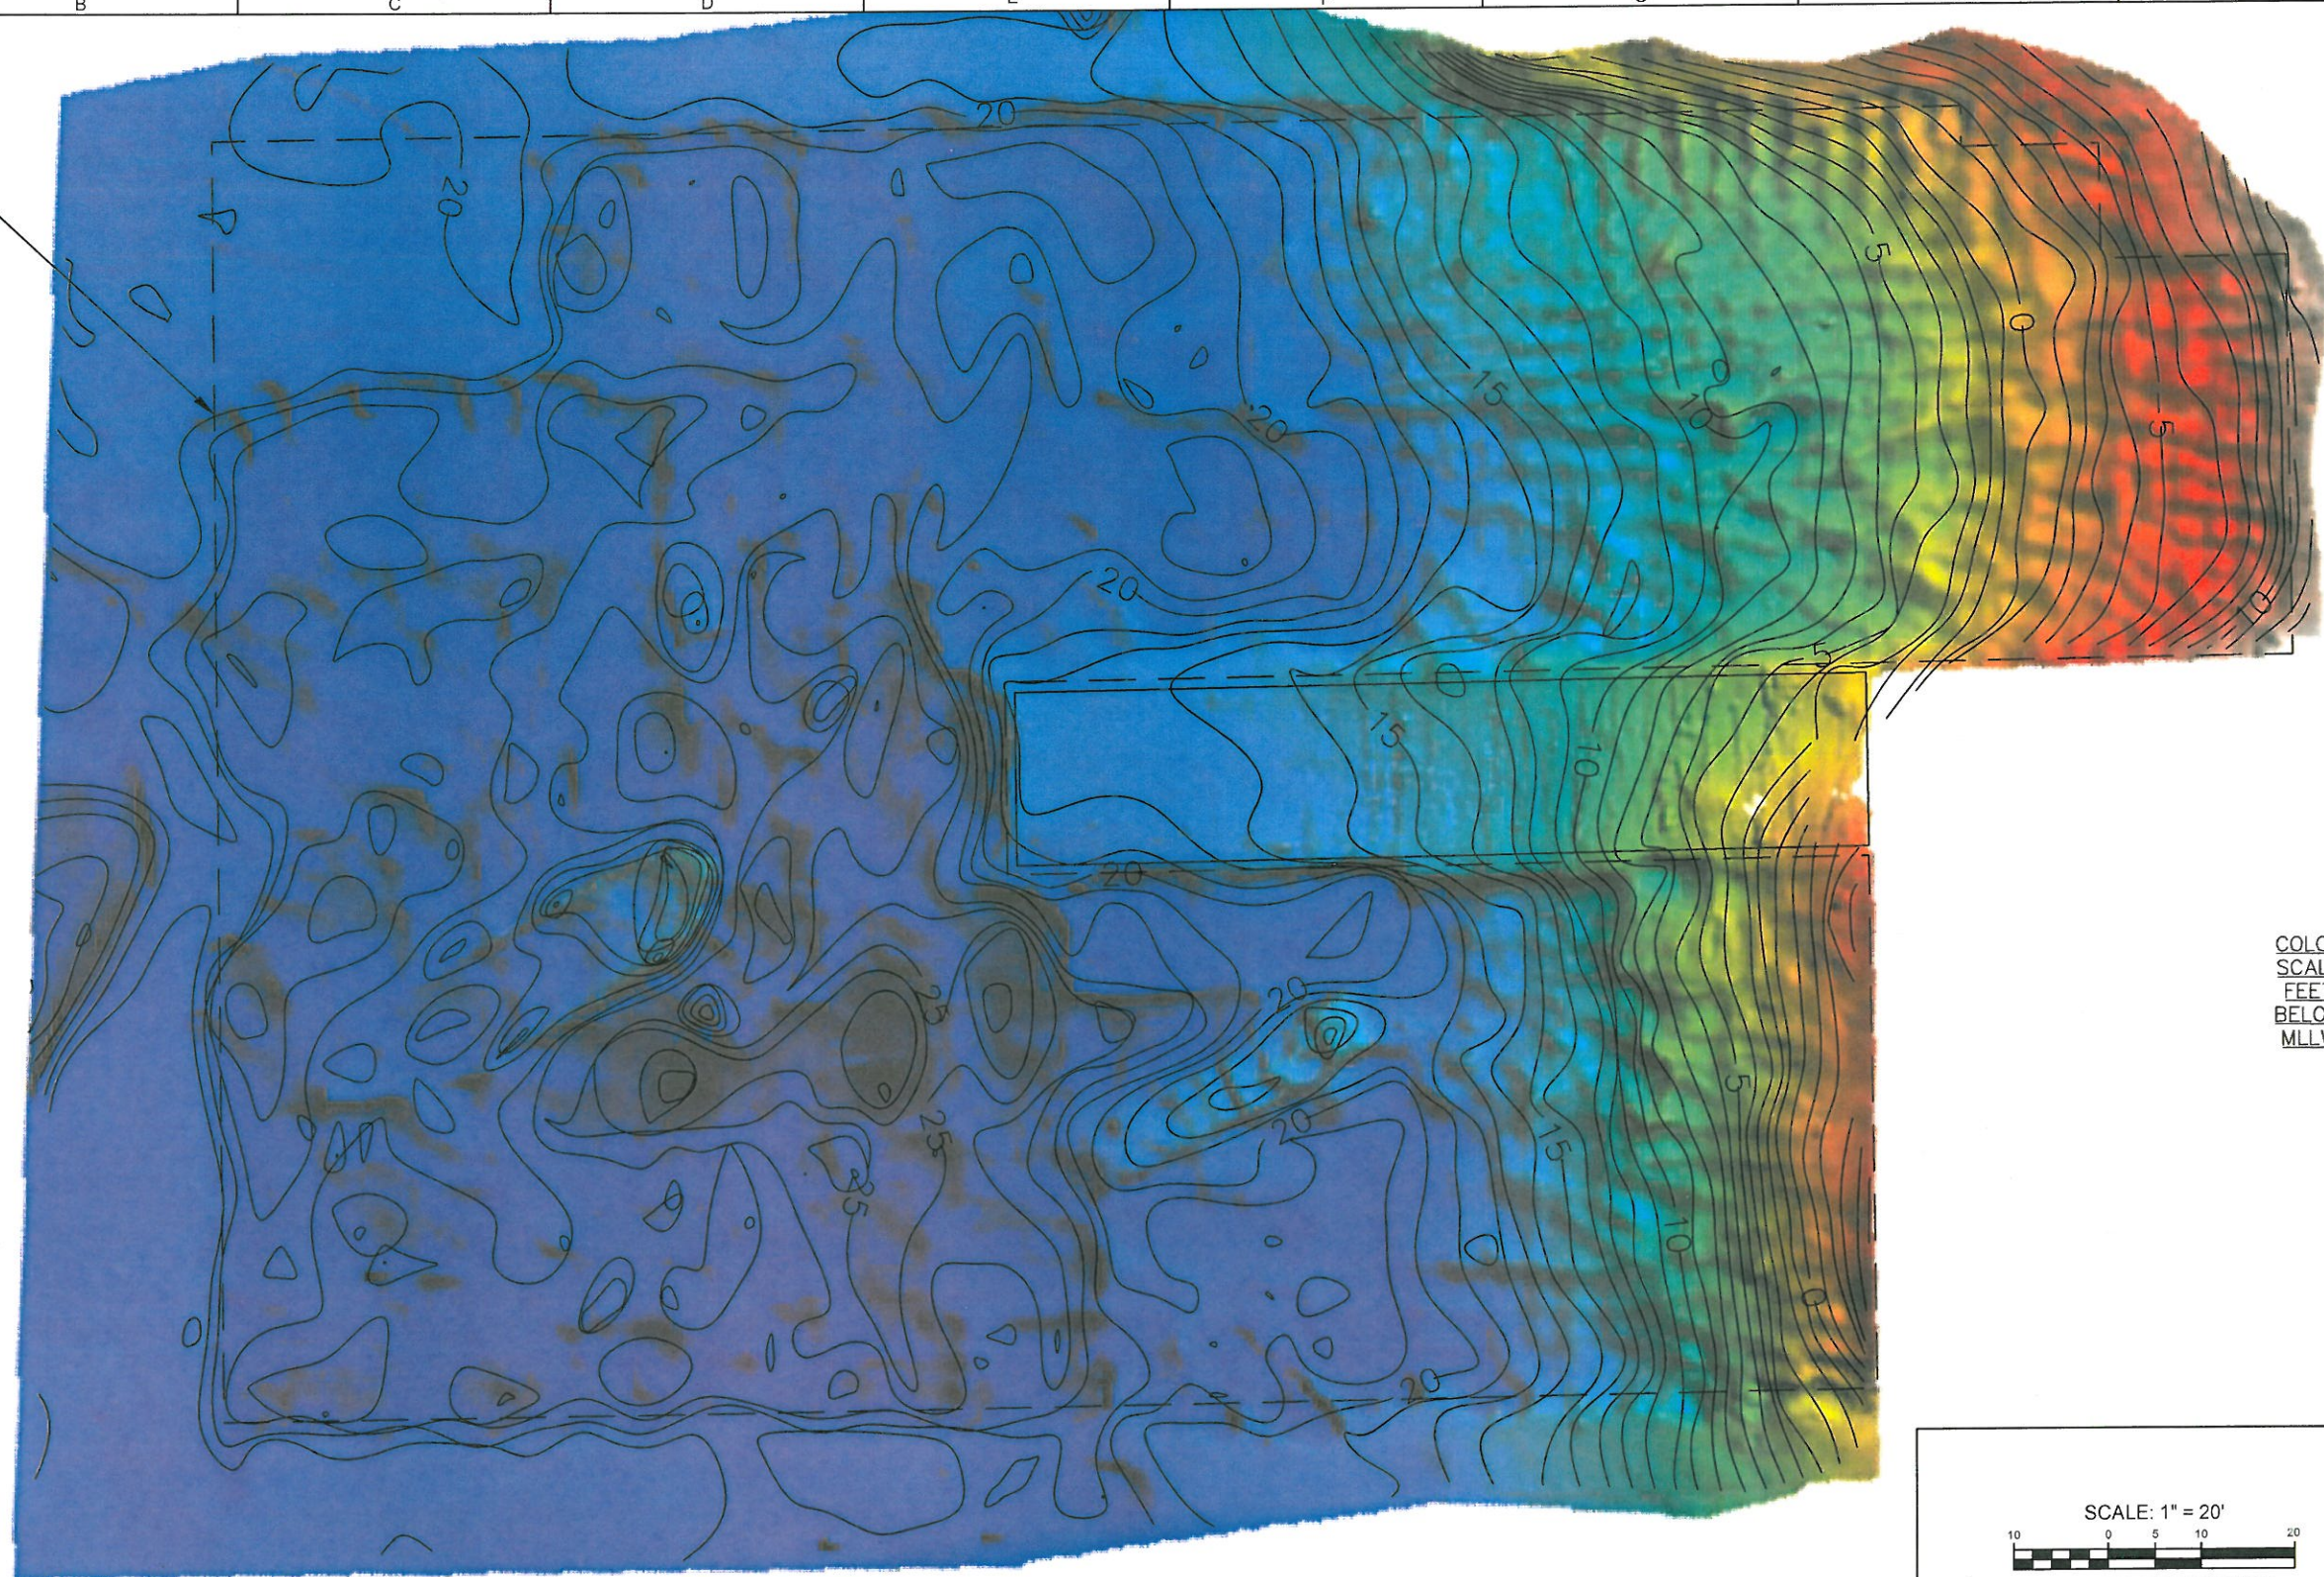
Reference  
Number:  
**S2**

Approximate  
Extent of  
Dredging

Multibeam Imagery and Contours

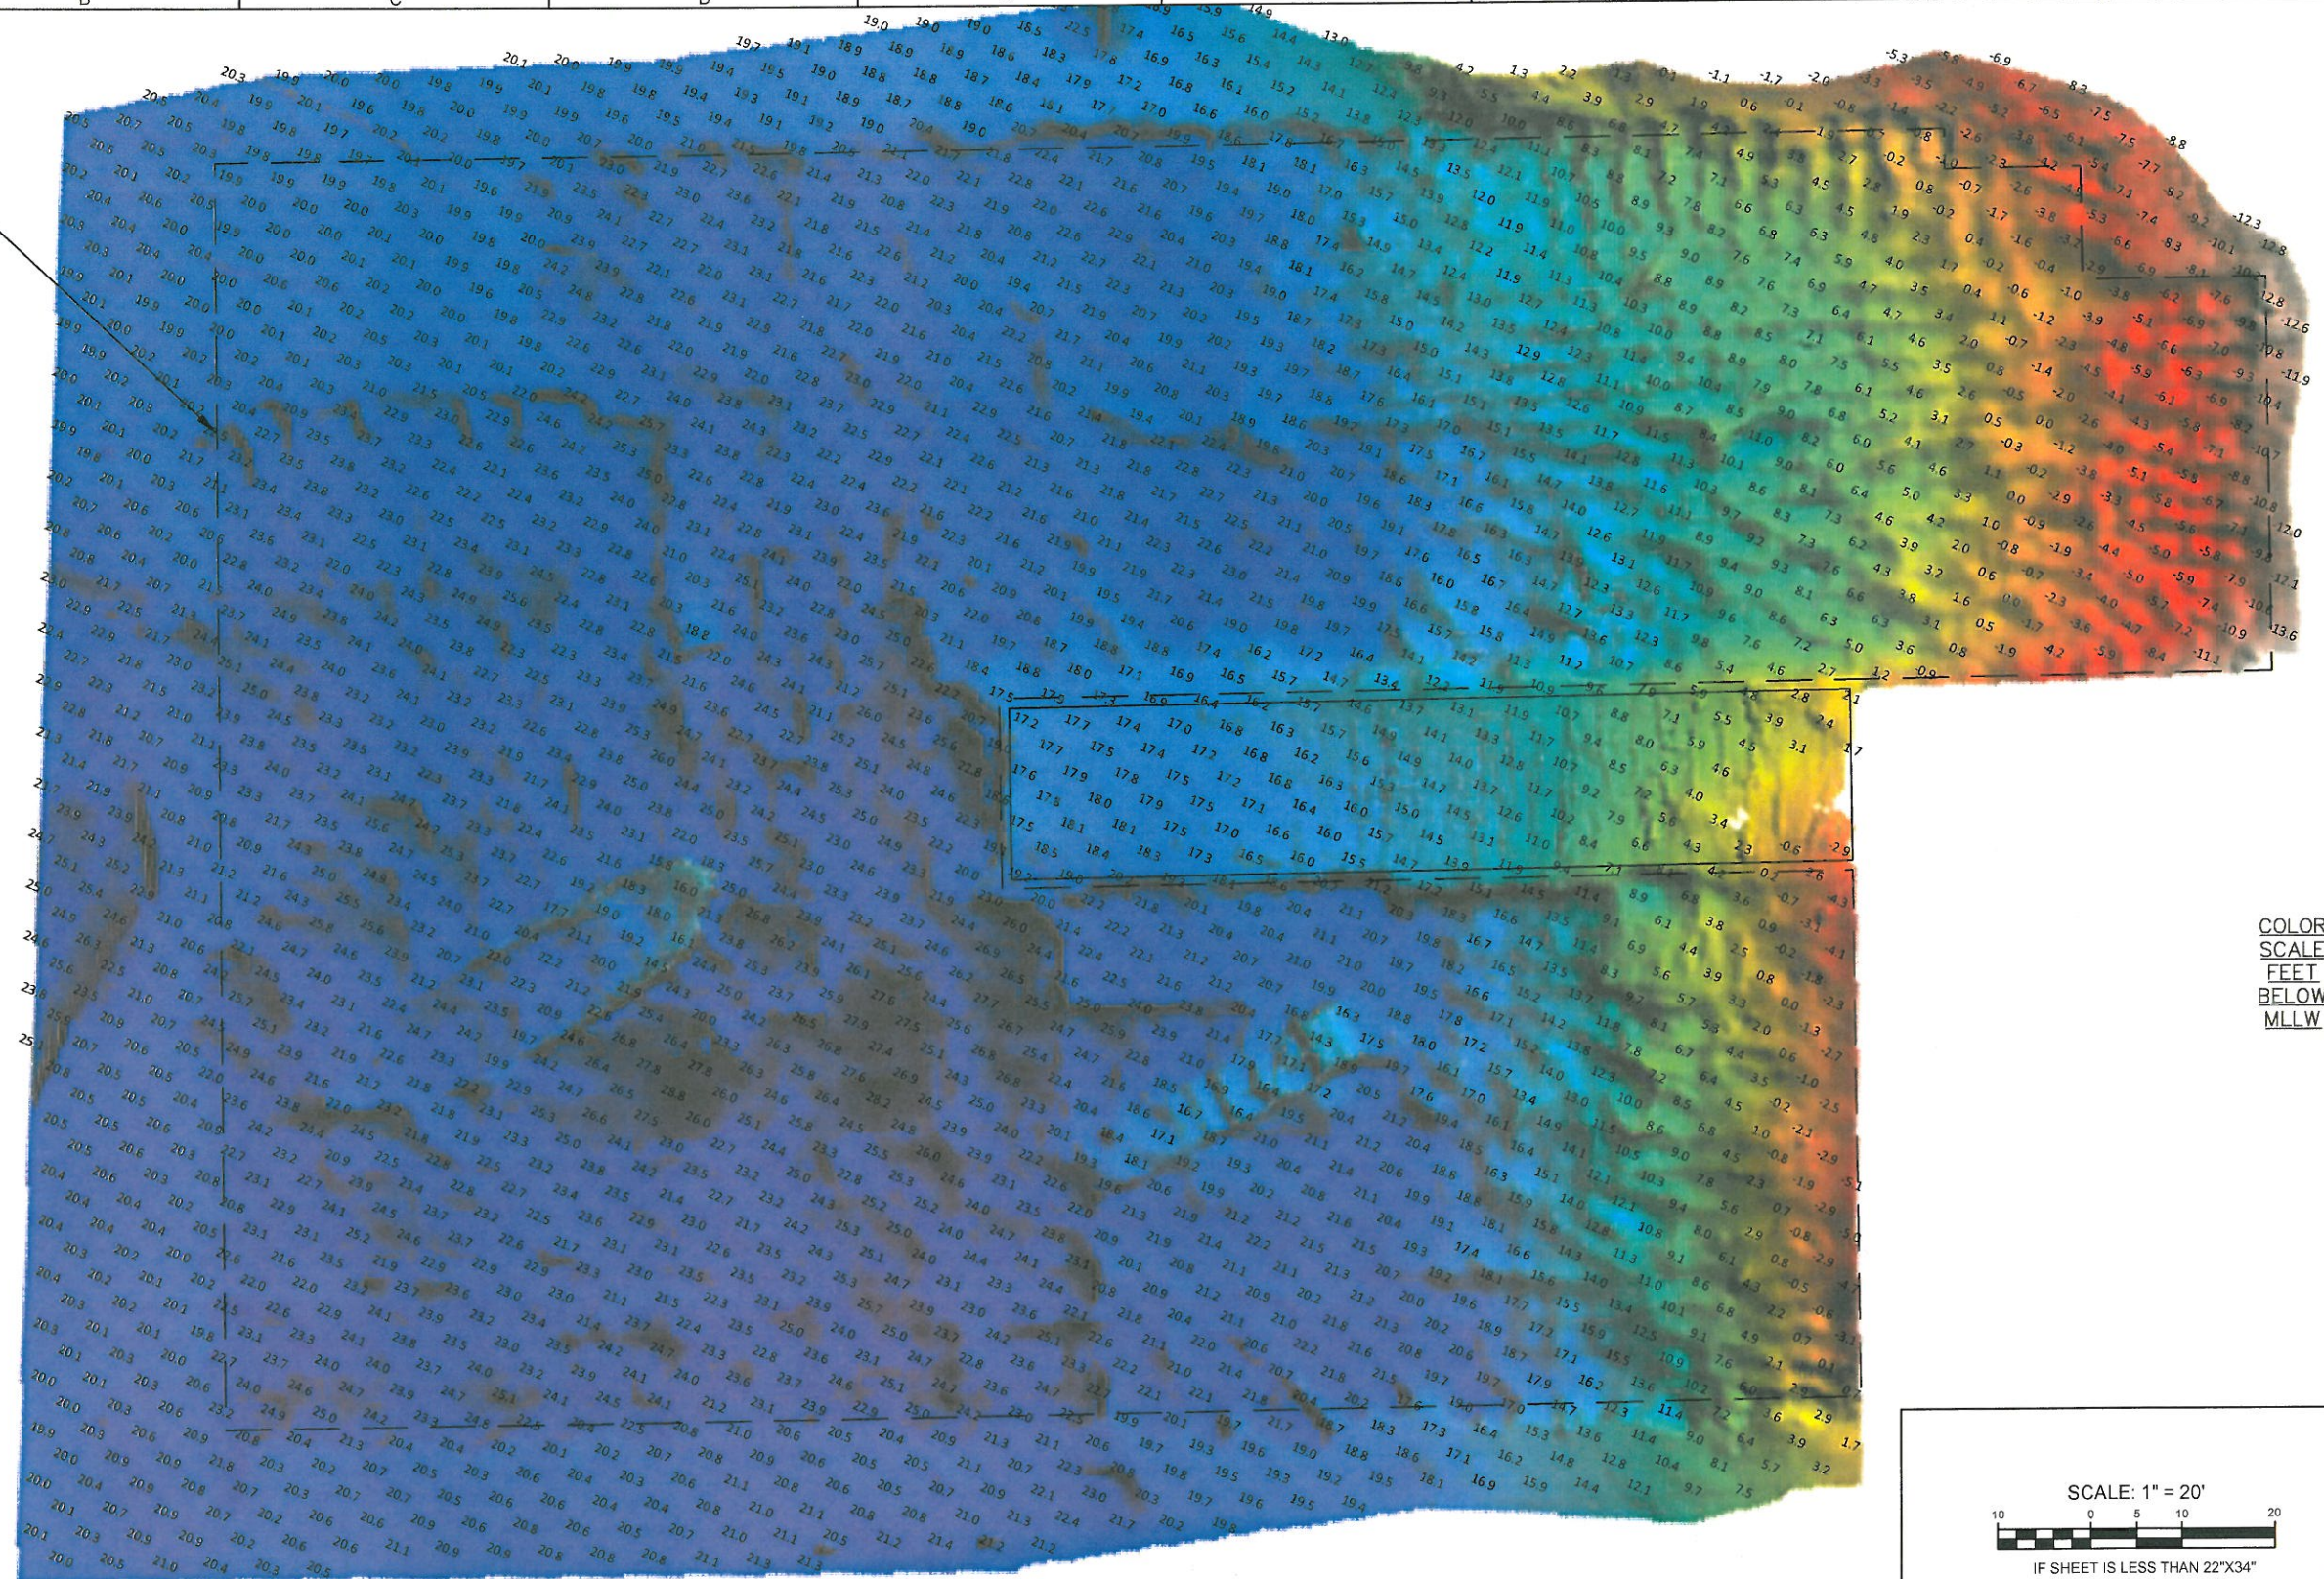
Reference  
Number:  
**S3**

Approximate  
Extent of  
Dredging

NORTHLAKE SHIPYARD  
SAND BLAST GRIT DREDGING  
INTERIM ACTION  
Soundings

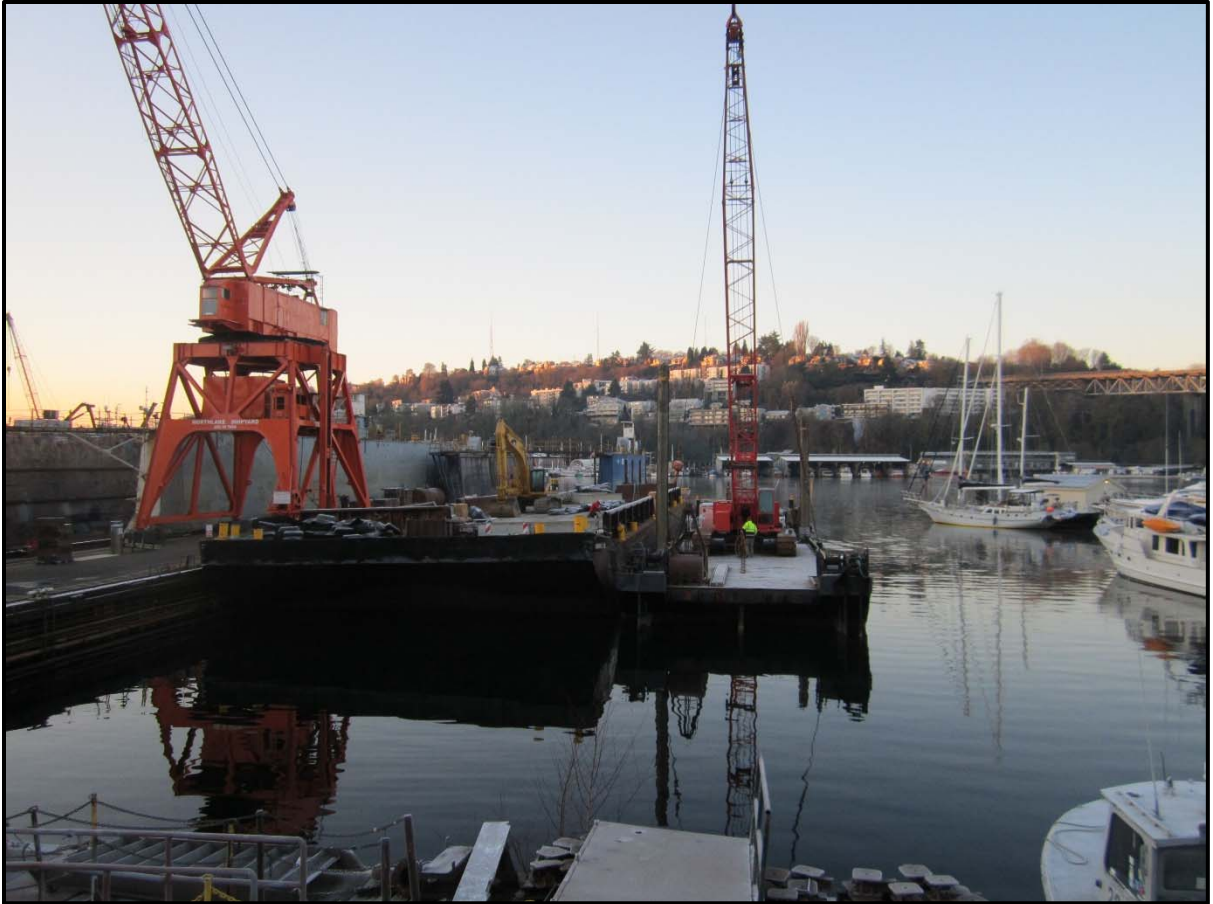
Photograph 1 – Pre-construction conditions and contractor mobilization at the Northlake Shipyard Site (Dec 4, 2013).

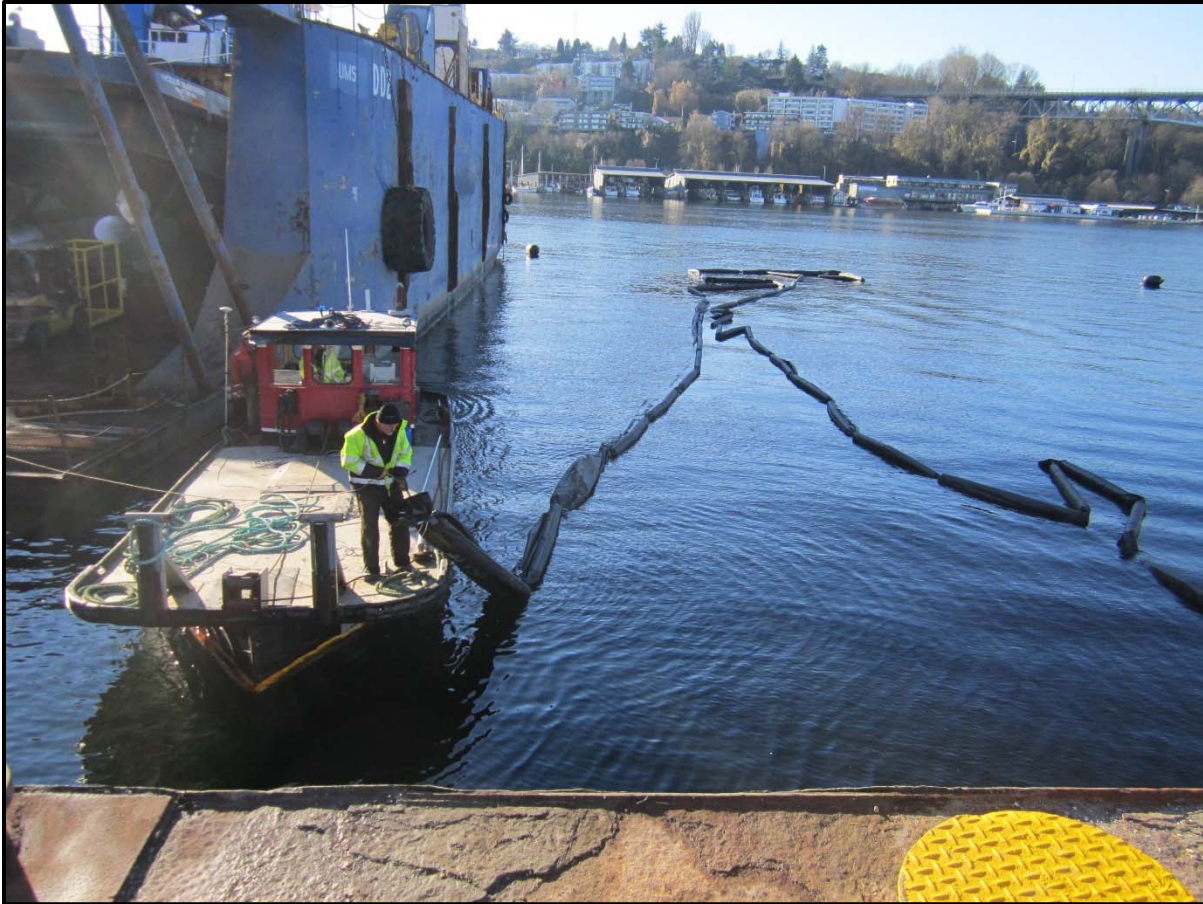
Photograph 3 – Deploying water quality controls at the beginning of construction (Dec 4, 2013).

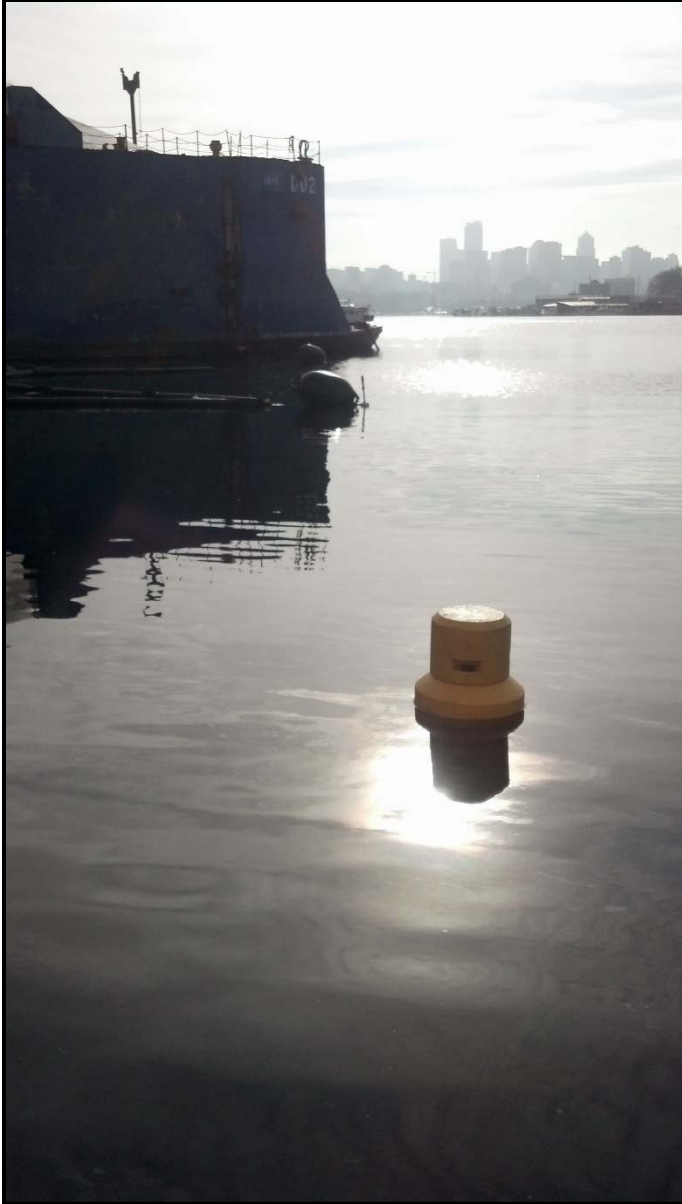
Photograph 4 – Water quality monitoring buoy in place (January 15, 2013).

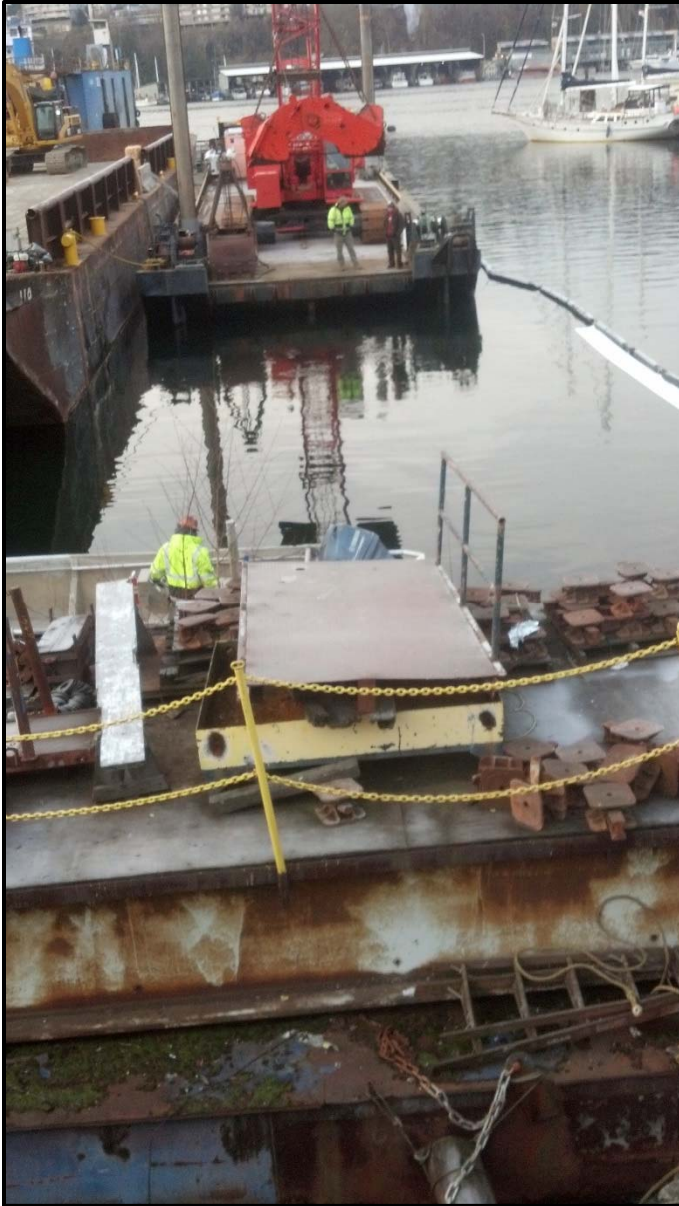
Photograph 6 – Contractor placing absorbent pads along the edges of the turbidity curtain (December 4, 2013).

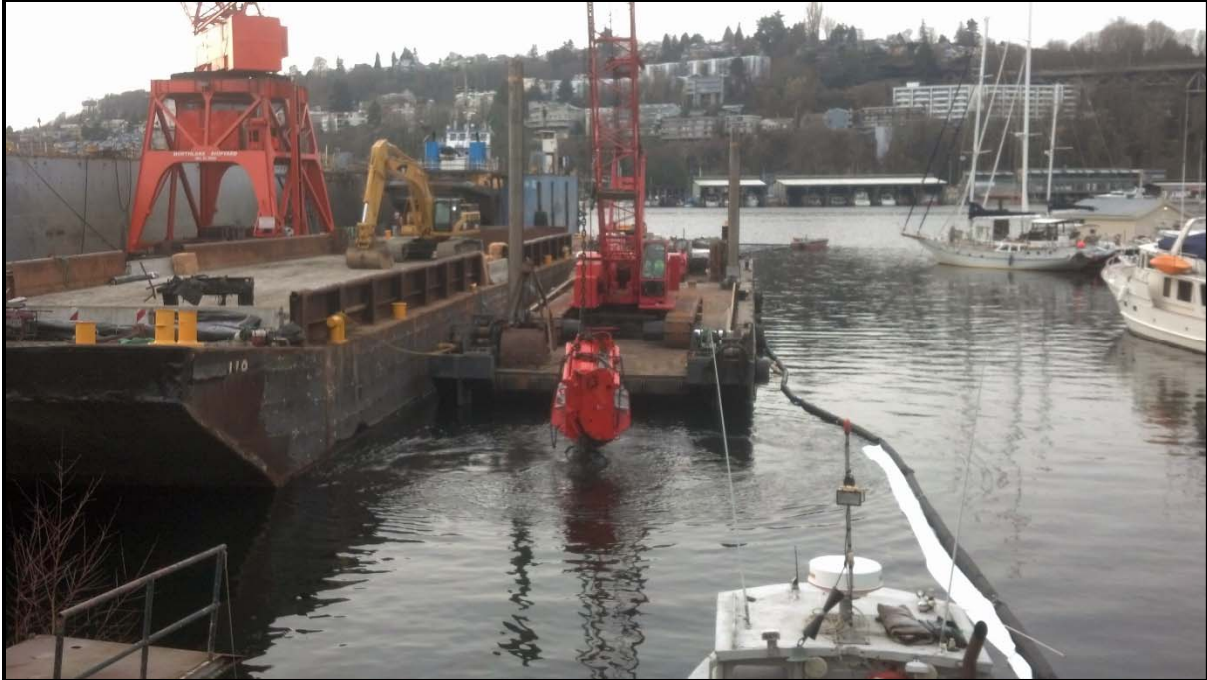
Photograph 7 – Dredging operations begin (December 5, 2013).

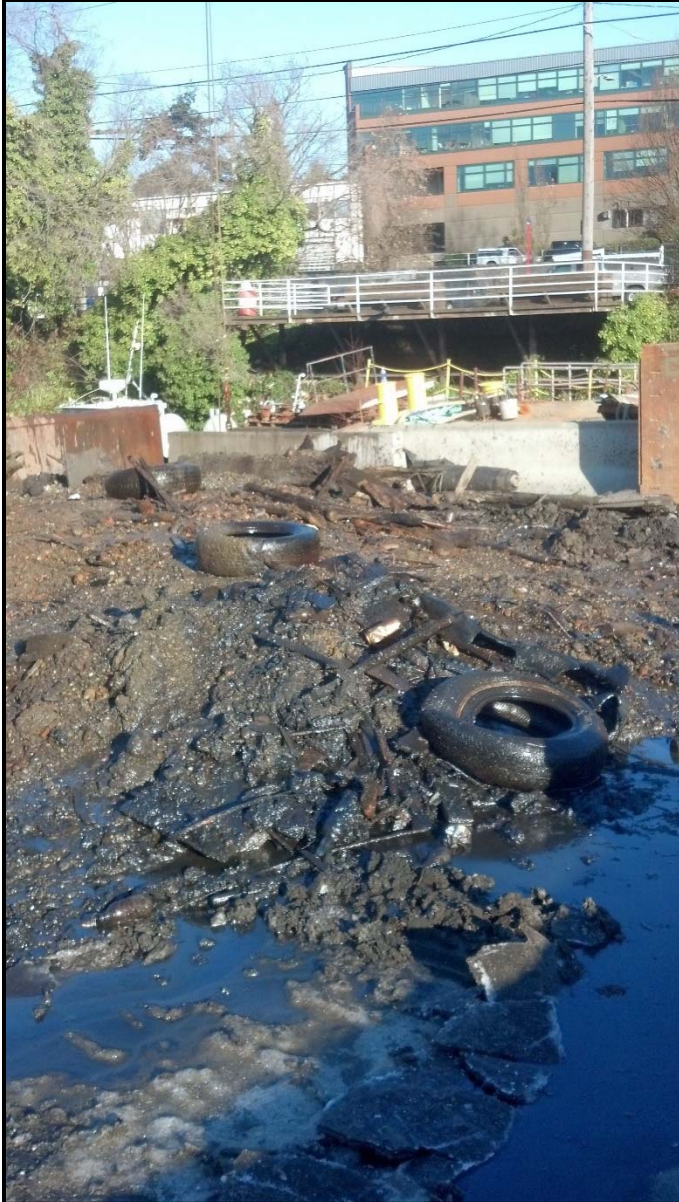
Photograph 9 – Example of dredge spoils and debris recovered from Waterway 21 (December 5, 2013).

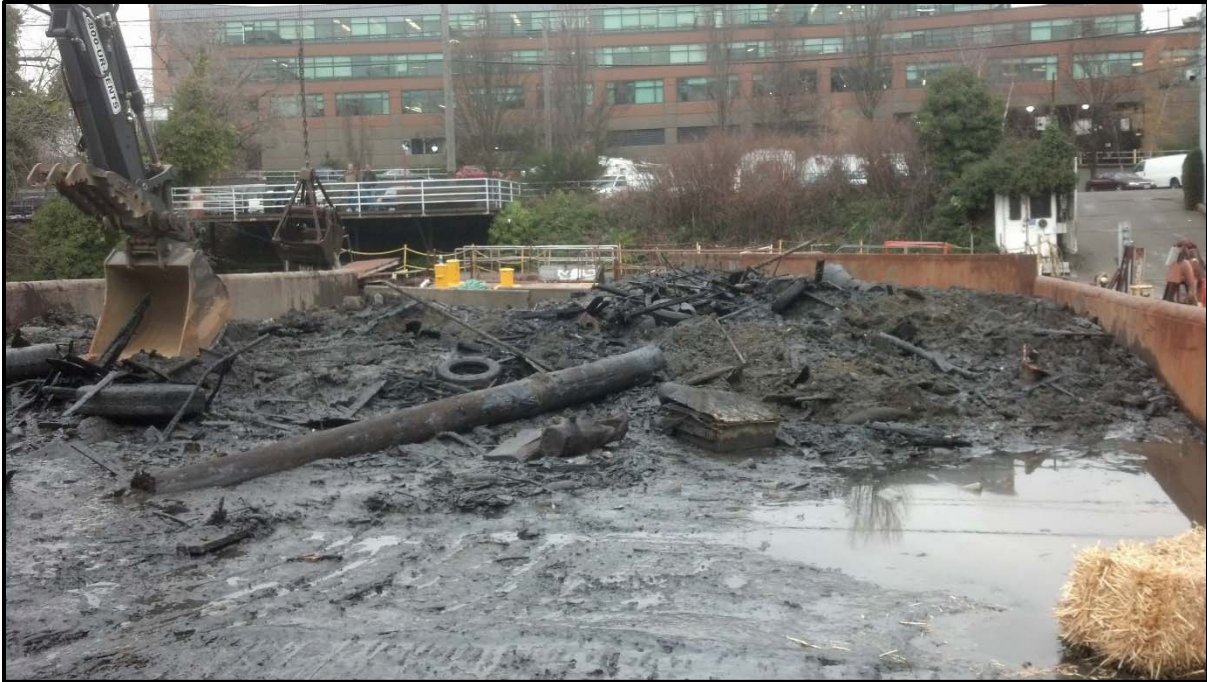
Photograph 10 – Dredge spoils and debris recovered from Waterway 21 (December 9, 2013).

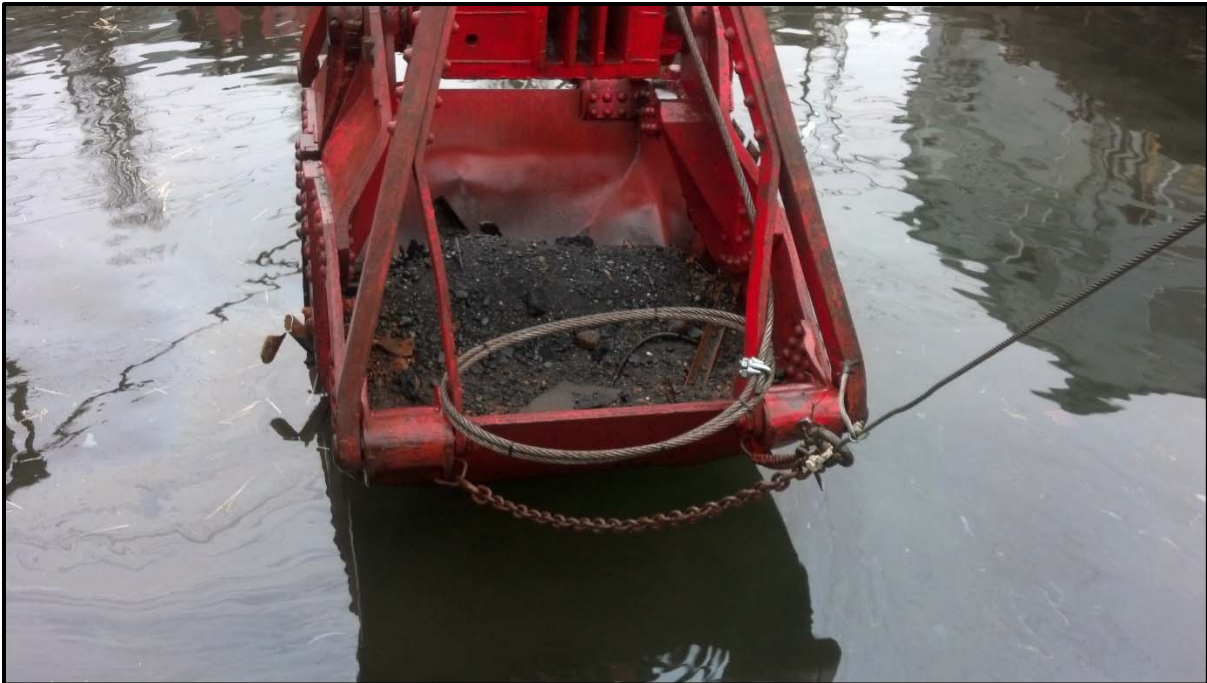
Photograph 11 – Example of sandblast grit in the dredge spoils (December 9, 2013).

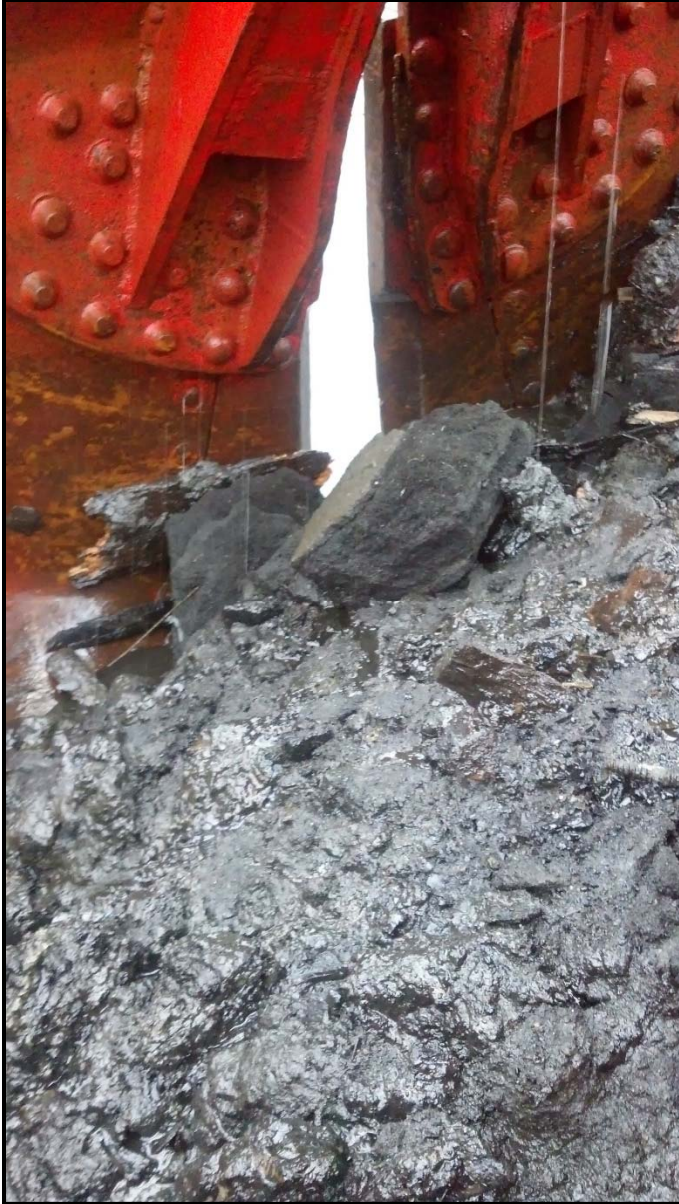
Photograph 12 – Compacted sandblast grit in dredge spoils (January 27, 2014).

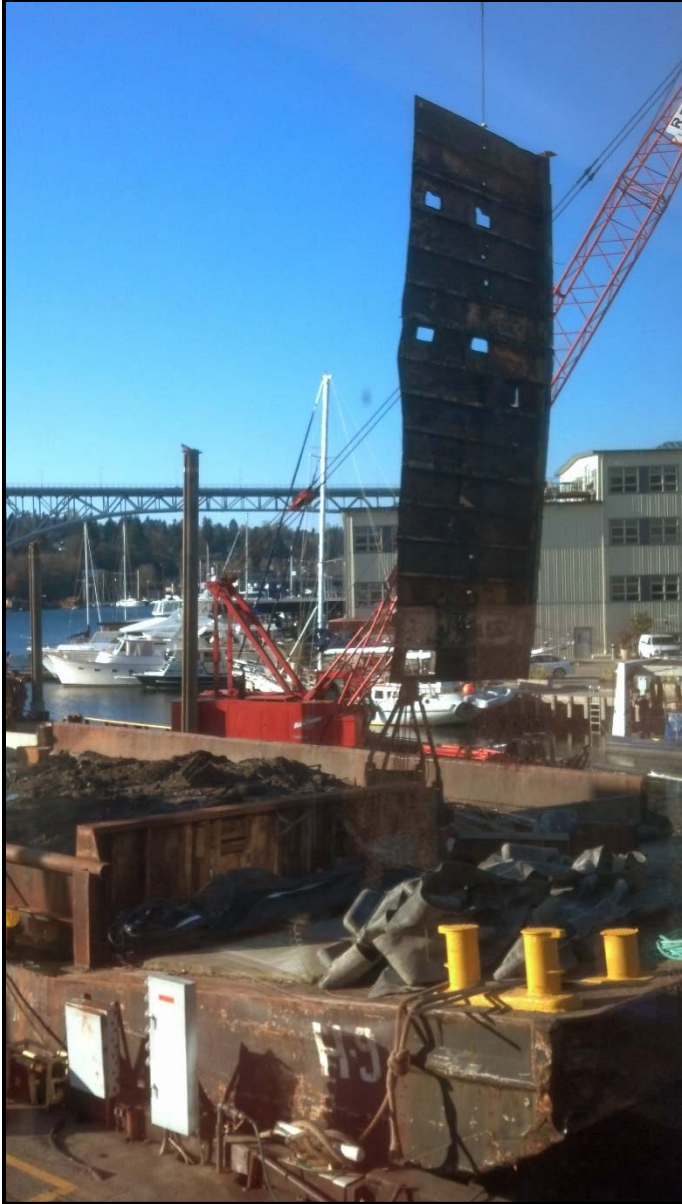
Photograph 13 – Large piece of scrap steel recovered from Waterway 21 (December 5, 2013).
