## Surveys and As-Built Drawings

# NORTHLAKE SHIPYARD SAND BLAST GRIT DREDGING INTERIM ACTION

## Multibeam Pre-Dredge Survey - Phase 1

APPENDIX B  
Selected Site Photographs

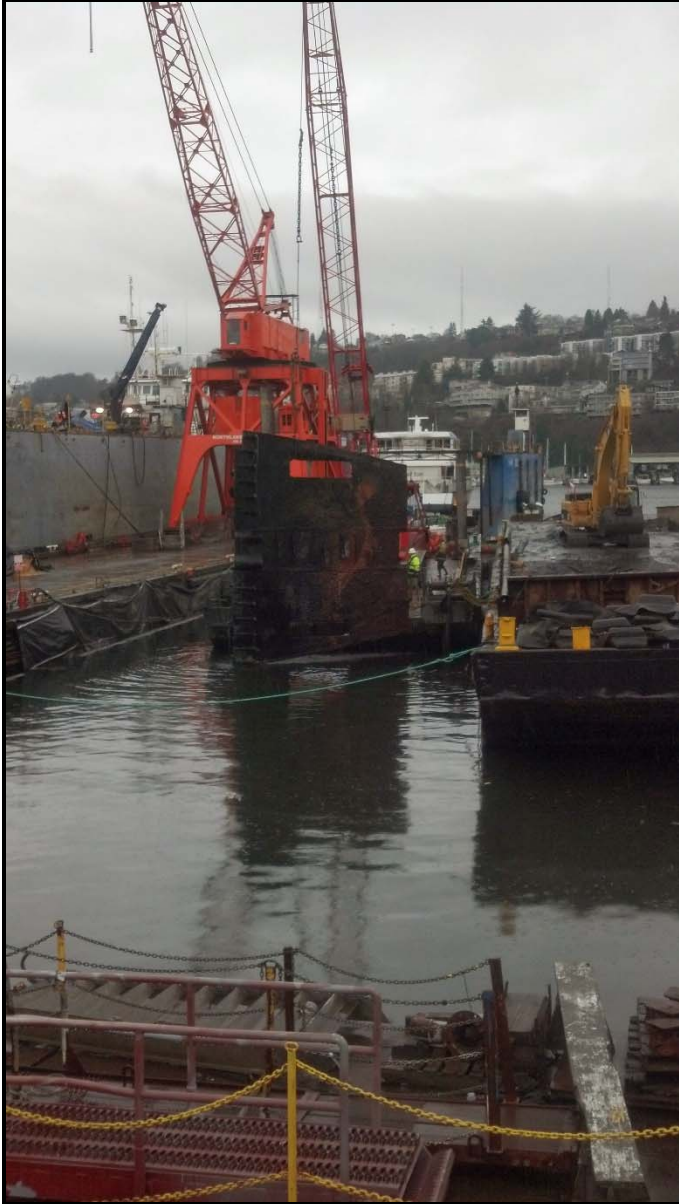
Photograph 14 – Large piece of steel recovered during dredging operations (December 27, 2013).

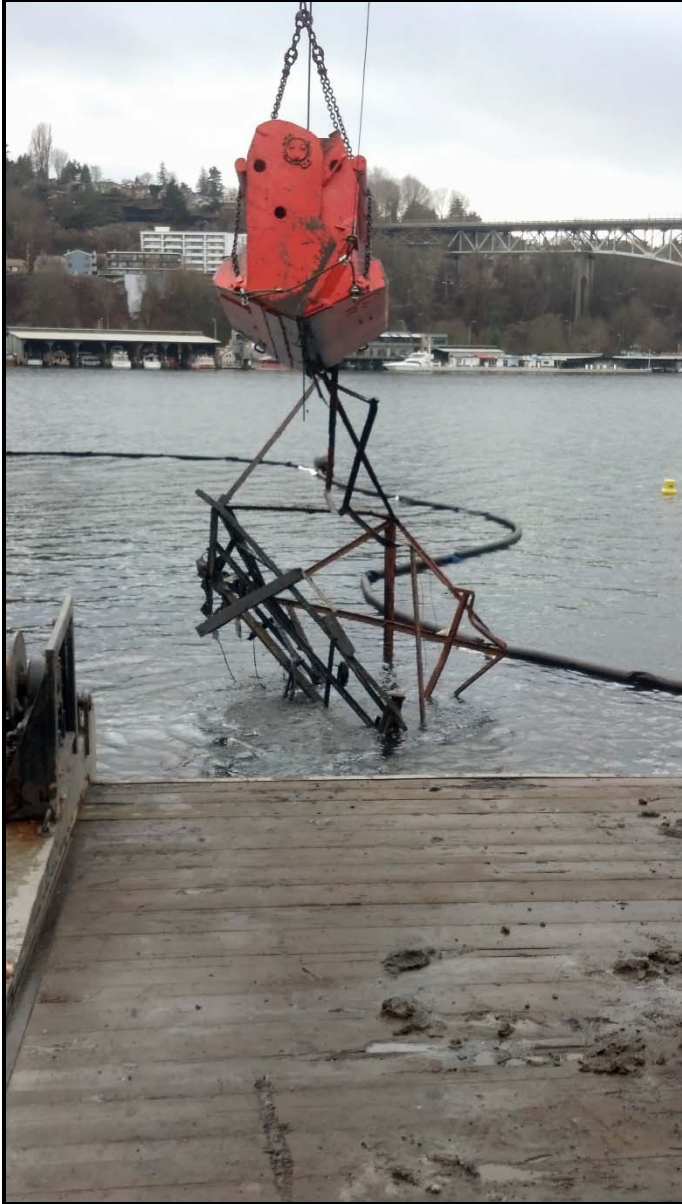
Photograph 15 – Example of scrap steel recovered during dredging operations (January 13, 2014).

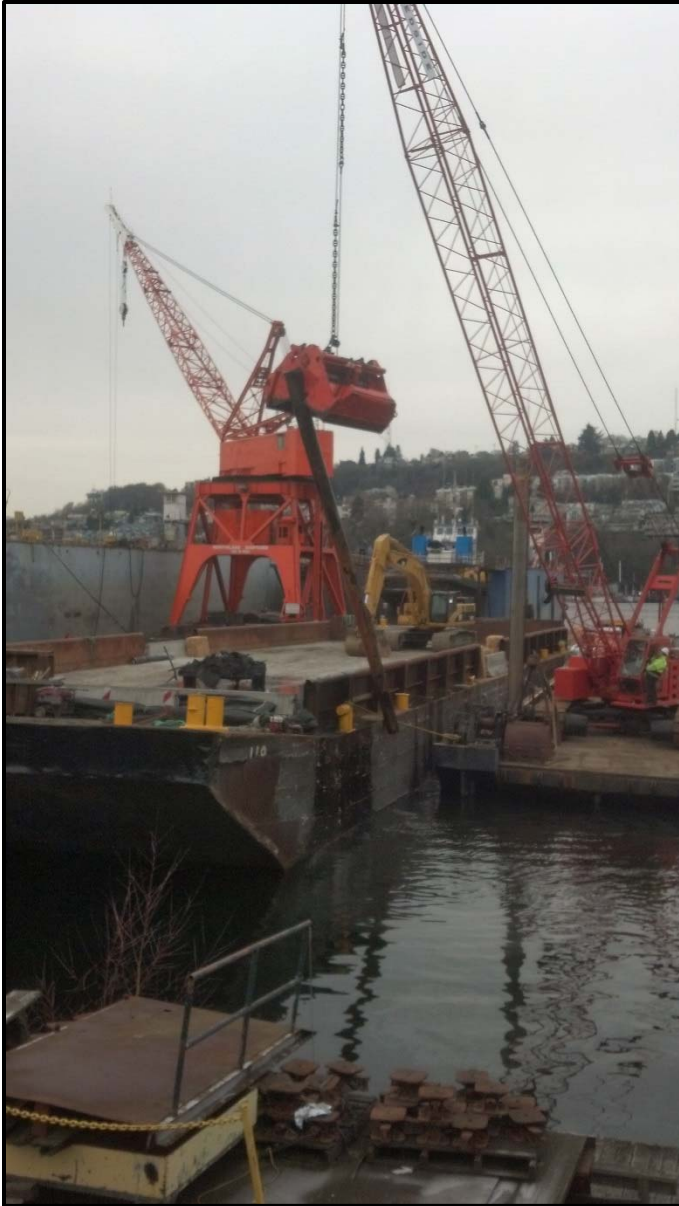
Photograph 16 – Example of timber pile recovered during dredging operations (December 5, 2013).

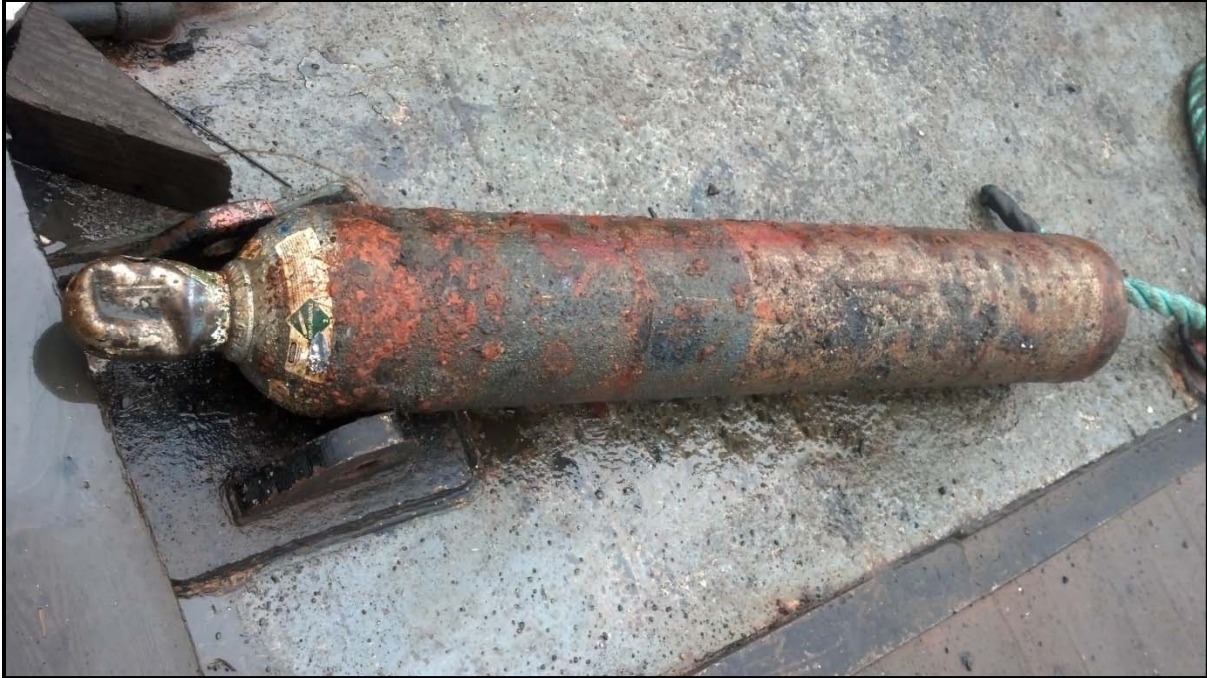
Photograph 17 – Example of gas cylinder recovered during dredging operations (December 27, 2014).

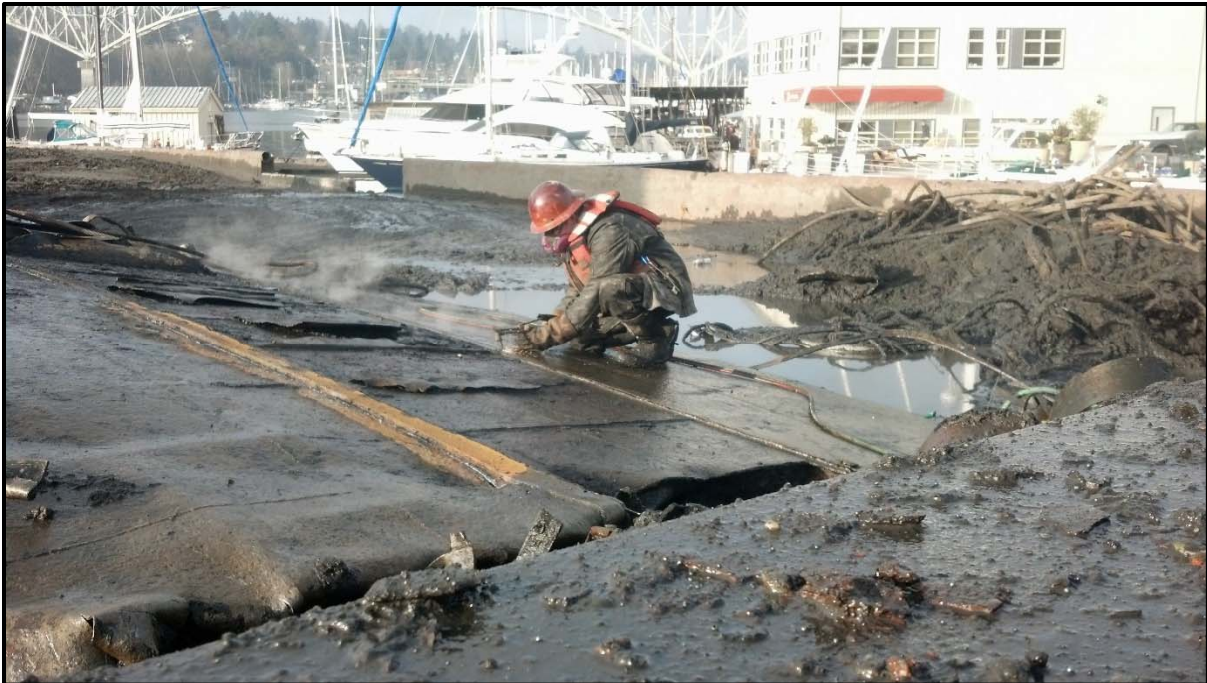
Photograph 18 – Contractor processing recovered scrap steel for off-site disposal (January 15, 2014).

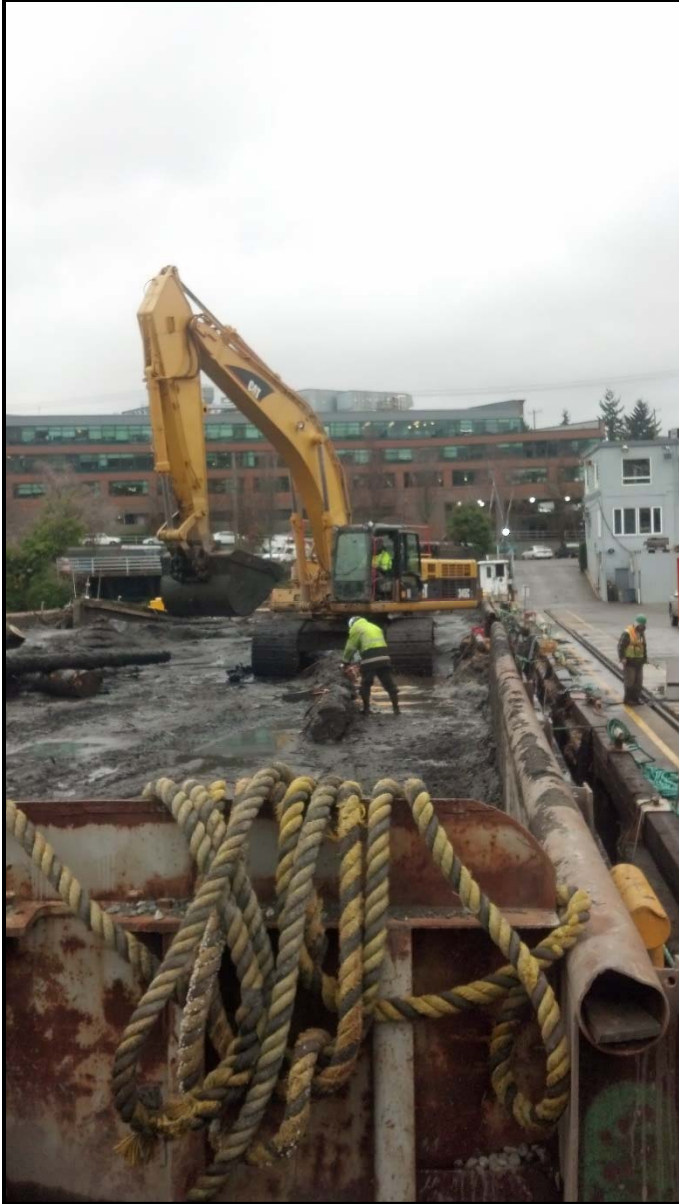
Photograph 19 – Contractor processing recovered timber piles for off-site disposal (January 10, 2014).

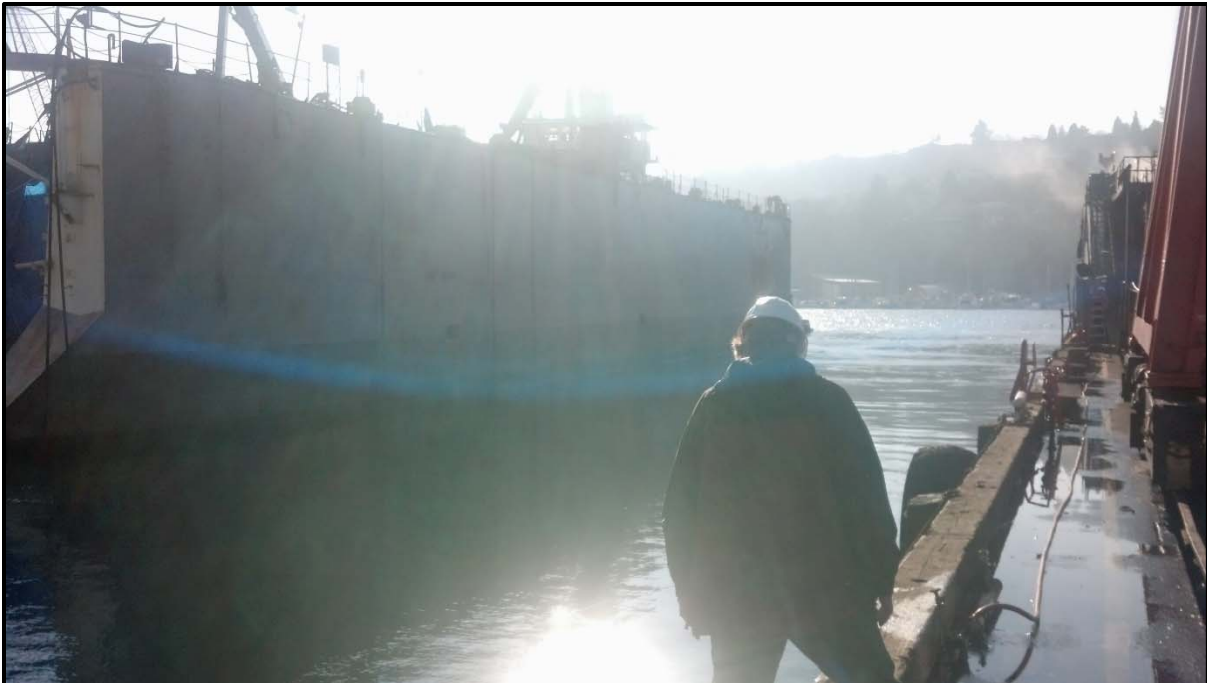
Photograph 21 – Northlake Shipyard relocating Dry Dock 9 to allow dredging operations to begin on the east side of the pier (January 23, 2014).

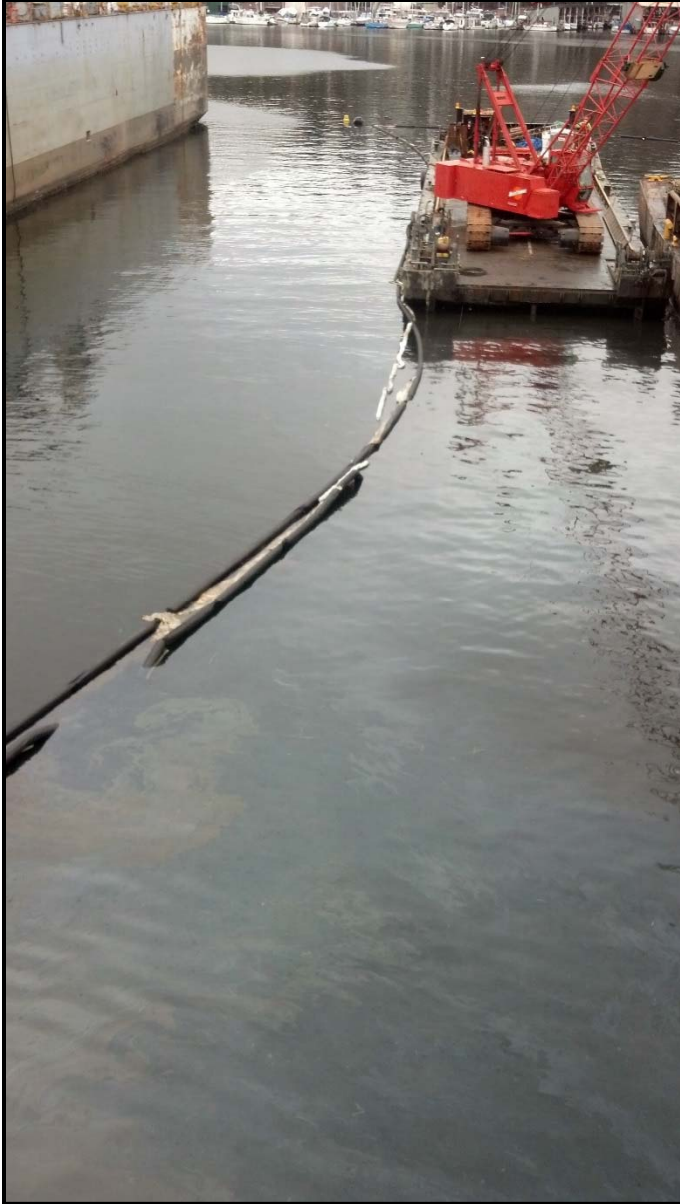
Photograph 23 – Water quality controls during Phase II dredging operations (January 31, 2014).

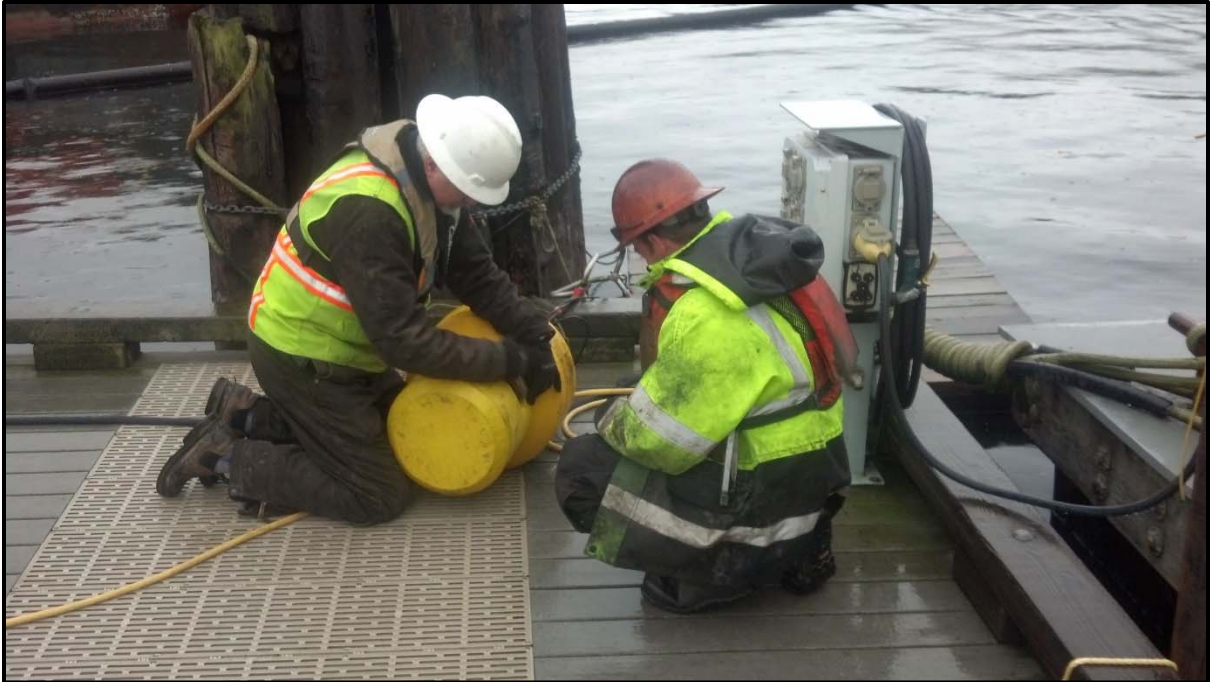
Photograph 24 – Contractor changing batteries on the water quality monitoring buoy (January 8, 2014).

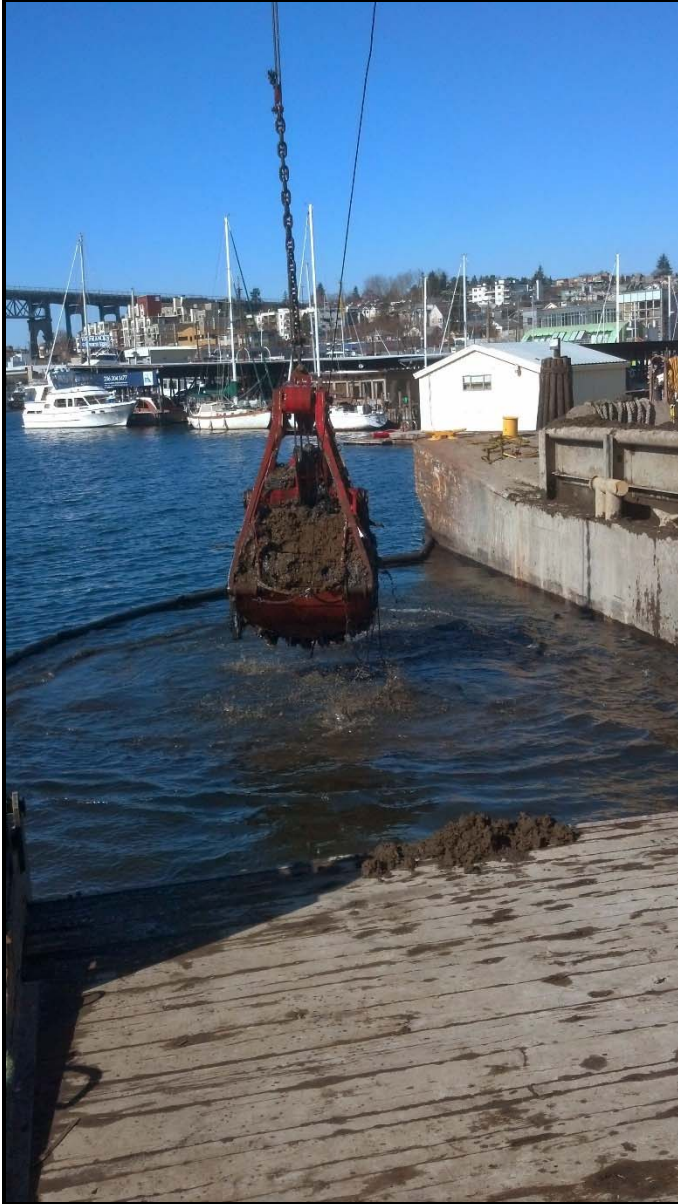
Photograph 26 – Example of dredge spoils containing native material (February 28, 2014).

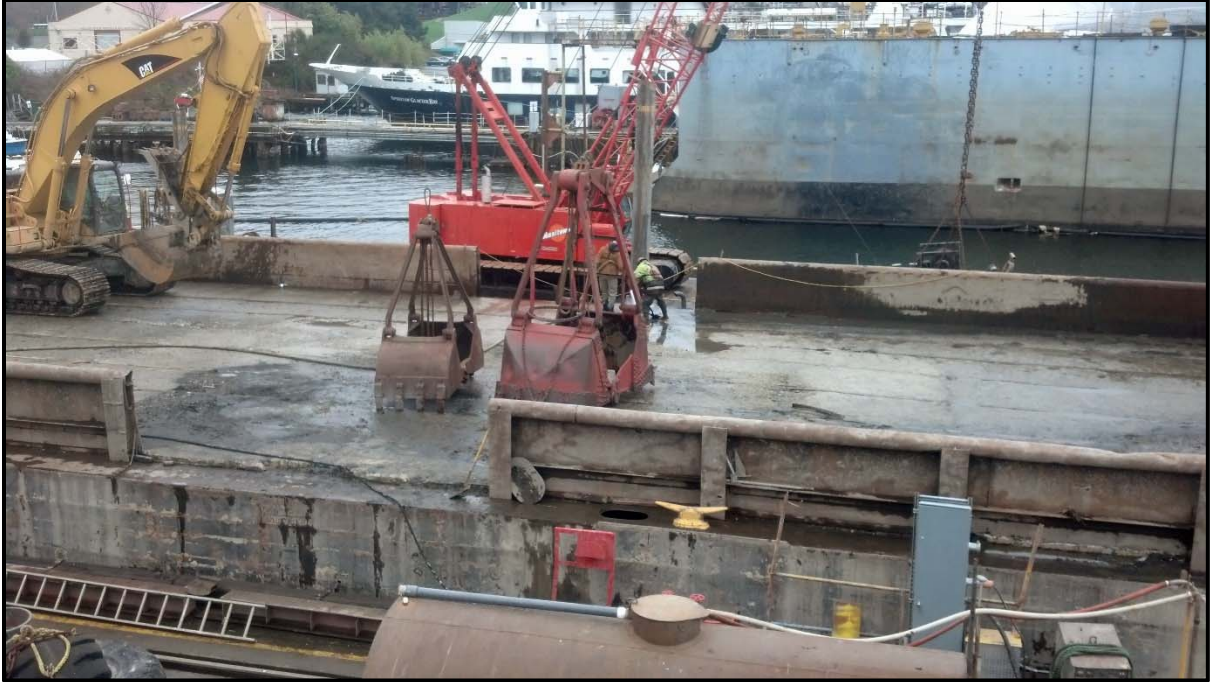
Photograph 27 – Cleaning the barge in preparation for thin-layer cap placement (March 6, 2014).

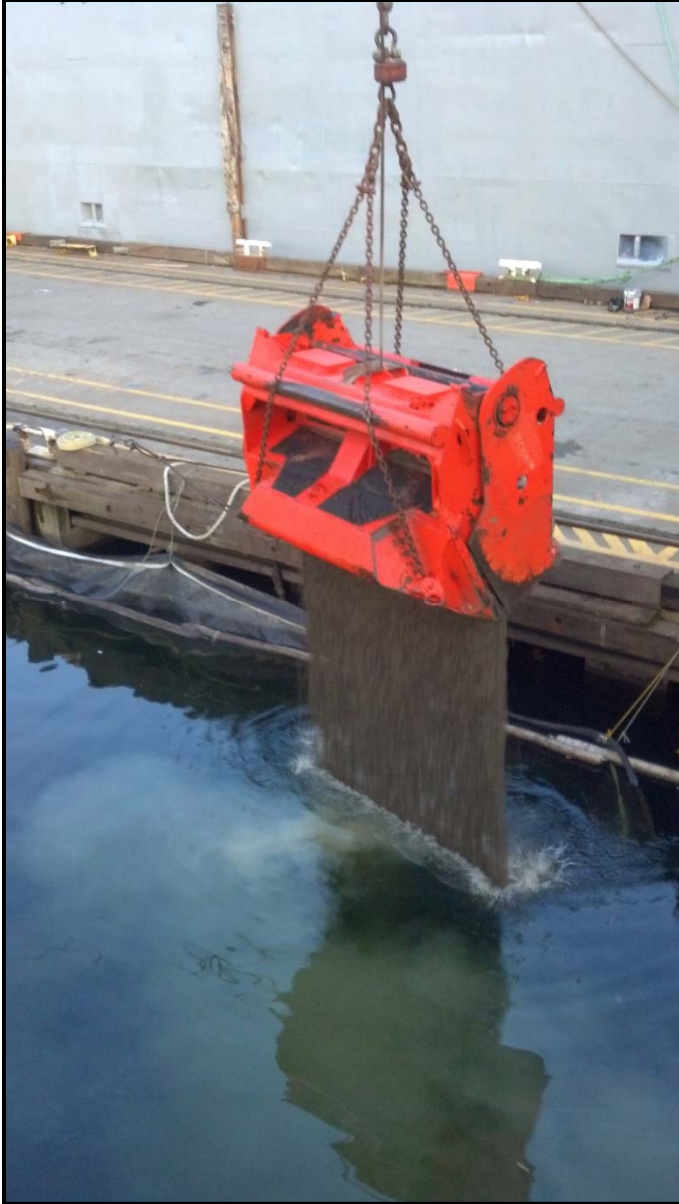
Photograph 29 – Contractor placing thin-layer capping material (March 13, 2014).
