## SCS ENGINEERS

December 19, 2014  
File No. 04214002.04

**Subject: Documentation Report for Repair of South Slope Cover System,  
Hidden Valley Landfill, Puyallup, Washington**

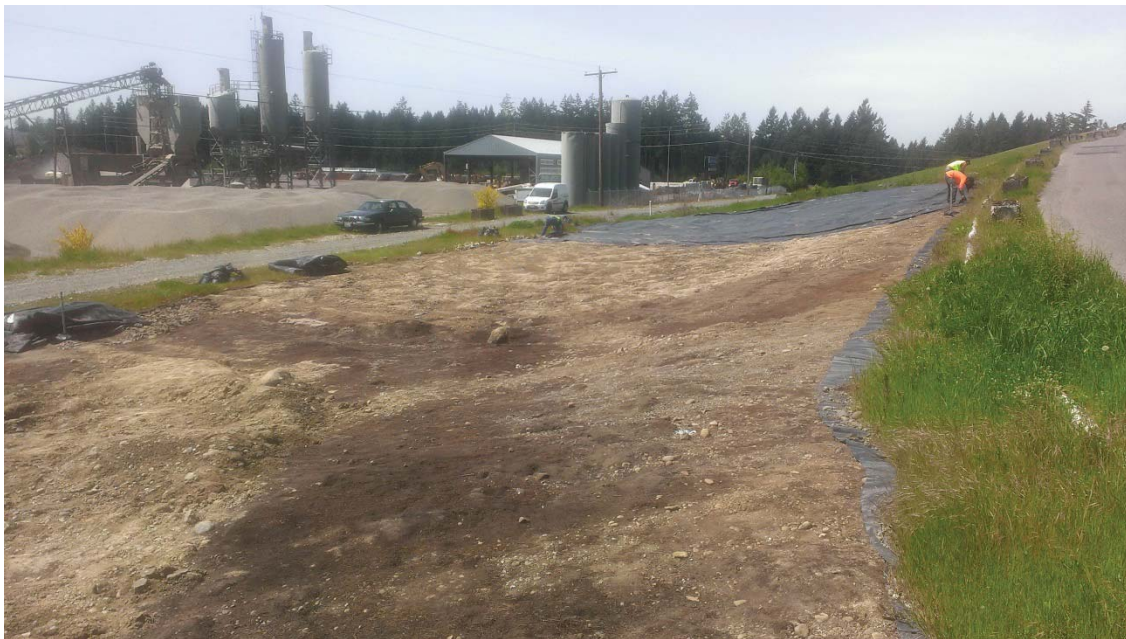
2014, May 12, viewing west. Removal of temporary plastic cover.

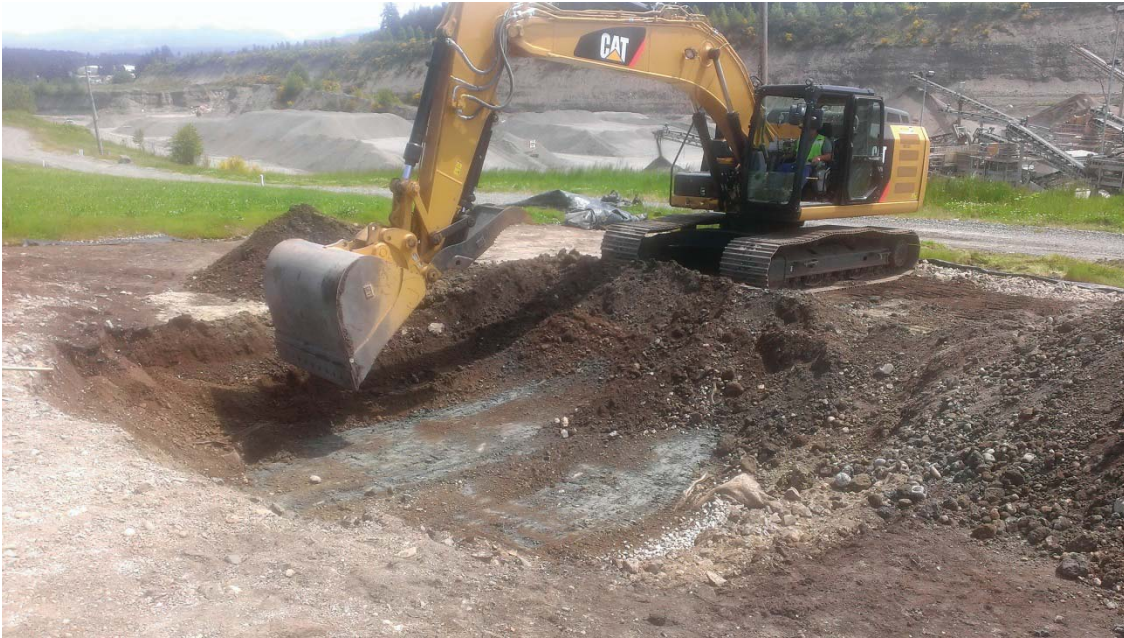
2014, May 12. Initial removal of cover soils, east sinkhole.

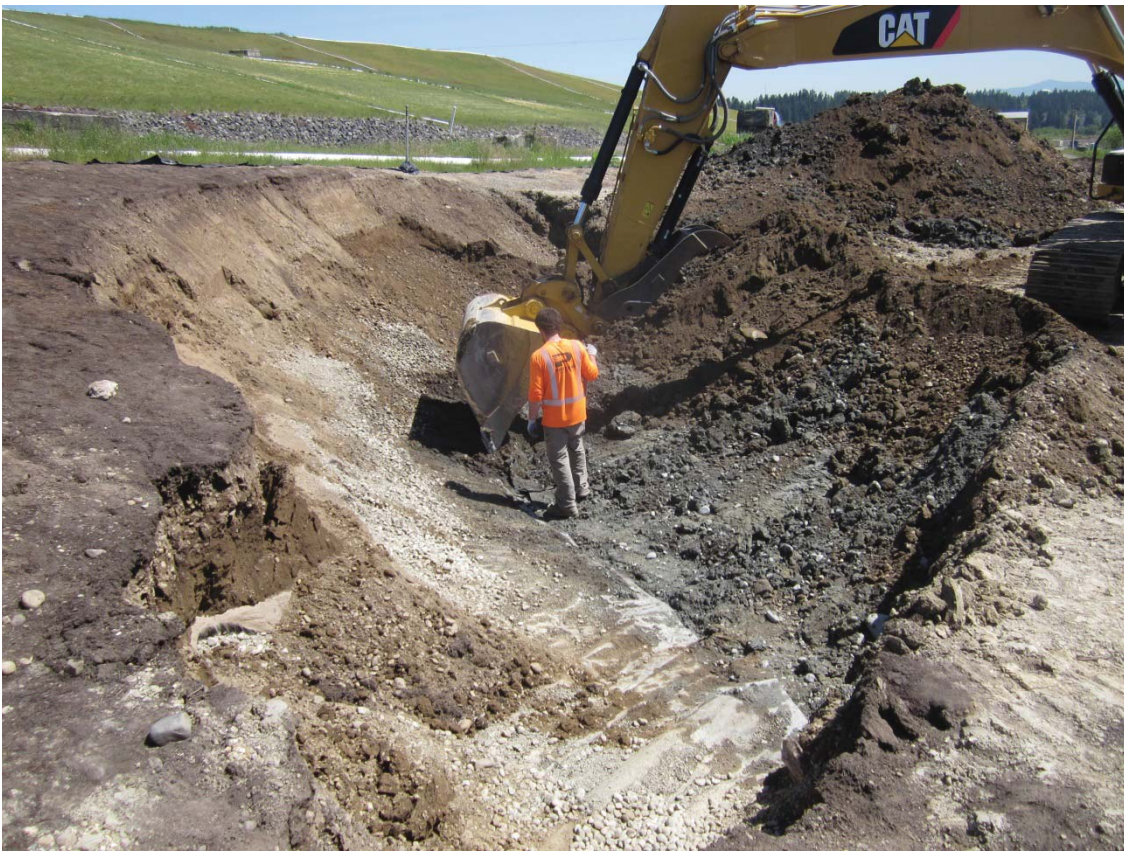
2014, May 13. Continuing removal of cover soils, east sinkhole.

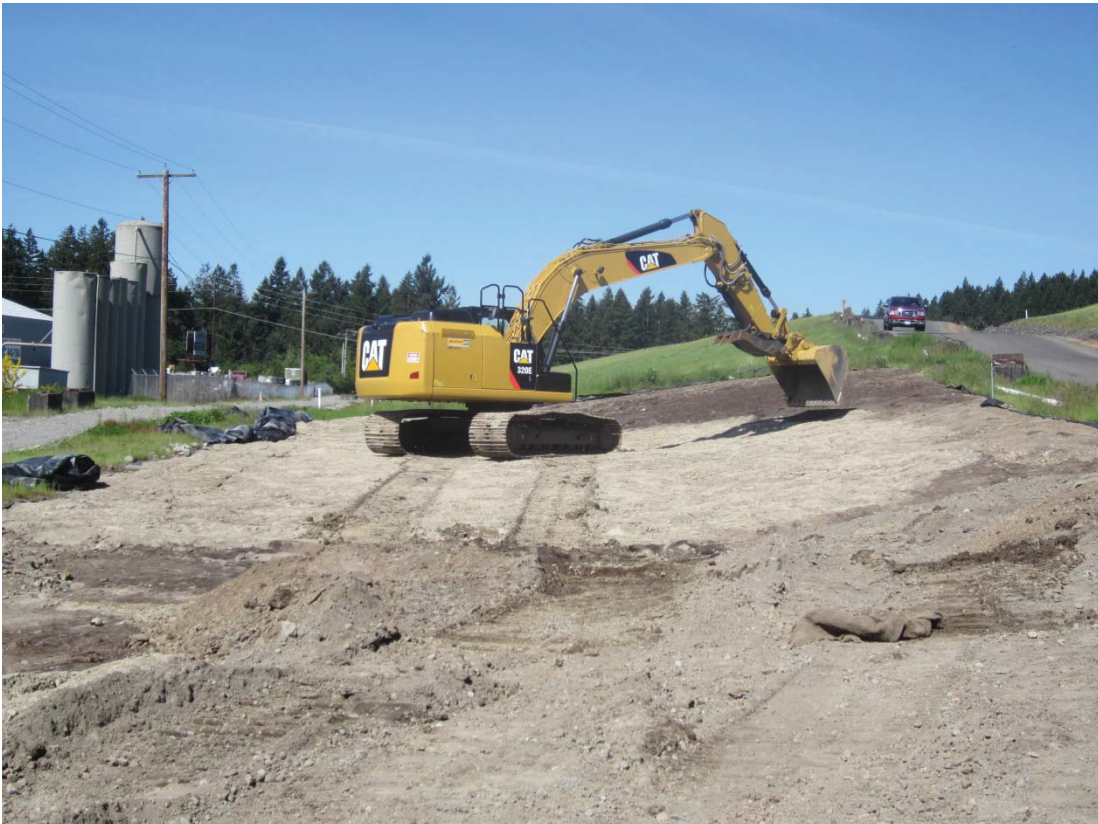
2014, May 13. Initial excavation at west sinkhole.

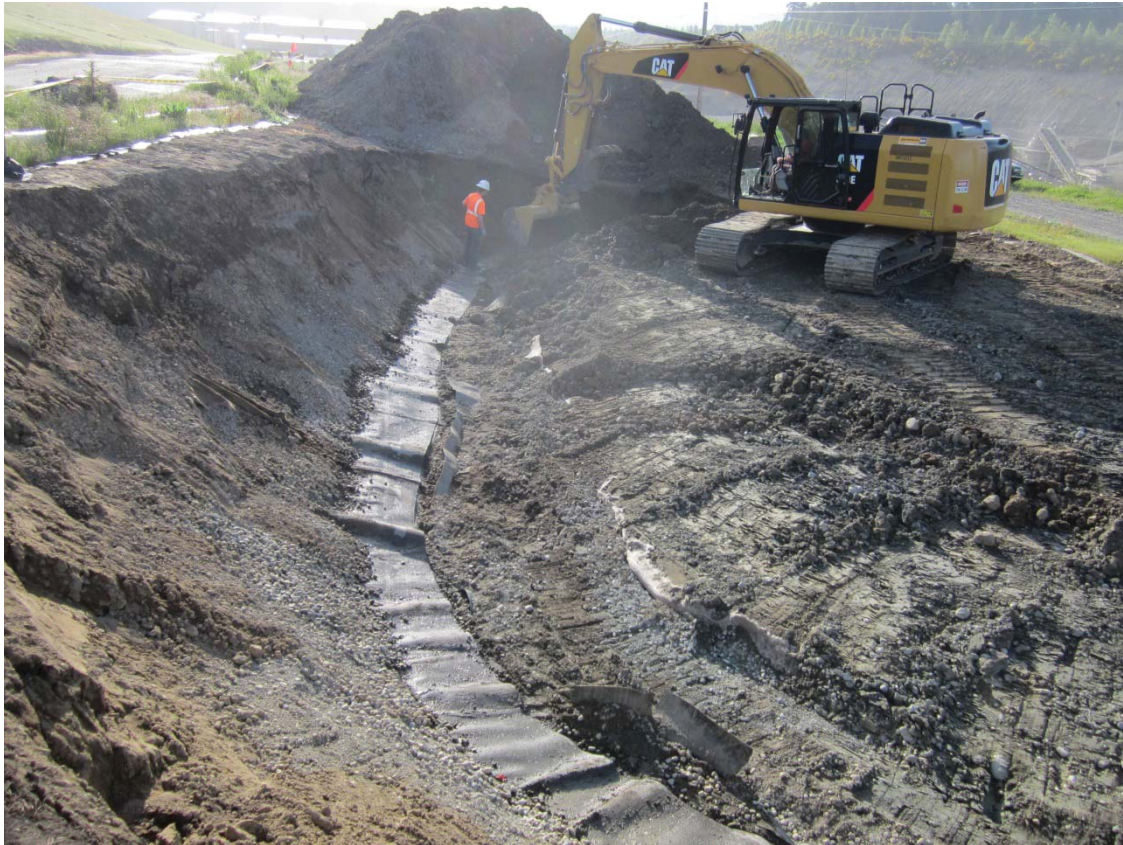
2014, May 14. Excavation at west sinkhole; viewing east.

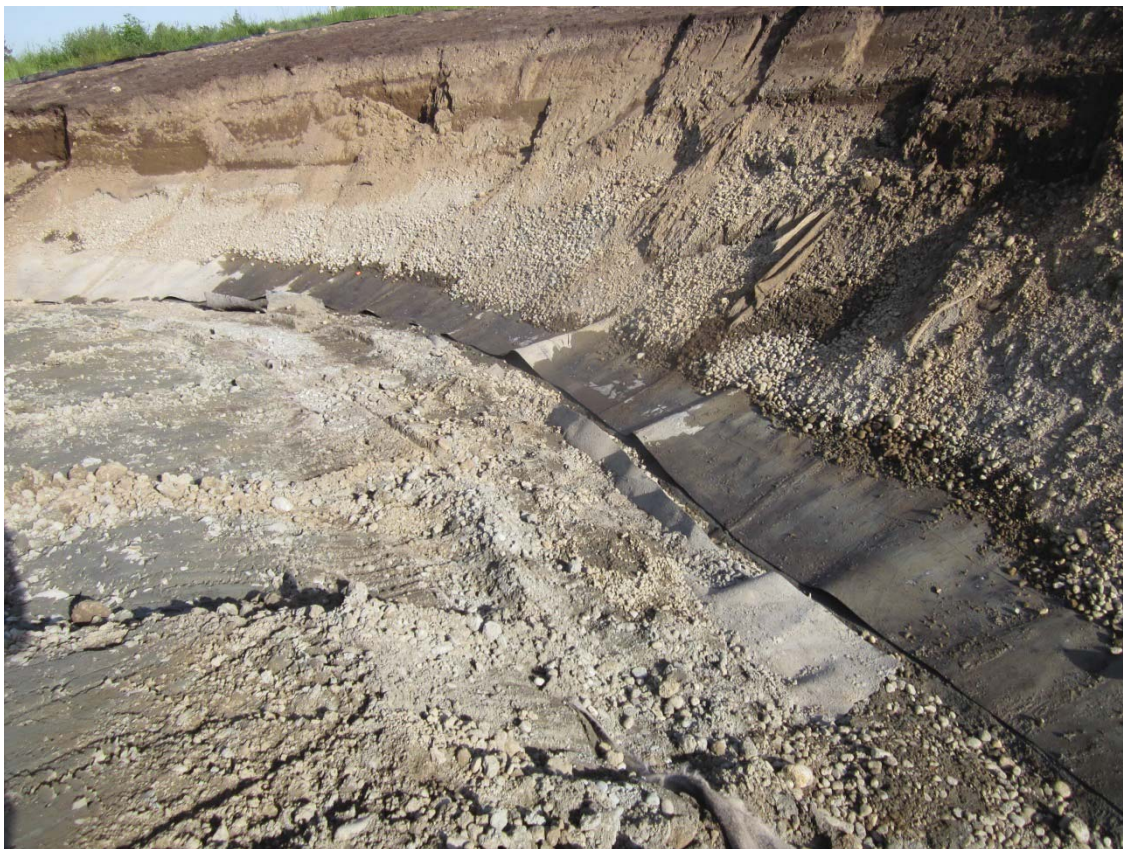
2014, May 14. Excavation at west sinkhole; viewing west.

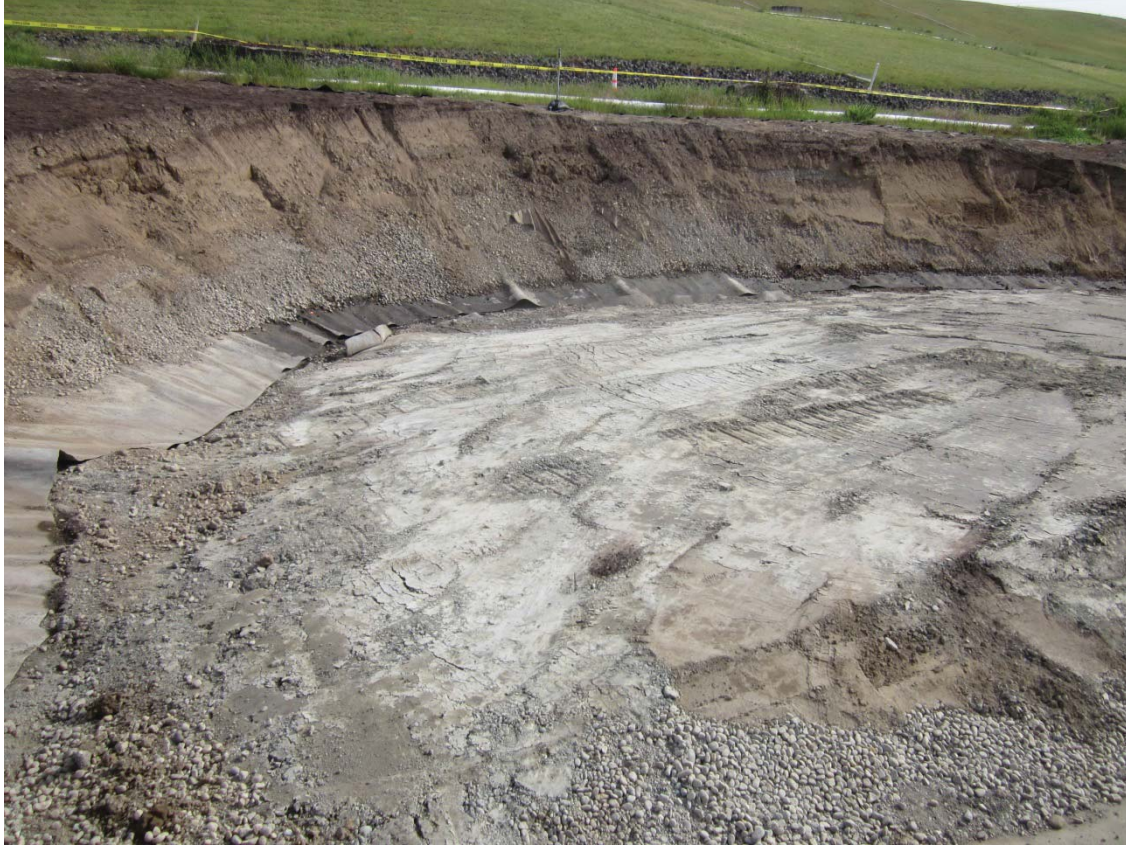
2014, May 15. Excavation at west sinkhole.

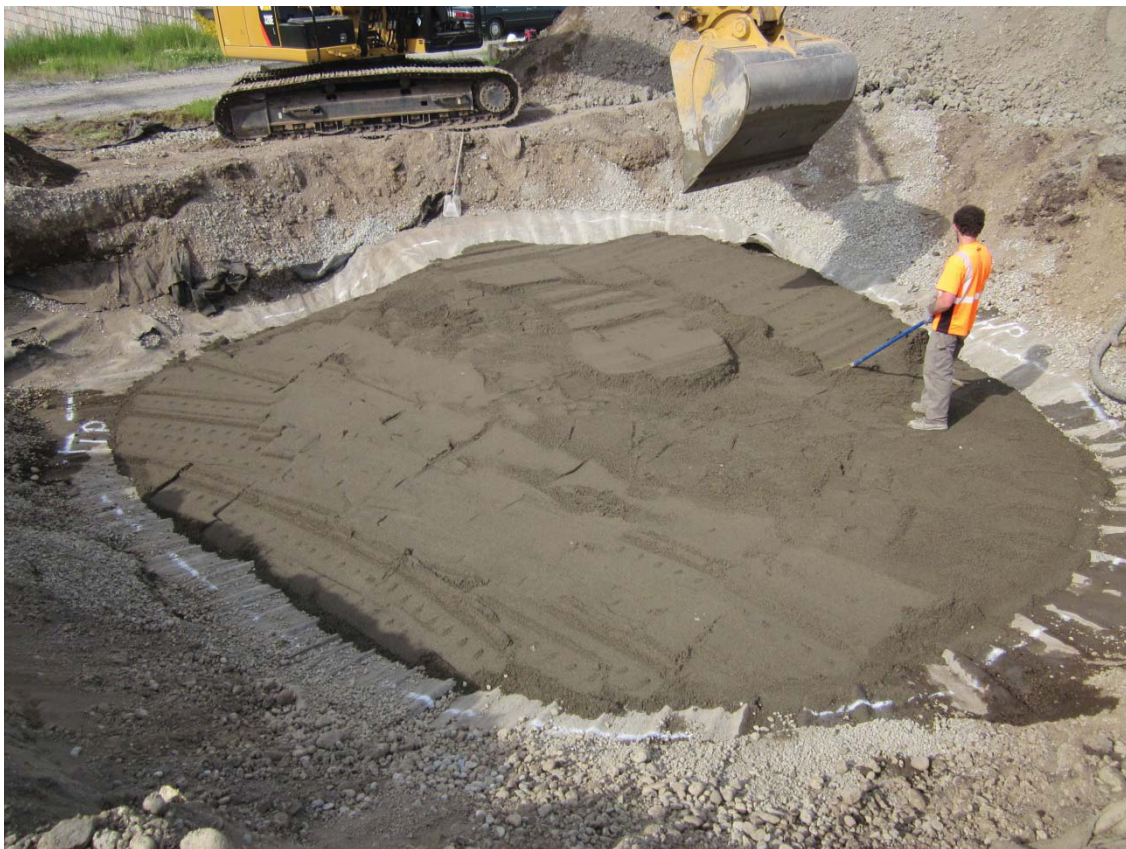
2014, May 15. Backfill placement at east sinkhole.

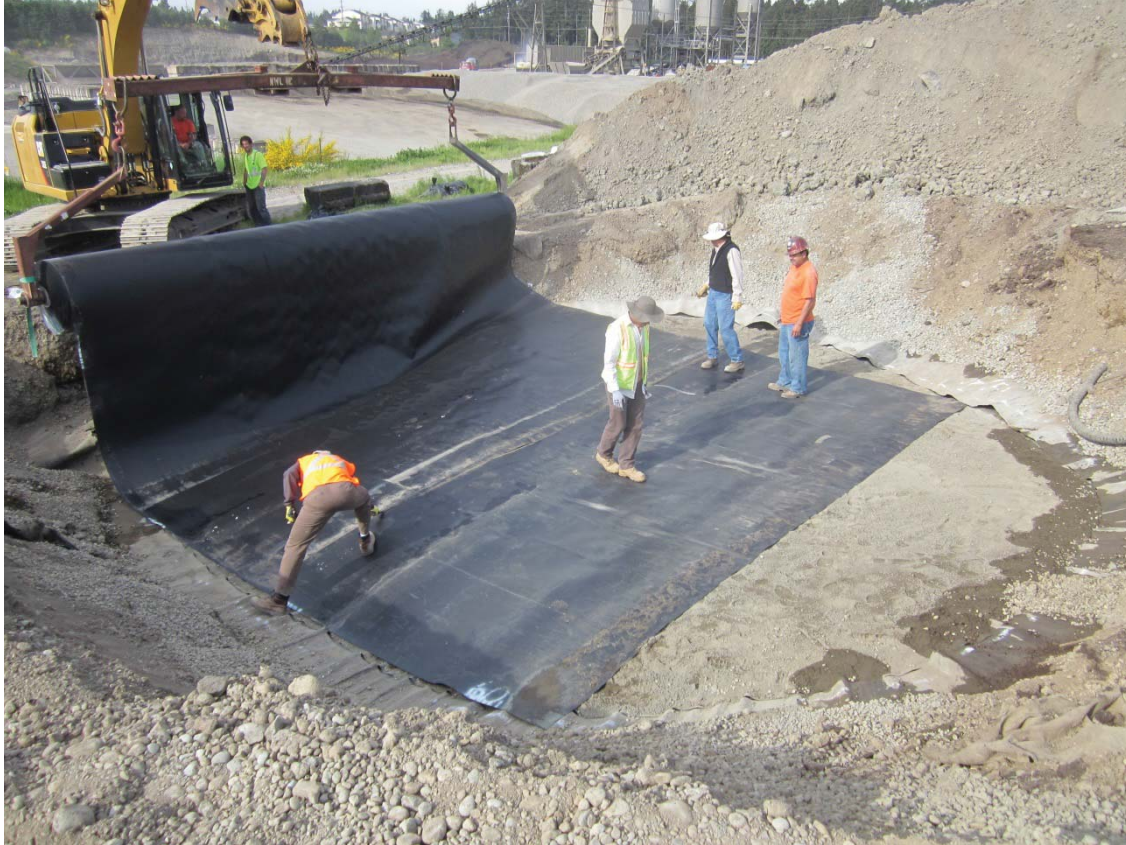
2014, May 16. Geomembrane placement; east sinkhole

Approximately 6,215 SF of black 60-mil HDPE 460ST-1000 texture geomembrane, manufactured by Solmax, was installed over the foundation and bedding soils as described previously. Only textured geomembrane was used for the cover repair. The geomembrane

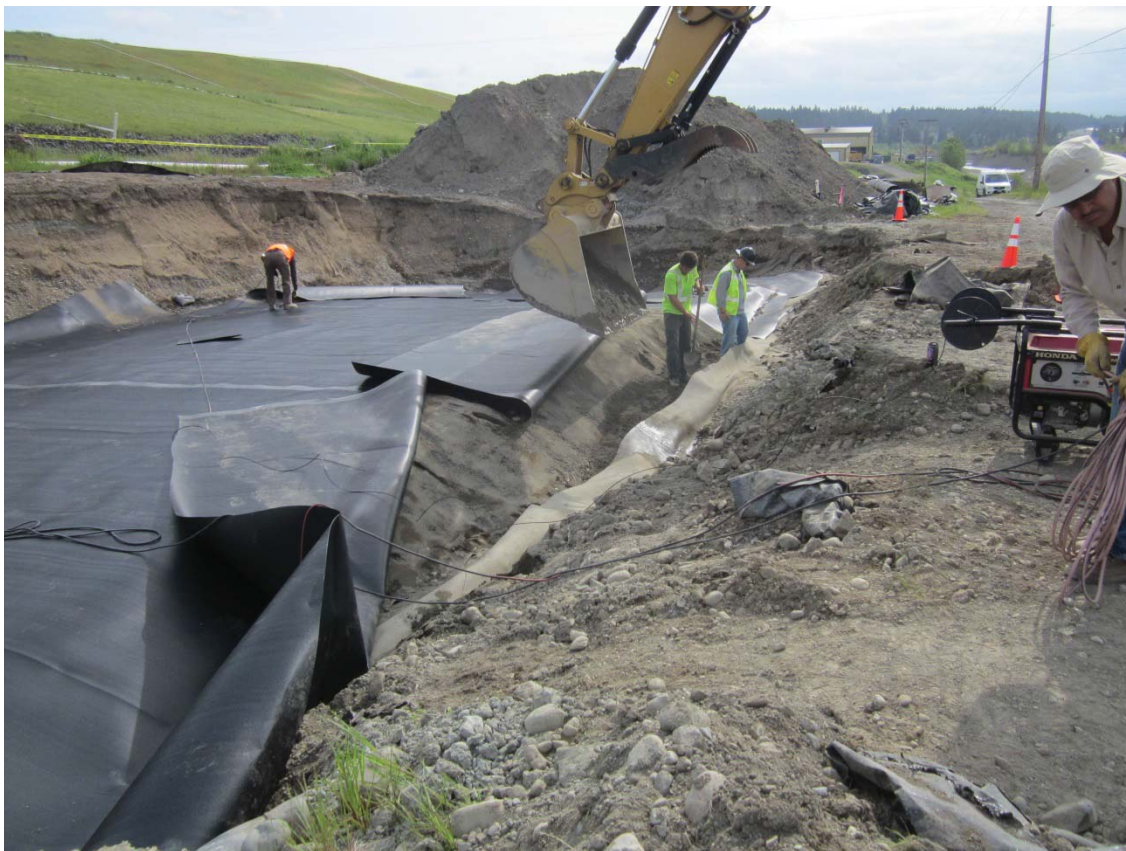
2014, May 16. Geomembrane placement; west sinkhole

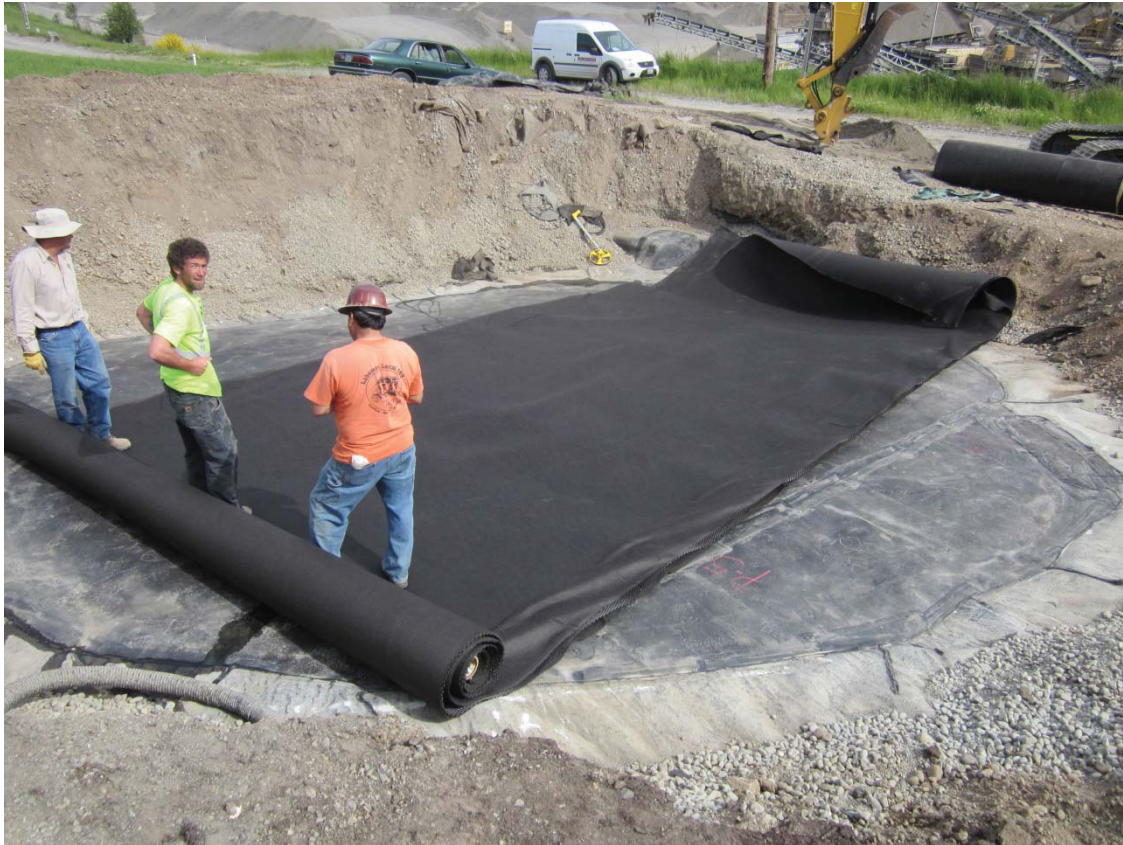
2014, May 16. Geonet composite installation; east sinkhole

The geonet composite was installed over the geomembrane liner to provide drainage and prevent damage from the overlying soil layer(s). The geonet composite was deployed using a spreader bar attached to an excavator. Seaming of the geonet composite was accomplished by using nylon ties spaced a maximum of 5 feet apart. In addition, the geotextile component of the geonet composite was heat seamed to provide additional strength and to prevent intrusion from overlying soils.

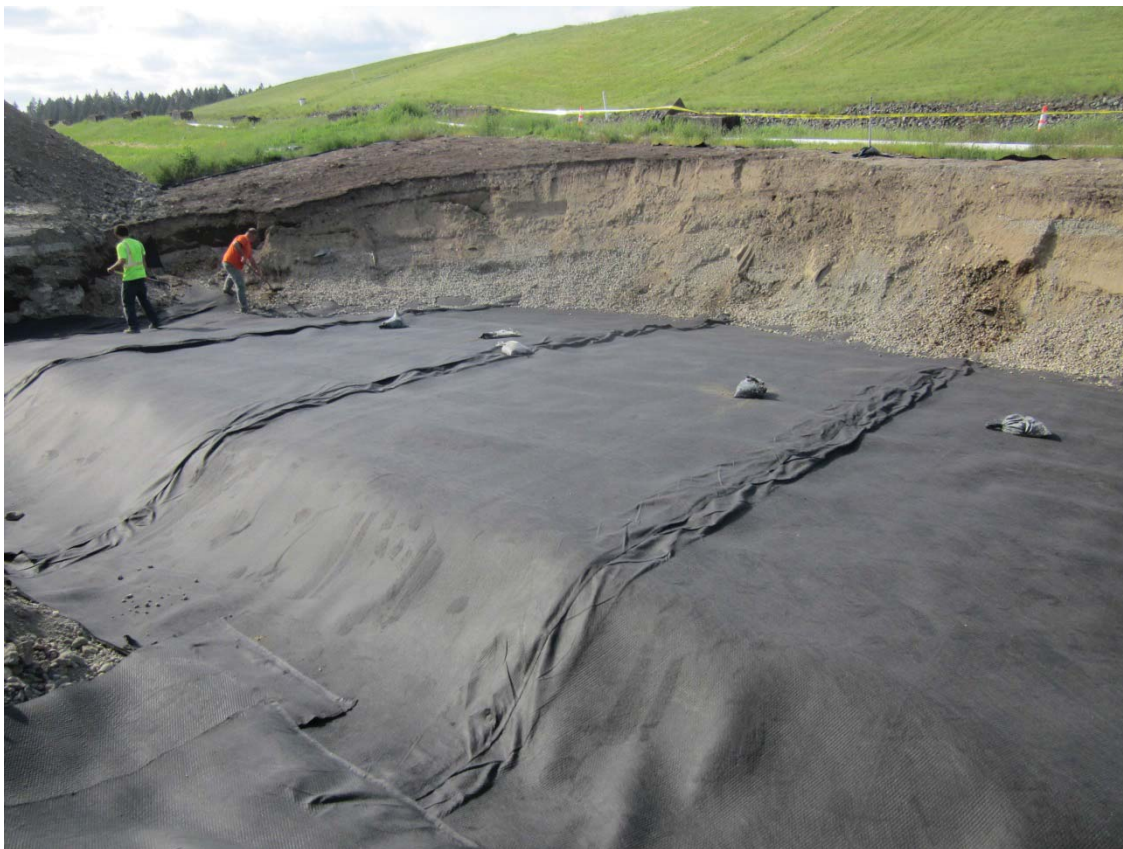
2014, May 16. Geonet composite installation; west sinkhole

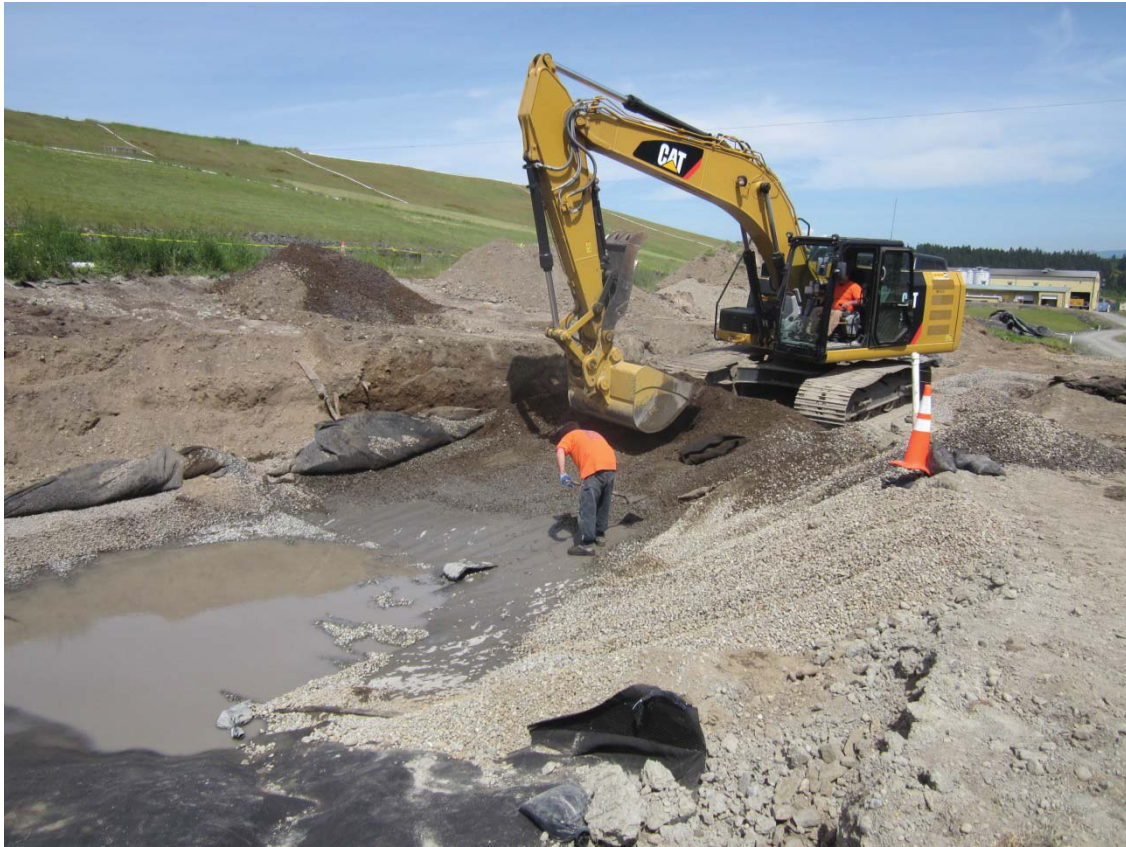
2014, May 22. Additional excavation to re-establish drainage.

To reestablish site drainage, a 155-foot long trapezoidal ditch was installed. Ditch slopes extended from the east side of the west sinkhole to the southeast, past the east sinkhole and into the perimeter collection channel (existing) near gas extraction well N-62. The existing geomembrane was cut and folded back to allow for excavation of the trapezoidal channel with 1 horizontal to 1 vertical side slopes (1H:1V). The drainage ditch was sloped at a minimum of 2 percent (ft/ft) from the low point of the west sinkhole to the perimeter channel. Over excavation of approximately 40 CY from below the existing geomembrane was performed to reestablish surface drainage and allow adequate thickness for placement of a foundation and bedding layer below the geomembrane. Excavated soil and waste debris was delivered to the transfer station for proper disposal.

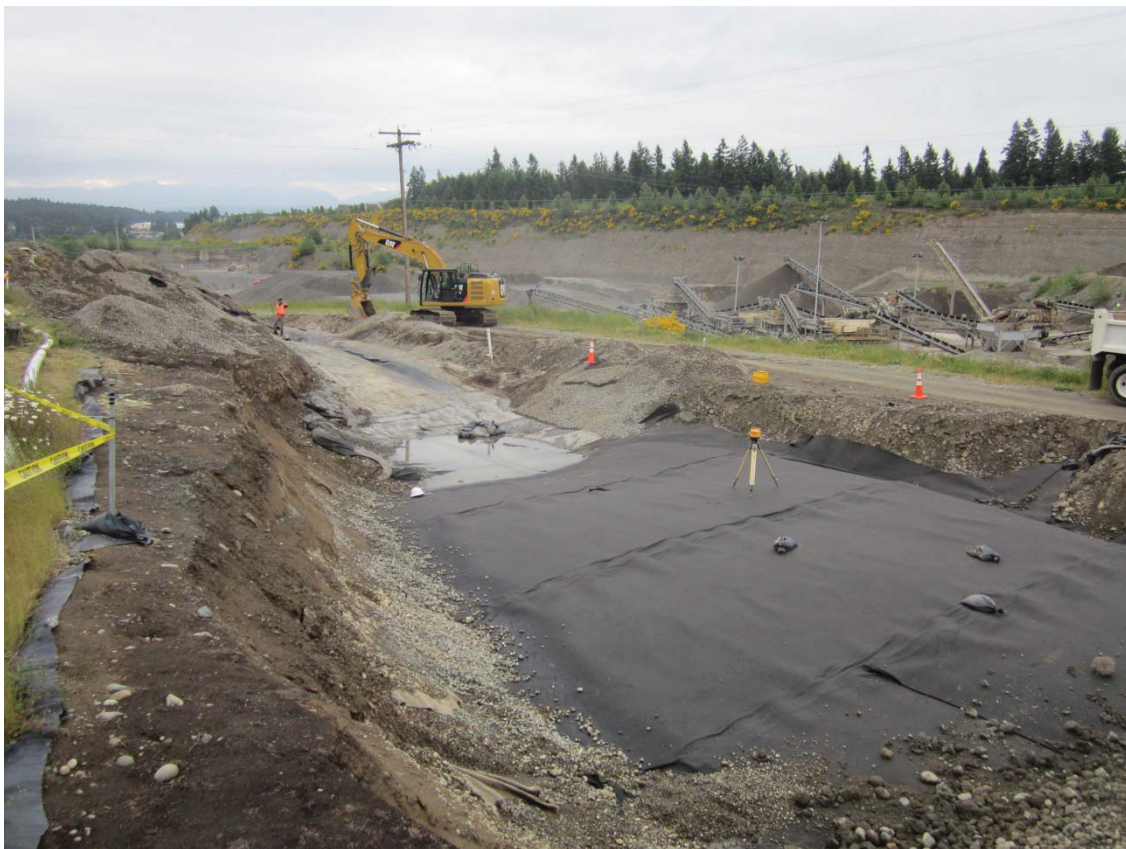
2014, May 29. Additional excavation to re-establish drainage.

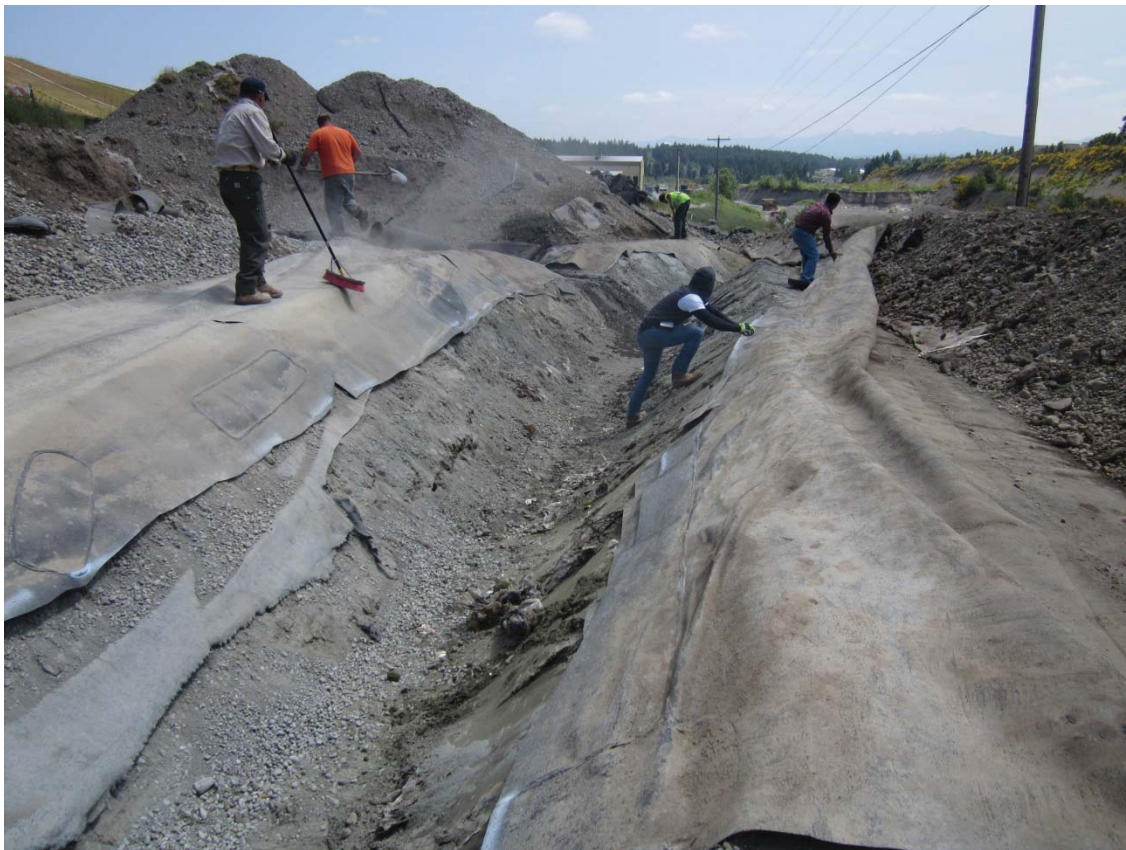
2014, May 30. Preparing subgrade for geomembrane placement.

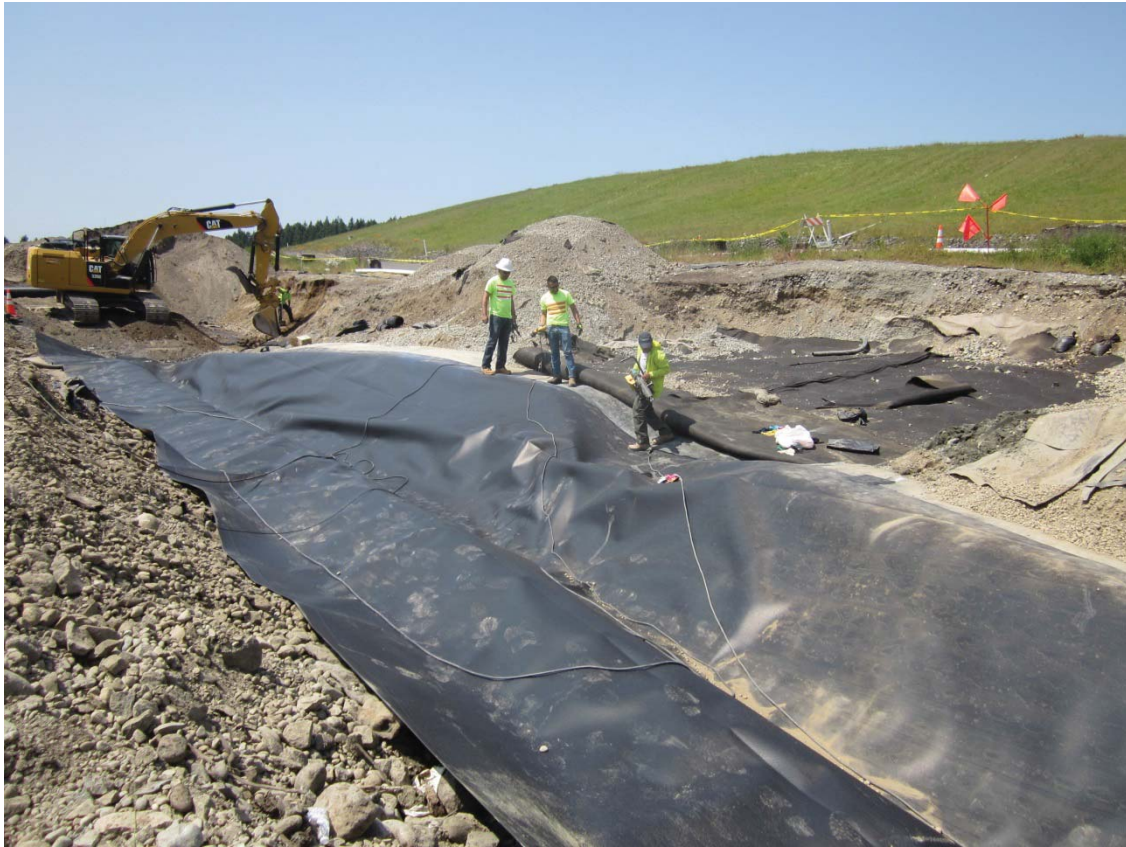
2014, May 30. Geomembrane installation.

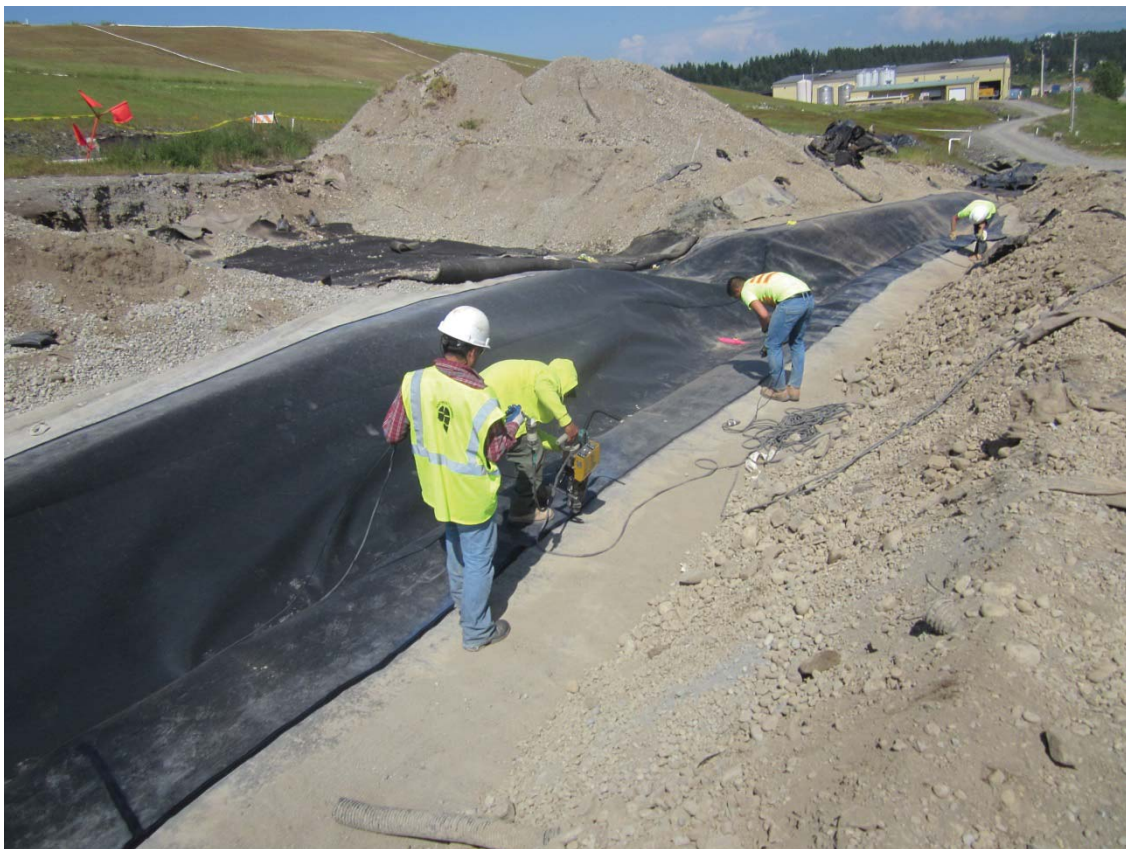
2014, May 30. Geomembrane installation.

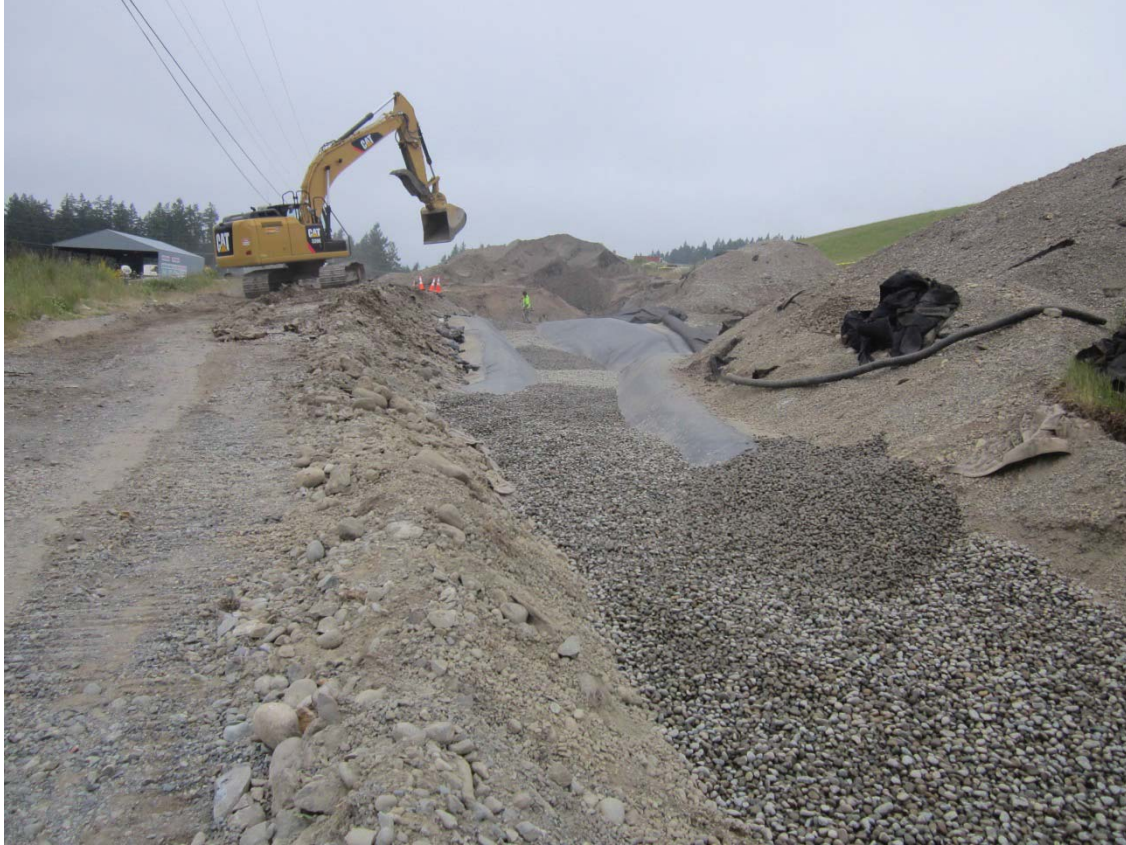
2014, June 2. Placement of drain rock within surface drainage feature.

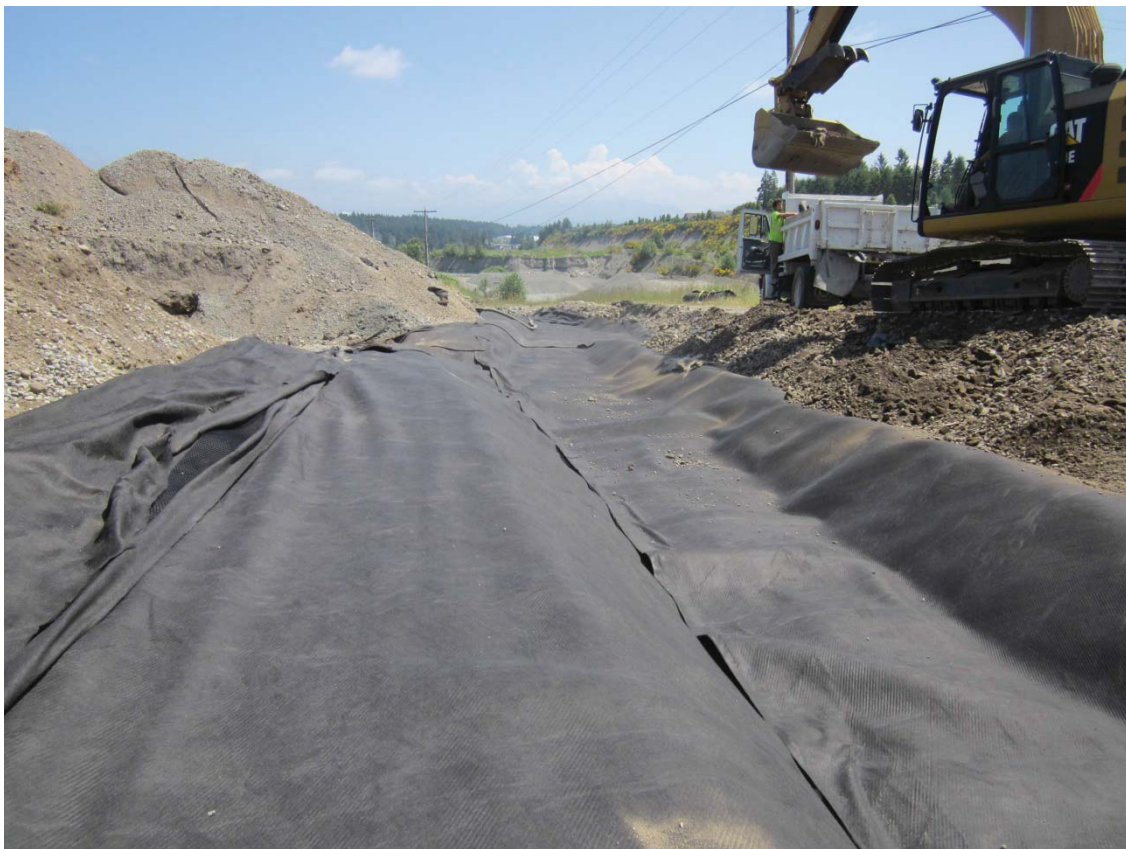
2014, June 2. Placement of geotextile filter over drain rock.

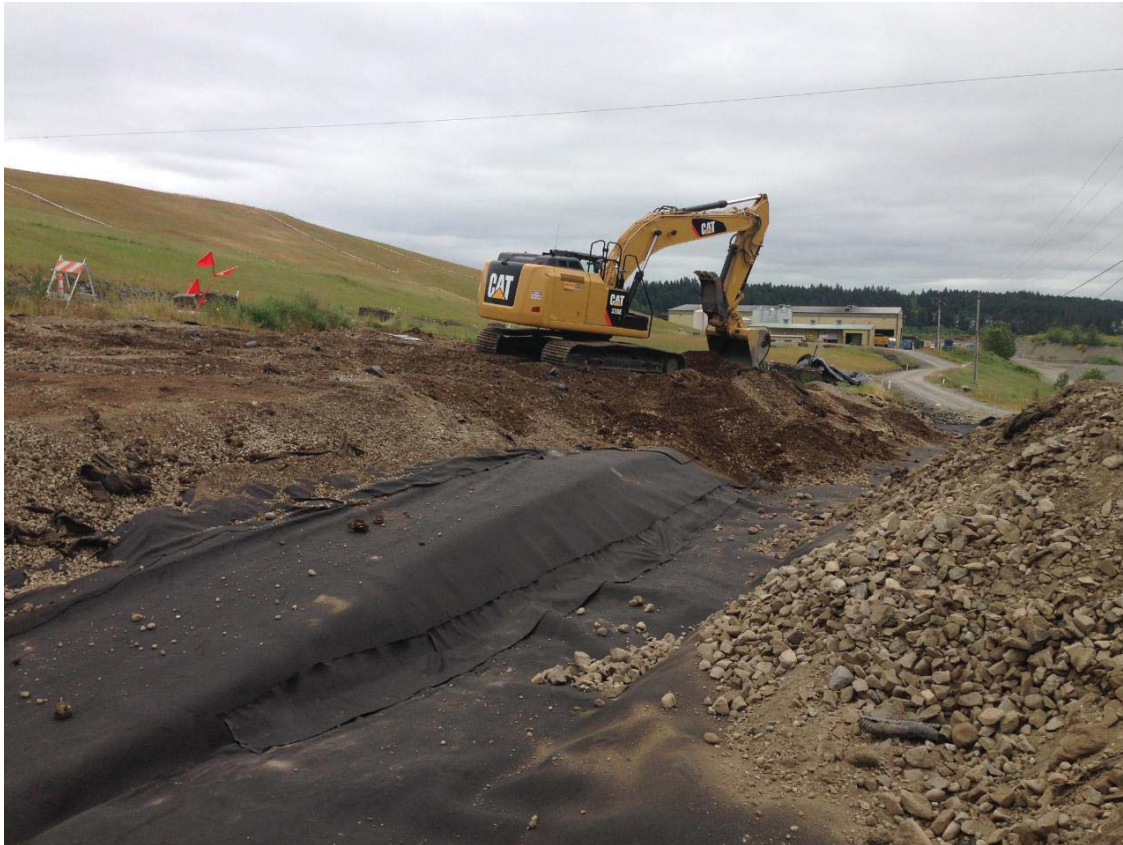
2014, June 3. Placement of cover soil.

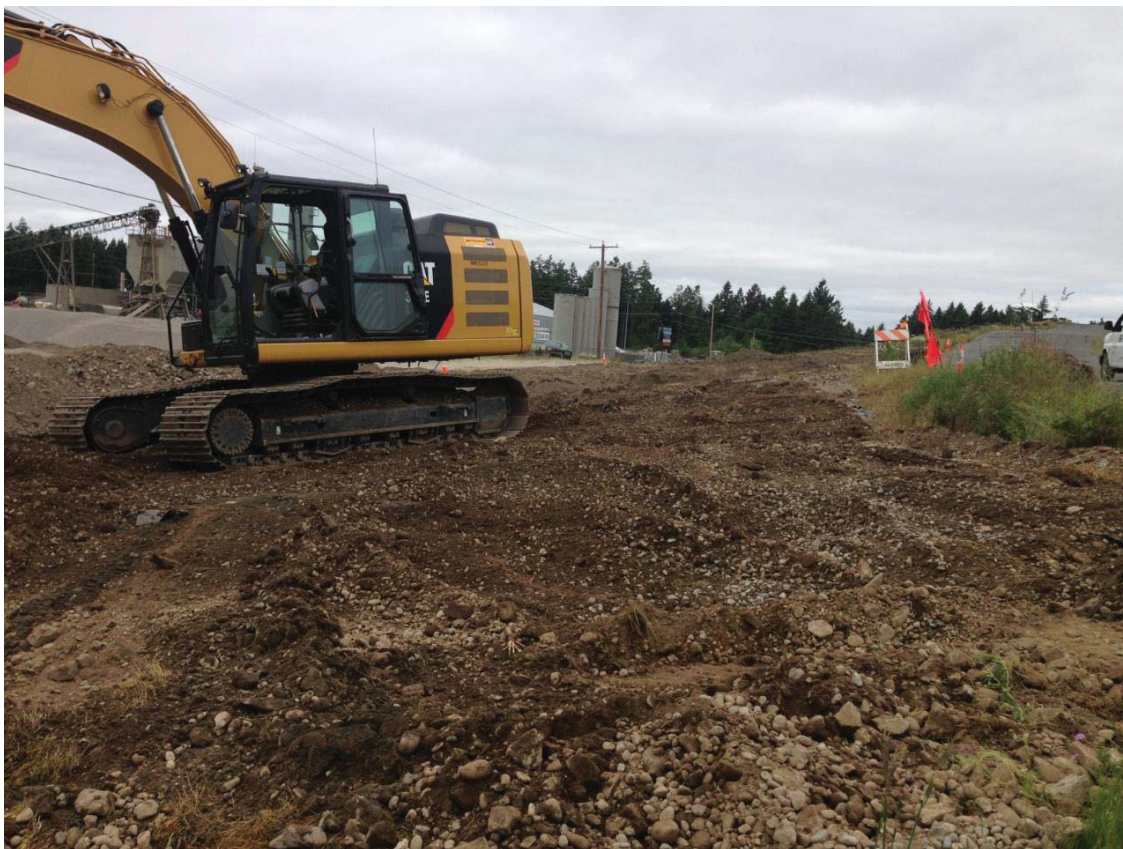
2014, June 3. Placement of cover soil.
