## **Site Check and Groundwater Monitoring Well Installation Report**

**Smitty's Conoco Lincoln**  
301 North 1<sup>st</sup> Street  
Yakima, Washington

AEG Project # 12-161  
Date of Report: January 5, 2015

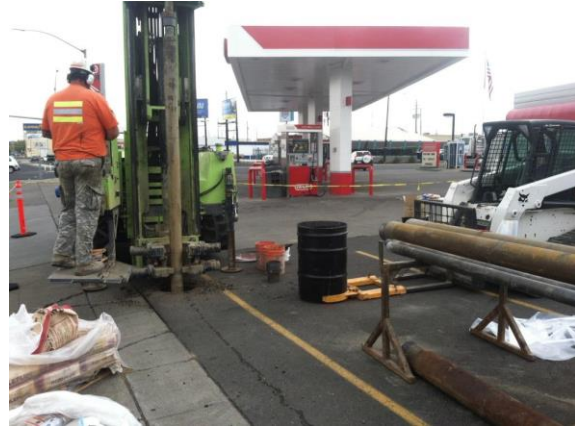
Photo #2: Drilling borehole MW-6 located downgradient from the fuel dispenser island shown in the background. Photo looking west

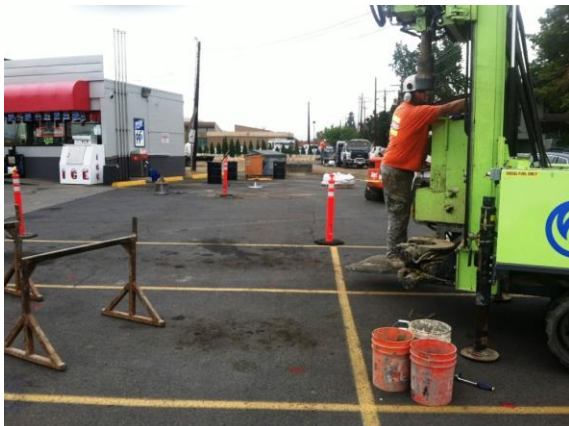
Photo #3: Location of borehole MW-7 on the parking area of the Site. Photo looking north from Lincoln Avenue.

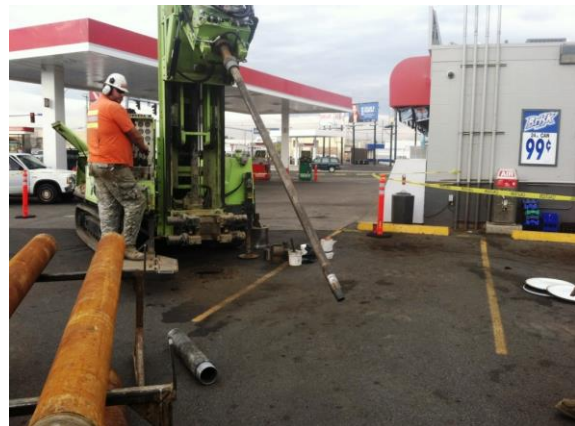
Photo #4: Drilling of borehole MW-8. Photo looking southwest towards the fuel dispenser island

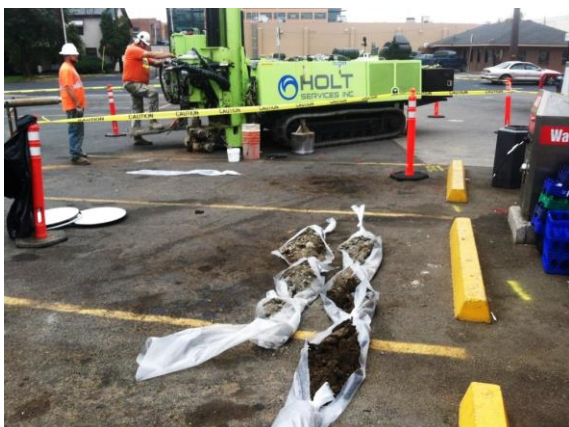
Photo #5: View of boring MW-8 advanced using a sonic rig. Soil cuttings from the boring for lithology description and screening of volatile organic compounds are shown in the foreground.

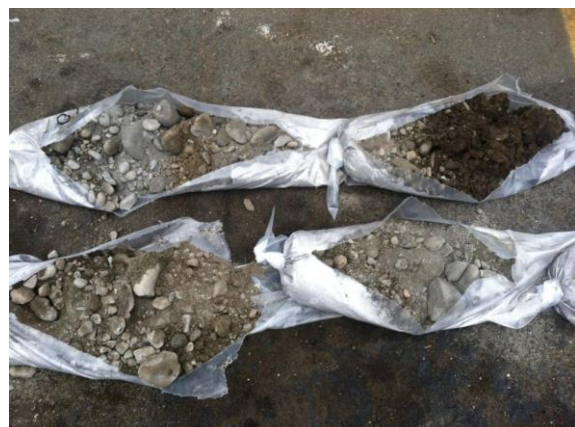
Photo #6: Continuous soil cores collected in plastic sheeting during borehole drilling.
