**Port of Seattle  
Lora Lake Apartments Site**

**Remedial Investigation/  
Feasibility Study**

**Appendix G  
Lora Lake Parcel  
Remedial Investigation Data Report**

**Attachment G.1  
Field Photographs**

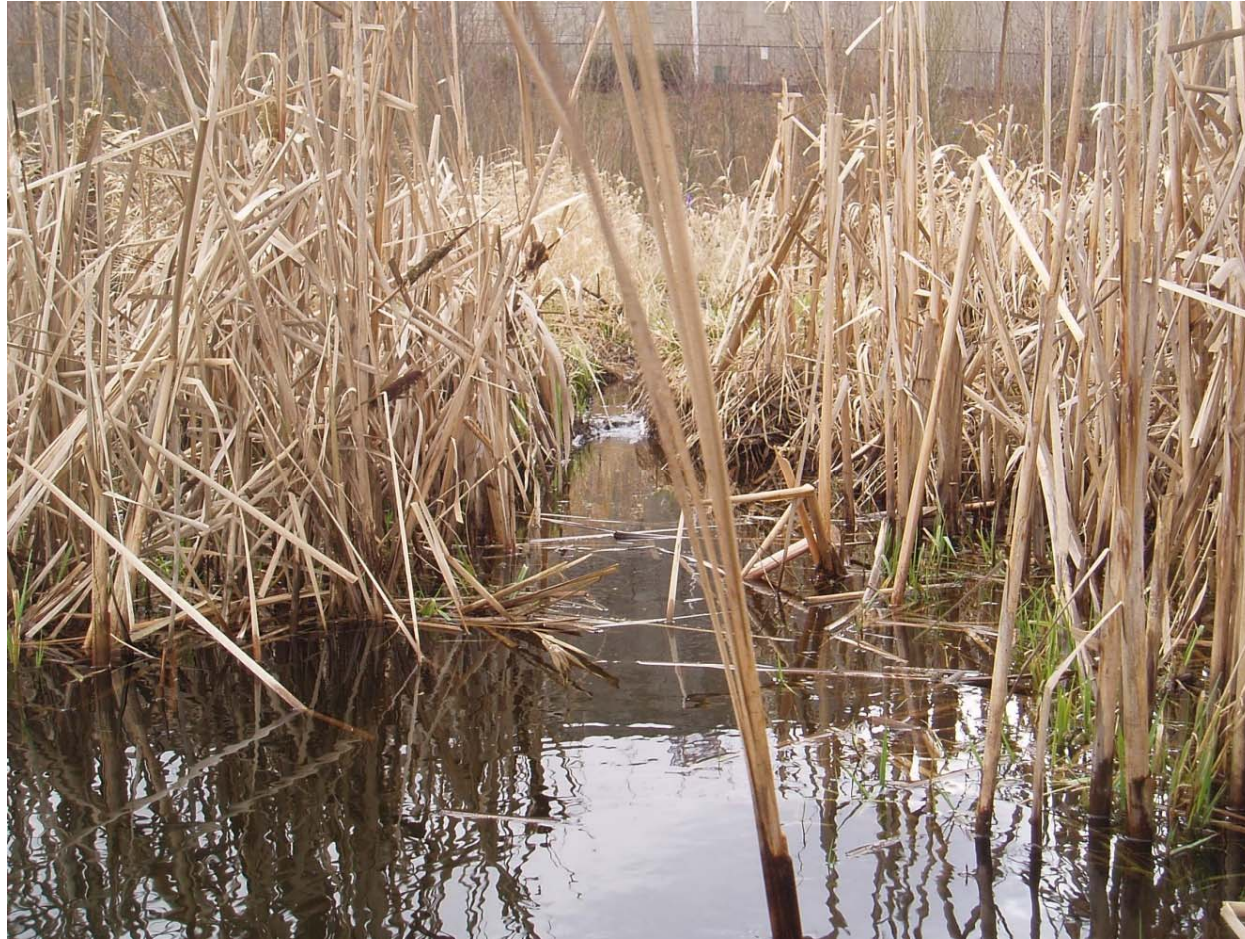
- Water was observed entering Lora Lake from the nearby wetlands to the south (refer to Figure G.2 for the approximate location), indicating surface water connectivity between the wetlands and lake (refer to Attachment G.1).

Photograph 1: Surface water connection from wetlands to Lora Lake. This wetland area is located to the south of Lora Lake.

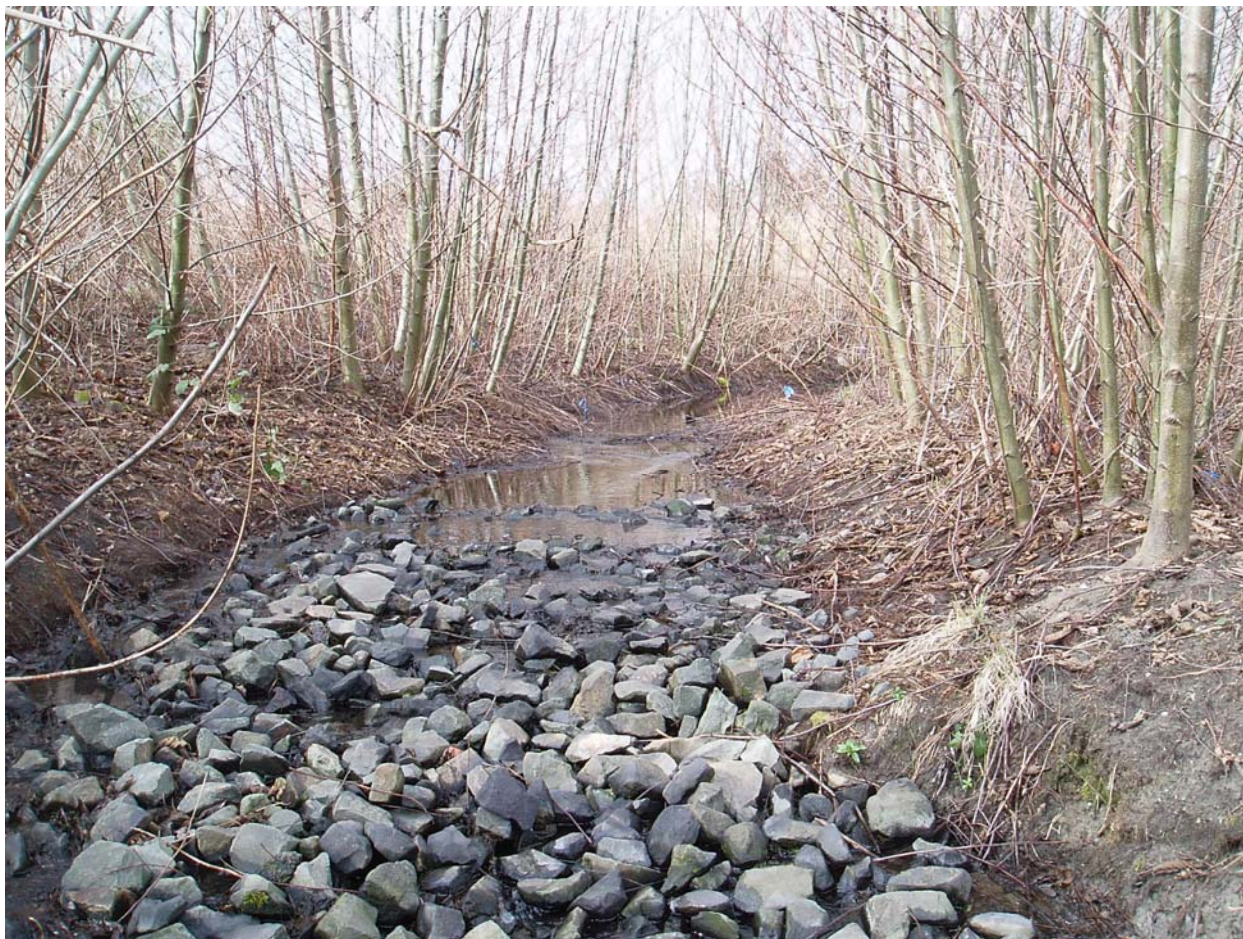
- Floyd|Snider field staff observed water from a drainage channel flowing into Lora Lake in the southwest corner of the lake. This drainage channel headed west, then curved north near the base of the slope below Des Moines Memorial Drive (refer to Figure G.2 for the approximate location of this drainage channel and photographs in Attachment G.1). The channel appeared to be manmade, with water approximately 1 foot deep in some locations along the channel. The channel ended near the northwest corner of the lake in a small ponded area. The ponded area was located approximately 75 to 100 feet northwest of the outlet of the City of Burien storm drain outfall into the Lora Lake sediment settling basin. The ponded area appeared to be slightly higher in elevation in comparison to the water level in the sediment settling basin.

Photograph 2: Drainage channel discharge point to Lora Lake, located near the southwest corner of Lora Lake.

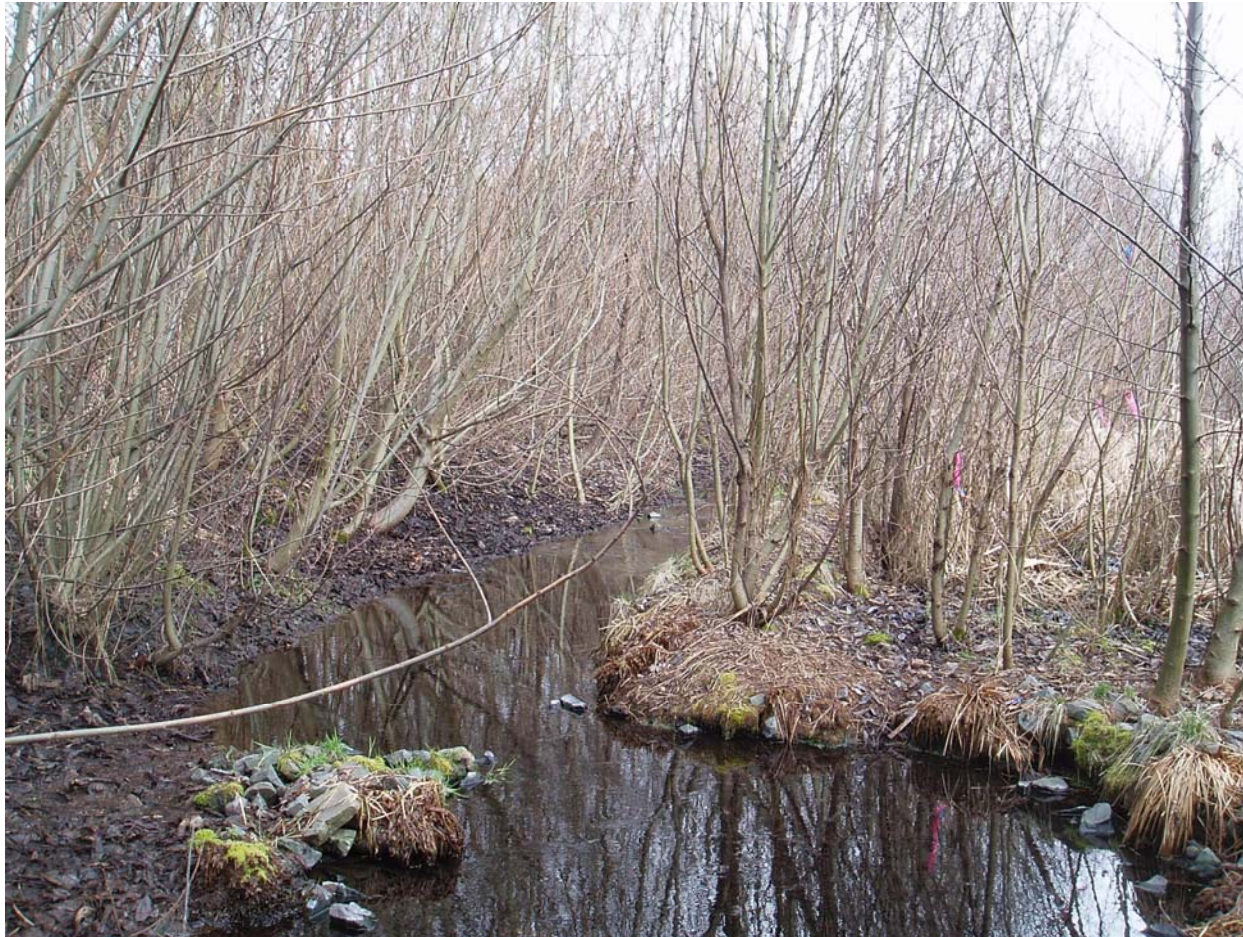
Photograph 3: Drainage channel upstream of the Lora Lake discharge point.

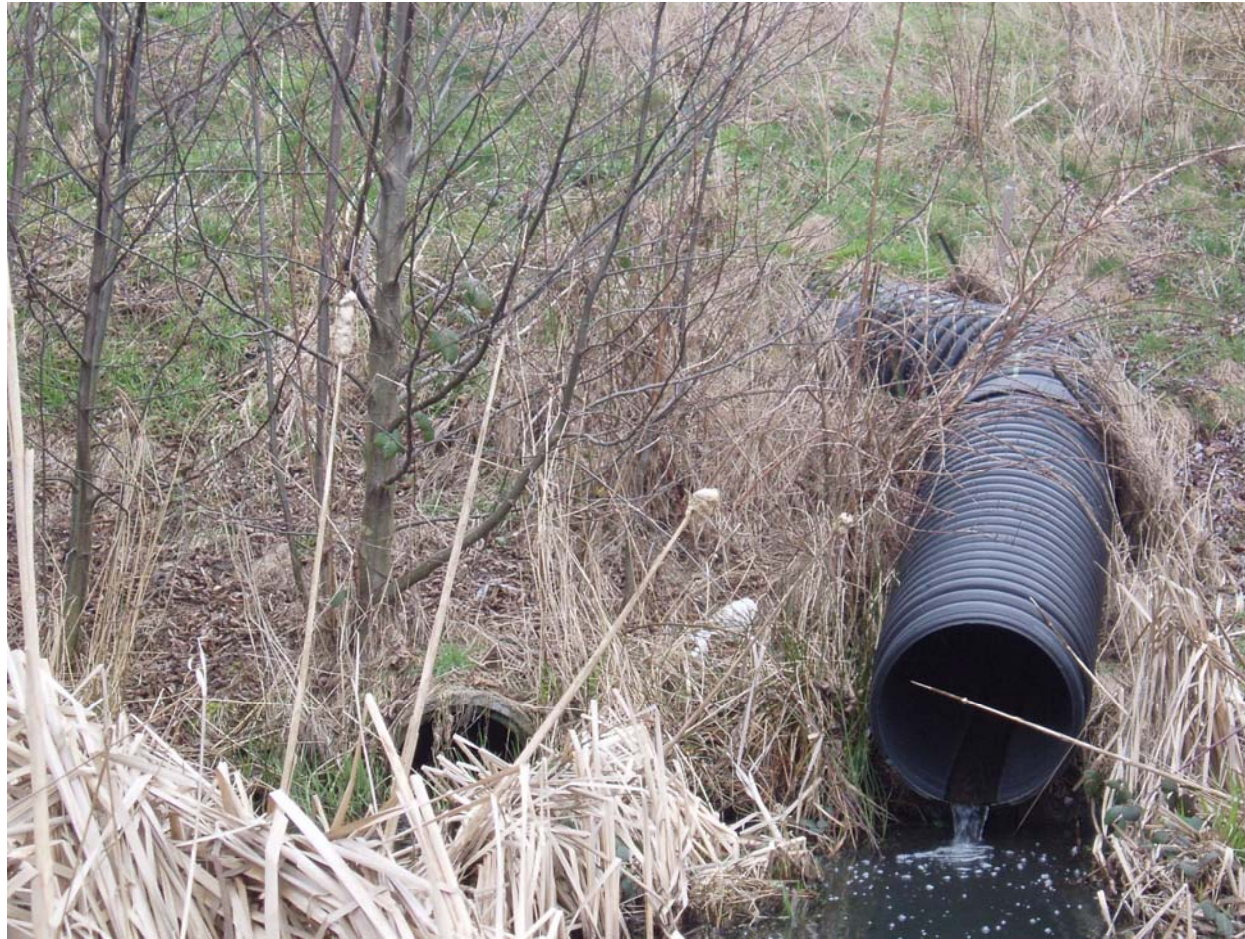
- Water was discharging from the City of Burien storm drain outfall (the 24-inch diameter corrugated polyethylene pipe) into the Lora Lake sediment settling basin at the time of the inspection (refer to Figure G.2). Another outfall, made of concrete, was observed during the inspection about 3 feet to the west of this outfall. This concrete outfall was 18 inches in diameter and partially submerged in the sediment settling basin at the time of inspection. No water appeared to be discharging from the outfall (refer to photographs in Attachment G.1). The bottom third of the outfall was filled with silt.

Photograph 4: City of Burien storm drain outfall and adjacent concrete outfall.

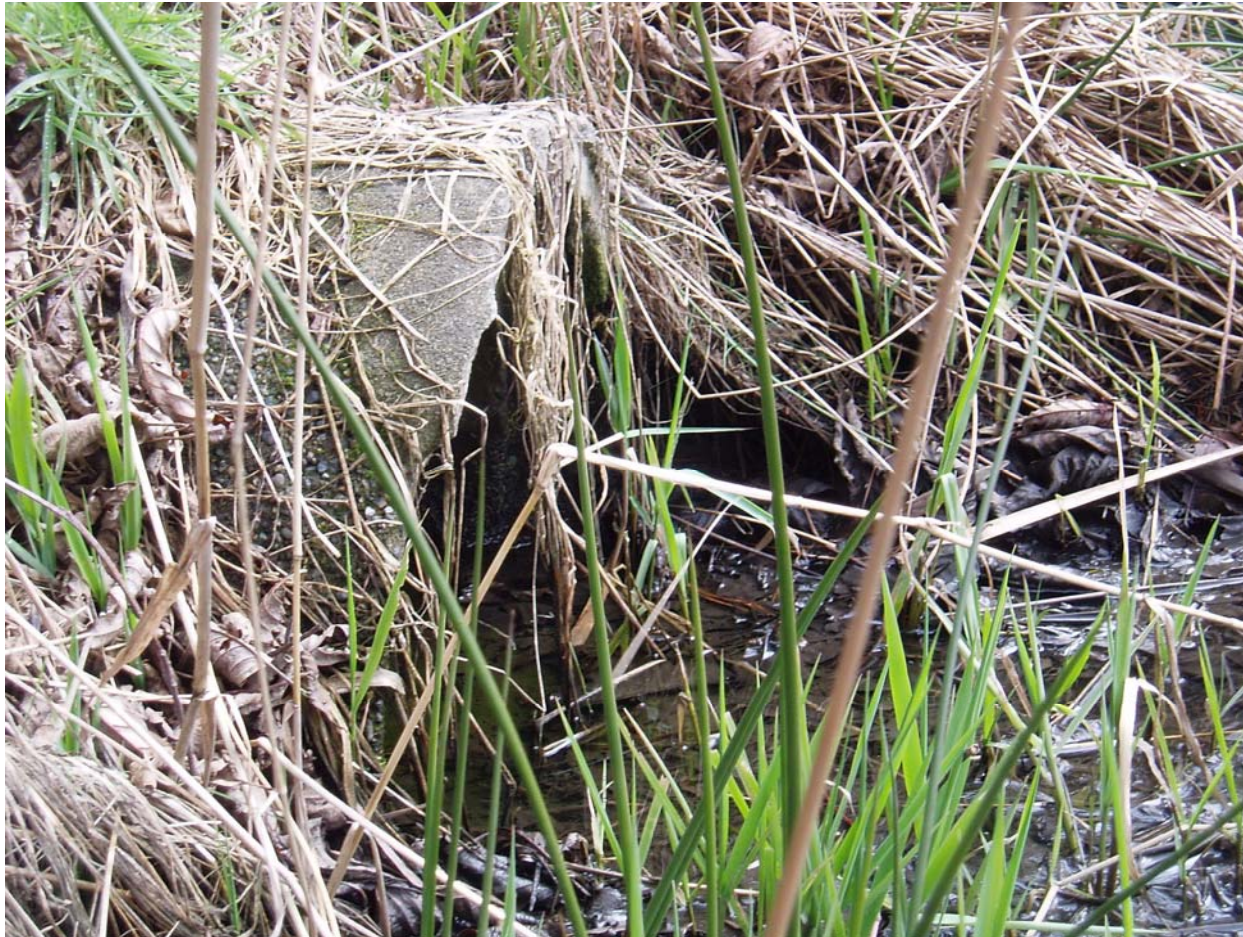
Photograph 5: No discharge was observed from the partially submerged concrete outfall.
