PCB Remedial Action Report

**Estate of Don Oline Storage Yard
1915 Marine View Drive
Tacoma, Washington**

EPI Project Number: 60701.1

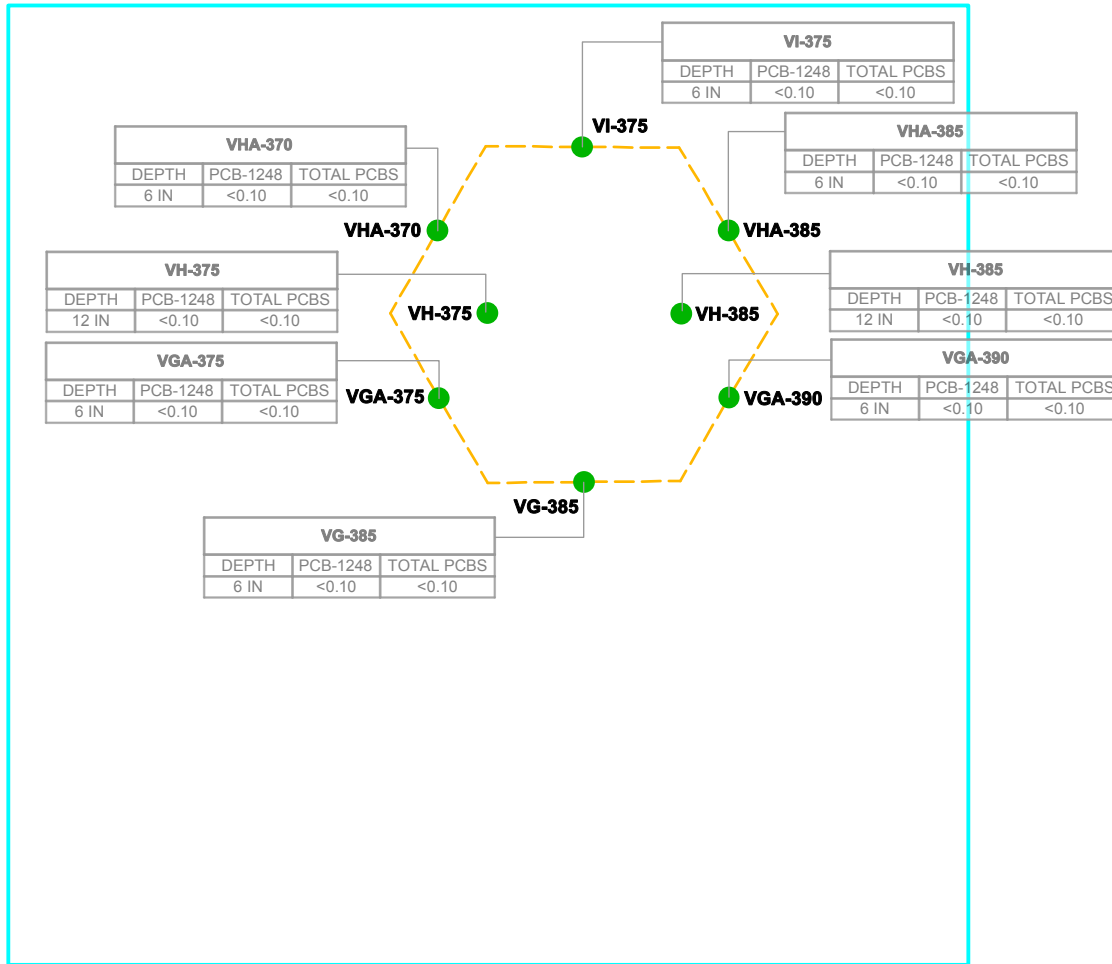
FIGURE 4
 AOC 2
 REMEDIAL EXCAVATION

AOC 2
CENTERED ON THE REPORTED LOCATION
OF EPA SOIL SAMPLE 08464308

< INDICATES RESULT IS **NOT** DETECTED ABOVE REPORTING LIMIT.
BOLD VALUE INDICATES THAT RESULT **IS** ABOVE REPORTING LIMIT.
 ALL CONCENTRATIONS IN MILLIGRAMS PER KILOGRAM.

AOC 2 was centered on EPA's reported geographical coordinates for a soil sample with a reported PCB concentration of 540 mg/kg. The reported coordinates corresponded to an area where equipment had previously been located on bare soil and gravel.

In compliance with the Final CAP, approximately 10 cubic yards of PCB-impacted soil was excavated and transported off-site to LRI Landfill for disposal. Following the removal of the concrete, eight performance samples were collected to determine if the remedial action was sufficient to remove materials with PCB concentrations greater than 1 mg/kg. The performance soil sample locations are presented on Figure 4.

Six sidewall and two floor samples were collected from the remedial excavation at AOC 2. No PCBs were detected at a concentration greater than the method detection limit. Figure 4 presents the soil analytical results for AOC 2.
