Final Report to:
**Washington State
Department of Ecology**

Remedial Investigation and Feasibility Study for the Landsburg Mine Site Ravensdale, Washington Volume I

Golder Associates Inc.

February 1, 1996

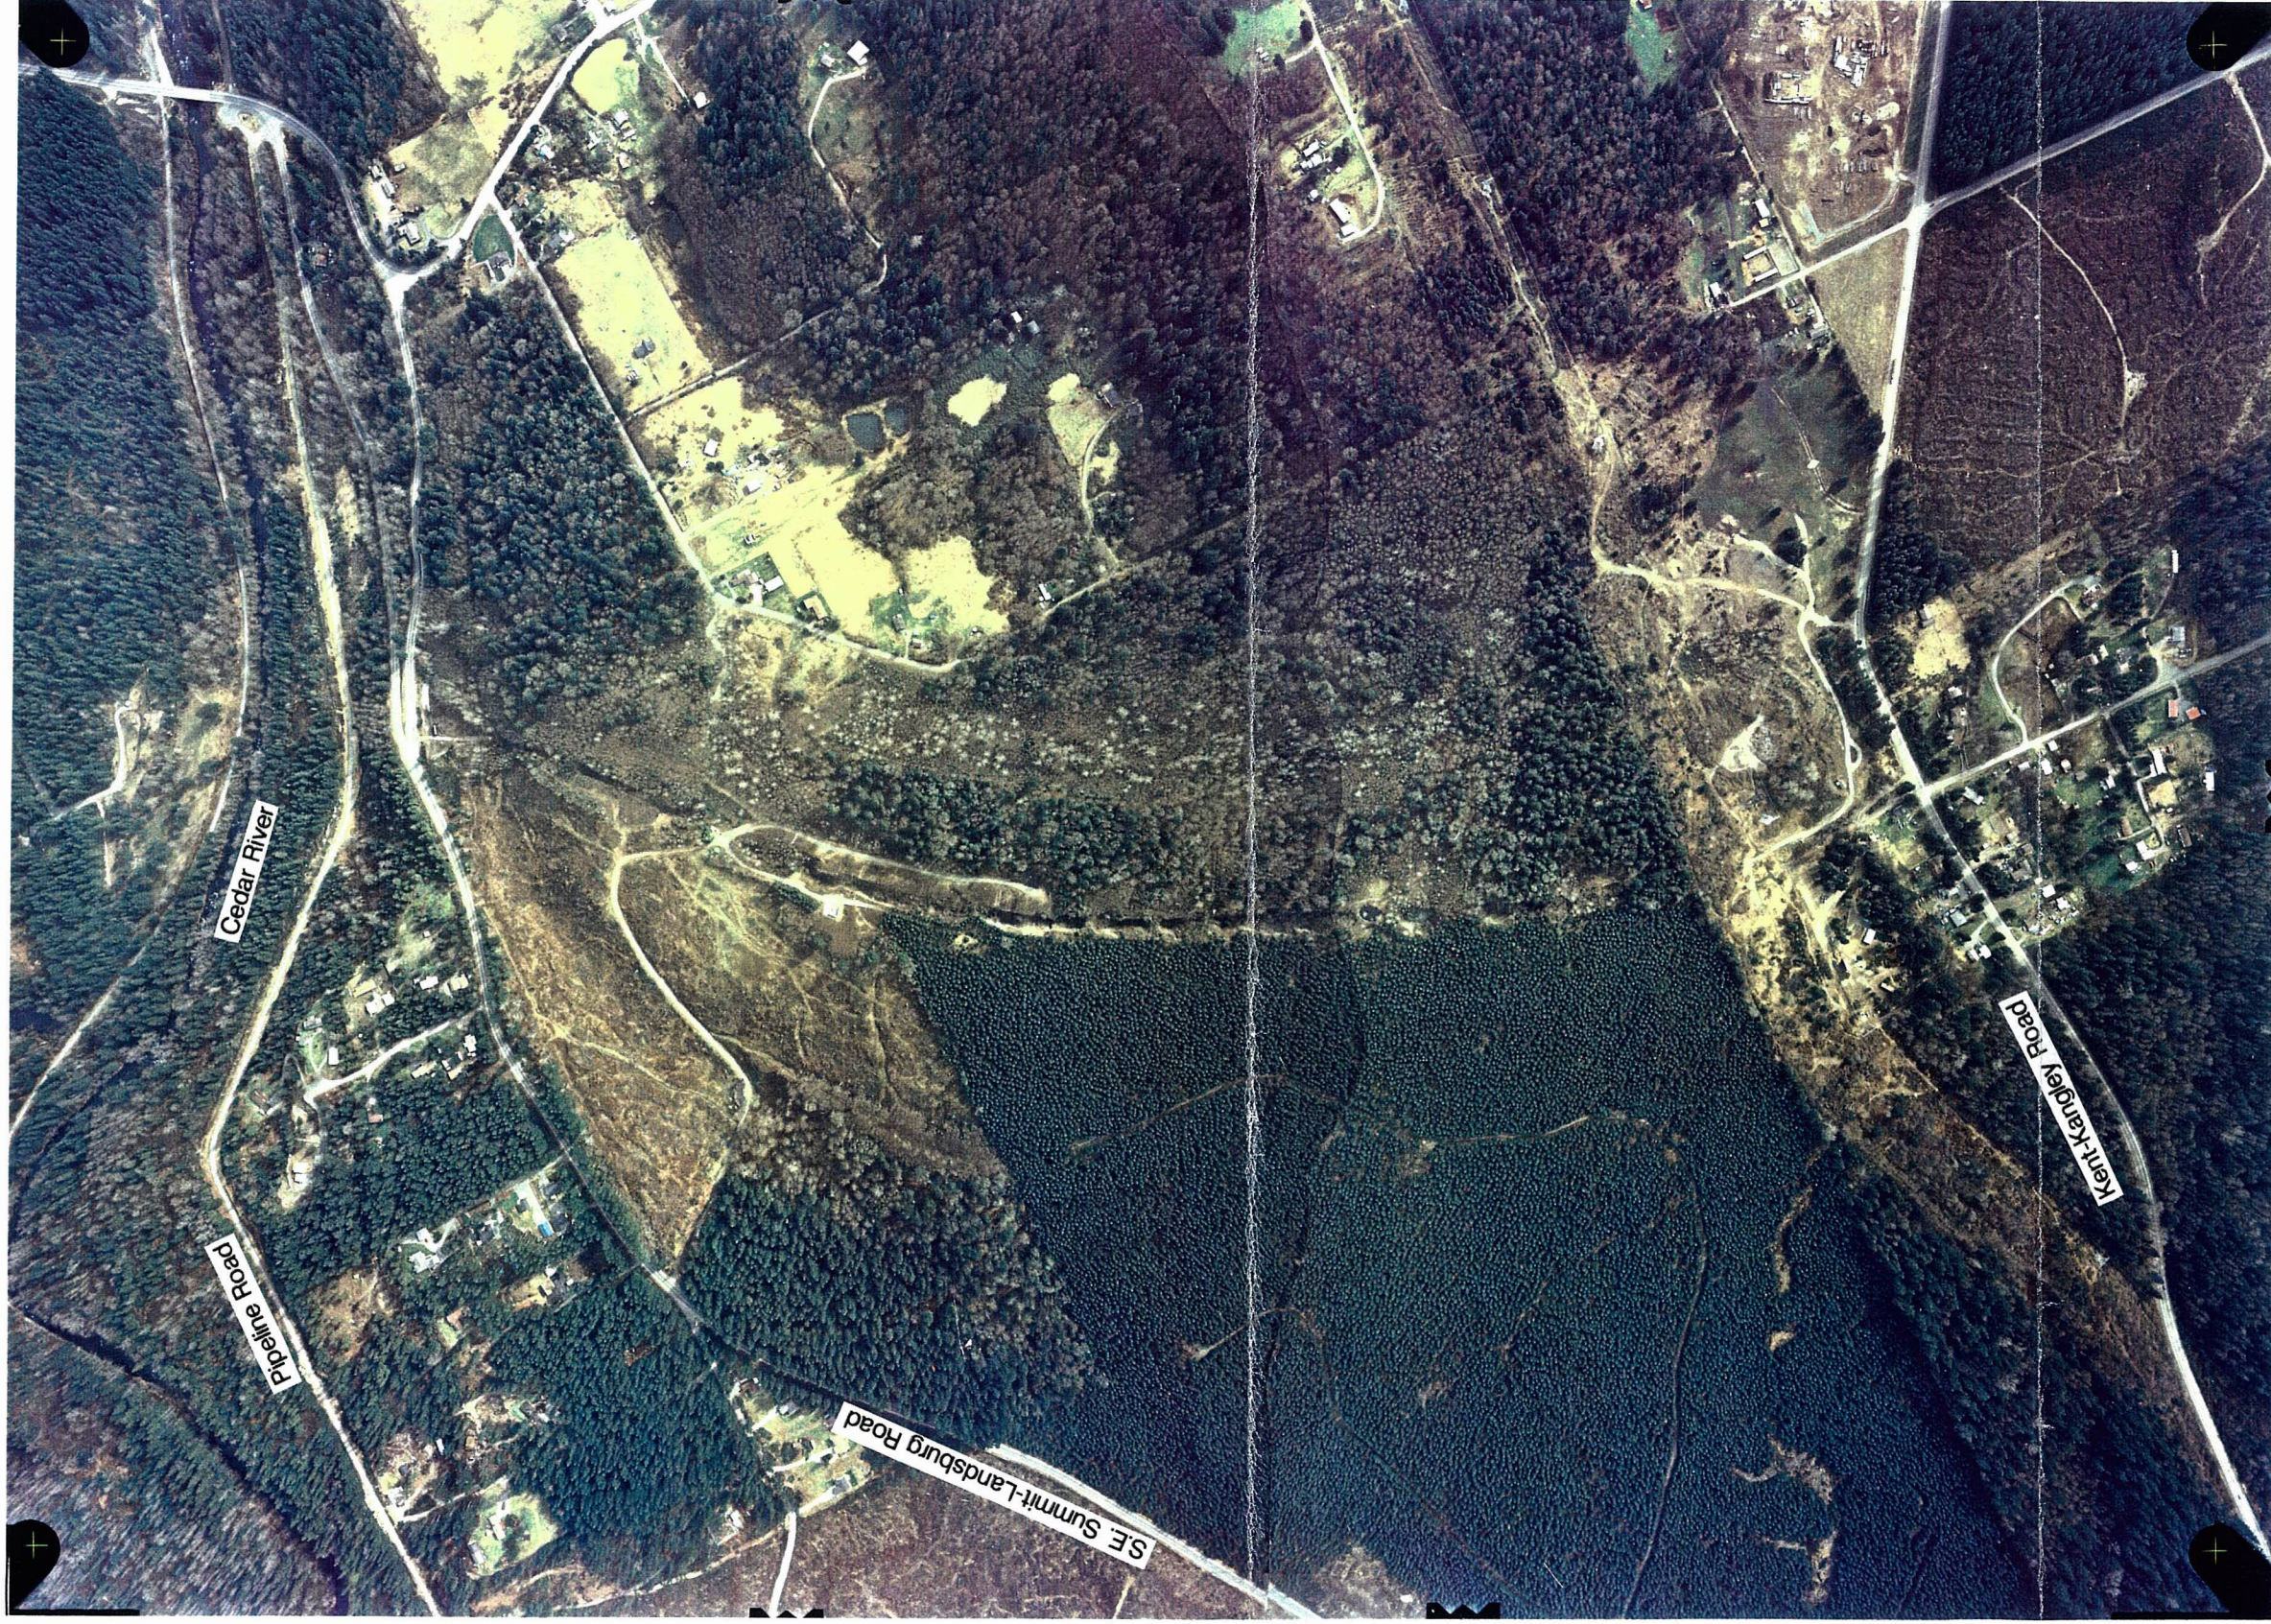
FIGURE 2-15
GROUNDWATER DISPOSAL LOCATION
AT SOUTH END OF TRENCH
 LANDSBURG MINE SITE/RI/FS/WA

Source: Walker and Associates. Photos taken 3-9-94.

location approximately 150 feet southwest of portal #2 (Figure 2-14). The water stored in Baker tanks at the LMW-3 and LMW-5 site was pumped to an infiltration area approximately 300 feet southeast of LMW-3 (Figure 2-15). Formation water collected in 55-gallon drums was disposed of in conjunction with the disposal of drill cuttings as described above. Information regarding the disposal of groundwater produced during well construction and development is presented in Pancoast (1994b).

Water was introduced at the north end of the trench in the immediate vicinity of portal #2 (Figure 2-14), and at the south end of the site at a location some 200 ft to the northeast from portal #3 (Figure 2-15). Disposal at the north end occurred directly to the trench. Disposal at the south end was outside the trench and away from the Roger's seam. At the north end, water was drained from 1:45 to 8:10 pm on August 16, 1994. At the south end, water was drained from 11:42 AM to 12:32 PM on the same date. Approximately 3,200 gallons were drained at the south end, and about 24,700 gallons at the north end. While it is not possible to analyze these data quantitatively to assess hydraulic properties of the coal seam, the data can be qualitatively evaluated.
