RE: Mill E/Koppers Site 2014 Ground Water Monitoring Summary Report

Technical Memorandum

**Project Name:** Mill E Site

**Subject:** Mill E 2014 Ground Water Monitoring Summary

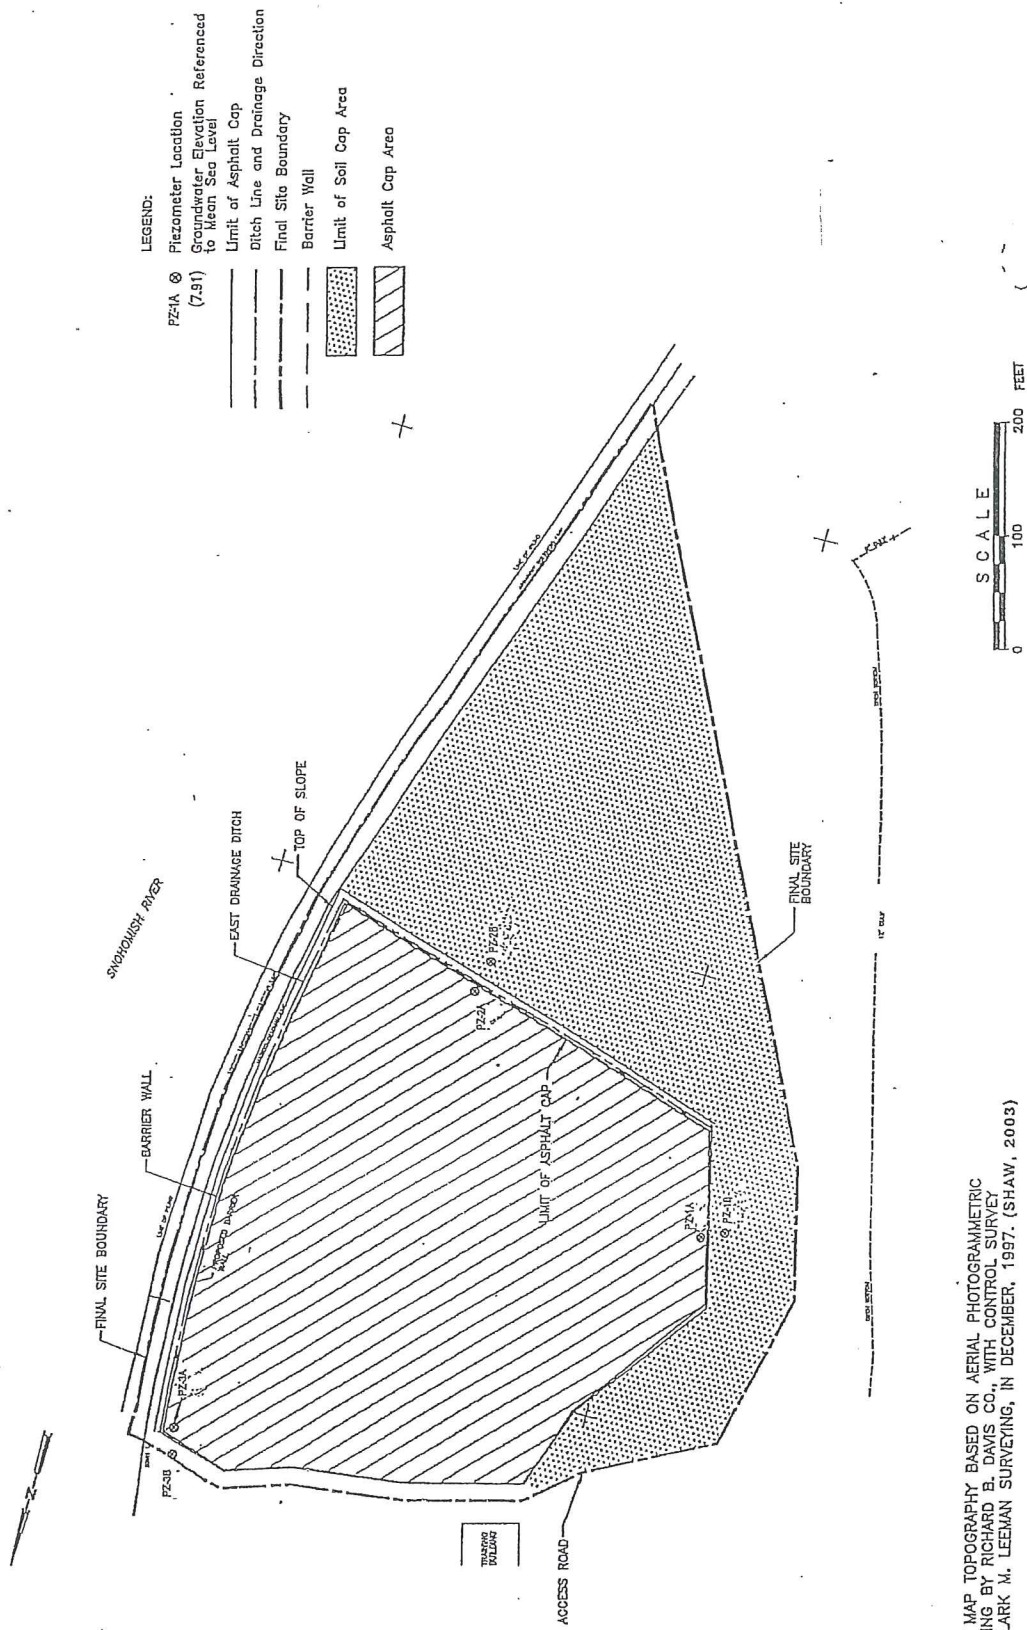
FIGURE 1

**FORMER MILL E/KOPPERS SITE PLAN**

Associated Earth Sciences, Inc. (AESI) performed annual ground water monitoring at the Mill E site on September 26, 2014, consistent with the Mill E's "Performance and Compliance Monitoring Plan" (PCMP) dated October 1998. During the September 2014 monitoring event, depth to water measurements were made in all of the site's six piezometers (PZ-1A, PZ-1B, PZ-2A, PZ-2B, PZ-3A, and PZ-3B). The depth to water measurements are summarized in Table 1. A site plan showing the approximate well locations is presented on Figure 1.

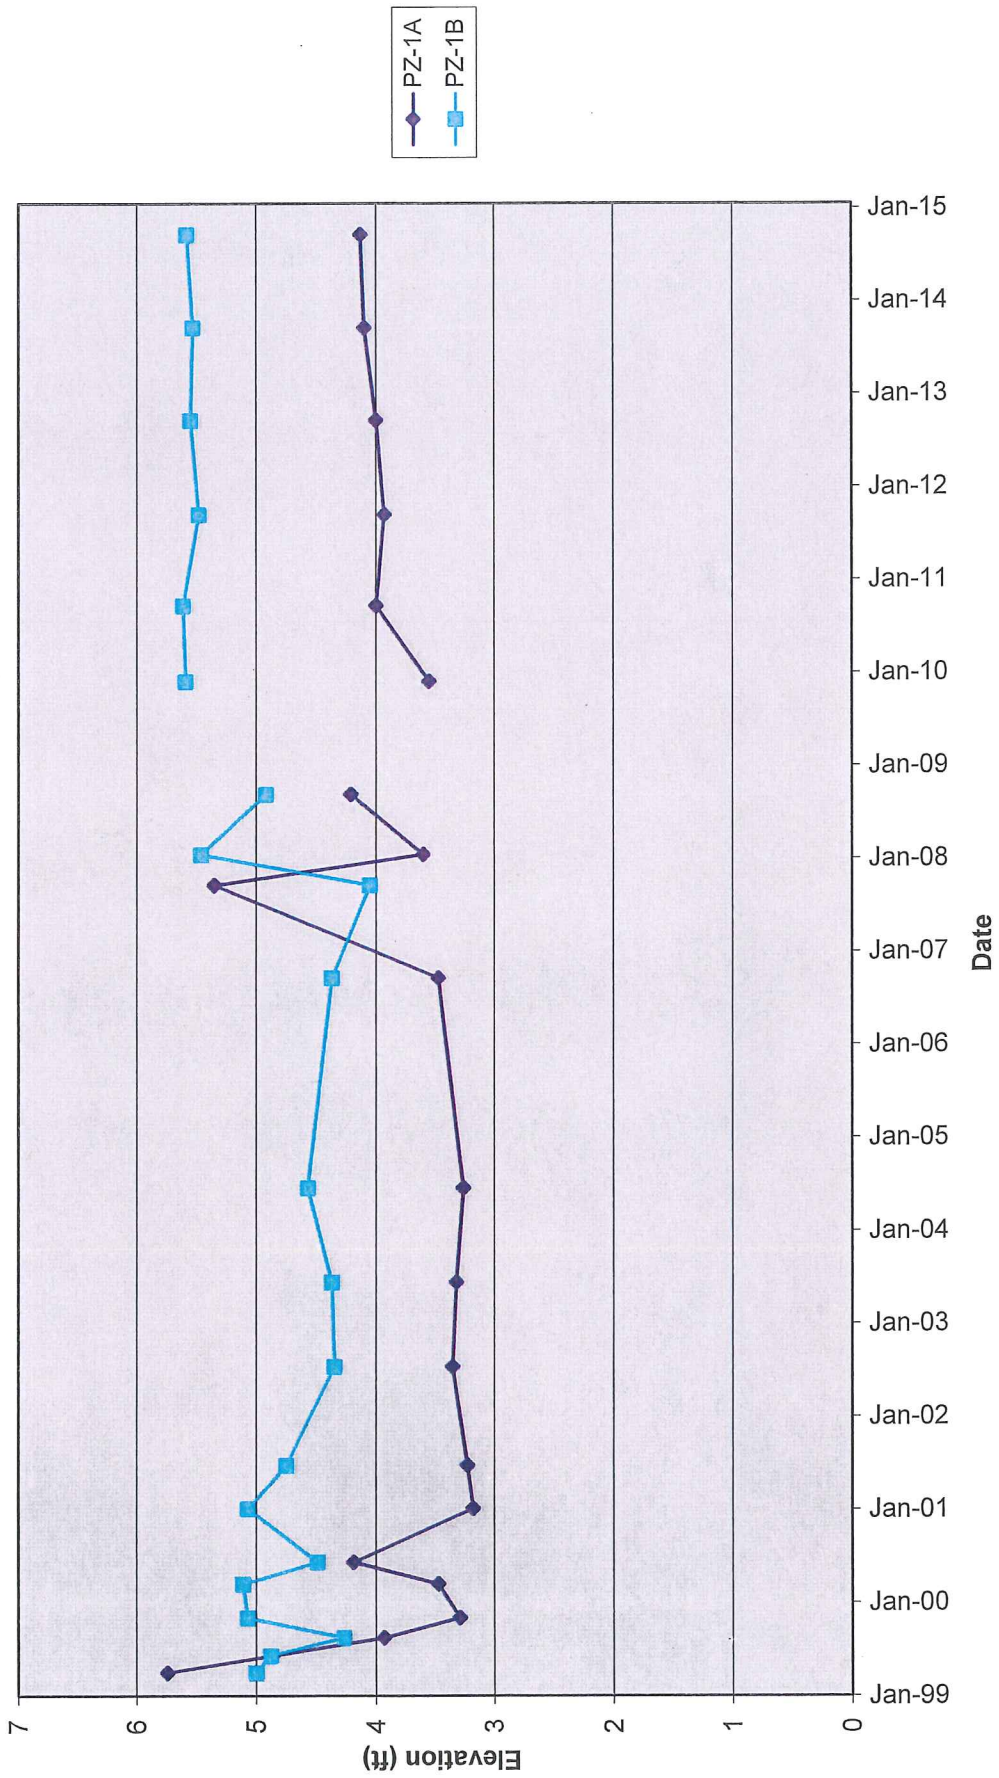
Figure 2 Mill E Groundwater Elevations Wells PZ-1A and PZ-1B  
 "A" Wells Inside Containment  
 "B" Wells Outside Containment

The data for wells PZ-1A/1B, PZ-2A/2B, and PZ-3A/3B suggests the barrier wall is generally performing as intended and isolating ground water inside the barrier from that outside the barrier.

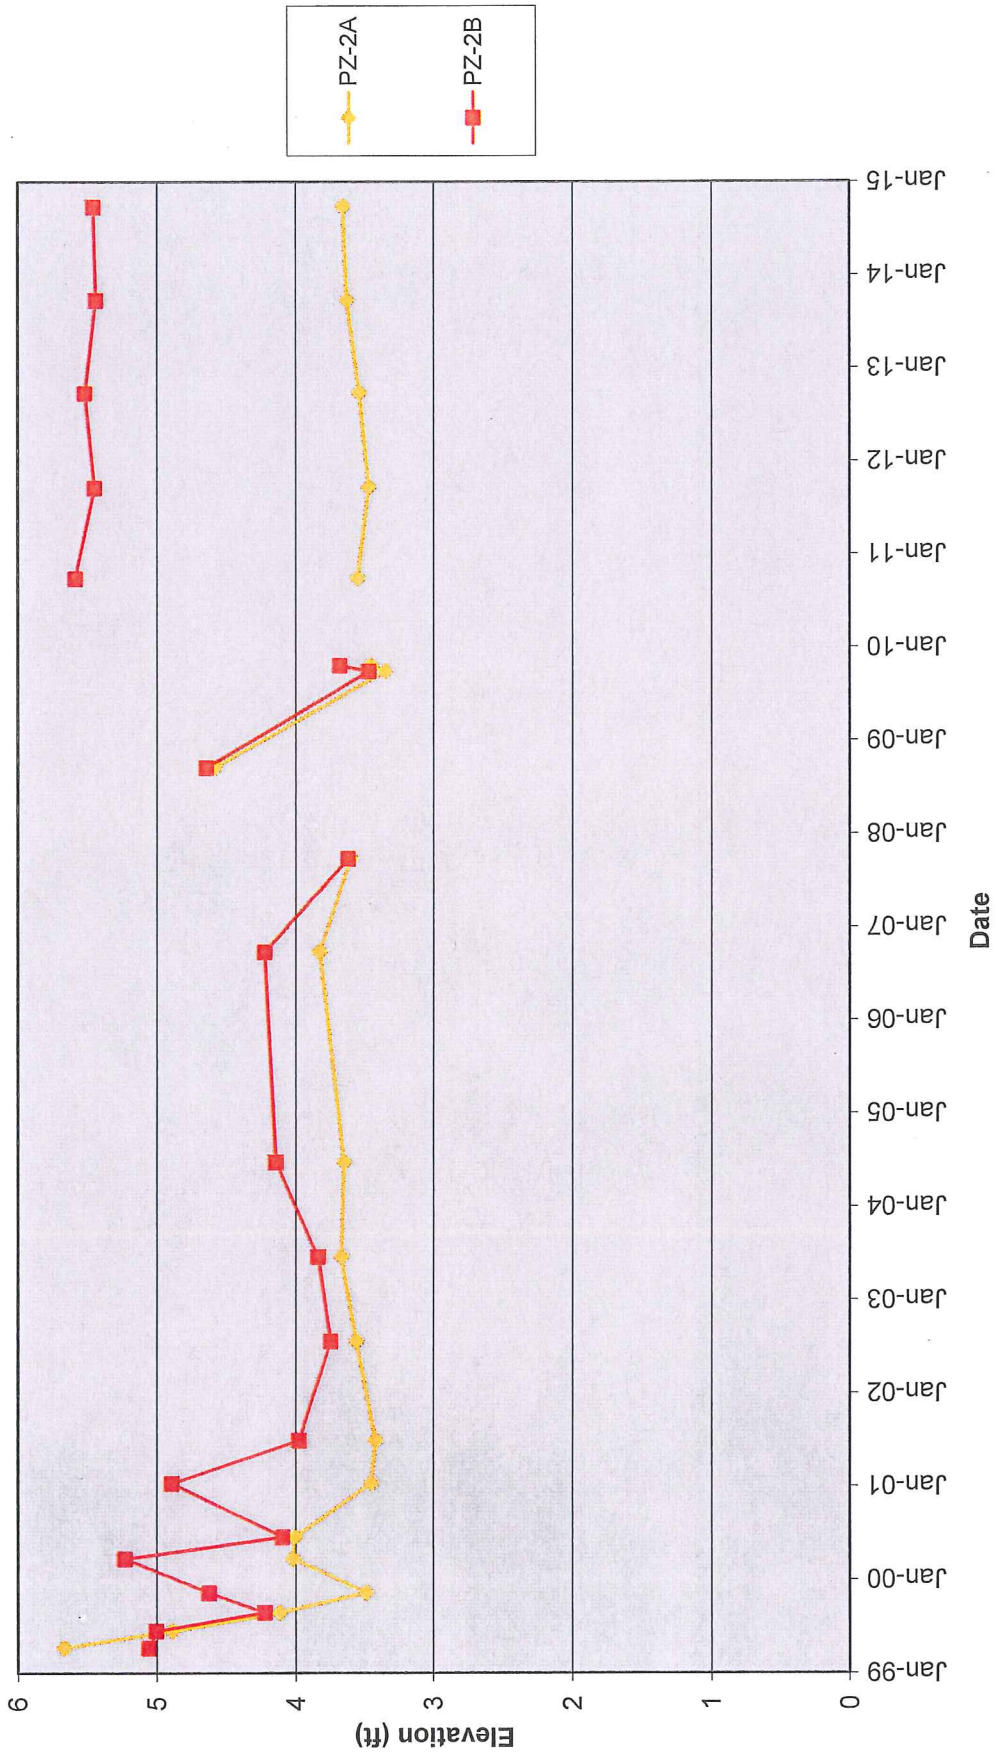
Figure 2A Mill E Ground Water Elevations Wells PZ-2A and PZ-2B  
 "A" Wells inside containment  
 "B" Wells outside containment

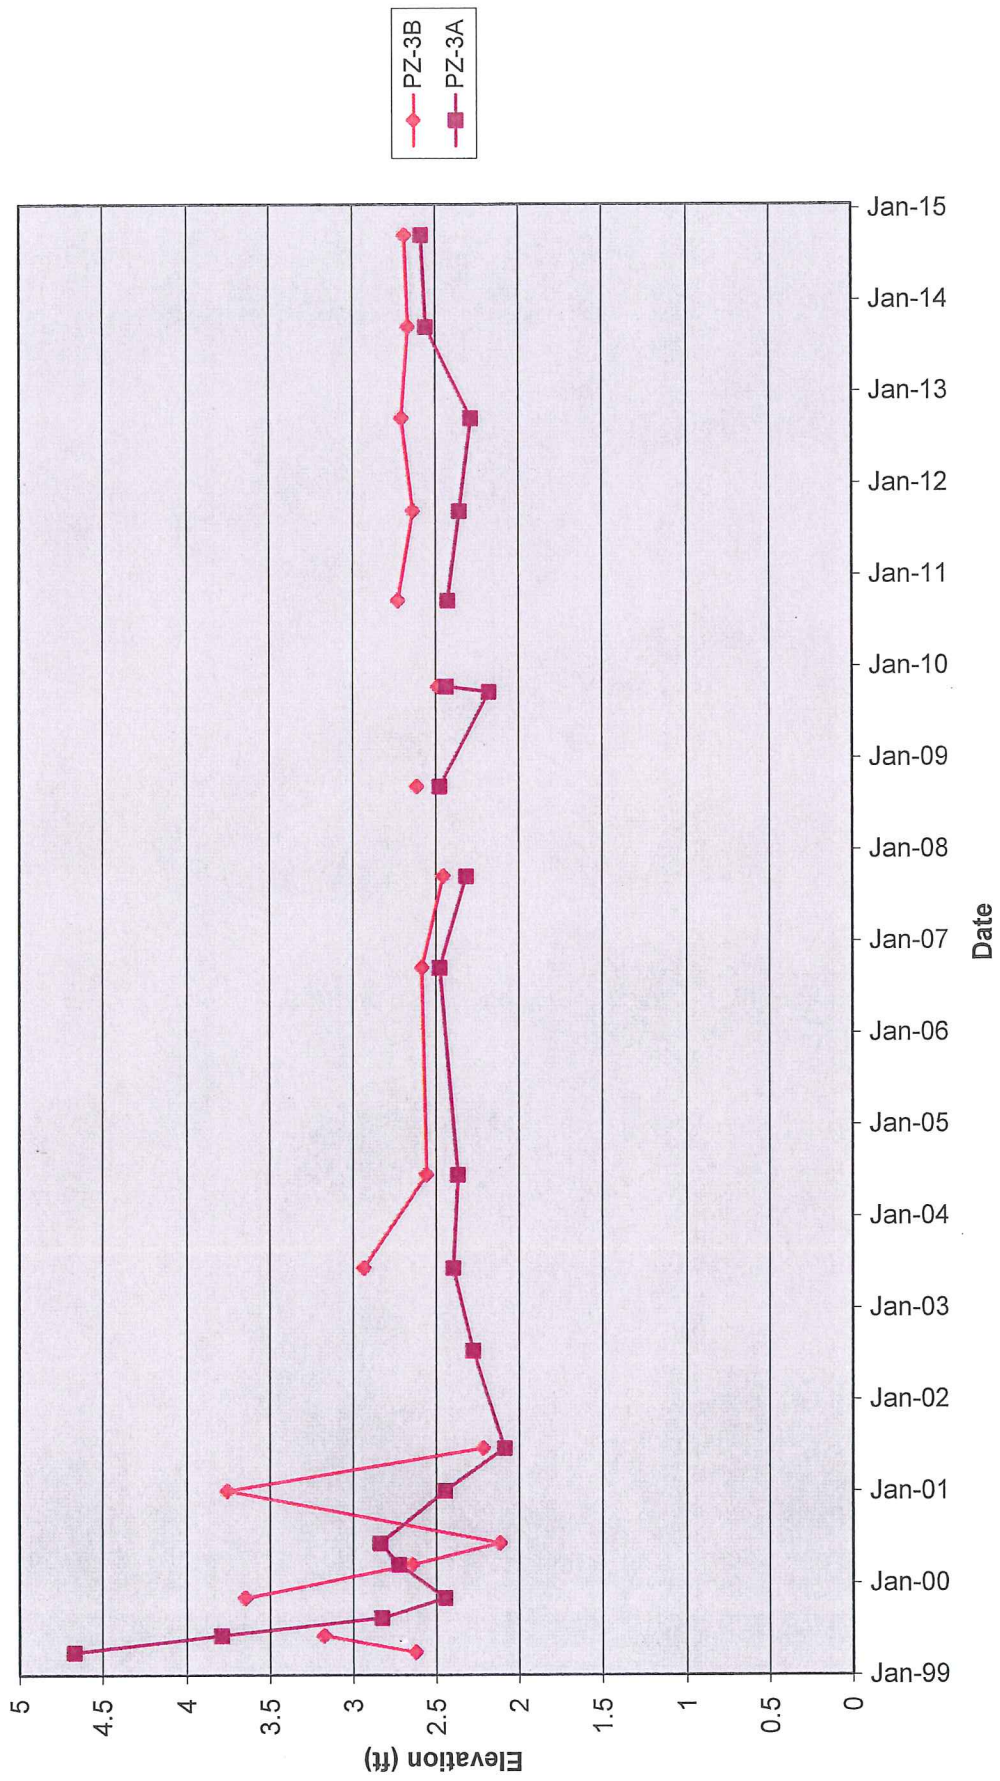
Figure 2B Groundwater Elevations Well PZ-3A and PZ-3B  
 "A" Wells Inside Containment  
 "B" Wells Outside Containment

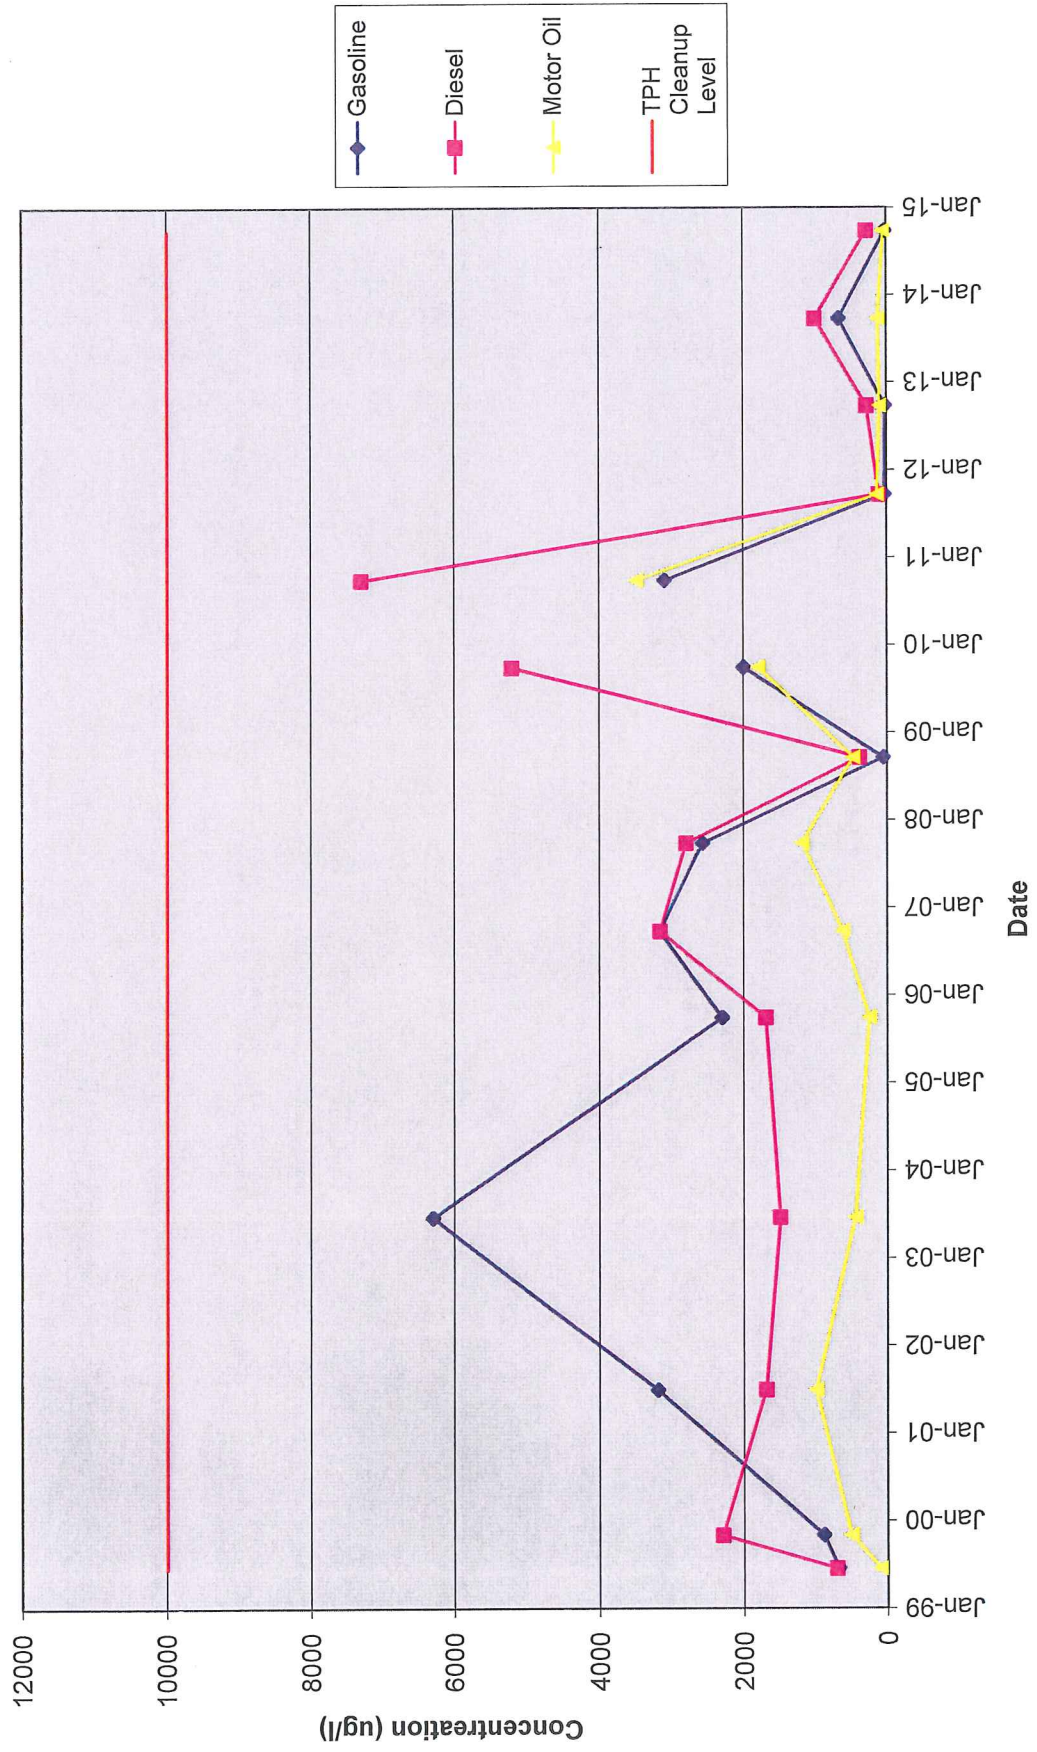
Figure 3 Mill E TPH Concentrations  
in Groundwater Well PZ-3A

The September 2014 ground water analytical results for the Mill E site were compared to the Model Toxics Control Act (MTCA) cleanup levels established in the 1998 Consent Decree. The results are presented in Table 3. Concentrations of all analytical parameters detected in the PZ-3A ground water sample were below the established MTCA cleanup standards, except for arsenic. The September 2014 PZ-3A result of 616 micrograms per liter ( $\mu\text{g/L}$ ) for arsenic is above the MTCA cleanup standard of 5  $\mu\text{g/L}$ . Review of historic ground water quality data for the site indicates the 2014 results are generally lower than 2013, but within the range of past measurements (Figures 3 through 5).

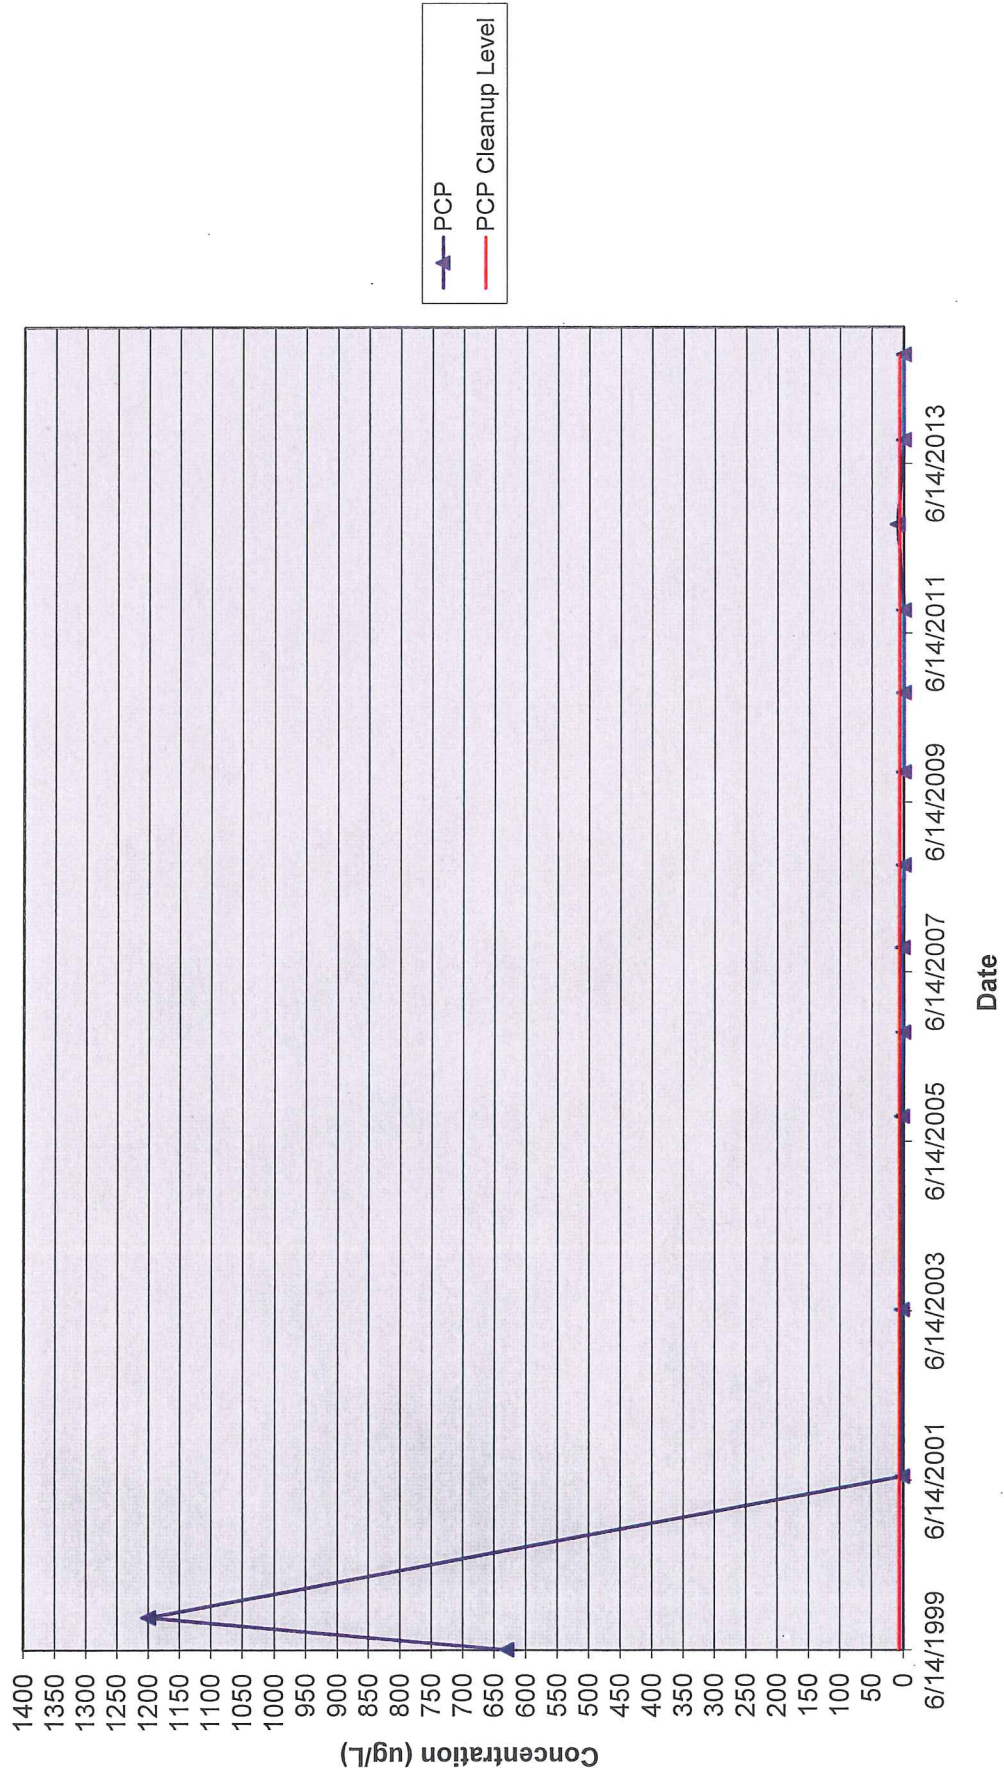
Figure 4 Mill E PCP Concentrations  
in Groundwater Well PZ-3A  
Non-detects plotted as 1/2 the reporting limit.

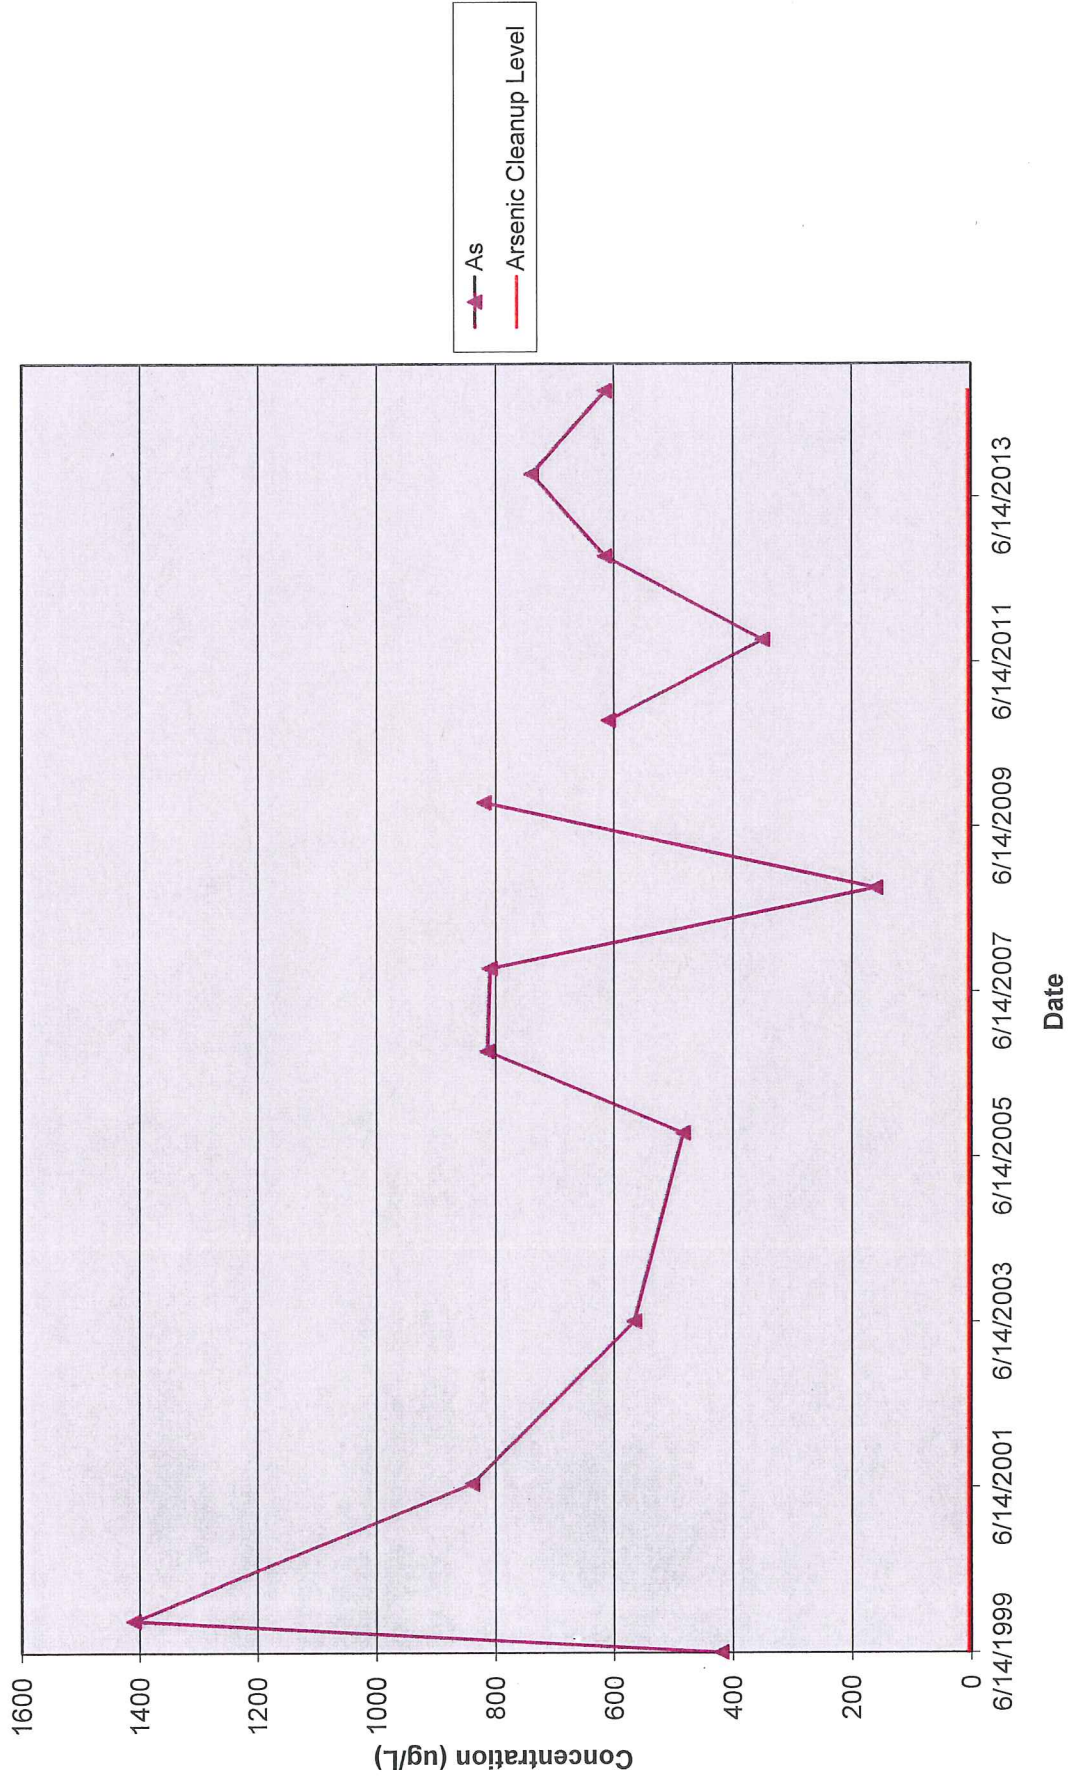
Figure 5 Mill E  
Arsenic Concentrations in Groundwater Well PZ-3A

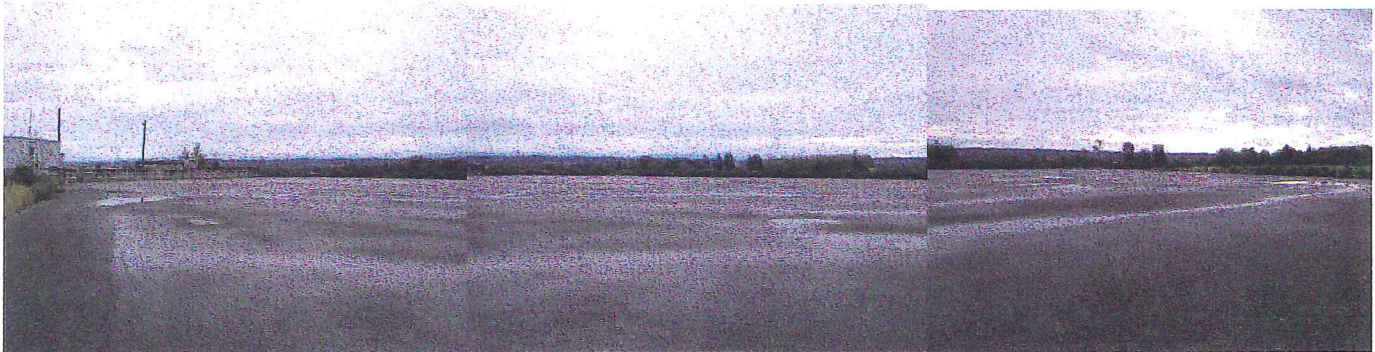
Matthew A. Miller, PE a professional engineer with our firm was on site and performed site observations. The property is currently vacant. During our site visit, the asphalt cap was observed to be in a serviceable condition with no obvious signs of cracking, fissures, or pumping. There are areas where shallow depressions were noted that result in bird baths on the asphalt. These are mainly in the areas noted previously. See Photos below looking towards the northeast to east at the entrance:

AESI should be contacted if indications of pavement distress are observed before our next scheduled site visit.
