# **INDEPENDENT REMEDIAL ACTION REPORT**

**EAGLE HARDWARE AND GARDEN, INC.  
STORE NO. 453**

**WENATCHEE, WASHINGTON**

**FEBRUARY, 1997**

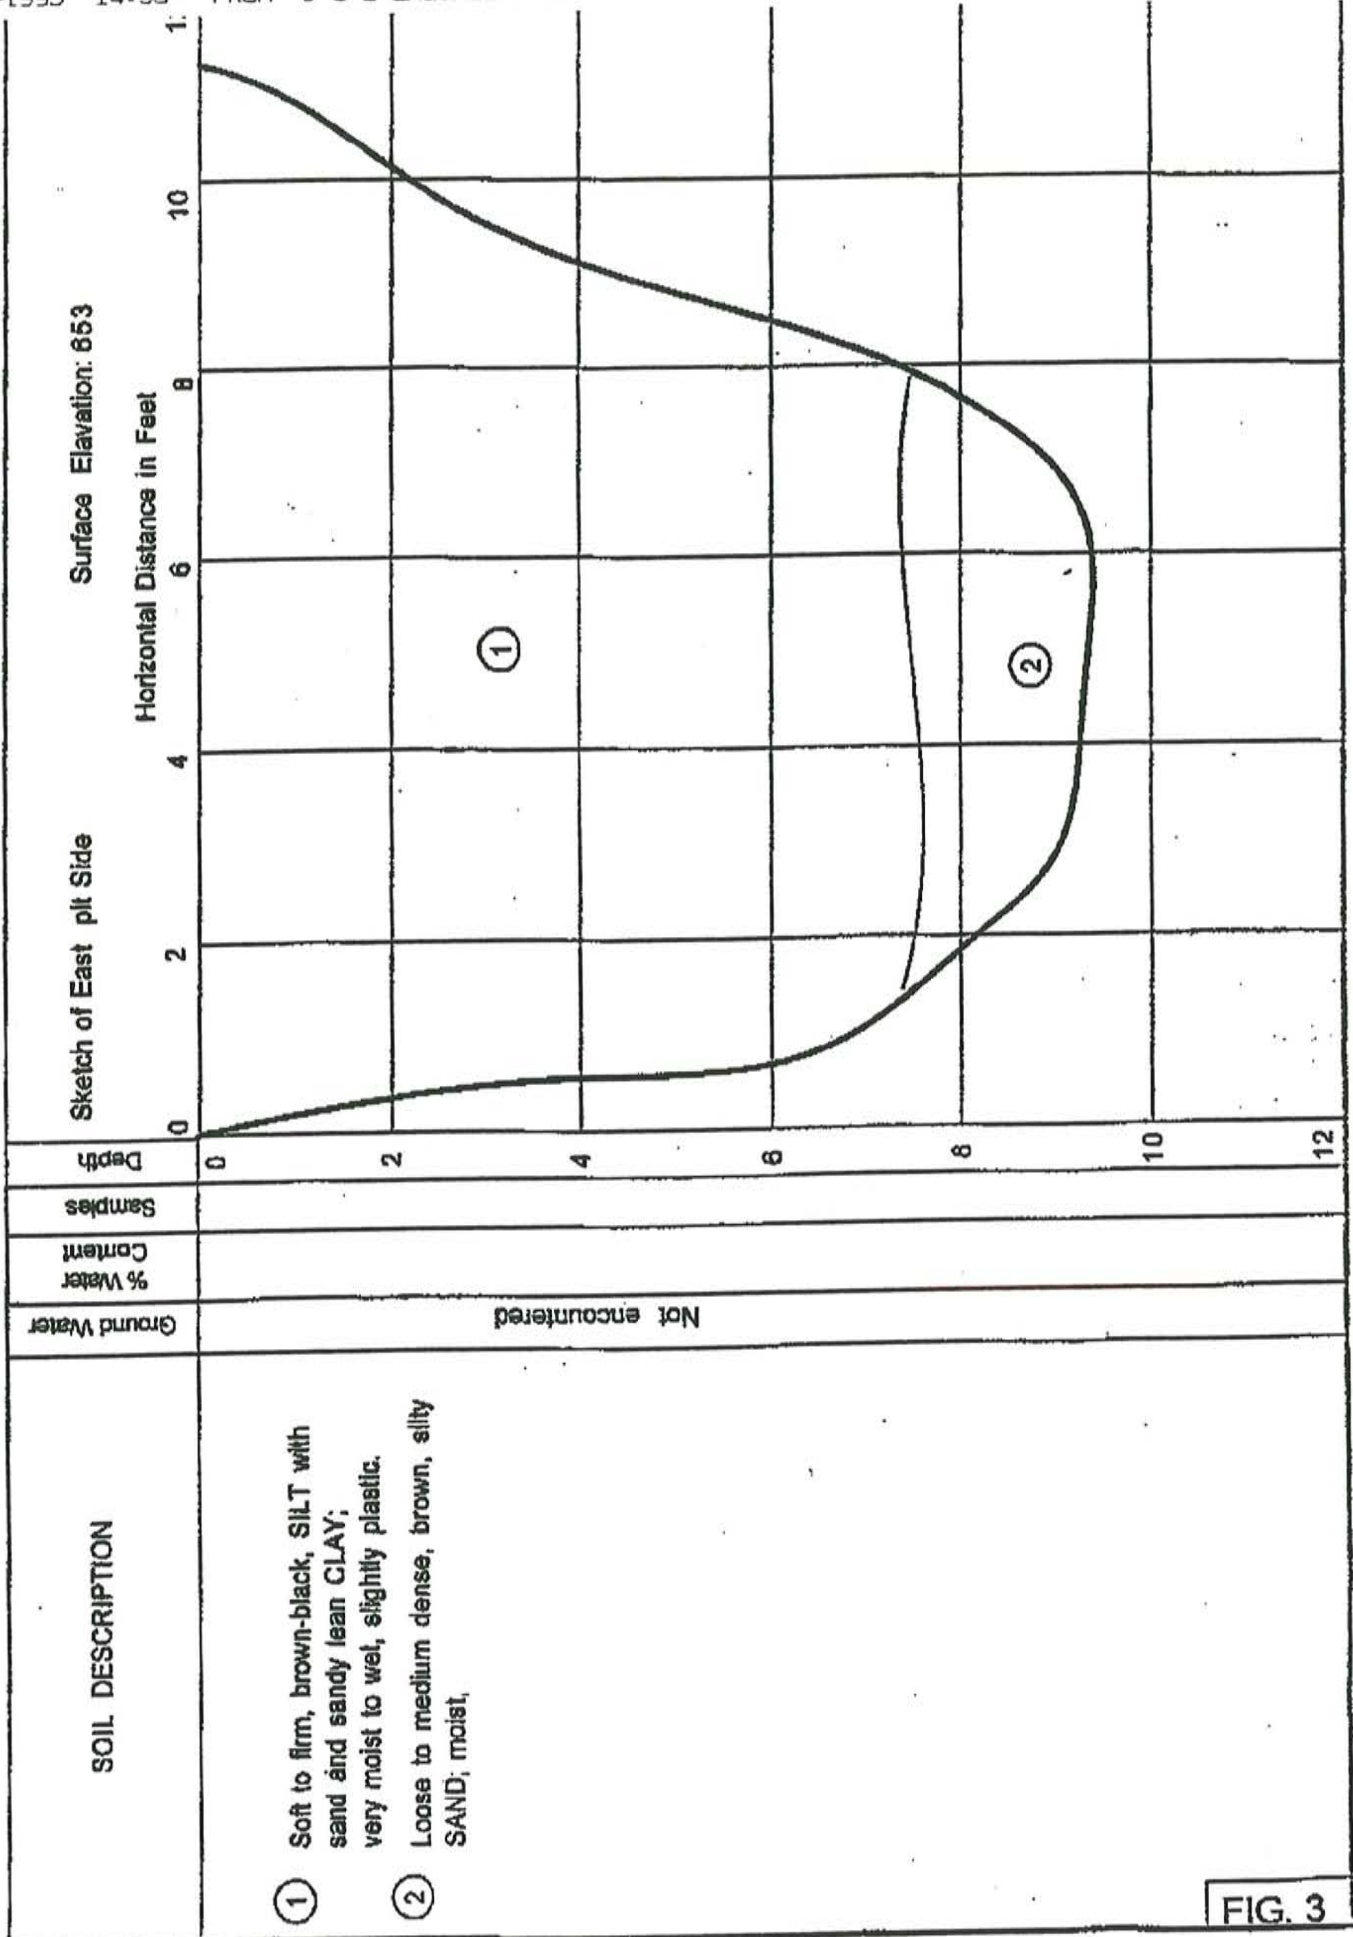
FIG. 3

LOG OF TEST PIT TP-3

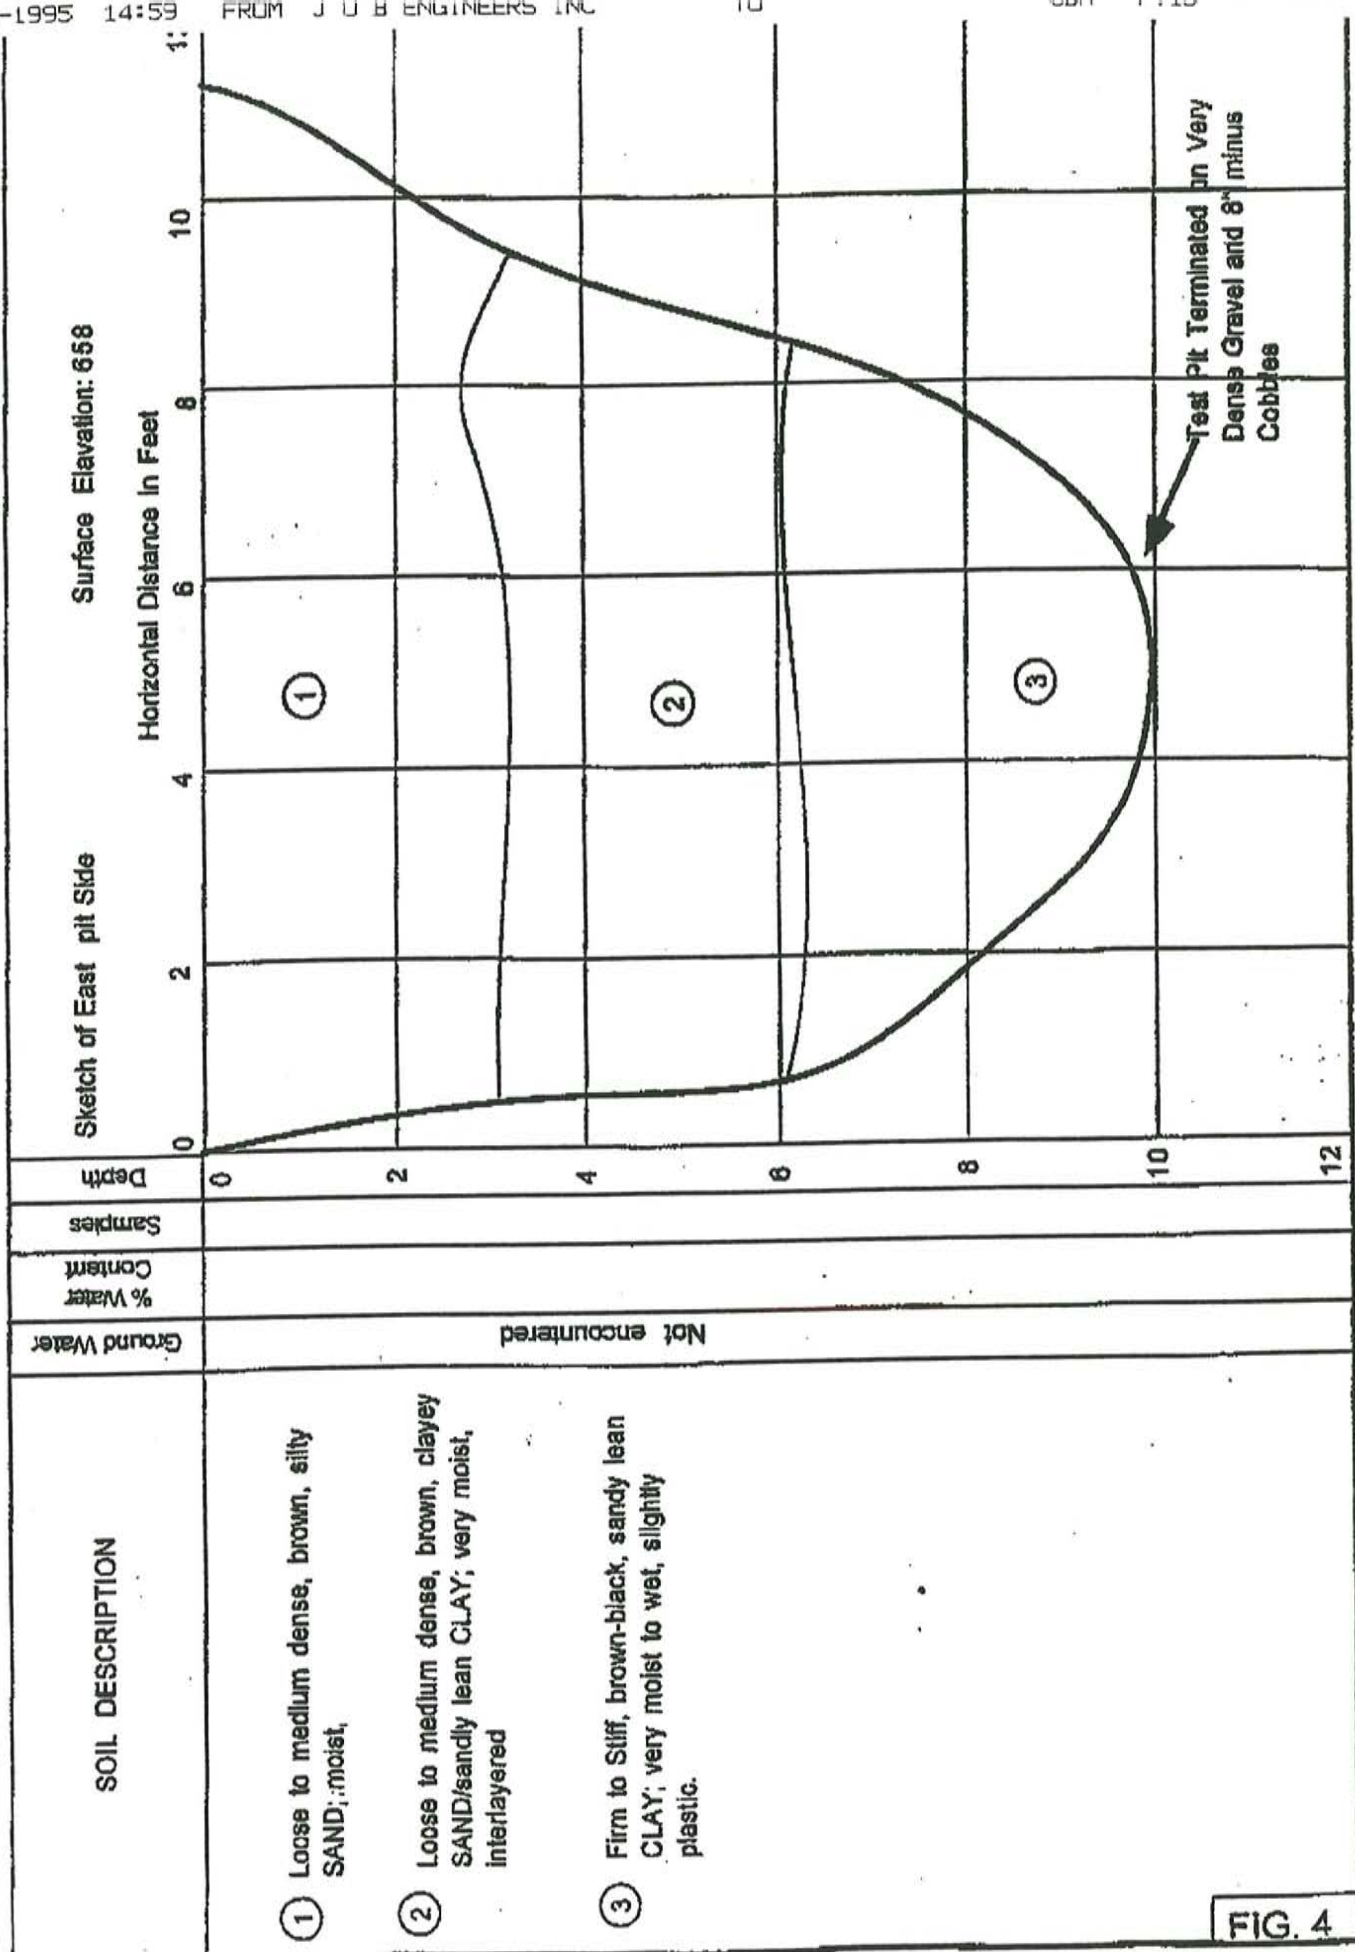
FIG. 4

LOG OF TEST PIT TP-4

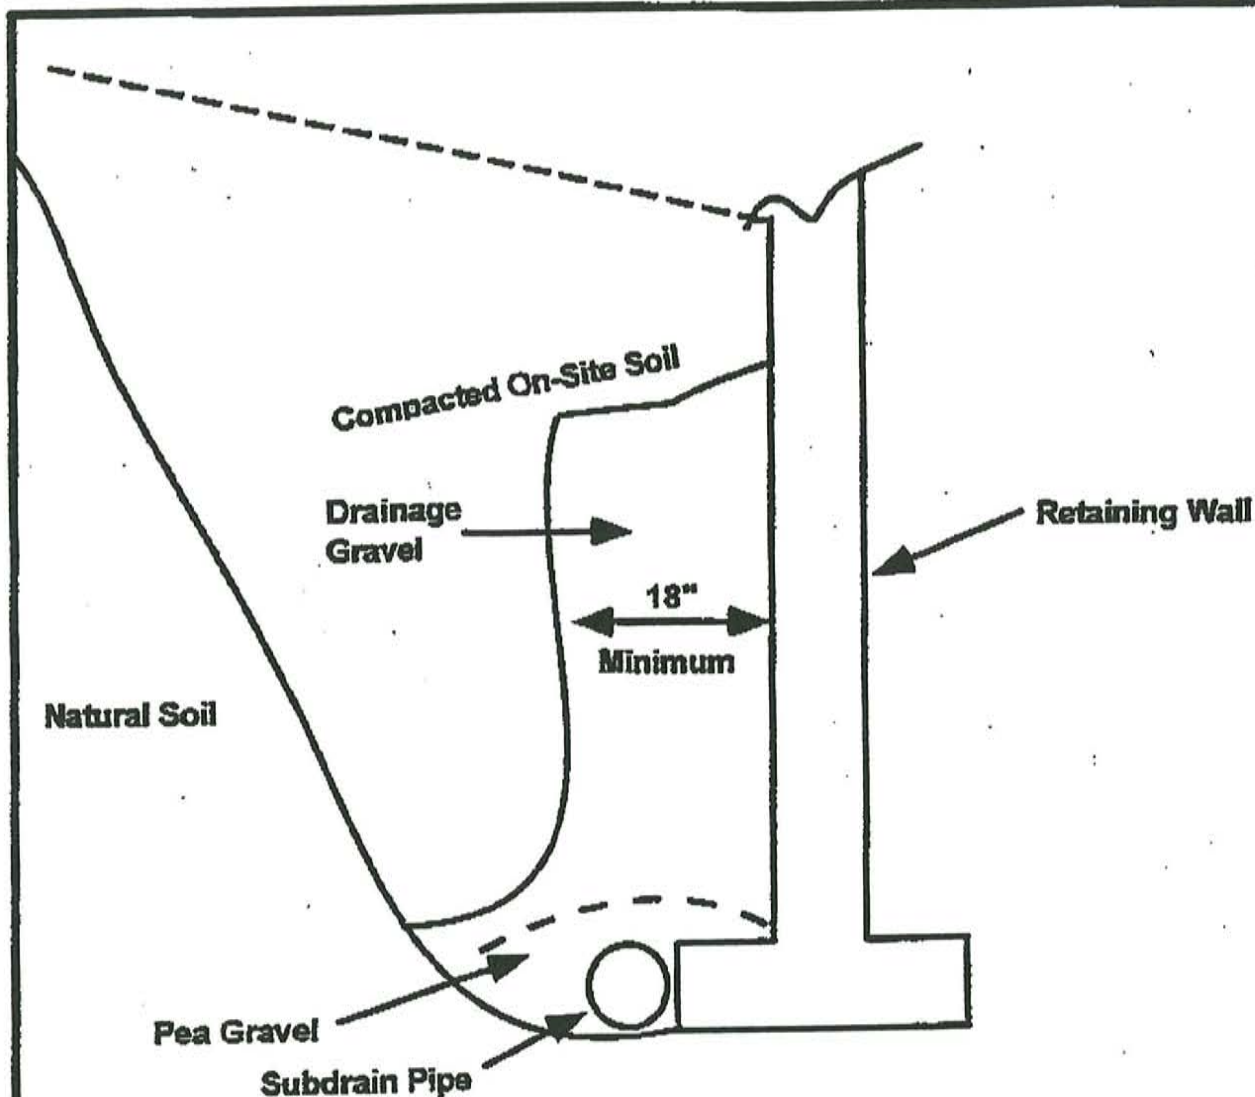
**Fig. 7**

1. Backfill behind wall should be compacted with hand-operated equipment to 90 % of the maximum dry density determined by ASTM D 1557.
2. Drainage Gravel to be 5/8" - minus commercially-produced base course or top course gravel. Pea Gravel to be commercially-produced product.
3. Subdrain pipe to be 4" minimum diameter, slotted pipe, sloped to drain 6" per 100', or steeper. Maximum slot width to be 1/8". Subdrain pipe to outlet at least 15' away from (downslope) of wall face.

embankment, most likely from snowmelt. We recommend that a wall drainage system be installed behind the wall, in accordance with the sketch shown in Figure 7. If the retaining wall concept is selected, we recommend that the construction include daily observation of the adjacent railroad tracks to observe any movement of the tracks toward the wall excavation. Even if construction does not extend into the railroad right-of-way, we recommend that the railroad company be informed of the planned construction, and that a preconstruction survey of the railroad tracks be coordinated and performed with the railroad's consent to establish the preconstruction location of the rails.

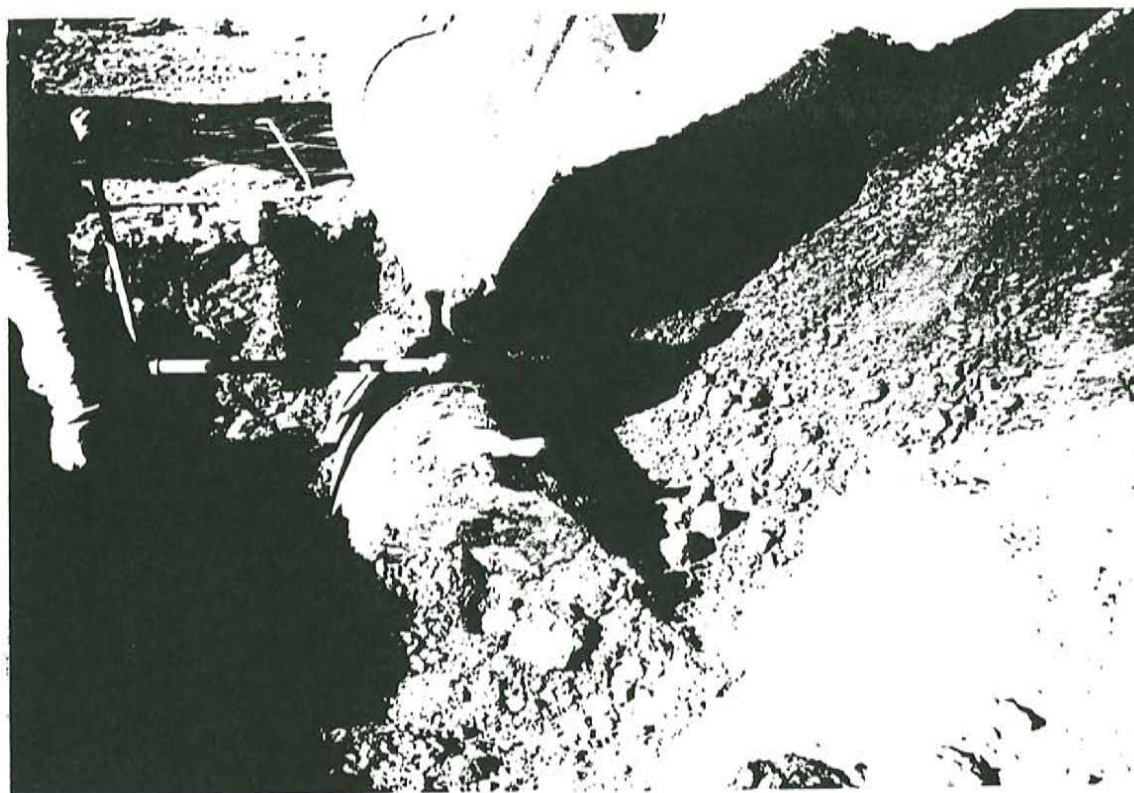
Photo 1 Gasoline UST excavation.

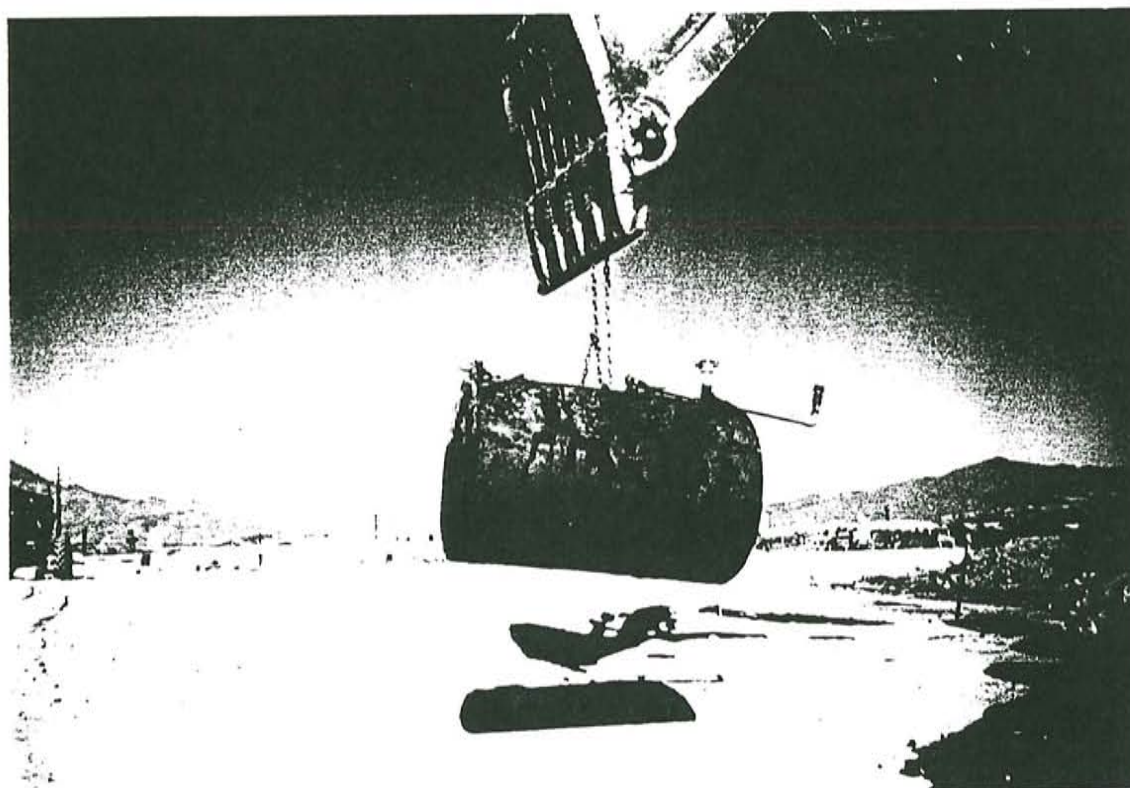
Photo 2 Former UST removed.

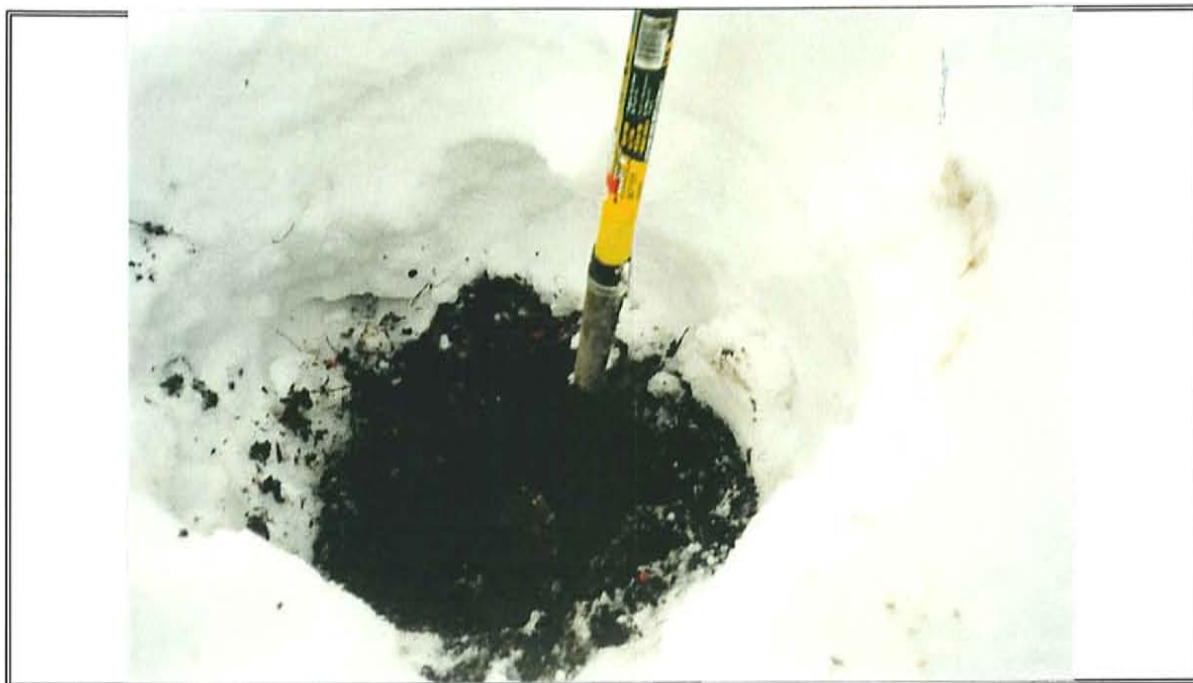
Photo #17

South central soil sample close-up.

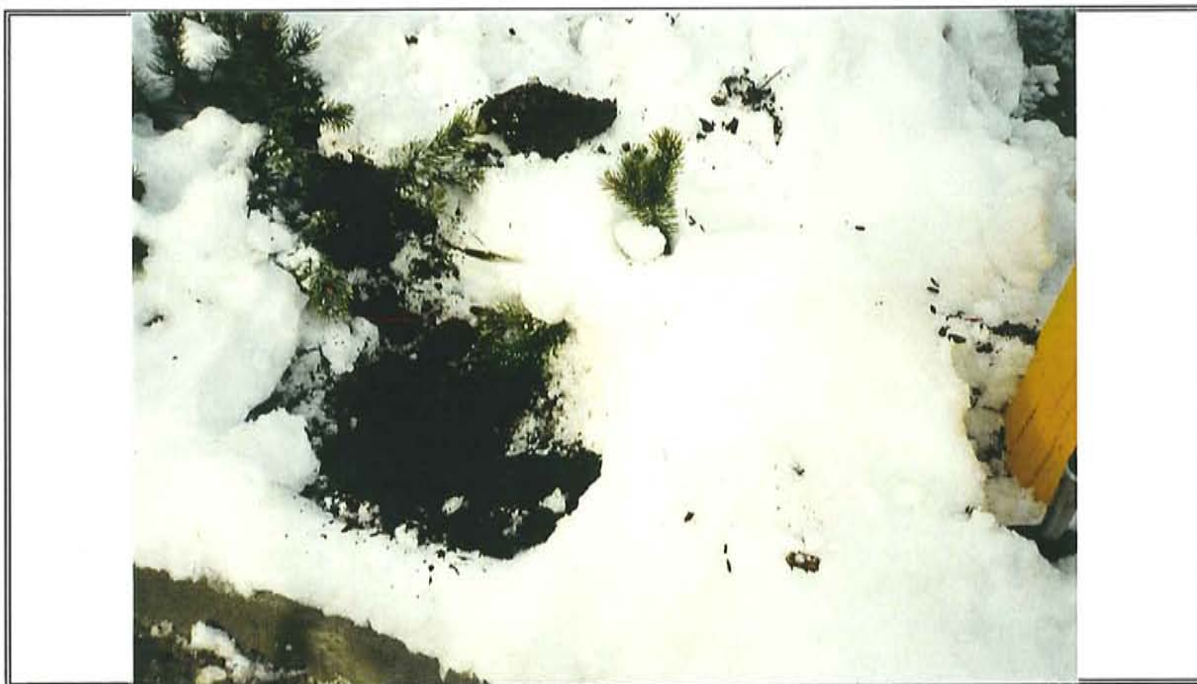
Photo #18

South central front soil sample close-up.

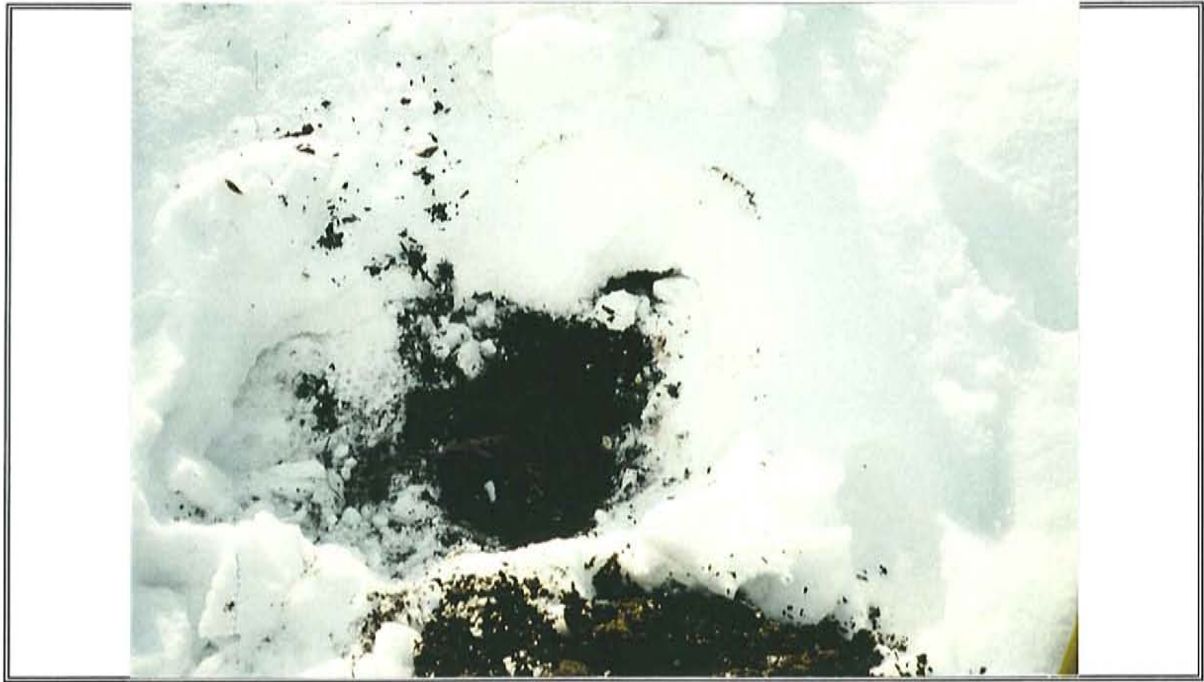
Photo #19

Southwest soil sample close-up.

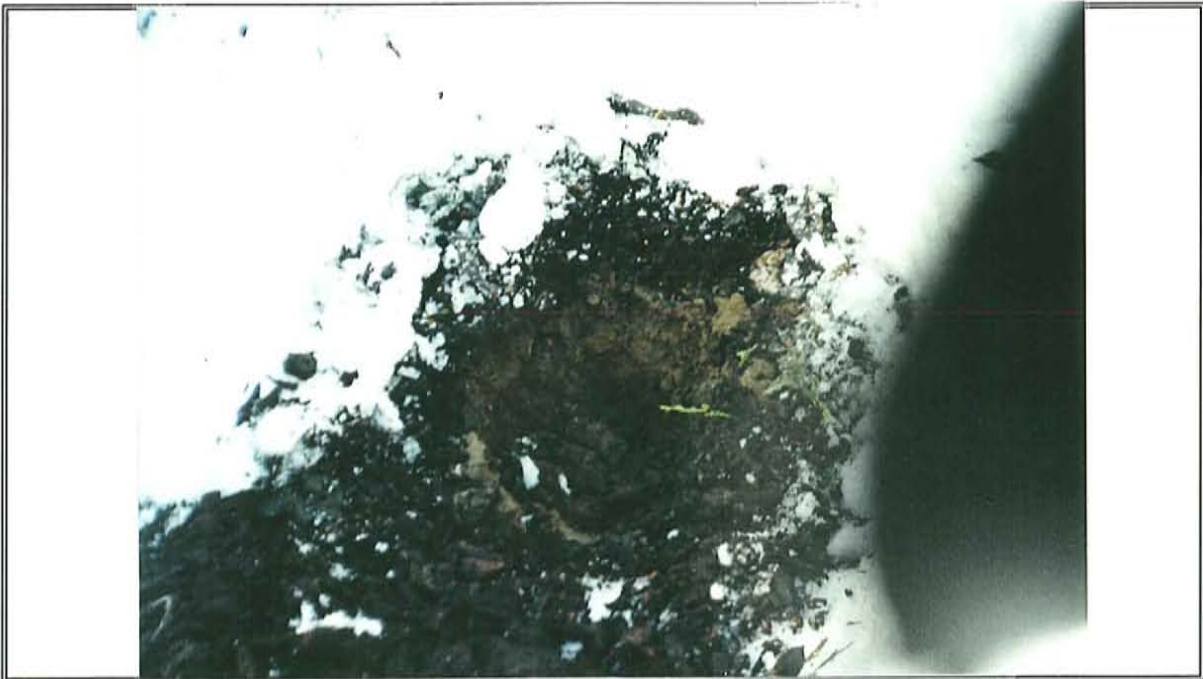
Photo #20

Northwest soil sample close-up.

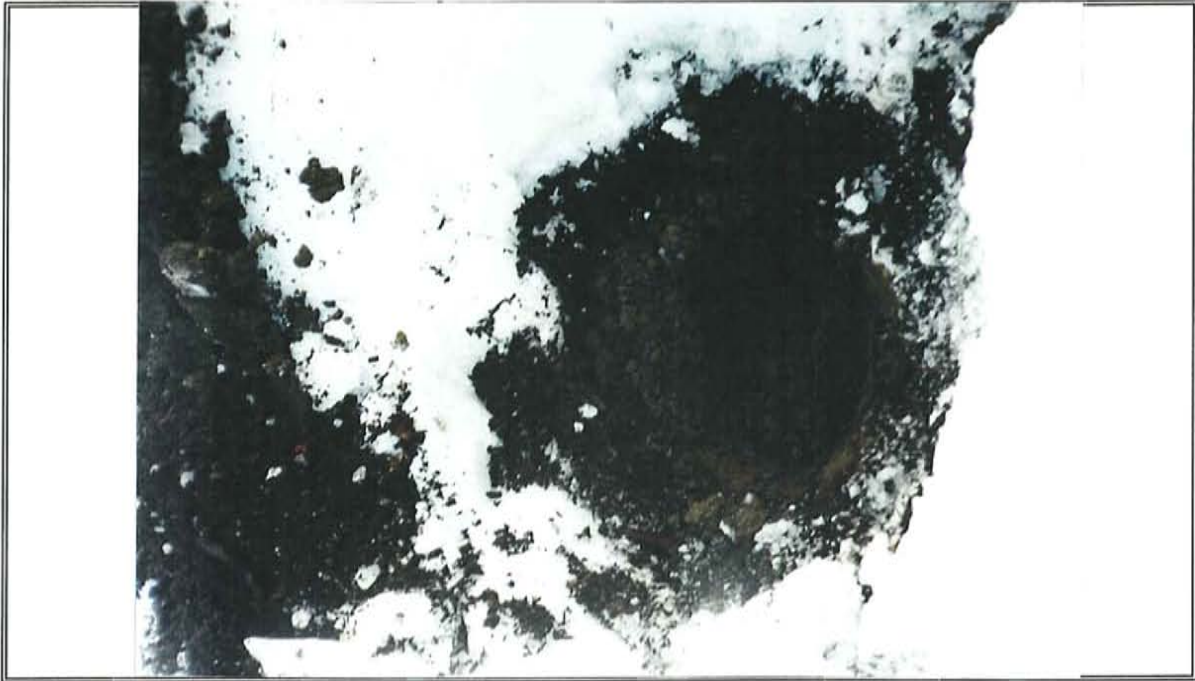
Photo #23

North front soil sample close-up.

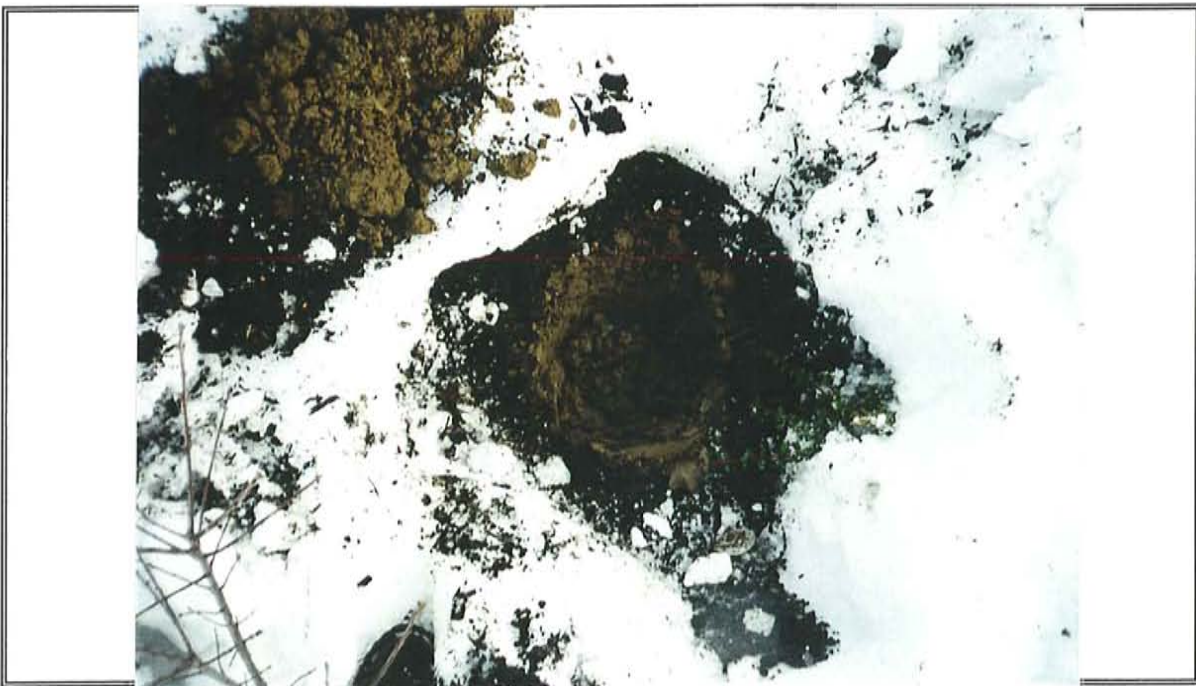
Photo #24

Northeast corner soil sample close-up.

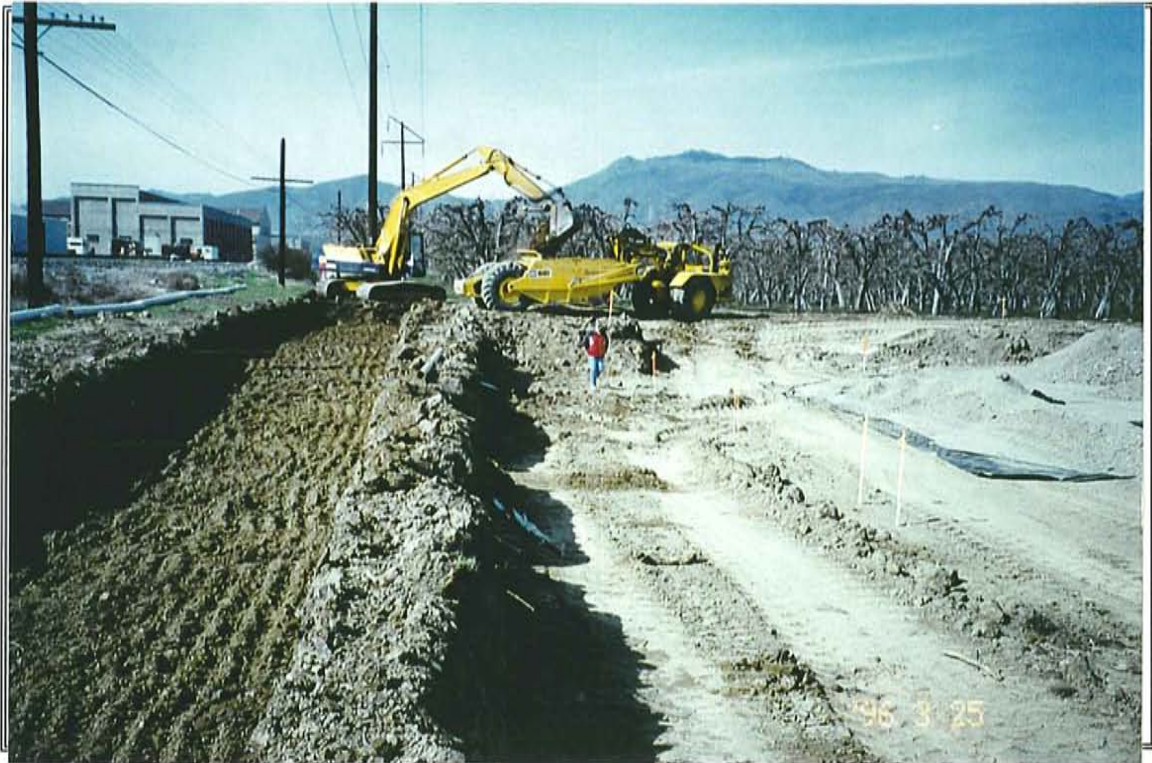
Photo #25 West property line central looking north during construction of planter areas.

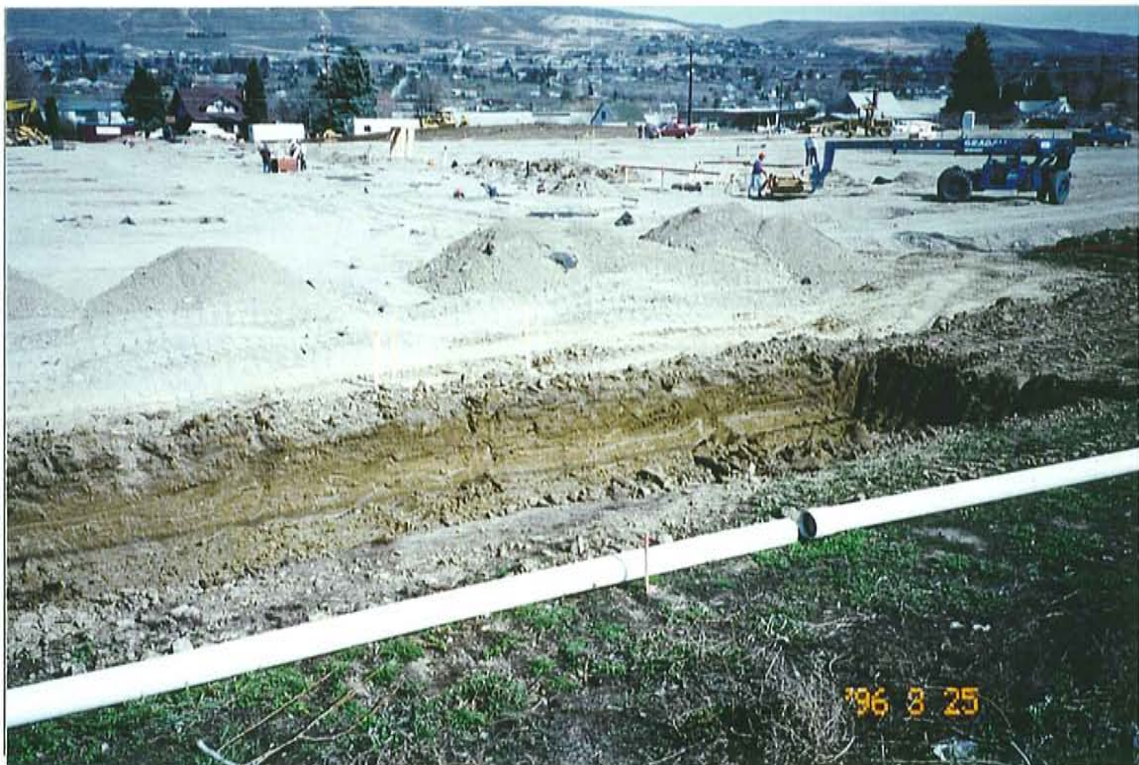
Photo #26 West property line central looking southeast during construction.

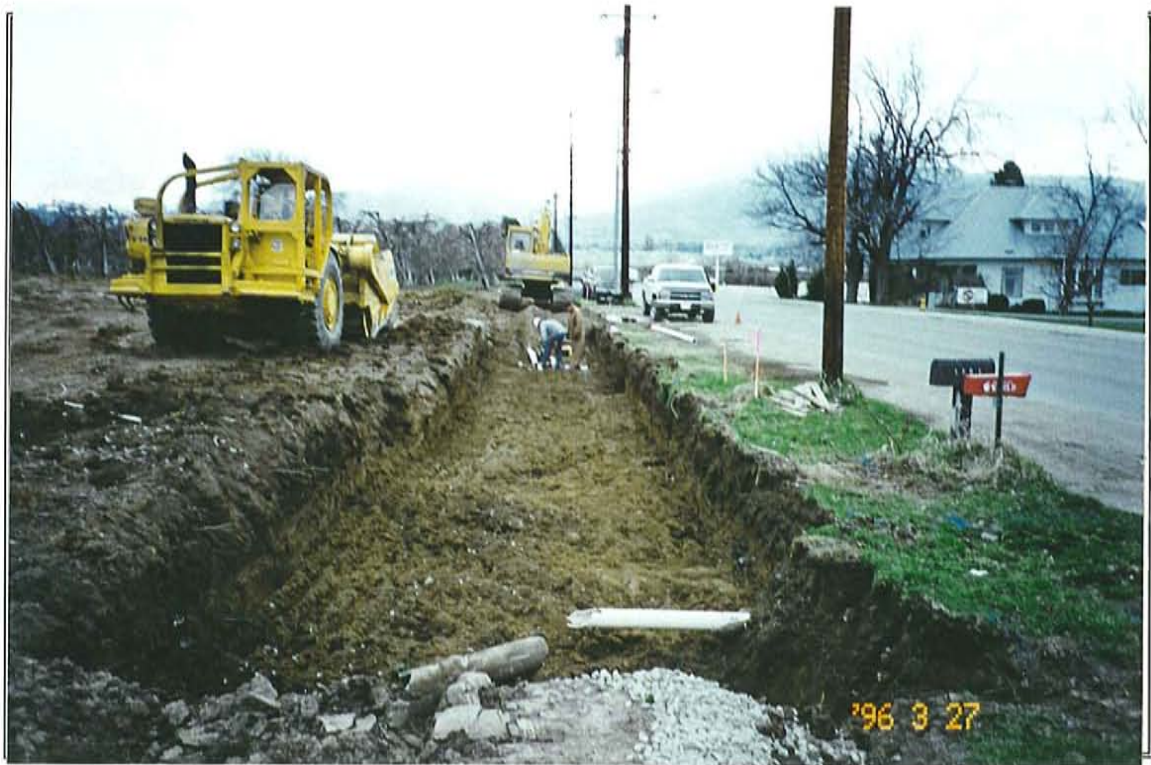
Photo #27 East property line looking north at planter construction.

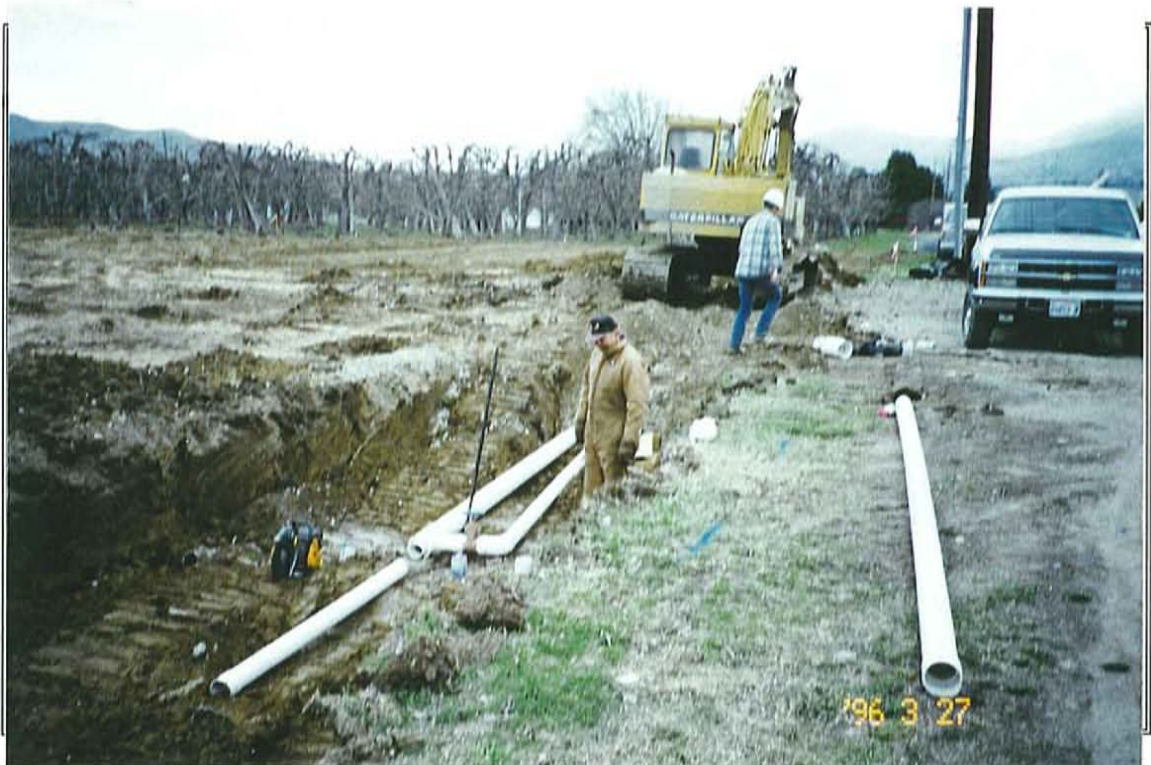
Photo #28 East property line looking northwest at planter construction.

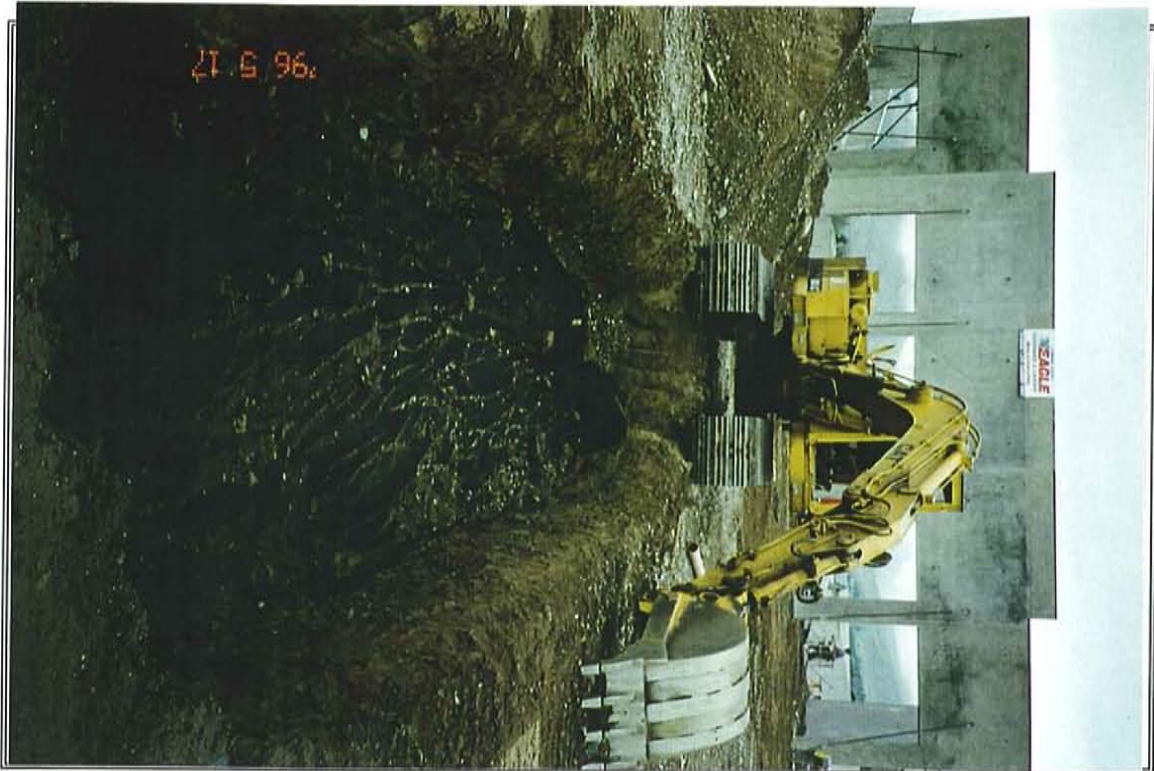
Photo #31 North parking lot entrance looking west at planter construction.

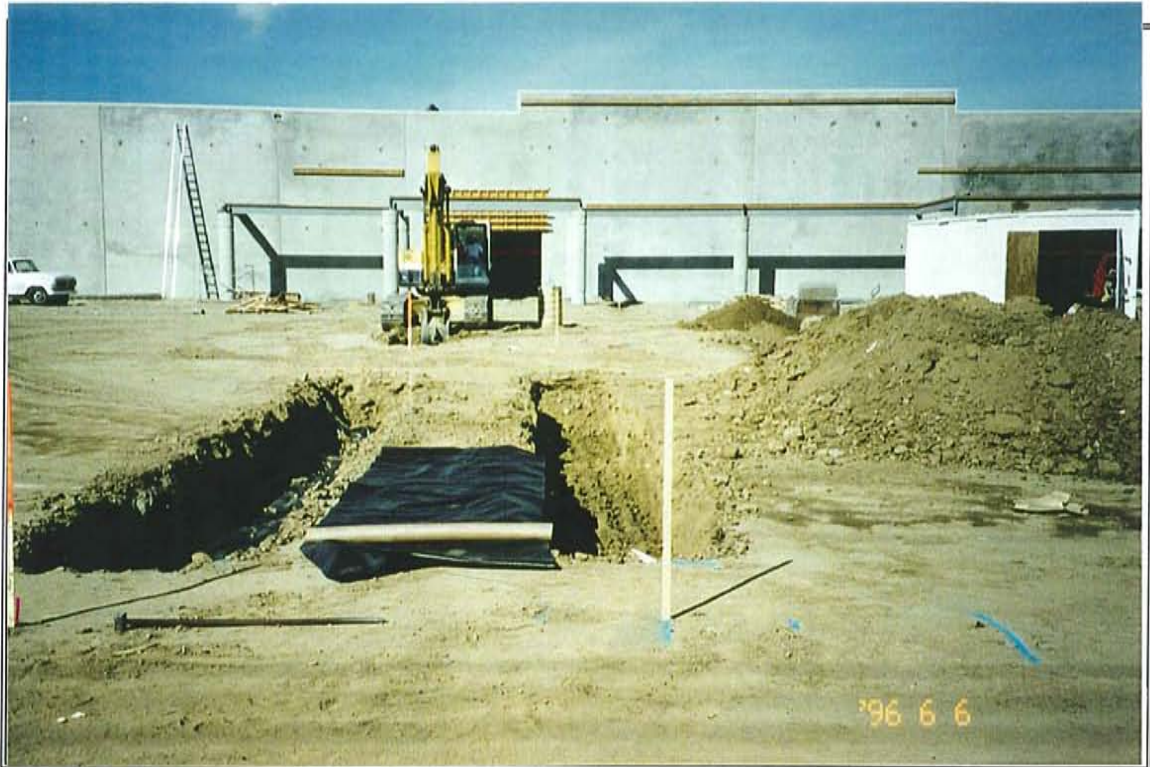
Photo #32 East property line looking west at building entrance planter construction.

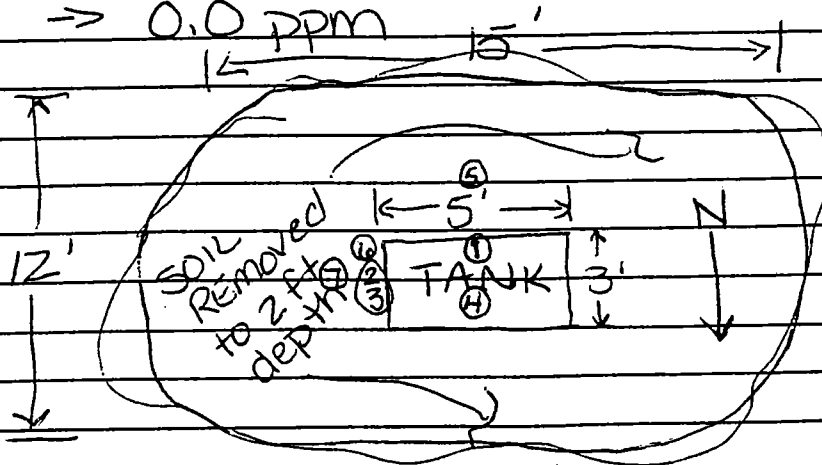
① sample locations

No evidence of leaking, No staining on soil, No odor

PID → 0.0 ppm
