## PHASE II ESA – SUBSURFACE INVESTIGATION

**SAMISH INDIAN NATION  
DEPARTMENT OF NATURAL RESOURCES OFFICE**

1017 29<sup>th</sup> Street  
Anacortes, Washington 98221

AEG Project #: 12-107

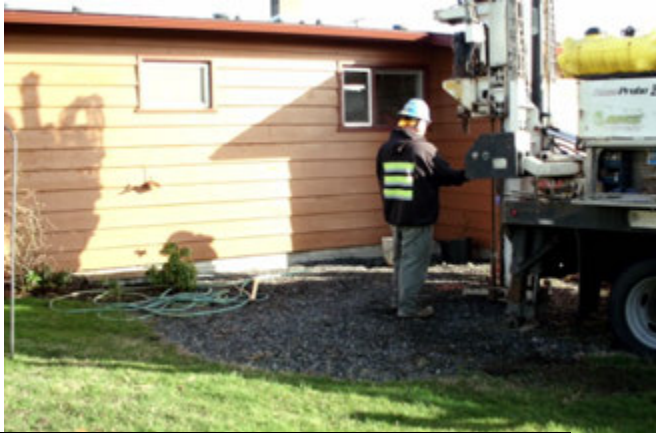
**Photo #1:** View of direct push probe drilling at boring B-1 – where former heating oil fuel tank was located. Note gravel surface area indicated area of excavation.

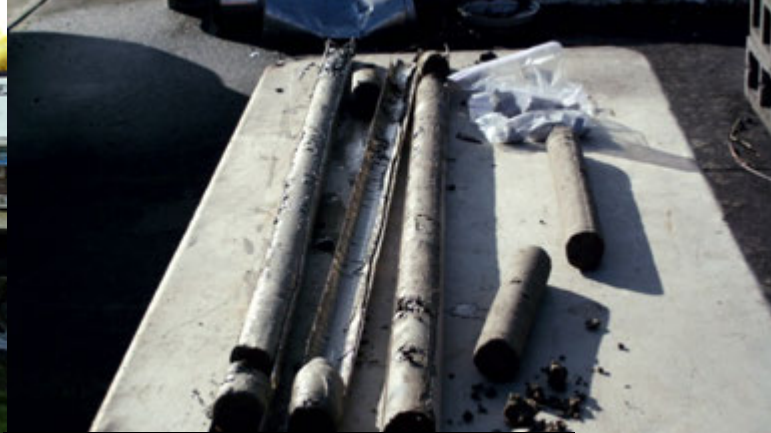
The subsurface conditions at the Site, at locations of investigation, generally consist of fill deposits underlain by clayey soil. Fill deposits were encountered at all locales from below ground surface to at least approximately four feet bgs. However, at boring B-1 (placed within the excavation pit for the former leaking fuel tank) fill deposits were logged to approximately six feet bgs. Fill deposits at B-1 consisted of sandy gravel backfill; else where it generally consisted

of soft to medium stiff silty clay with local gravel. These deposits were underlain by native soil represented by stiff, low plasticity, expansive clay to 15 feet bgs, the maximum depth explored.

**Photo #2:** View of the typical soil encountered at the Site – stiff clay. These cuttings are from boring B-1.

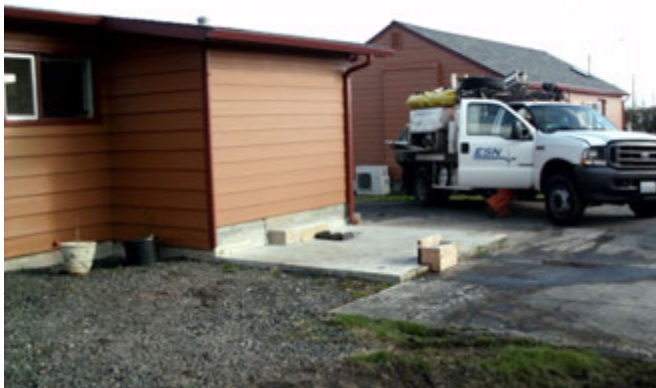
**Photo #3:** View of direct push probe drilling at boring B-2, inferred downgradient east of former fuel tank (looking to the east).

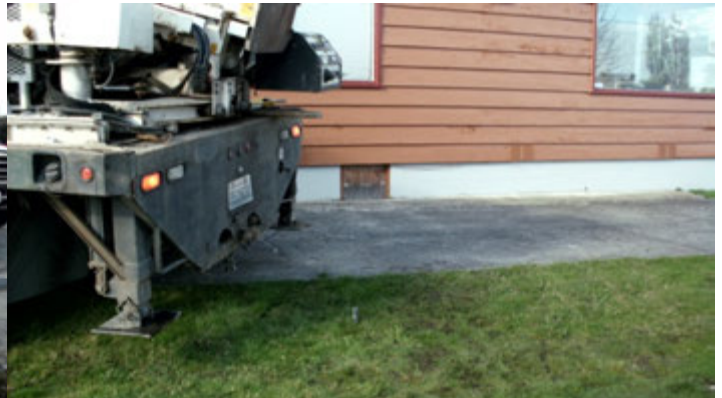
**Photo #4:** View of attempt to collect groundwater at boring B-2 via leaving a temporary PVC screen in the subsurface for at least 3 hours.

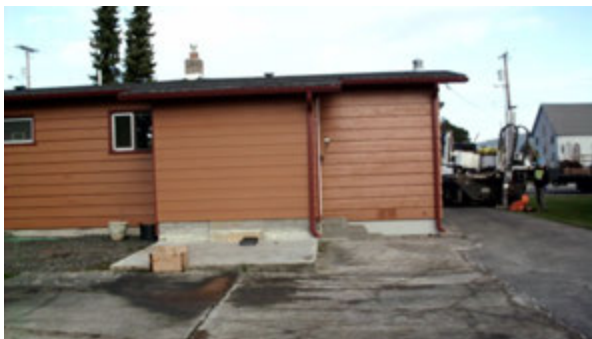
**Photo #5:** View of direct push probe drilling at boring B-3, inferred downgradient northeast of former fuel tank (looking to the northeast).

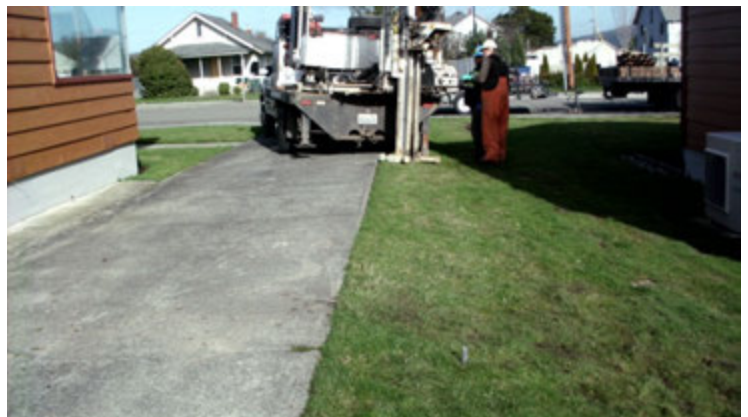
**Photo #6:** Close-up view of subsurface investigation at boring B-3. Note the top of a gray PVC screen at boring B-2, in the foreground. (view looking to the north).

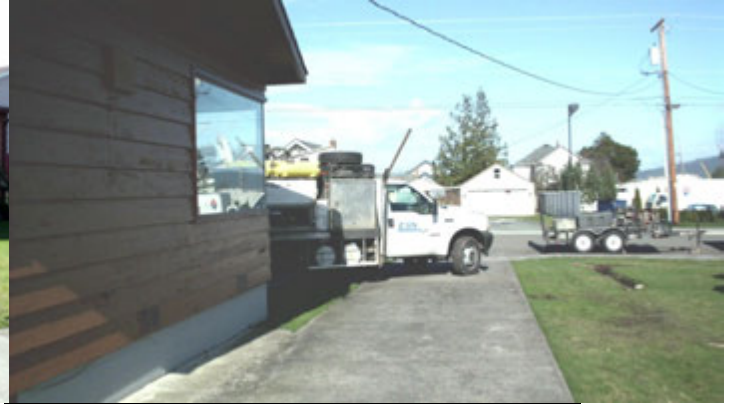
| Photo<br>#8: | Alternate view of subsurface investigation at boring B-4 (looking to the north). |
