**UST Closure and Site Assessment
Trident Seafoods Anacortes Facility
1400 Fourth Street
Anacortes, WA**

March 13, 2009

**G-Logics Project 01-0478-C
Copyright 2009 G-Logics, Inc.
All Rights Reserved**

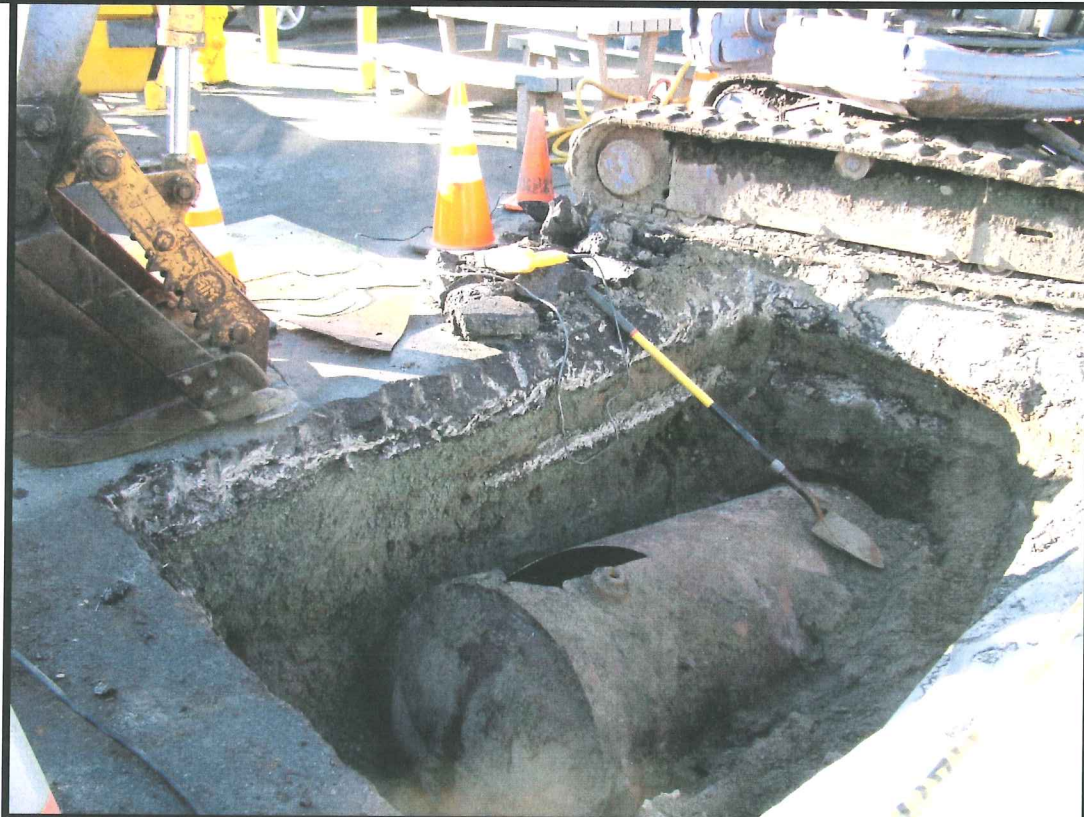
2

Description: View of UST after having been uncovered, triple-rinsed, and inerted.

Comments: Note 8-inch thick asphalt pavement.

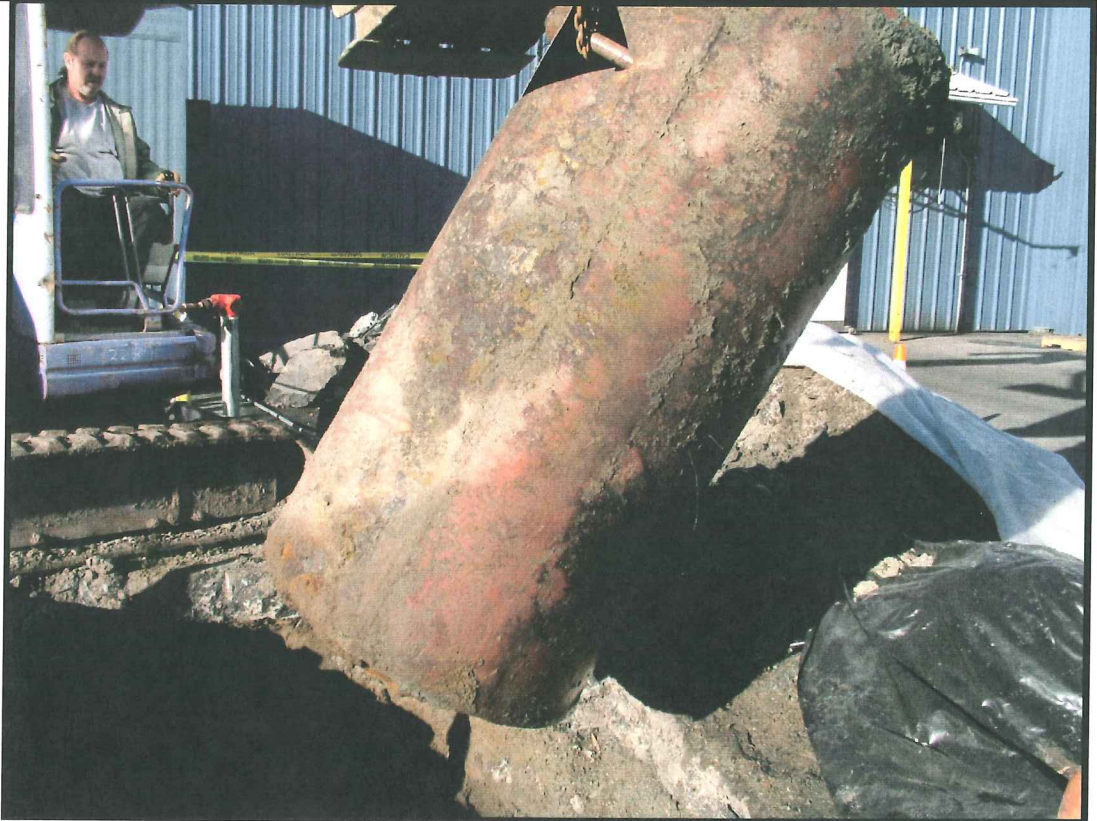
3

Description: View of UST being lifted from the excavation.

Comments: The south side of the UST can be seen. Note the bottom portion of the tank is darker due to moisture/water.

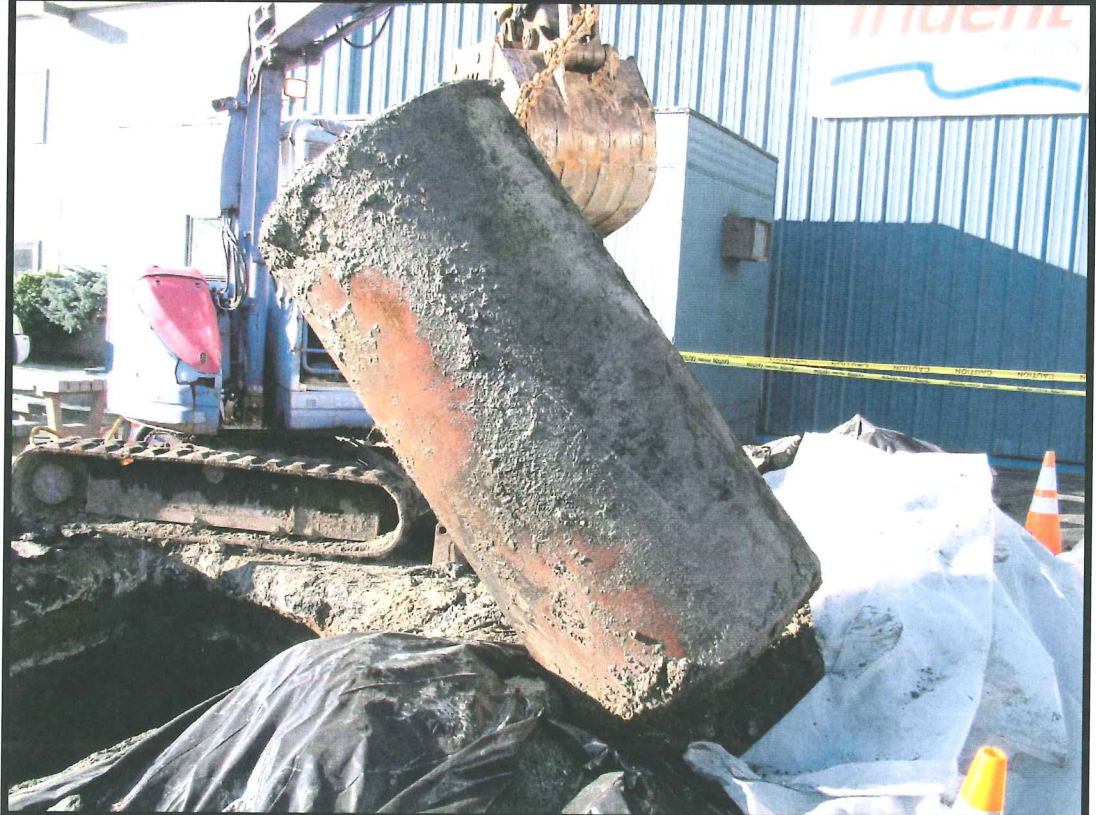
4

Description: View of UST being lifted from the excavation.

Comments: The north side and bottom of the UST can be seen.

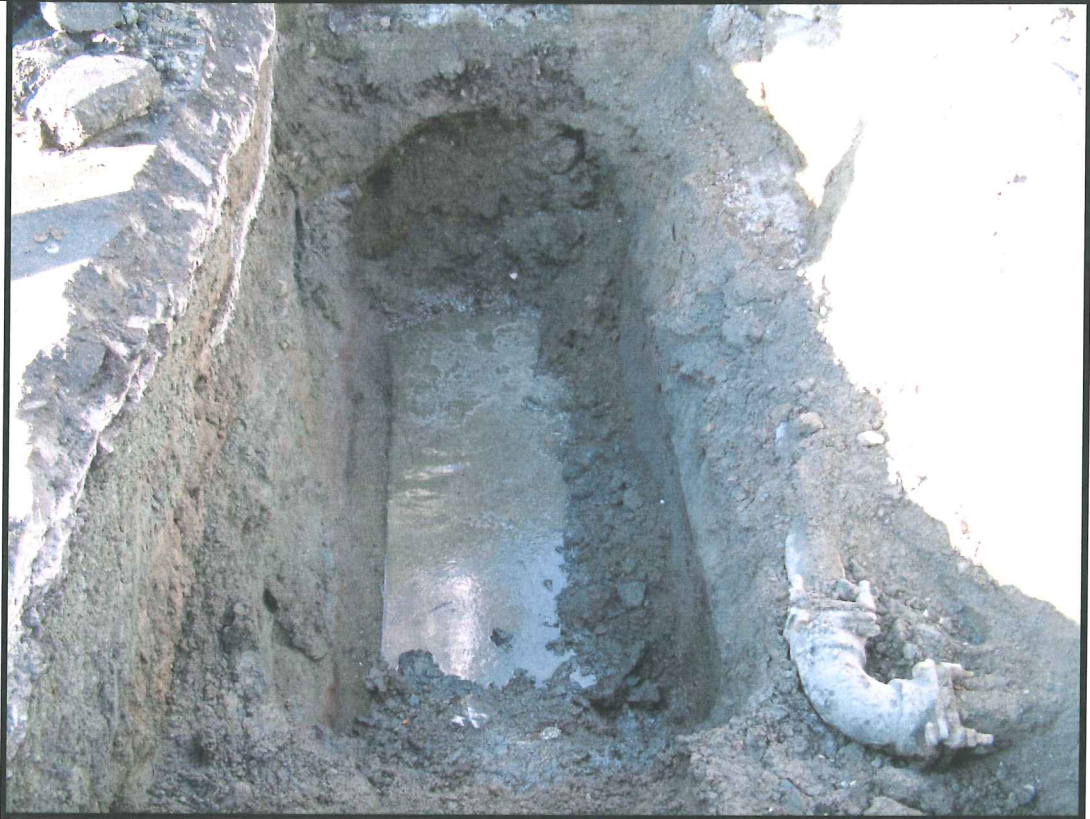
5

Description: View of UST excavation immediately following tank removal, looking to the west.

Comments: Note water in bottom of excavation and water pipe along the north side (to the right).

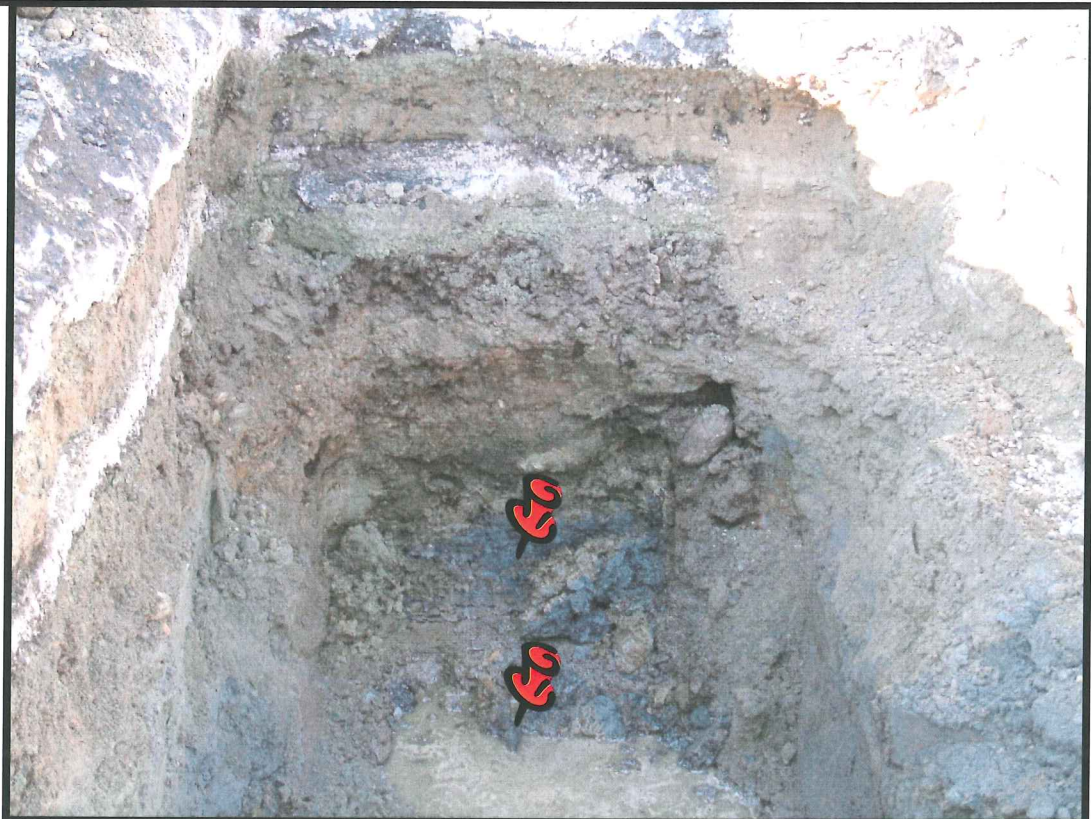
6

Description: View of gray-colored soils at the west sidewall of the excavation.

Comments: Approximate locations of sample SW-W-5 shown by top pin and SW-W-6 by the bottom pin.
