**US GENERAL SERVICES ADMINISTRATION
FEDERAL CENTER SOUTH UNDERGROUND STORAGE
TANK ASSESSMENT
FINAL REPORT**

October 5, 2011

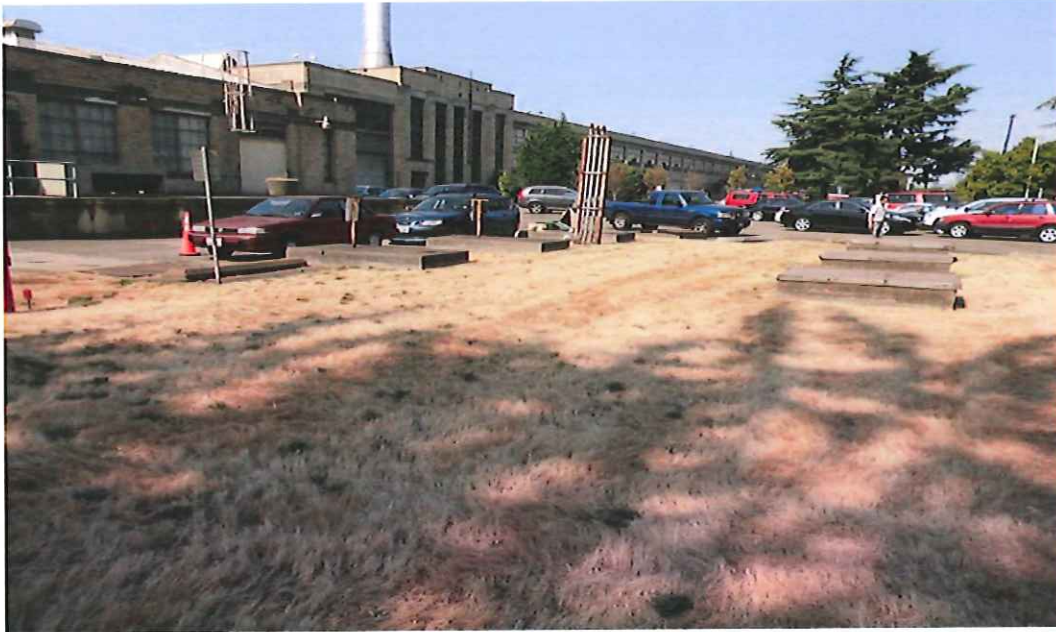
Photograph 1: View of UST vent and fill vaults and the three tanks vents. Building 1206 is seen to the left of the UST structures and Building 1201 is in the background right.

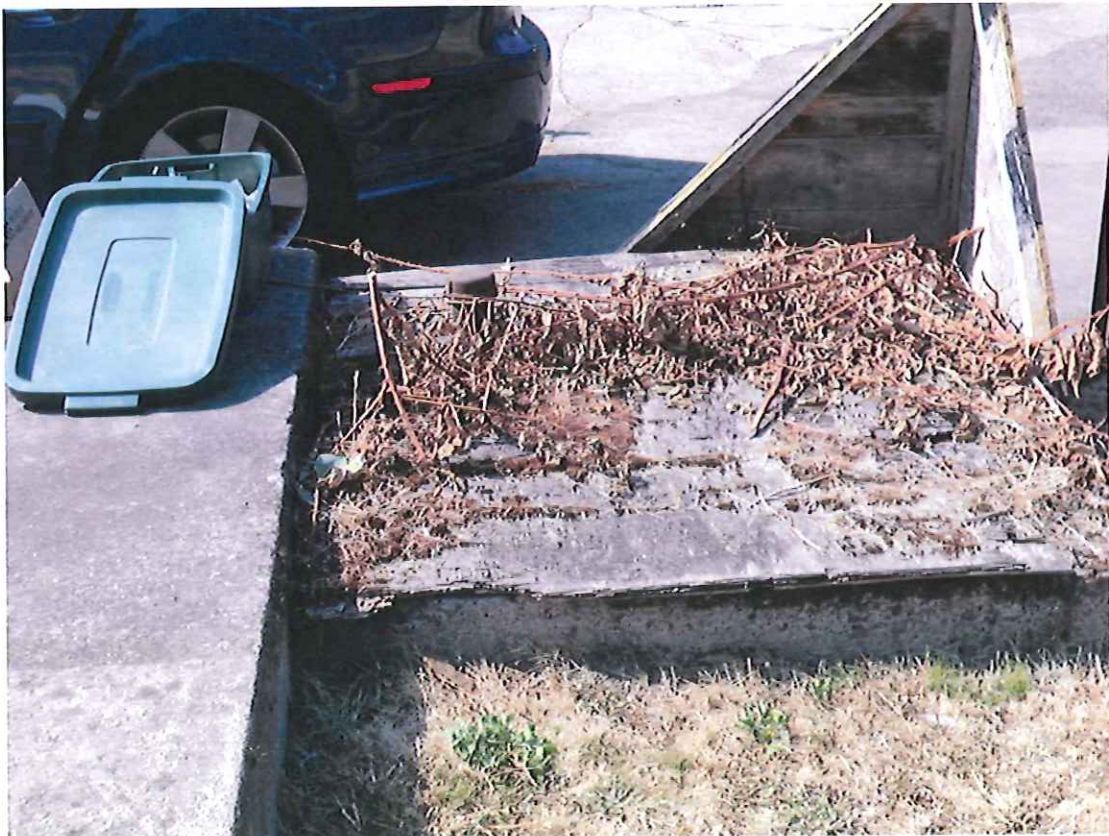
Typically Bunker C USTs had a smaller starter tank used to supply fuel to a heating source that would heat the Bunker C in order to lower the viscosity of the fuel and allow it to flow. EHSI found an extraneous fill port on the north side of UST 1. Review of as-built drawings did not show the presence of a starter tank for the former Bunker C storage system.

Photograph 2: View of the Federal Center South heating oil UST fill port on the north side of the Federal Center South UST 1. This may indicate the presence of a fourth tank at the Federal Center South facility.

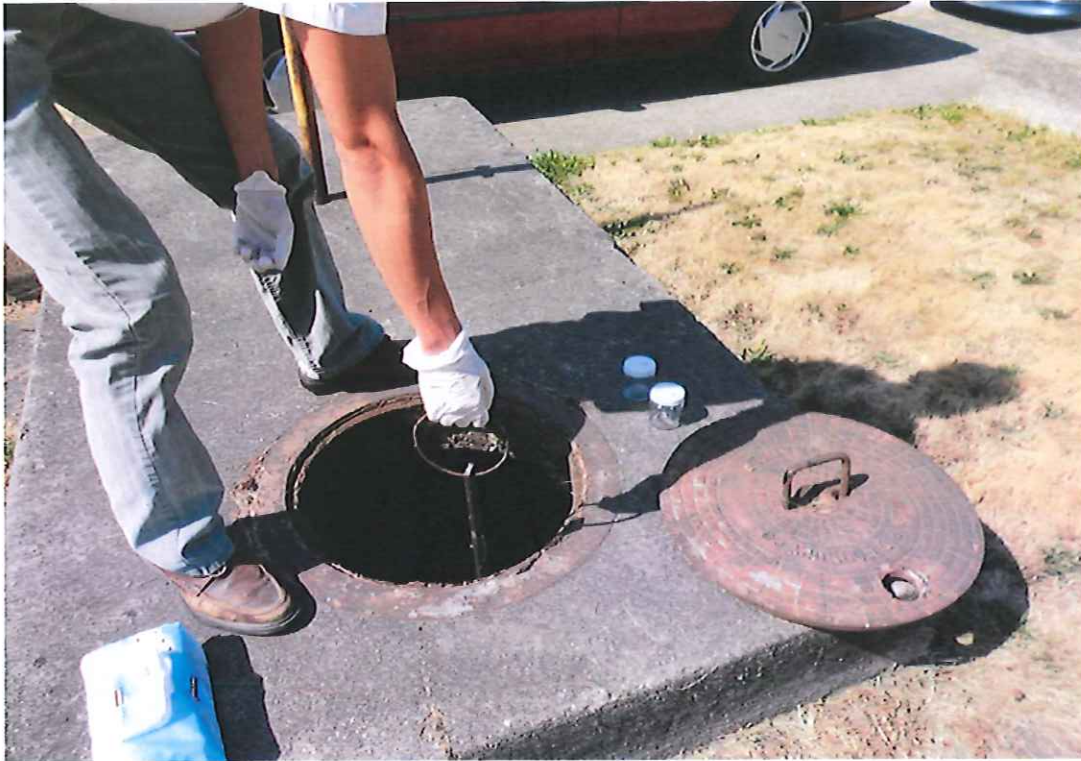
Photograph 3: View of UST 3 fill port with dip stick on the east side of the tank.

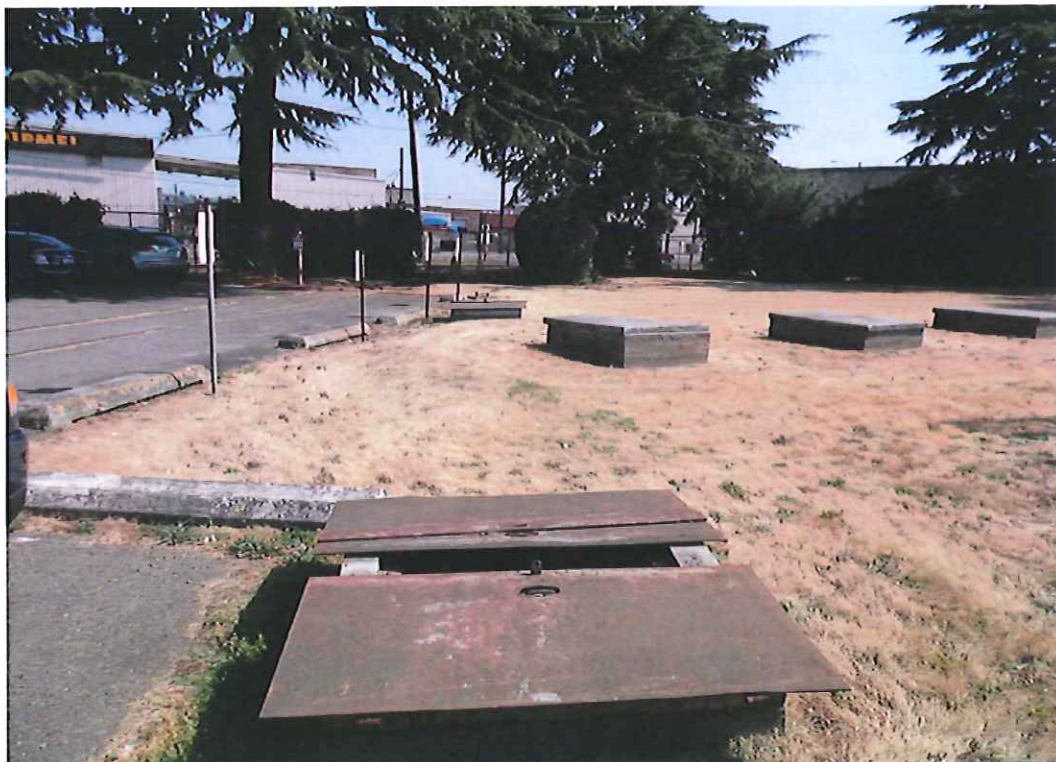
Photograph 4: View of the USTs location from the west, in foreground is a fuel pump vault and the fill port vault are seen in the background.
