CARTY LAKE BANK USE PLAN

ADDENDUM TO THE JOINT AQUATIC RESOURCES PERMIT
APPLICATION NO. NWS-2013-1209

CARTY LAKE REMEDIAL ACTION
111 W DIVISION STREET
RIDGEFIELD, WASHINGTON

Prepared for
PORT OF RIDGEFIELD
RIDGEFIELD, WA
October 22, 2014
Project No. 9003.01.40

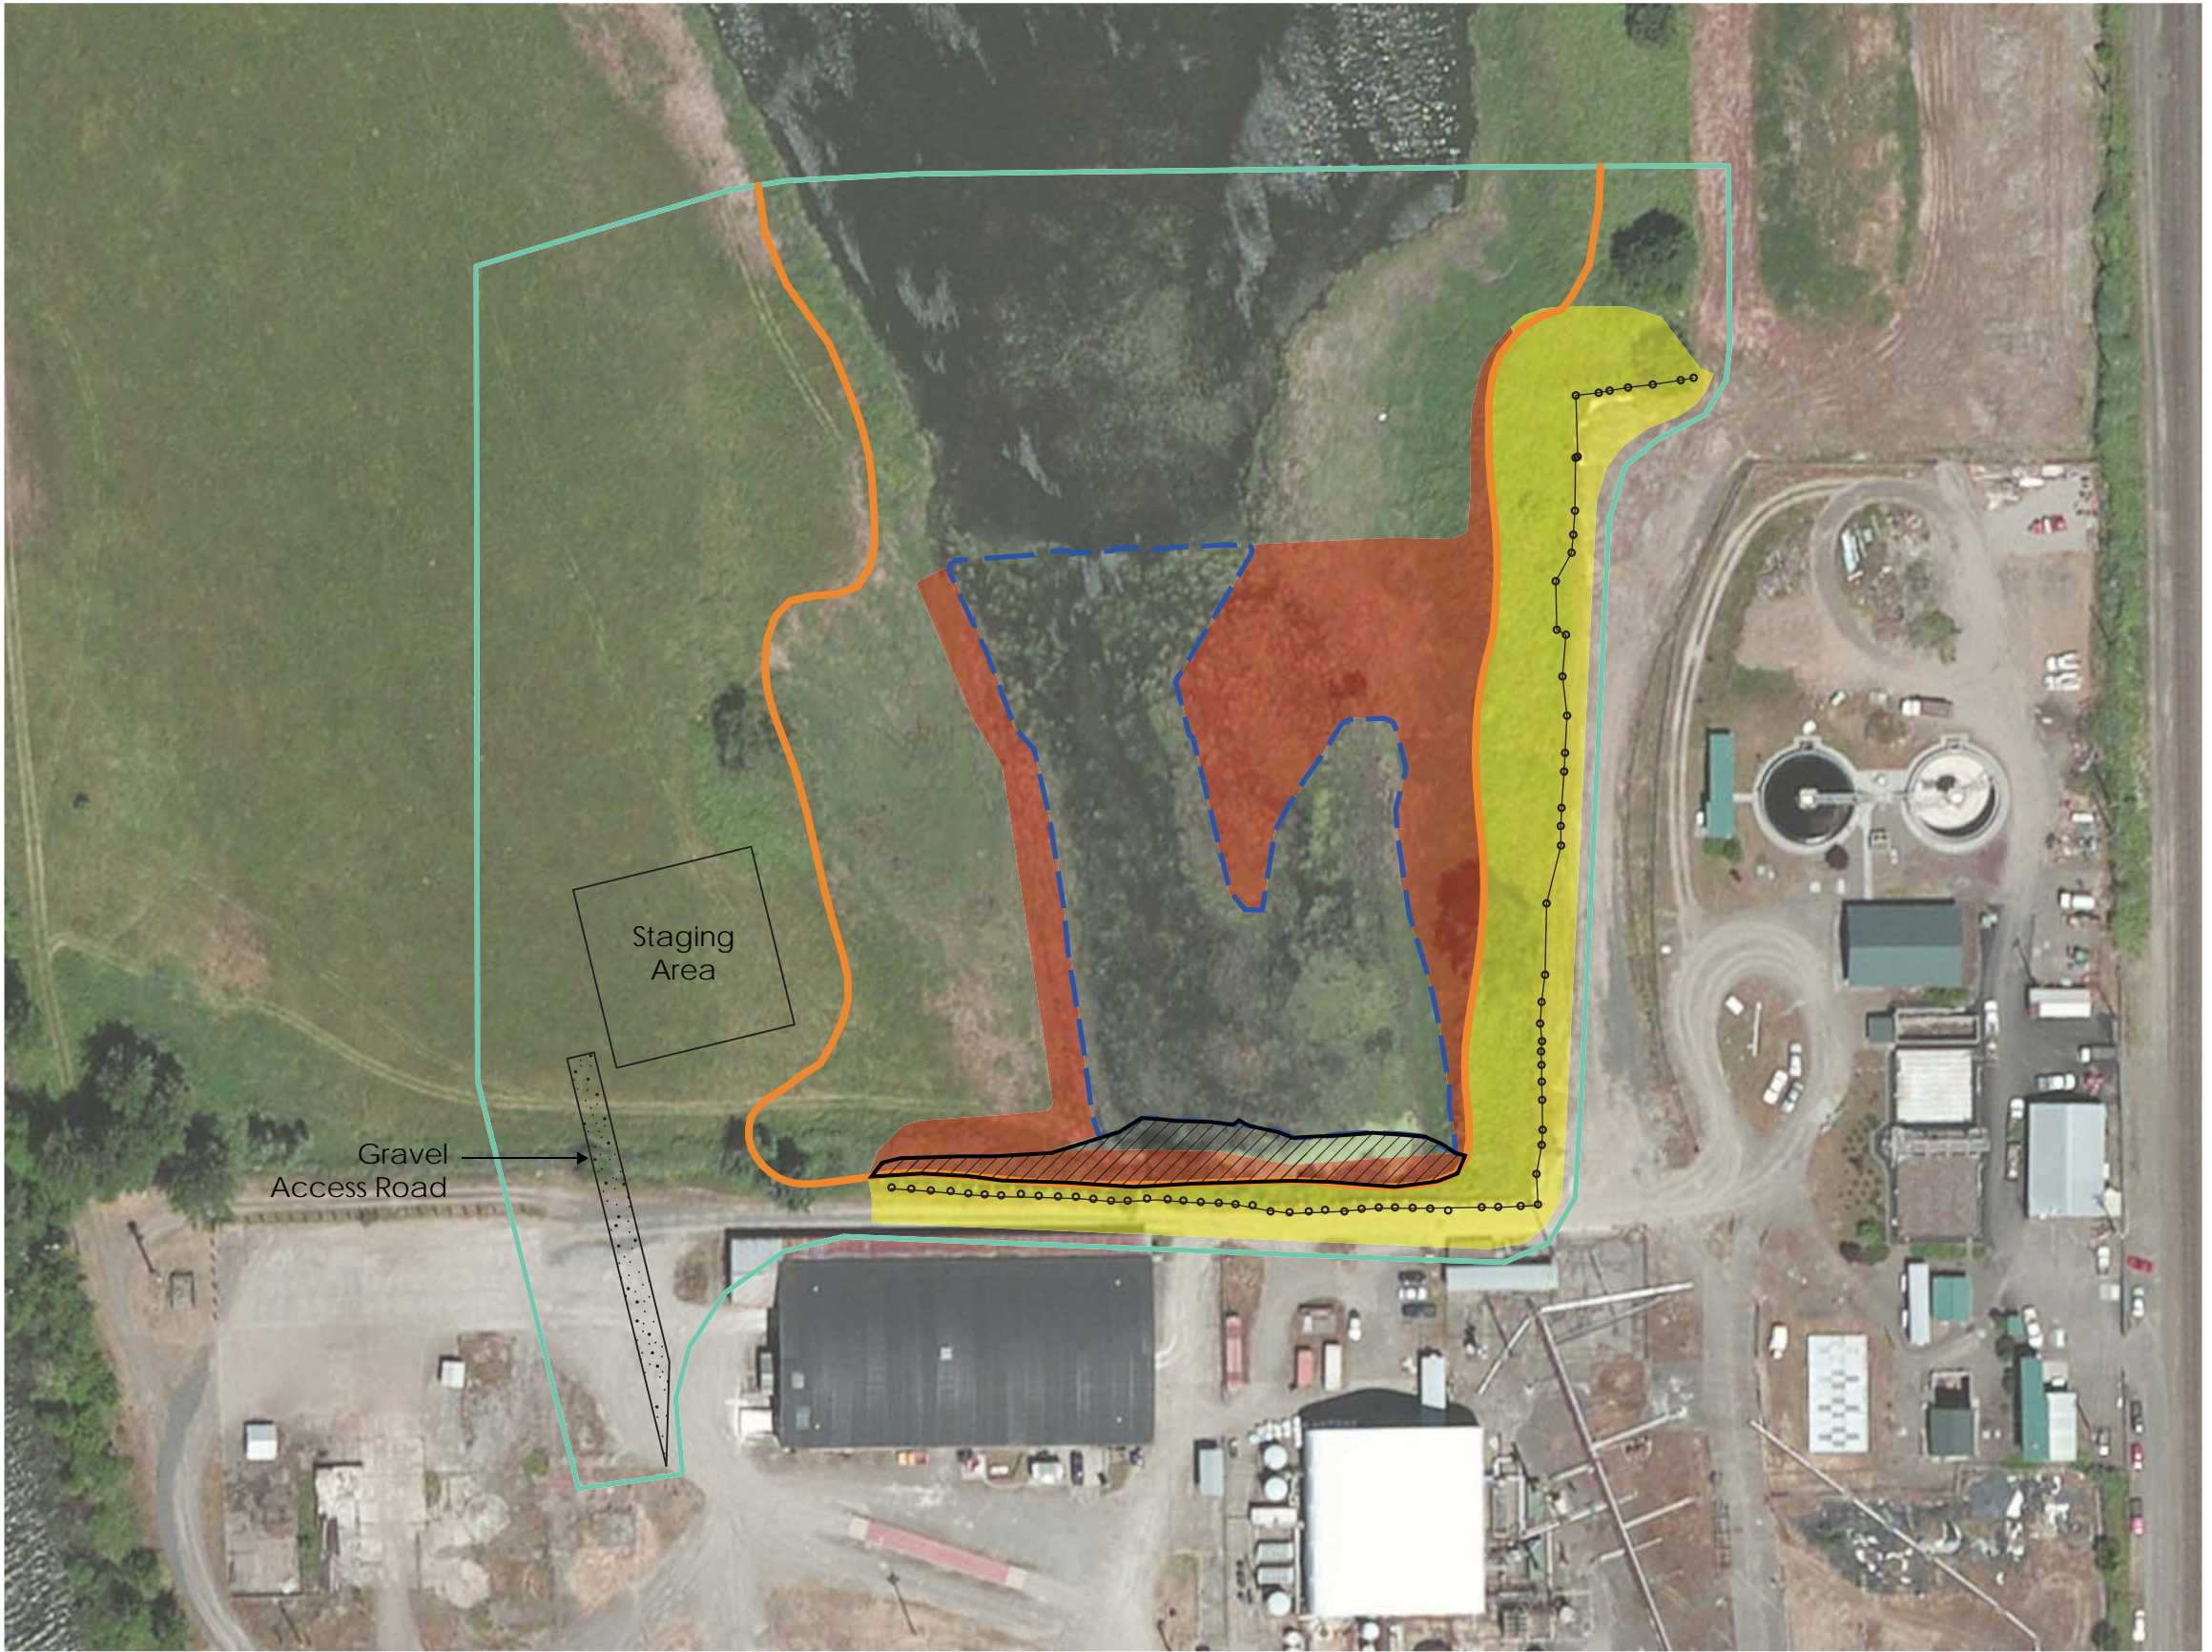
FIGURE
2

- Site Boundary
8.6 ACRES
- Wetland Boundary
4.7 ACRES
- - - Mitigation Site
1.2 ACRES
- ⋯⋯⋯ Existing Bulkhead
- Current Wetland Areas
Adjacent to Mitigation
Area 0.94 ACRES
- Wetland Fringe and
Upland Bank
0.93 ACRES
- Wetland Mitigation
Banking
Up to 0.23 ACRES

SITE OVERVIEW
CARTY LAKE
 PORT OF RIDGEFIELD
 RIDGEFIELD, WASHINGTON

A portion of the Port's property is separated from the southern portion of Carty Lake by a treated wooden soldier pile and lagging bulkhead. This bulkhead, shown in Figure 2, is approximately 1,800 feet long and between 7 and 10 feet tall. Portions of this bulkhead have begun to fail, and failure of the wall could result in release of contamination into Carty Lake. Remedial construction therefore includes a permanent transition from the grades on the Port's property to the RNWR in the form of constructed earthen embankments against the existing southern and eastern walls of the bulkhead. The embankments will functionally replace the existing bulkhead.

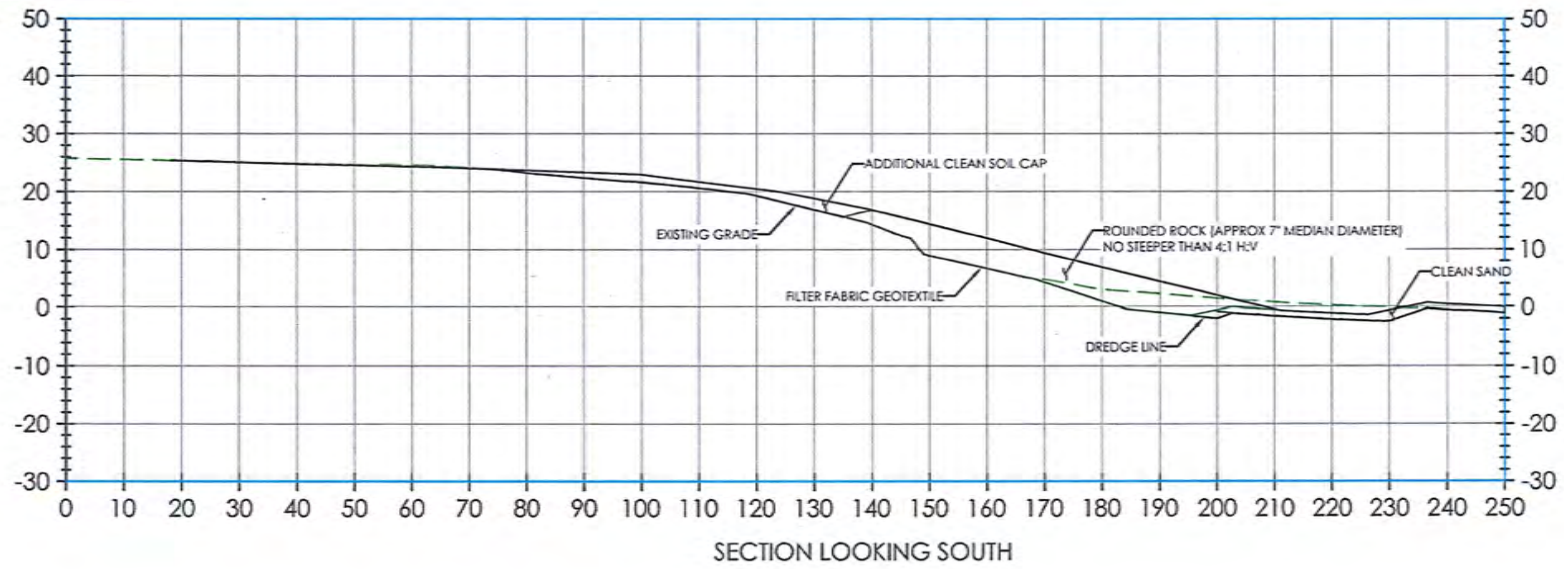
STA: 7+85

This attachment includes critical Sections 7+85 and 19+00 that were used in our slope stability analysis. The sections were provided by MFA.

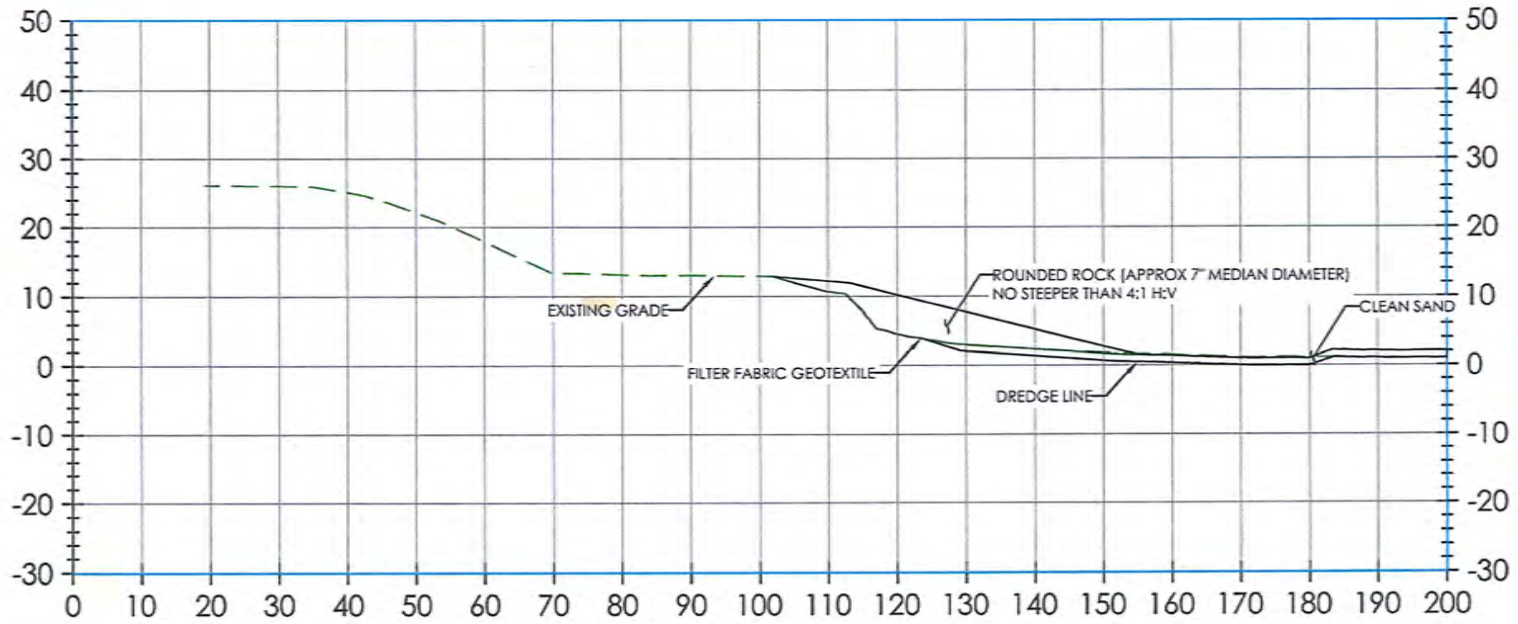
STA: 19+00

SECTION LOOKING SOUTH

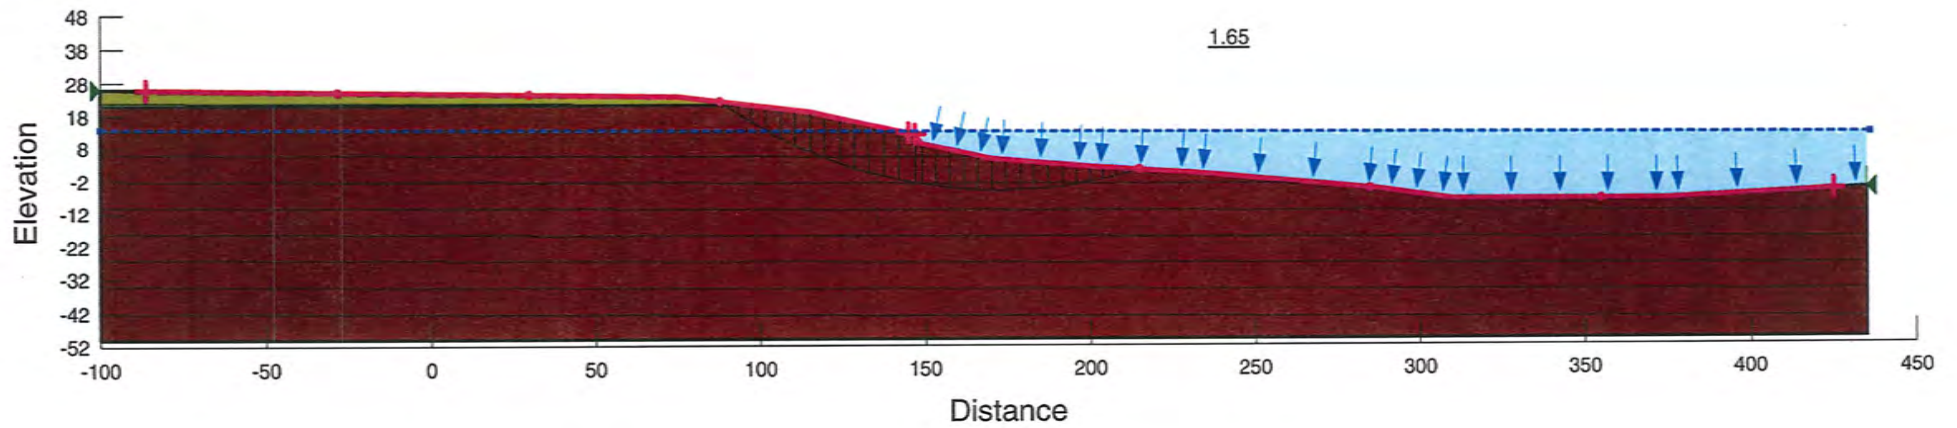
**Lake River Remediation
Critical Section at 7+85
Existing Condition - OHW**

Name: Cap Fill Unit Weight: 110 pcf Cohesion: 25 psf Phi: 30 °
Name: Soft Alluvial Soils Unit Weight: 100 pcf Cohesion: 0 psf Phi: 22 °

Station	Global Stability Factor of Safety						
	Existing Condition		Temporary Condition		Permanent Condition		
	OHW	Rapid Drawdown	OHW	Rapid Drawdown	OHW	Rapid Drawdown	Seismic
7+85	1.65	1.22	1.52	1.16	1.84	1.20	1.15
19+00	1.68	1.17	1.65	1.18	1.76	1.2	1.19

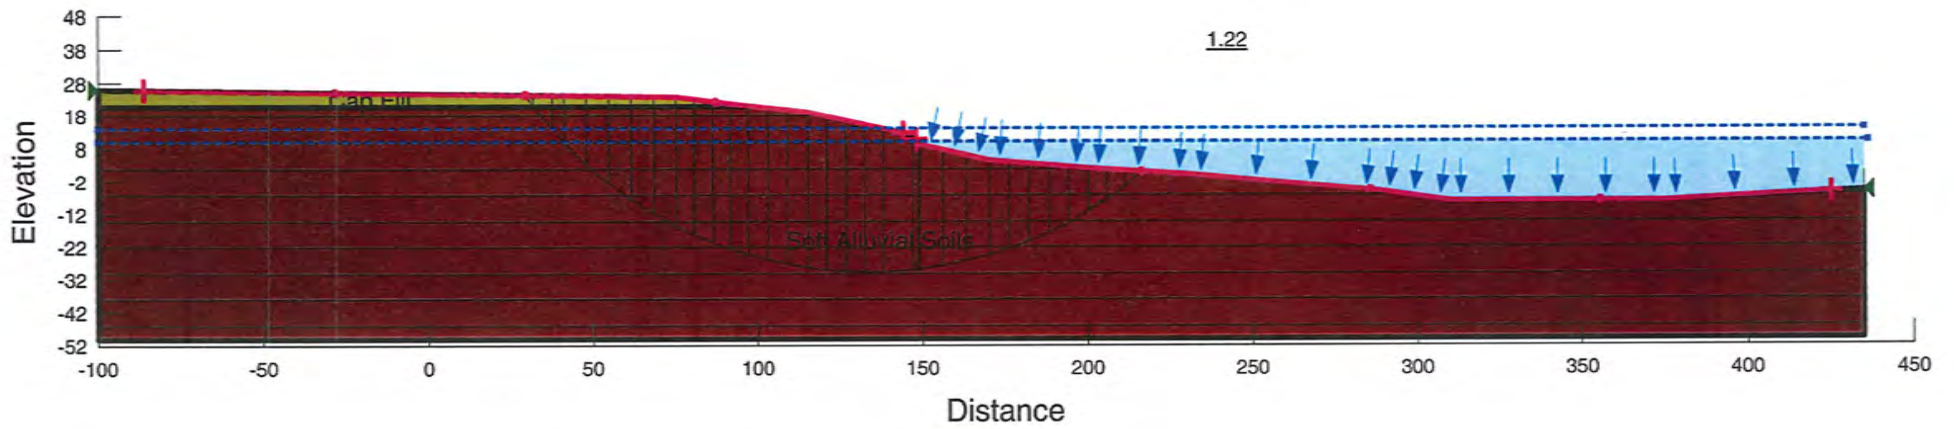
Lake River Remediation
Critical Section at 7+85
Existing Condition - Rapid Drawdown

Name: Cap Fill Unit Weight: 110 pcf Cohesion: 25 psf Phi: 30 ° Total Cohesion: 600 psf Total Phi: 0 ° Piezometric Line After Drawdown: 1
Name: Soft Alluvial Soils Unit Weight: 100 pcf Cohesion: 0 psf Phi: 22 ° Total Cohesion: 250 psf Total Phi: 0 ° Piezometric Line After Drawdown: 1

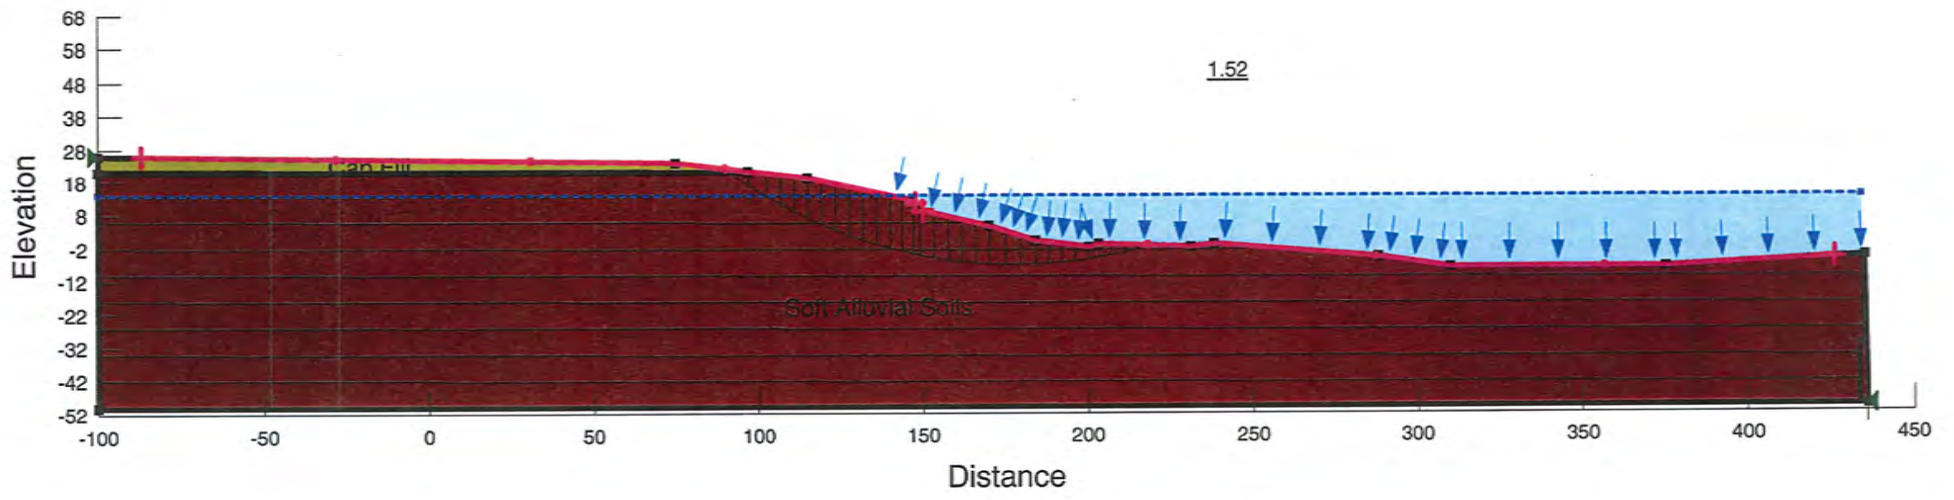
**Lake River Remediation
Critical Section at 7+85
Temporary Condition - OHW**

Name: Cap Fill Unit Weight: 110 pcf Cohesion: 25 psf Phi: 30 °
Name: Soft Alluvial Soils Unit Weight: 100 pcf Cohesion: 0 psf Phi: 22 °

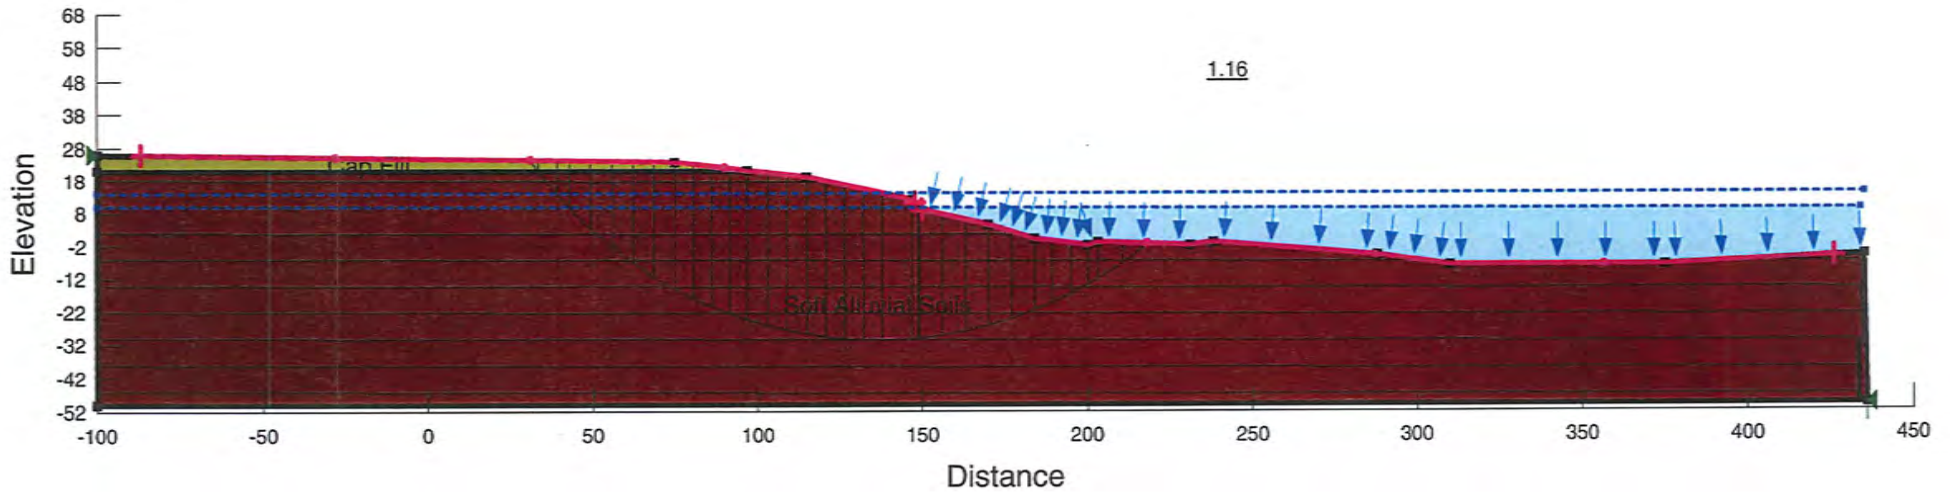
**Lake River Remediation
Critical Section at 7+85
Temporary Condition - Rapid Drawdown**

Name: Cap Fill Unit Weight: 110 pcf Cohesion: 25 psf Phi: 30° Total Cohesion: 600 psf Total Phi: 0° Piezometric Line After Drawdown: 1
Name: Soft Alluvial Soils Unit Weight: 100 pcf Cohesion: 0 psf Phi: 22° Total Cohesion: 250 psf Total Phi: 0° Piezometric Line After Drawdown: 1

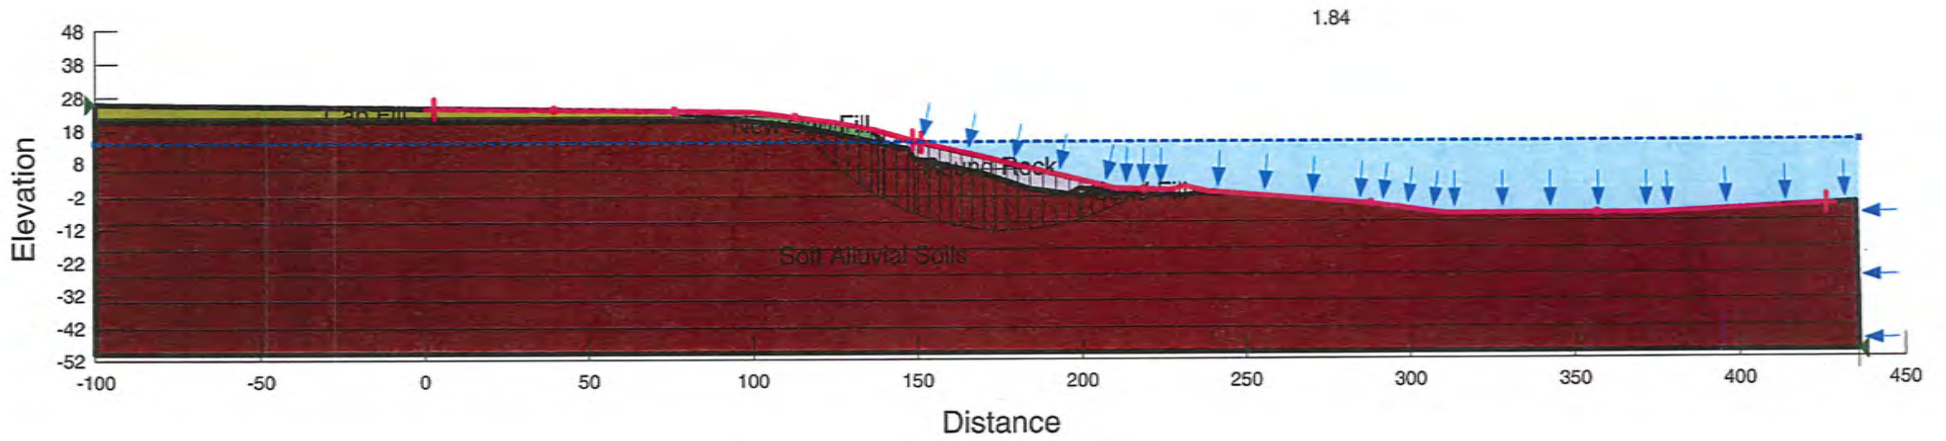
**Lake River Remediation
Critical Section at 7+85
Permanent Condition - OHW**

Name: Cap Fill Unit Weight: 110 pcf Cohesion: 25 psf Phi: 30 °
 Name: Soft Alluvial Soils Unit Weight: 100 pcf Cohesion: 0 psf Phi: 22 °
 Name: New Cap Fill Unit Weight: 110 pcf Cohesion: 25 psf Phi: 30 °
 Name: Round Rock Unit Weight: 125 pcf Cohesion: 0 psf Phi: 28 °
 Name: Sand Fill Unit Weight: 100 pcf Cohesion: 0 psf Phi: 32 °

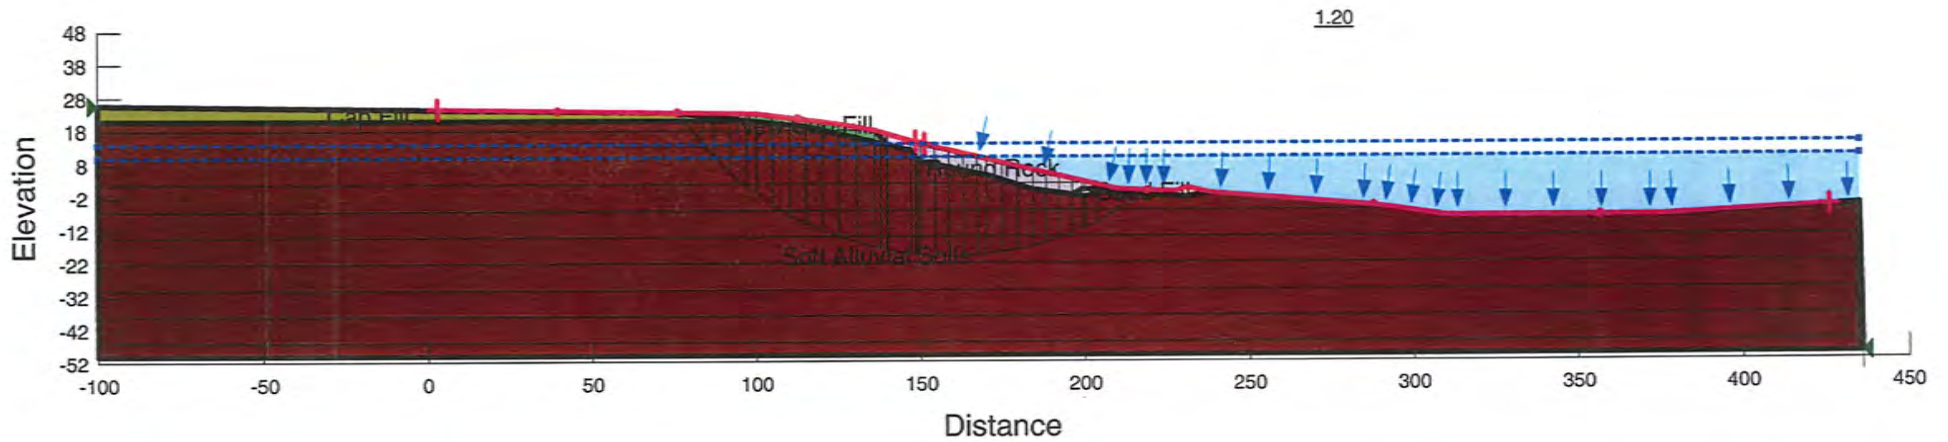
**Lake River Remediation
Critical Section at 7+85
Permanent Condition -Rapid Drawdown**

Name: Cap Fill Unit Weight: 110 pcf Cohesion: 25 psf Phi: 30° Total Cohesion: 600 psf Total Phi: 0° Piezometric Line After Drawdown: 2
 Name: Soft Alluvial Soils Unit Weight: 100 pcf Cohesion: 0 psf Phi: 22° Total Cohesion: 250 psf Total Phi: 0° Piezometric Line After Drawdown: 2
 Name: New Cap Fill Unit Weight: 110 pcf Cohesion: 25 psf Phi: 30° Total Cohesion: 1,000 psf Total Phi: 0° Piezometric Line After Drawdown: 2
 Name: Round Rock Unit Weight: 125 pcf Cohesion: 0 psf Phi: 28° Total Cohesion: 1 psf Total Phi: 27° Piezometric Line After Drawdown: 2
 Name: Sand Fill Unit Weight: 100 pcf Cohesion: 0 psf Phi: 32° Total Cohesion: 1 psf Total Phi: 31° Piezometric Line After Drawdown: 2

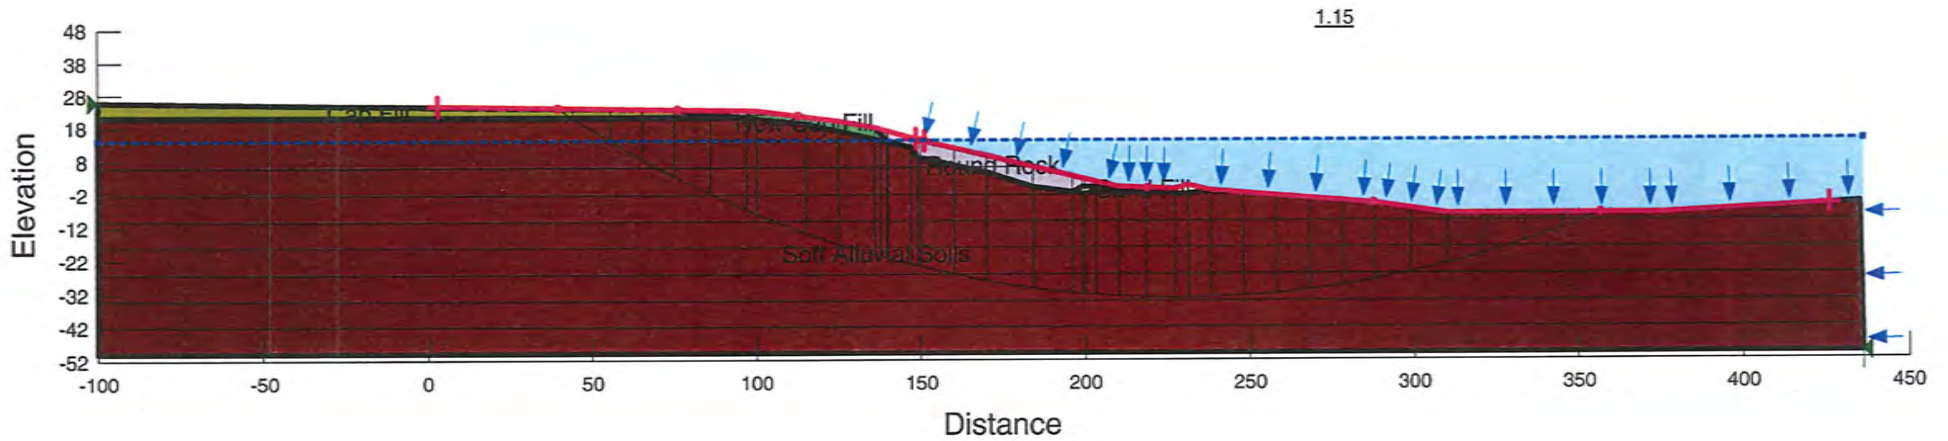
**Lake River Remediation
Critical Section at 7+85
Permanent & Seismic Condition - OHW**

Name: Cap Fill Unit Weight: 110 pcf Cohesion: 25 psf Phi: 30 °
 Name: Soft Alluvial Soils Unit Weight: 100 pcf Cohesion: 100 psf Phi: 25 °
 Name: New Cap Fill Unit Weight: 110 pcf Cohesion: 25 psf Phi: 30 °
 Name: Round Rock Unit Weight: 125 pcf Cohesion: 0 psf Phi: 28 °
 Name: Sand Fill Unit Weight: 100 pcf Cohesion: 0 psf Phi: 32 °

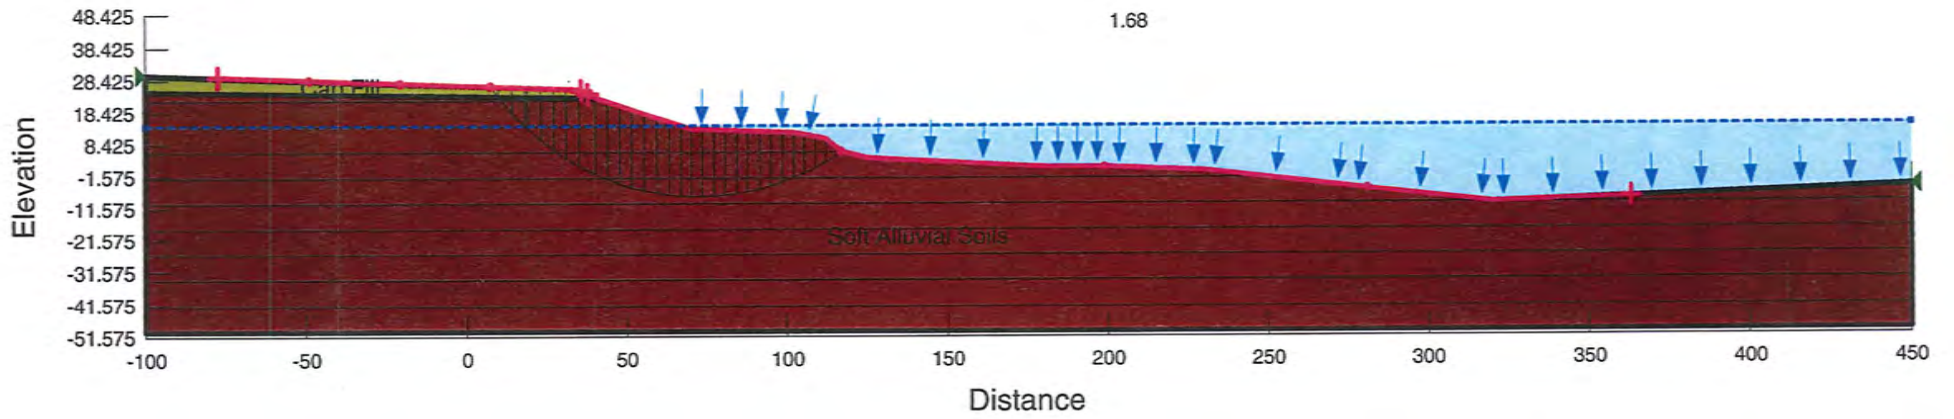
Lake River Remediation
Critical Section at 19+00
Existing Condition - OHW

Name: Cap Fill Unit Weight: 110 pcf Cohesion: 25 psf Phi: 30 °
Name: Soft Alluvial Soils Unit Weight: 100 pcf Cohesion: 0 psf Phi: 22 °

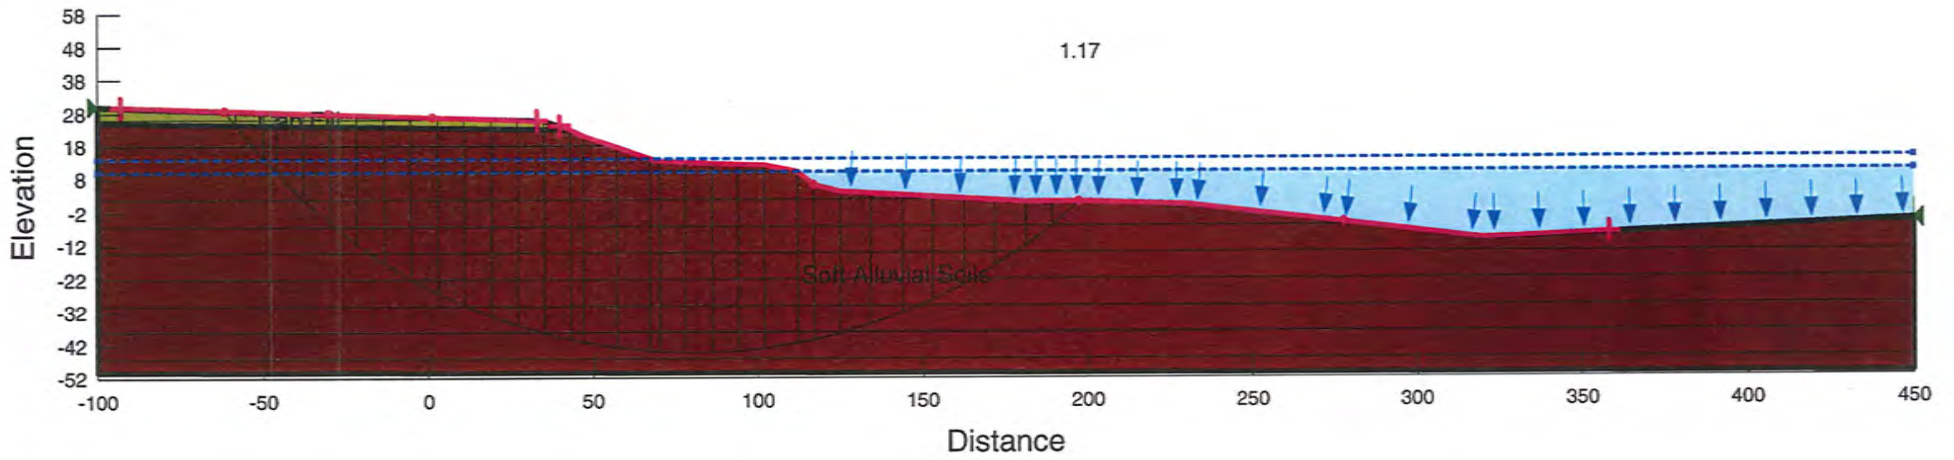
**Lake River Remediation
Critical Section at - 19+00
Existing Condition - Rapid Drawdown**

Name: Cap Fill Unit Weight: 110 pcf Cohesion: 25 psf Phi: 30 ° Total Cohesion: 600 psf Total Phi: 0 ° Piezometric Line After Drawdown: 2
Name: Soft Alluvial Soils Unit Weight: 100 pcf Cohesion: 0 psf Phi: 22 ° Total Cohesion: 250 psf Total Phi: 0 ° Piezometric Line After Drawdown: 2

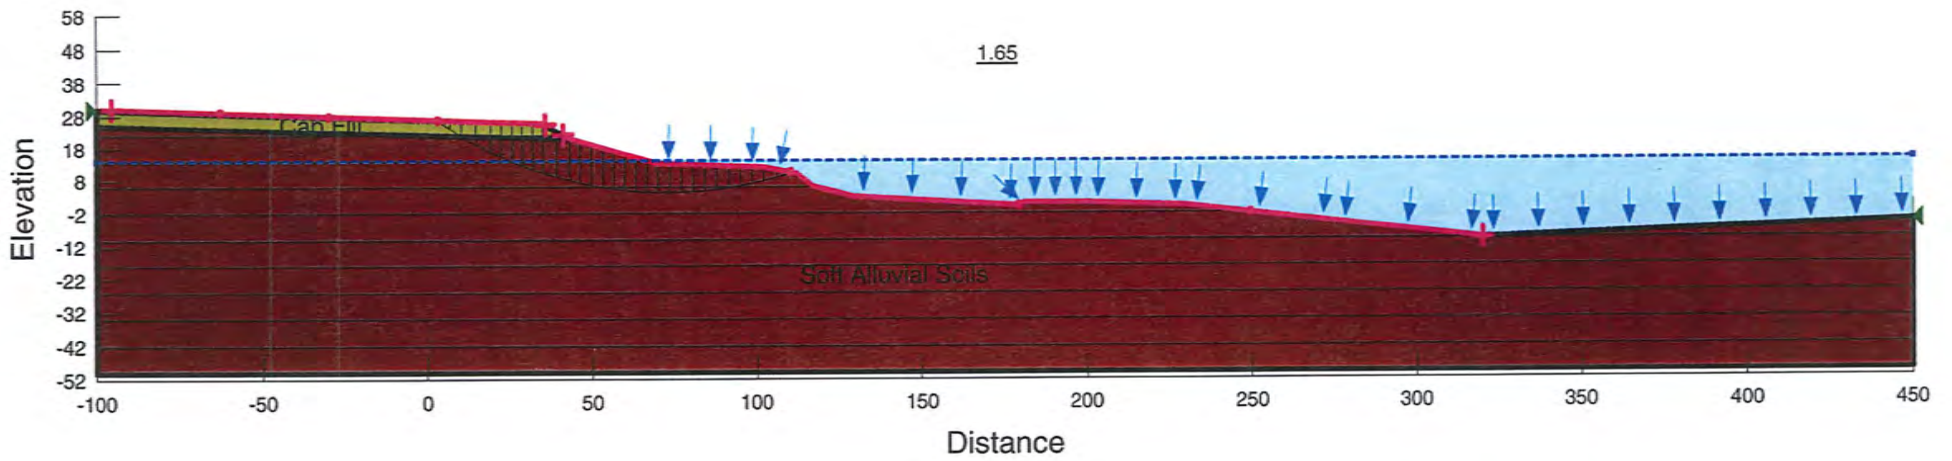
**Lake River Remediation
Critical Section at - 19+00
Temporary Condition - OHW**

Name: Cap Fill Unit Weight: 110 pcf Cohesion: 25 psf Phi: 30 °
Name: Soft Alluvial Soils Unit Weight: 100 pcf Cohesion: 0 psf Phi: 22 °

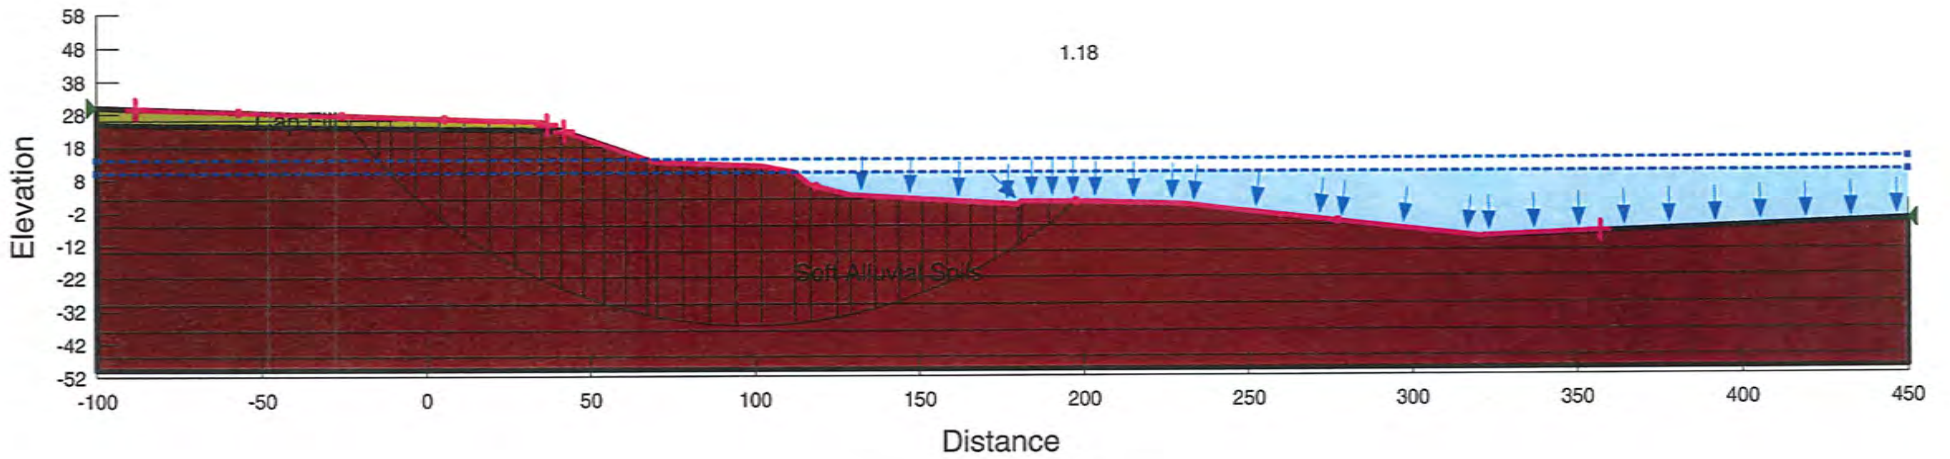
**Lake River Remediation
Critical Section at - 19+00
Temporary Condition - Rapid Drawdown**

Name: Cap Fill Unit Weight: 110 pcf Cohesion: 25 psf Phi: 30 ° Total Cohesion: 600 psf Total Phi: 0 ° Piezometric Line After Drawdown: 2
Name: Soft Alluvial Soils Unit Weight: 100 pcf Cohesion: 0 psf Phi: 22 ° Total Cohesion: 250 psf Total Phi: 0 ° Piezometric Line After Drawdown: 2

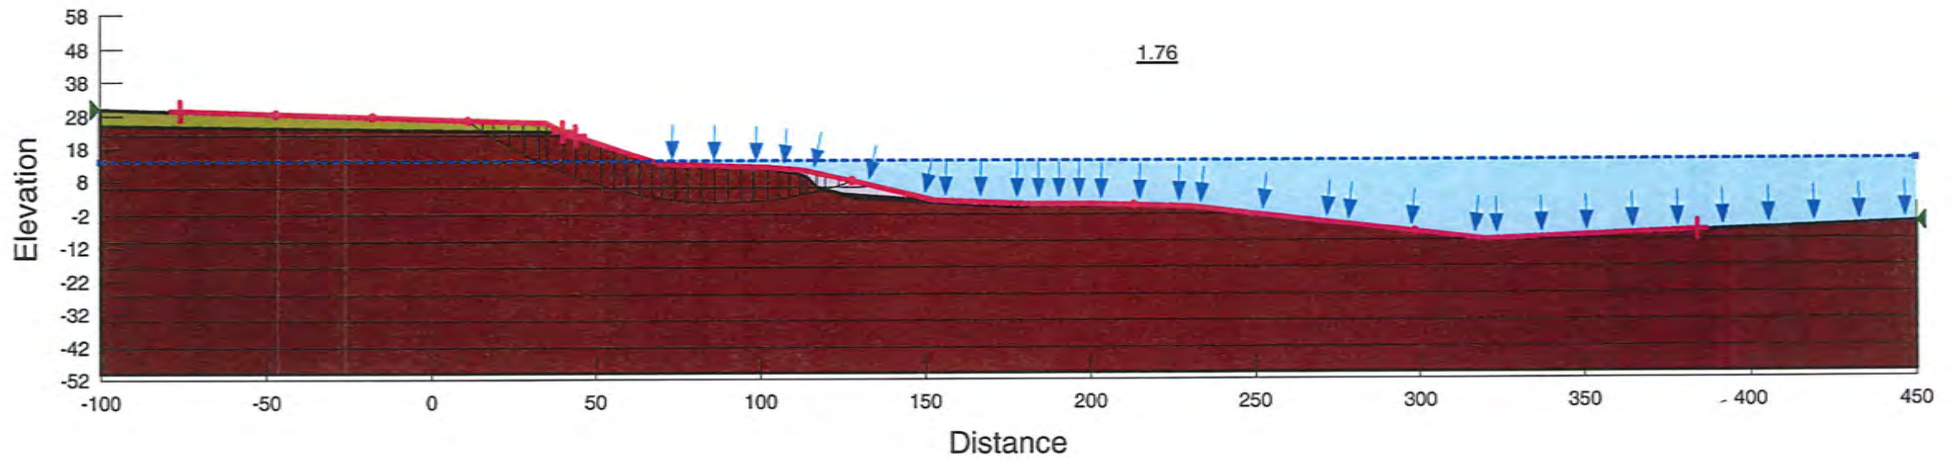
**Lake River Remediation
Critical Section at 19+00
Permanent Condition - OHW**

Name: Cap Fill Unit Weight: 110 pcf Cohesion: 25 psf Phi: 30 °
Name: Soft Alluvial Soils Unit Weight: 100 pcf Cohesion: 0 psf Phi: 22 °
Name: Round Rock Unit Weight: 125 pcf Cohesion: 0 psf Phi: 28 °
Name: Sand Fill Unit Weight: 100 pcf Cohesion: 0 psf Phi: 32 °

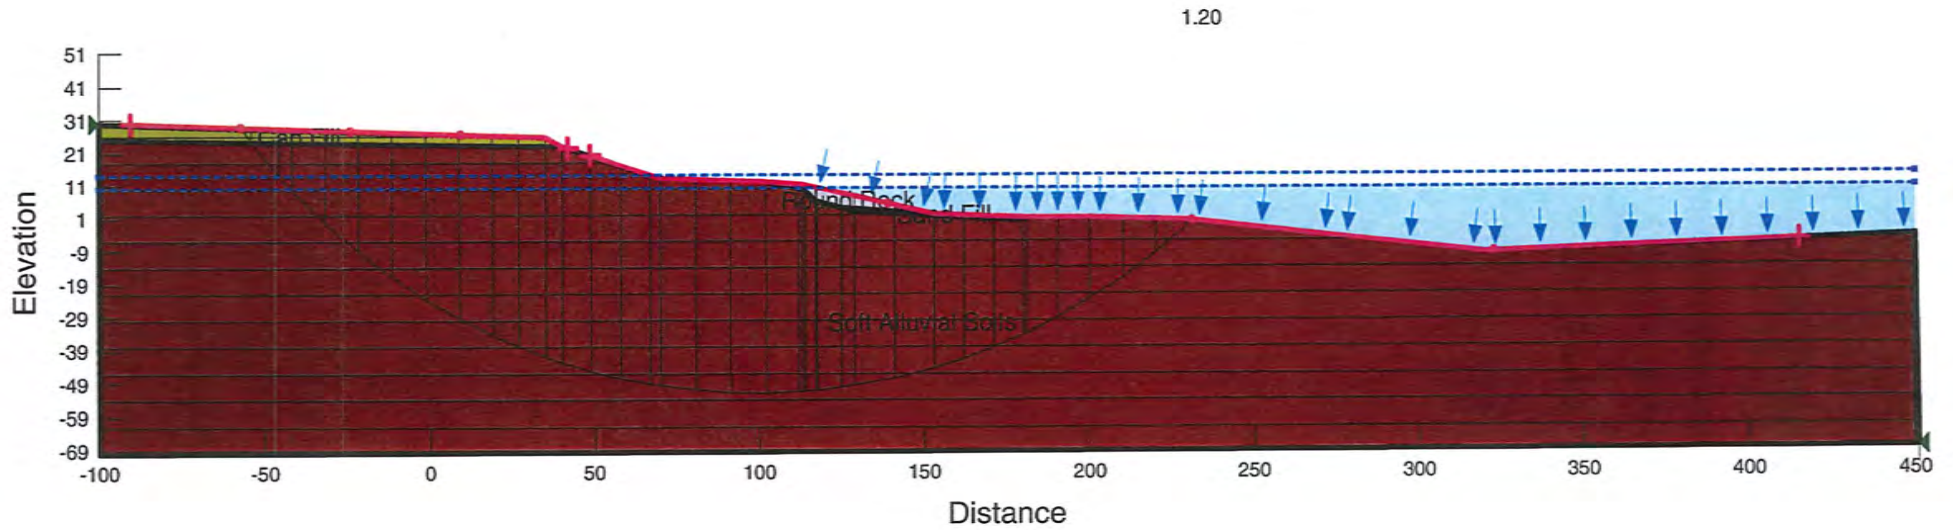
**Lake River Remediation
Critical Section at 19+00
Permanent Condition - Rapid Drawdown**

Name: Cap Fill Unit Weight: 110 pcf Cohesion: 25 psf Phi: 30° Total Cohesion: 600 psf Total Phi: 0° Piezometric Line After Drawdown: 2
 Name: Soft Alluvial Soils Unit Weight: 100 pcf Cohesion: 0 psf Phi: 22° Total Cohesion: 250 psf Total Phi: 0° Piezometric Line After Drawdown: 2
 Name: Round Rock Unit Weight: 125 pcf Cohesion: 0 psf Phi: 28° Total Cohesion: 1 psf Total Phi: 27° Piezometric Line After Drawdown: 2
 Name: Sand Fill Unit Weight: 100 pcf Cohesion: 0 psf Phi: 32° Total Cohesion: 1 psf Total Phi: 31° Piezometric Line After Drawdown: 2

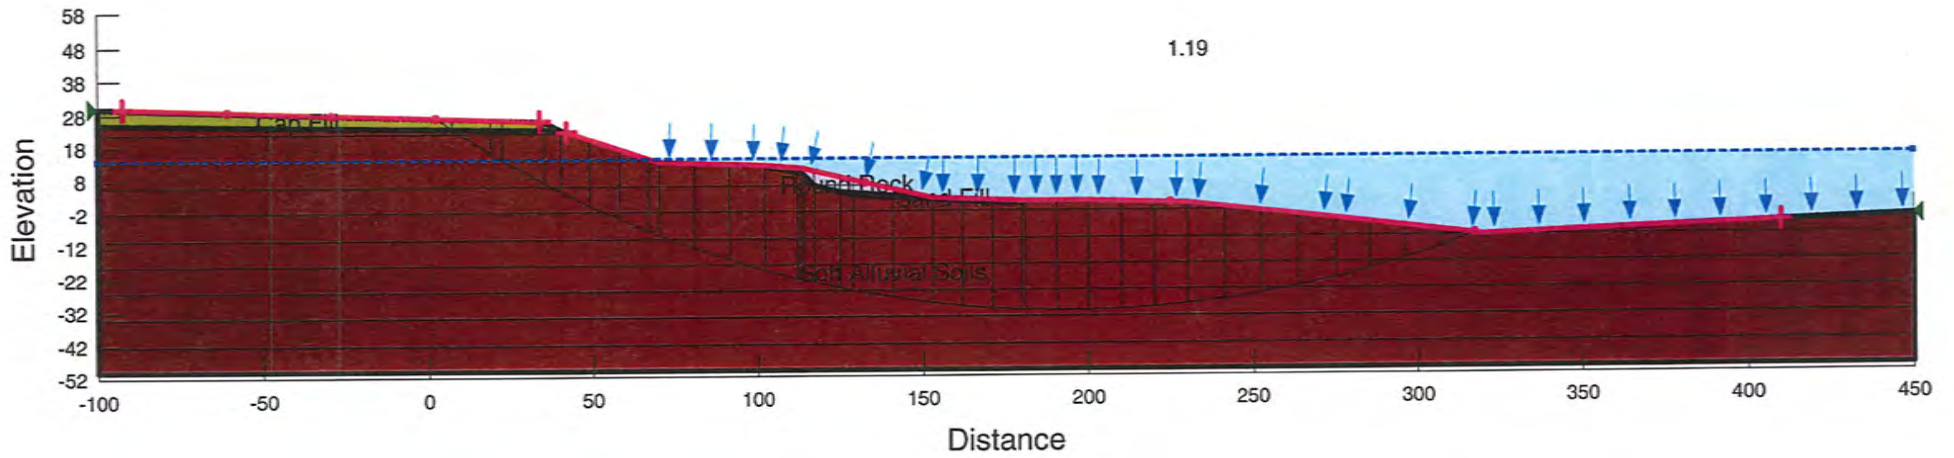
**Lake River Remediation
Critical Section at 19+00
Permanent & Seismic Condition - OHW**

Name: Cap Fill Unit Weight: 110 pcf Cohesion: 25 psf Phi: 30 °
Name: Soft Alluvial Soils Unit Weight: 100 pcf Cohesion: 100 psf Phi: 25 °
Name: Round Rock Unit Weight: 125 pcf Cohesion: 0 psf Phi: 28 °
Name: Sand Fill Unit Weight: 100 pcf Cohesion: 0 psf Phi: 32 °

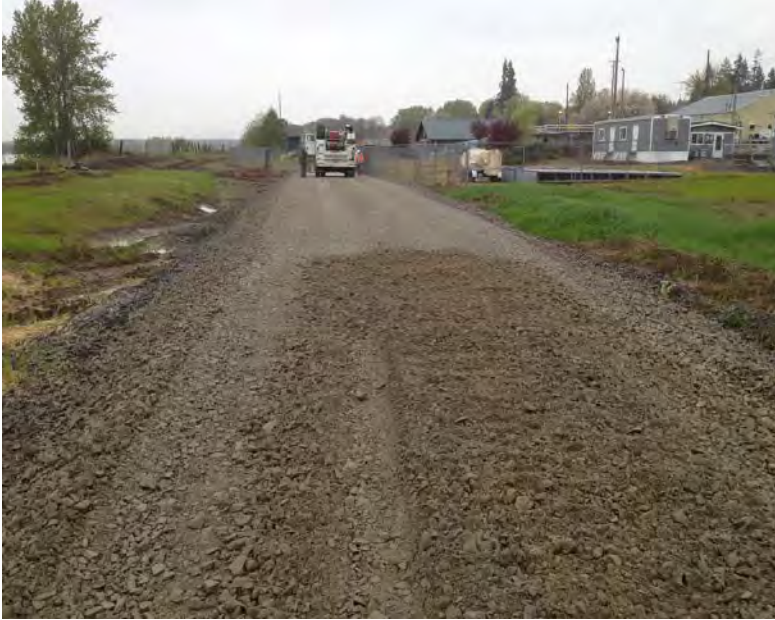
Photo 1: Crushed rock placed on roadway

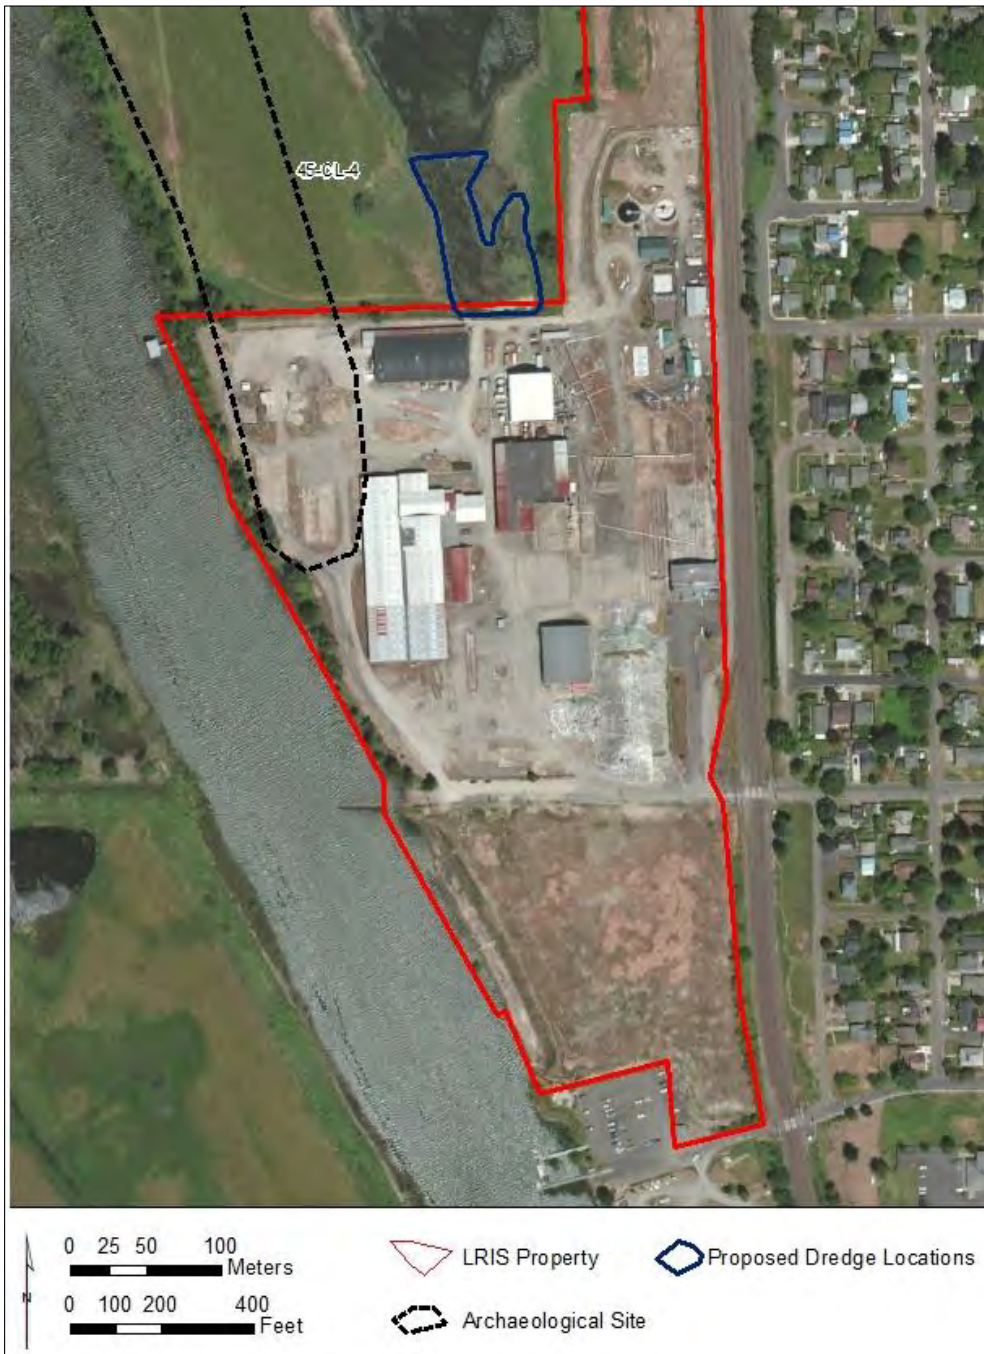
Figure 4. Maximum extent of the Carty Lake dredge area.
