CARTY LAKE BANK USE PLAN

ADDENDUM TO THE JOINT AQUATIC RESOURCES PERMIT
APPLICATION NO. NWS-2013-1209

CARTY LAKE REMEDIAL ACTION
111 W DIVISION STREET
RIDGEFIELD, WASHINGTON

Prepared for
PORT OF RIDGEFIELD
RIDGEFIELD, WA
October 22, 2014
Project No. 9003.01.40

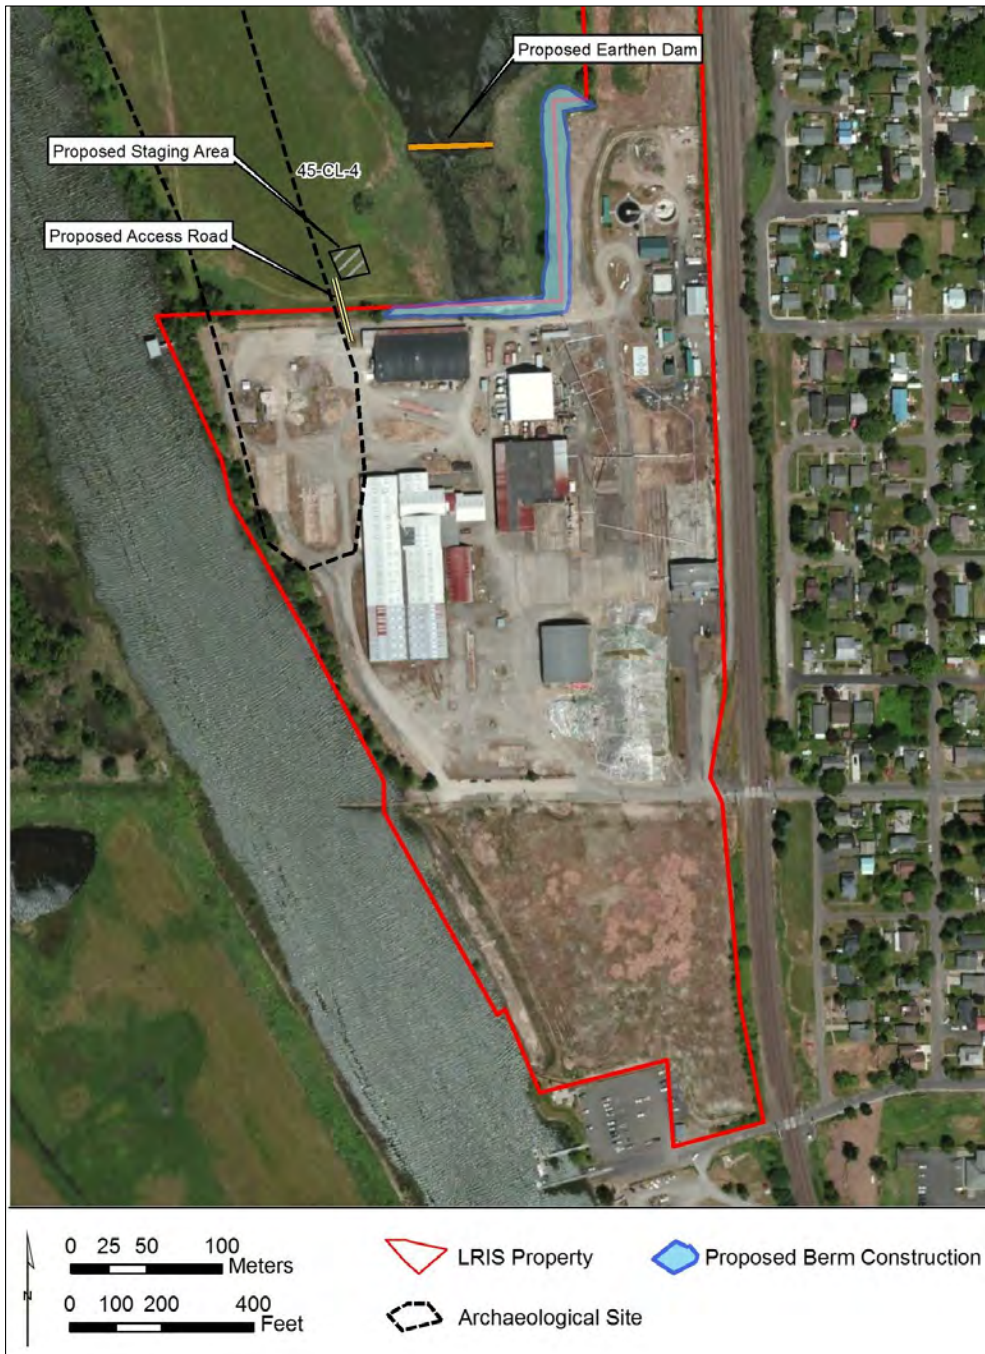
Figure 5. Proposed location of berm construction and associated features at Carty Lake.
